LONG-TERM SURVEILLANCE PLAN FOR THE BODO CANYON DISPOSAL SITE, DURANGO, COLORADO

September 1996

Uranium Mill Tailings Remedial Action Project

**Prepared by
Jacobs Engineering Group Inc.
Albuquerque, New Mexico**

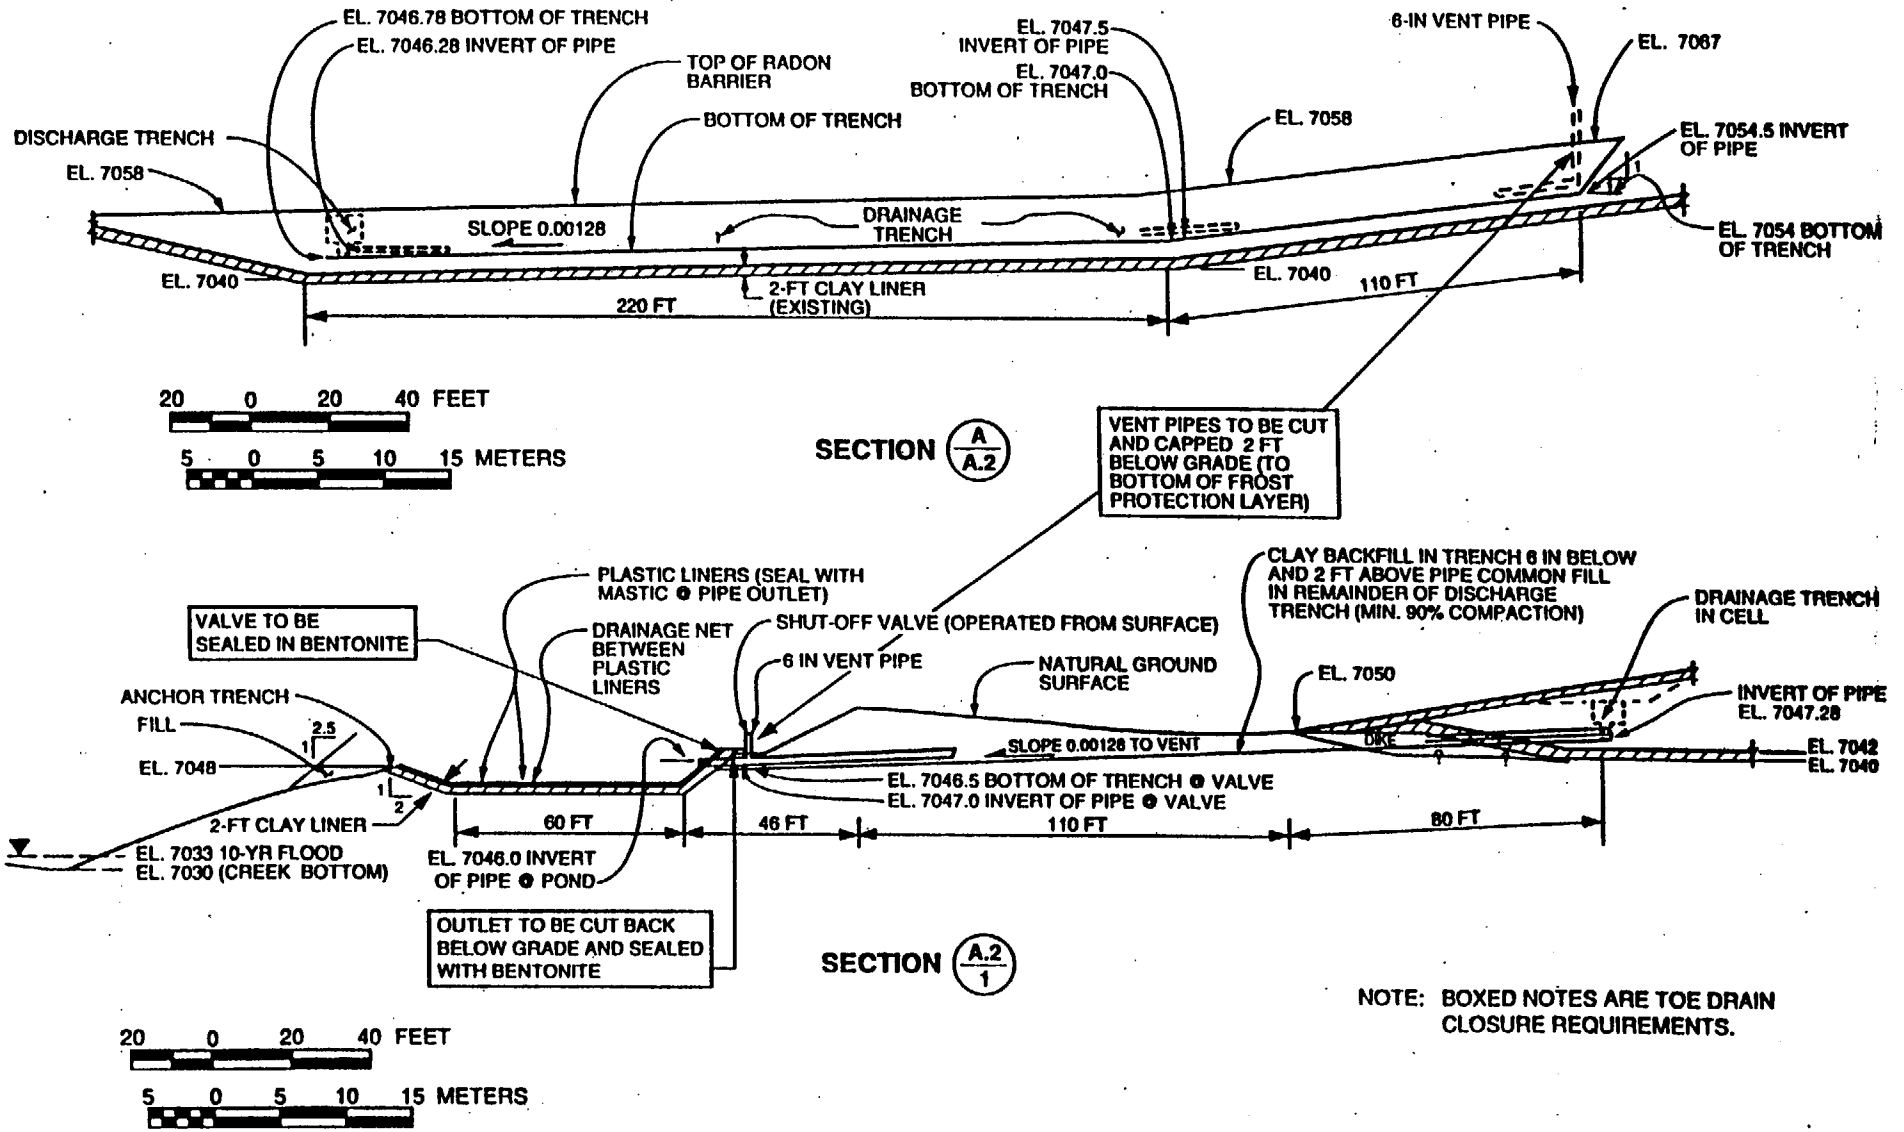
FIGURE A3.2
CROSS SECTION OF DISCHARGE TRENCH AND HOLDING POND
BODO CANYON, COLORADO, SITE

The toe drain and holding pond were installed after extensive seepage appeared on the eastern slope of the disposal cell during construction in the fall of 1988. The toe drain enabled cell closure to proceed by allowing correct placement of the clay cover on unsaturated tailings in the area where the seep appeared. This procedure also prevented hydrostatic pressure from developing against the inside surface of the sideslope. Other alternatives for dewatering the cell were considered, such as deep wells, an ejector system, and horizontal drains. The toe drain was selected because it allowed the disposal cell construction to proceed with minimal effect on the original completion schedule.
