June 20, 2000

Enclosed are the following IRS reports:

- OFFSITE POWER VOLTAGE INADEQUACIES (NRC Information Notice 2000-06).
- INADEQUATE ASSESSMENT OF THE EFFECT OF DIFFERENTIAL TEMPERATURES ON SAFETY-RELATED PUMPS (NRC Information Notice 2000-08).
- USE OF RISK-INFORMED DECISIONMAKING IN LICENSE AMENDMENT REVIEWS (NRC Regulatory Issue Summary 2000-07).

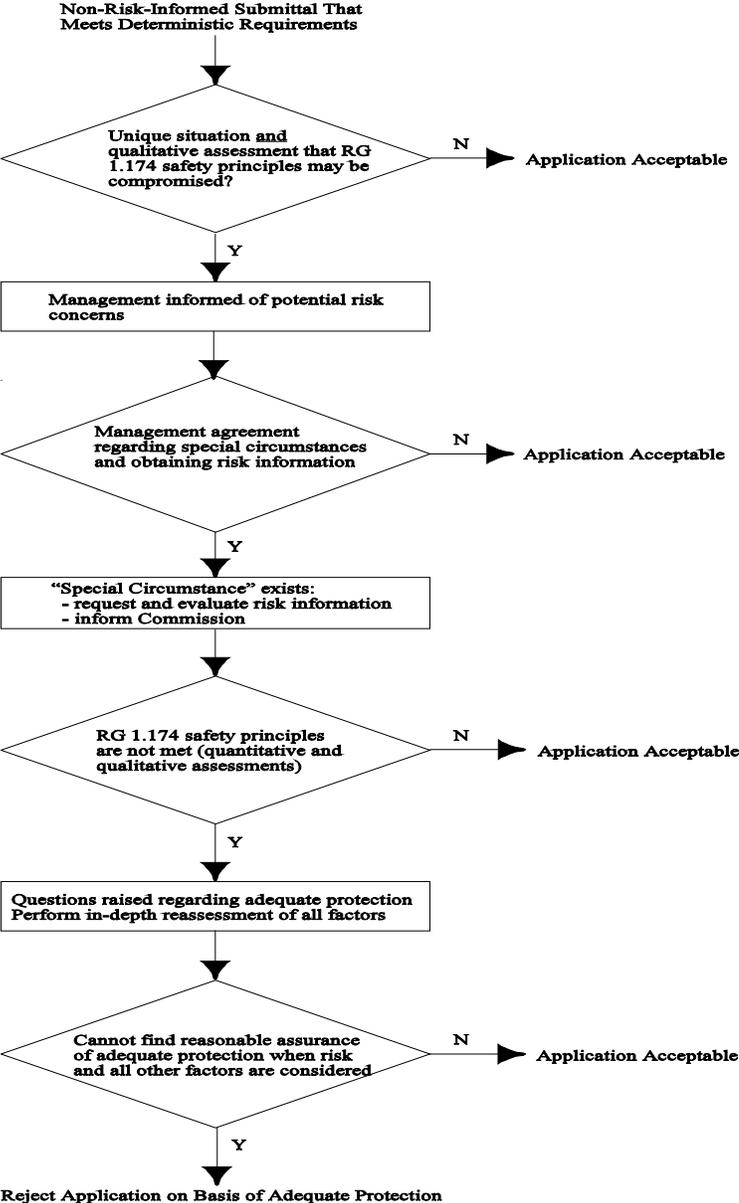
Figure 1 - Process and Logic for Considering Risk in License Amendment Reviews

The process depicted in Figure 1 will be used in the staff review of both licensee-initiated risk-informed license amendment requests, as well as license amendment requests in which the licensee chooses to not submit risk information.

For non-risk-informed license amendment requests, the preliminary assessment would be qualitative with a decision based on engineering judgment since quantitative risk information would not generally be presented in submittals that are not risk informed. If “special circumstances” are believed to exist, the staff will explore in more detail the underlying engineering issues contributing to the risk concern, and the potential risk significance of the license amendment request. These “special circumstances” represent conditions or situations that would raise questions about whether there is adequate protection and that could rebut the normal presumption of adequate protection from compliance with existing requirements. The application and related issues would be given increased attention from the U.S. Nuclear Regulatory Commission management at this point.

Situations that exceed RG 1.174 guidance could constitute a trigger point at which questions are raised as to whether the proposed change provides reasonable assurance of adequate protection. A more in-depth assessment of the special circumstances, the safety principles, and the issues identified for management attention in Section 2.2.6 of RG 1.174 would then be made in order to reach a conclusion regarding the level of safety associated with the requested change. The final acceptability of the proposed change would be based on a consideration of current regulatory requirements, as well as on adherence to the safety principles, and not solely on the basis of a comparison of quantitative probabilistic risk assessment results with numerical acceptance guidelines. The authority provided by the Atomic Energy Act and current regulations requires rejection of a license amendment request if the NRC finds that adequate protection is not provided.
