SUBJECT: NRC COMBINED INSPECTION 50-245/99-05; 50-338/99-05; and 50-423/99-05

On April 19, 1999, the NRC completed an inspection at Millstone Units 1, 2, and 3 reactor facilities. The enclosed report presents the results of that inspection.

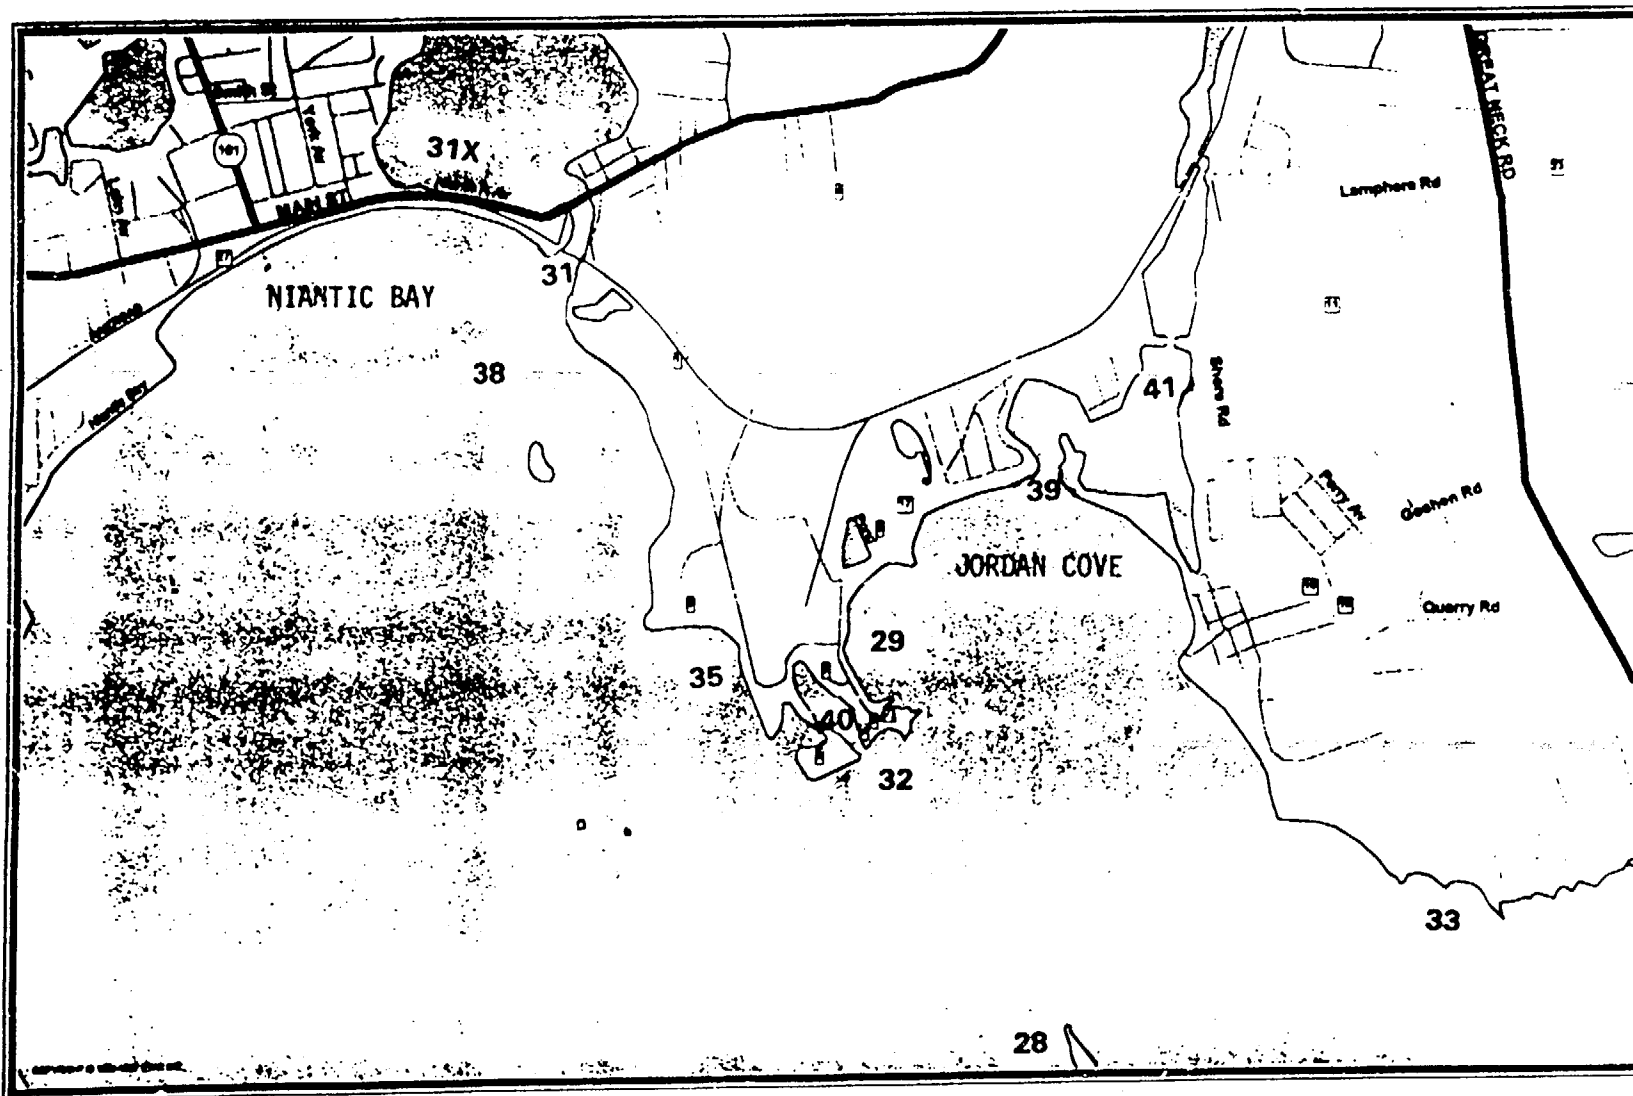
FIGURE 1 to ENCLOSURE 2
AQUATIC SAMPLING LOCATIONS (WITHIN 2 MILES)

Location	Location Name	Direction/Distance from Release Point	Sample Type
28	Two Tree Island	0.8 Mi, SSE	Mussels
29	West Jordan Cove	0.4 Mi, NNE	Clams
31	Niantic Shoals	1.8 Mi, NW 1.5 Mi, NNW	Sediment, Oysters Mussels
31-X	Niantic Shoals	1.8 Mi, NW	Scallops
32	Vicinity of Discharge	-----	Sediment, Oysters, Fish, Seawater, Mussels, Fucus
33	Seaside Point	1.8 Mi, ESE	Sediment
35	Niantic Bay	0.3 Mi, WNW	Lobster, Fish
38	Waterford Shellfish Bed #1	1.0Mi, NW	Clams
39	Jordan Cove Bar	0.8 Mi, NE	Clams
40	Quarry	---	Fish, Oyster, Crabs, Seawater
41	Upper Jordan Cove	1.2 Mi, NE	Mussels

1. NRC Combined Inspection Report 50-245/99-05; 50-336/99-05; 50-423/99-05
2. Table 1, "Aquatic Environmental Sampling Types and Locations" and Figure 1, "Aquatic Sampling Locations"

The inspector reviewed the 1995, 1996, and 1997 Annual Radiological Environmental Operating Reports (AREOR) required by the Technical Specifications (TS). These annual reports provided a comprehensive summary of the results of various environmental measurements taken in support of the licensee's Radiological Environmental Monitoring Program (REMP). The inspector also reviewed the licensee's environmental monitoring results for 1998 relative to samples of clams, scallops, lobster, oysters, and mussels collected at various locations, including Jordan Cove, as stipulated in the Radiological Effluent Monitoring and Offsite Dose Calculation Manual (REMODCM). Aquatic environmental sampling types and locations, within 2 miles from the discharge point (as listed in Table 1 and illustrated in Figure 1 which are contained in an attachment to this inspection report) were particularly assessed since these represented the areas in closest proximity to the release point (sample location 40).
