## **EXHIBIT 6**

### **Millstone Unit 3 Refueling Outage 6 (1999): Excerpts from Reactor Engineering Logs**

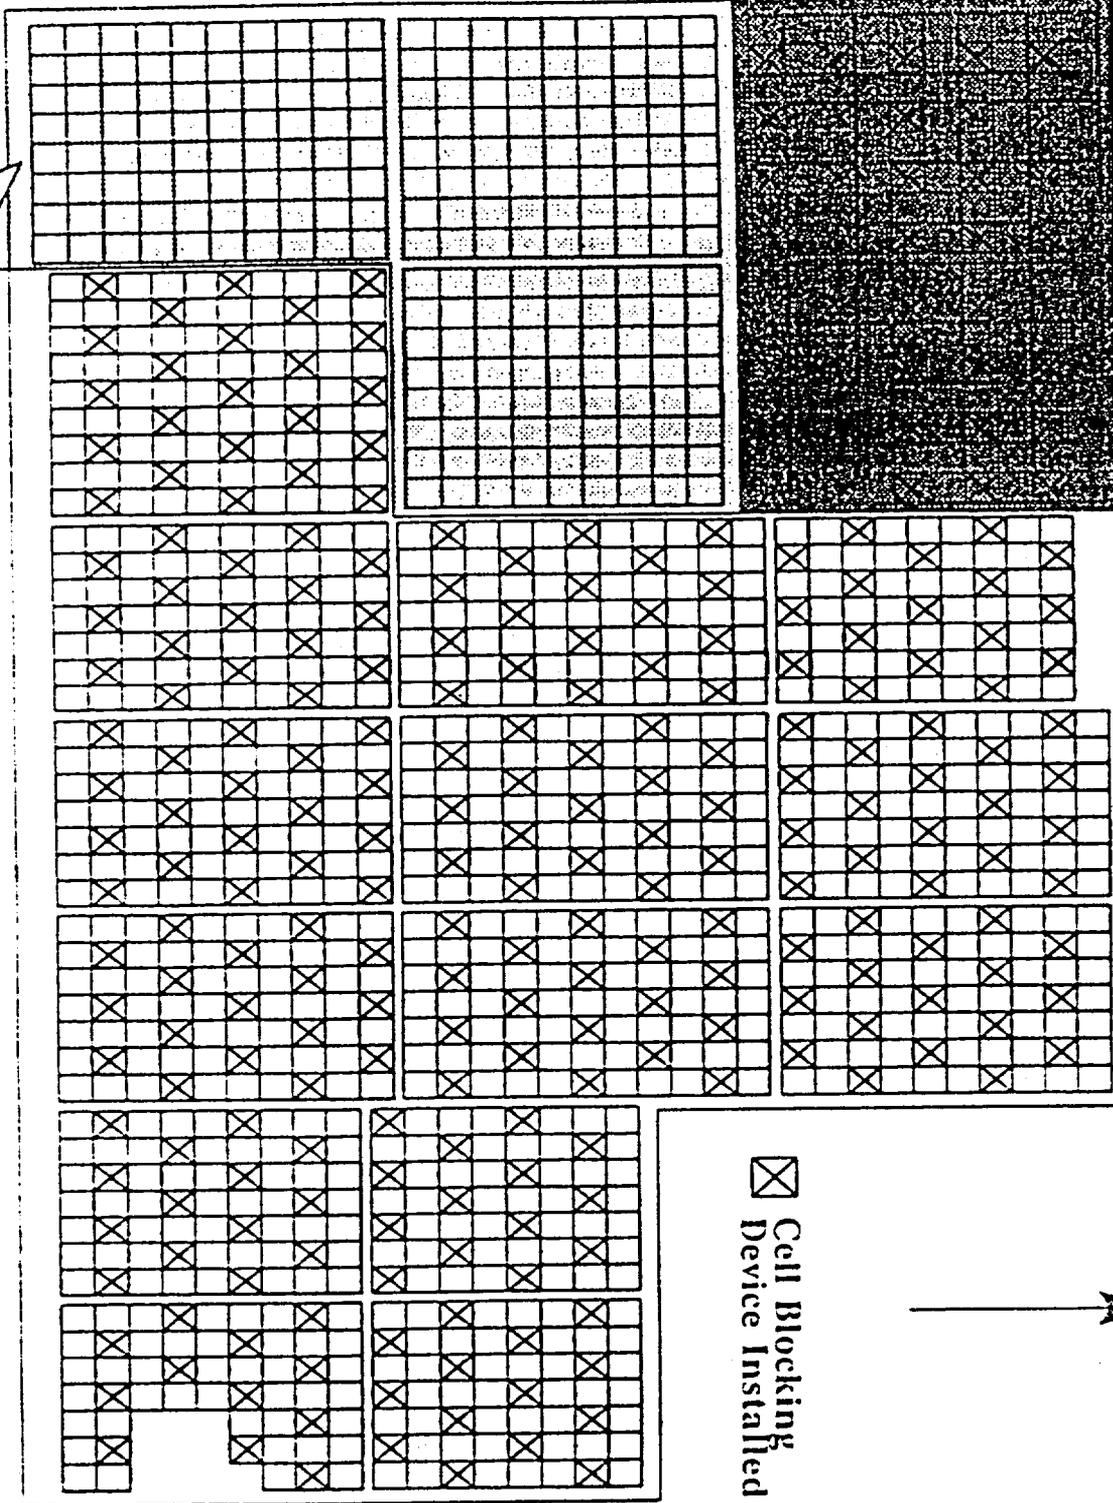
SECRET FUEL POOL ARRANGEMENT UNIT #2

REGION A

REGION C

Cell Blocking  
 Device Installed
