Sherwood Tailings Reclamation Plan

Responses to NRC Comments

Prepared by Washington Department of Health
Environmental Health Programs
Division of Radiation Protection
Waste Management Section

July 2000

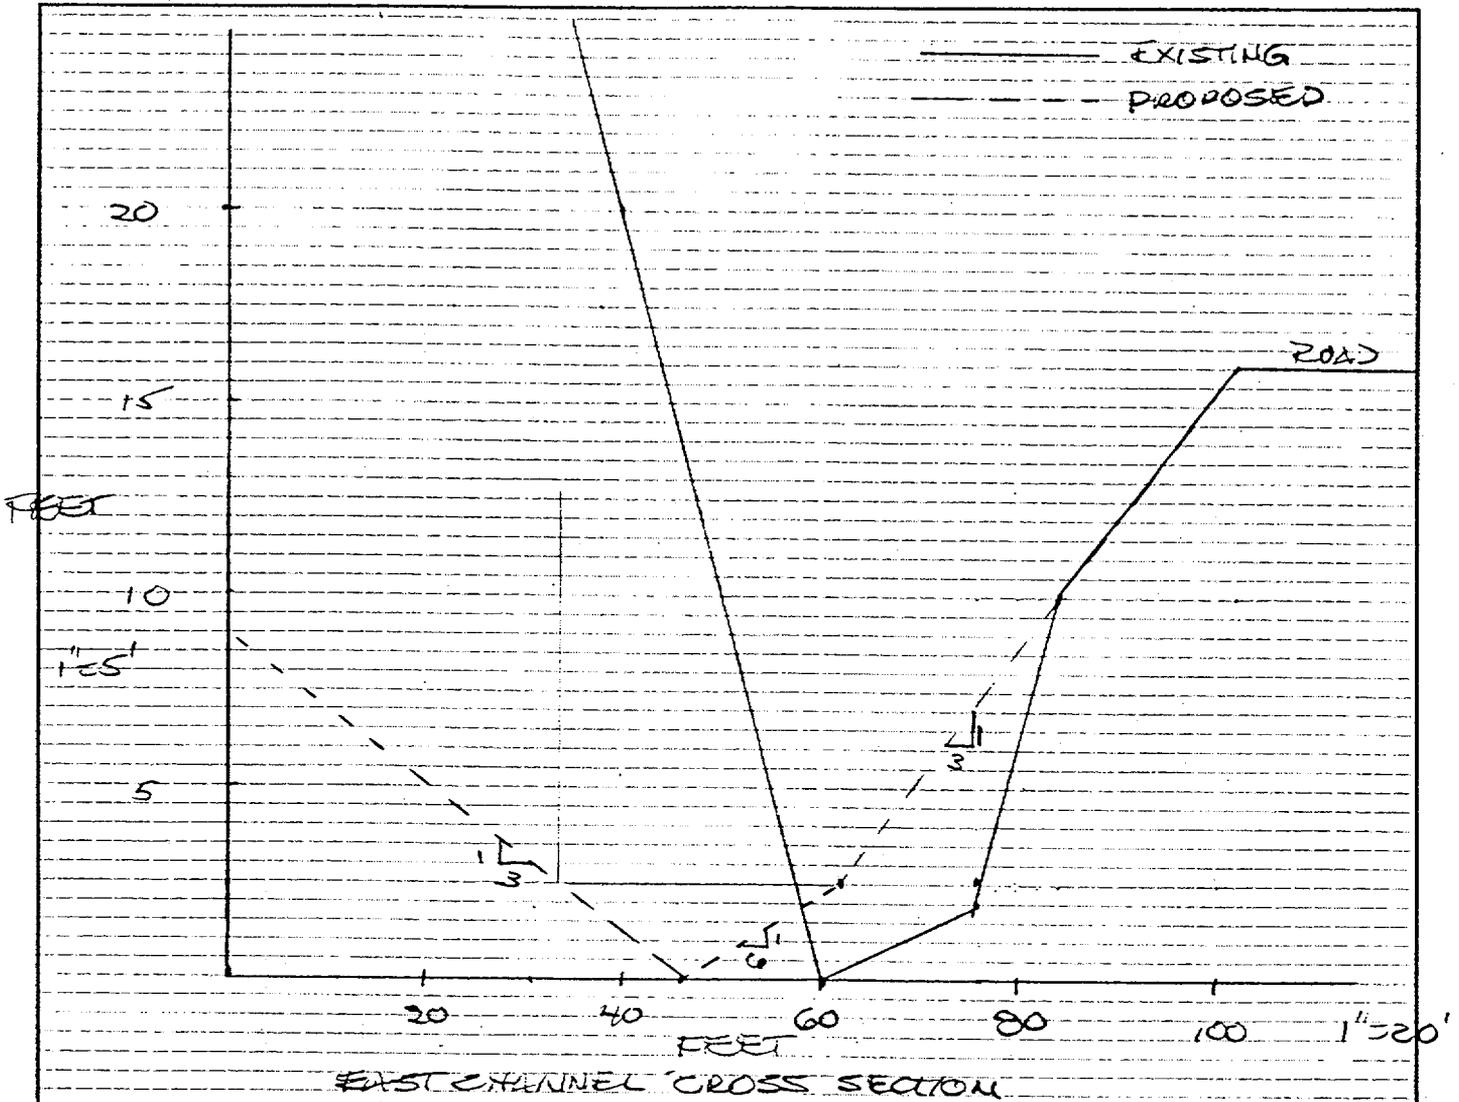
COMPUTE NORMAL DEPTH OF PROPOSED CHANNEL

$$Q = \frac{1.49 A R^{2/3} S^{1/2}}{n}$$

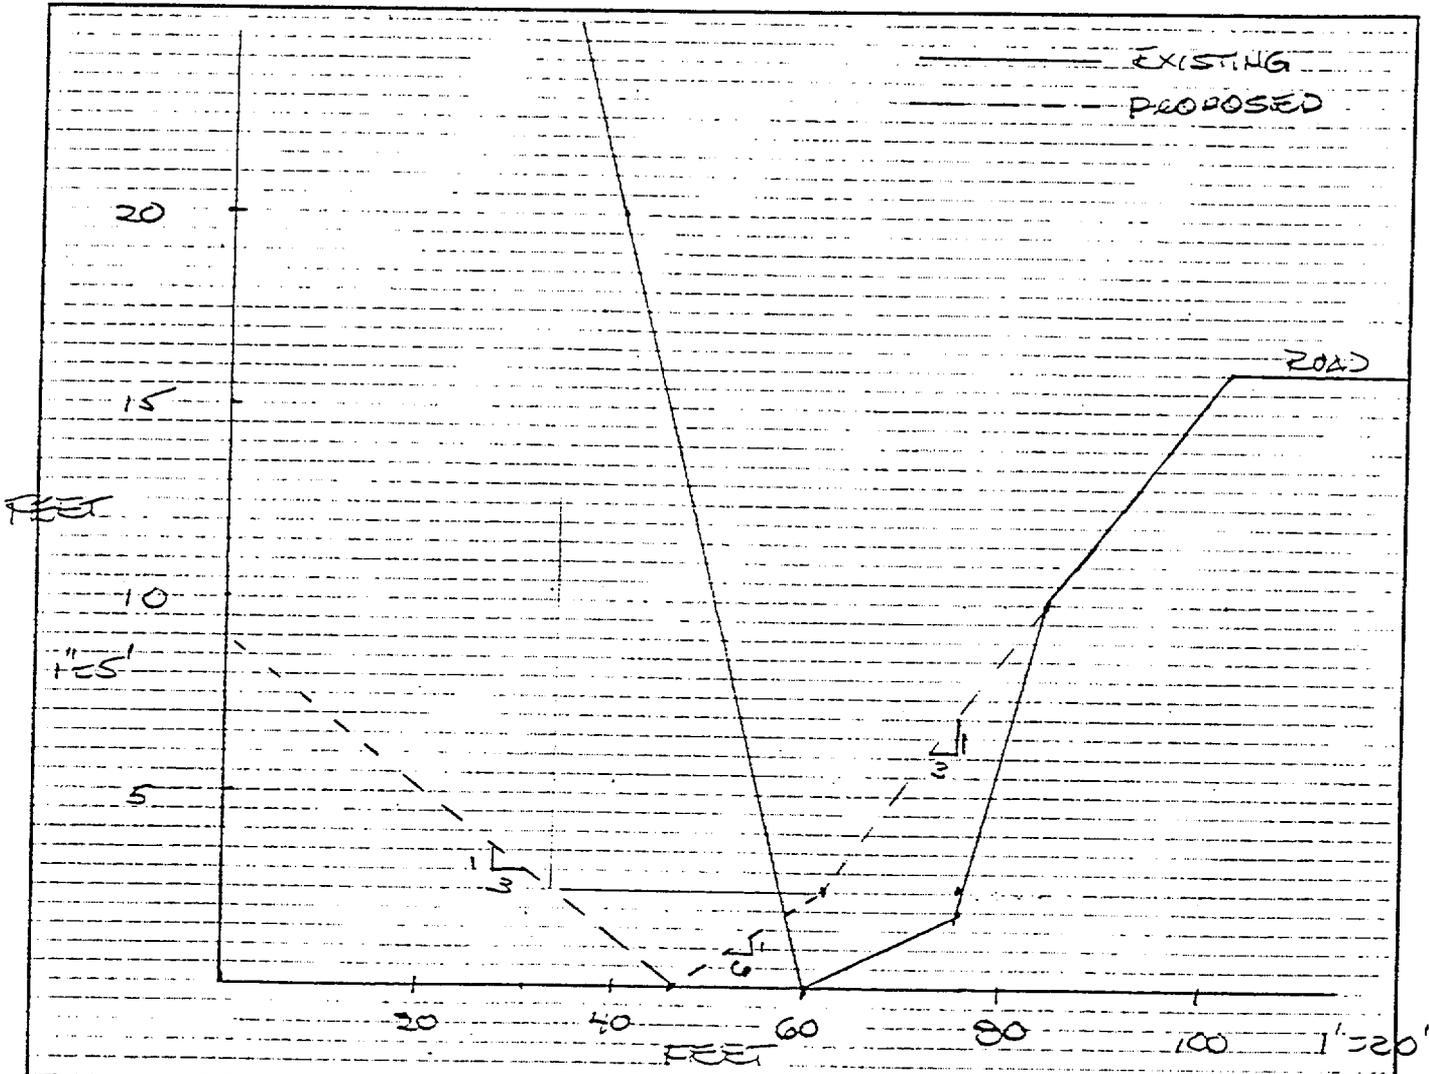
EAST CHANNEL CROSS SECTION

COMPUTE NORMAL DEPTH OF PROPOSED CHANNEL

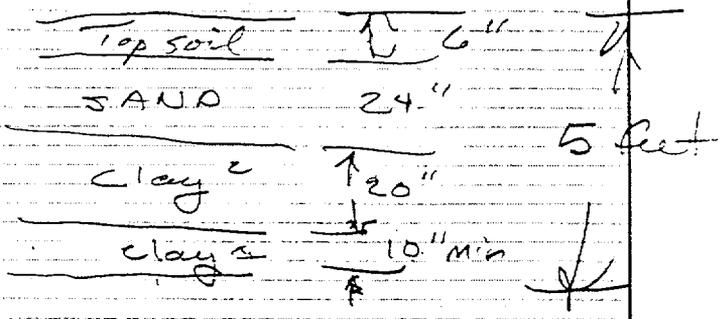
Reclamation cover

Main pond

- 1 Minus 200 fraction 56% or greater
- 2 Min " " 27% or " "

Compaction Standard ASTM D 698 (Standard Proctor)

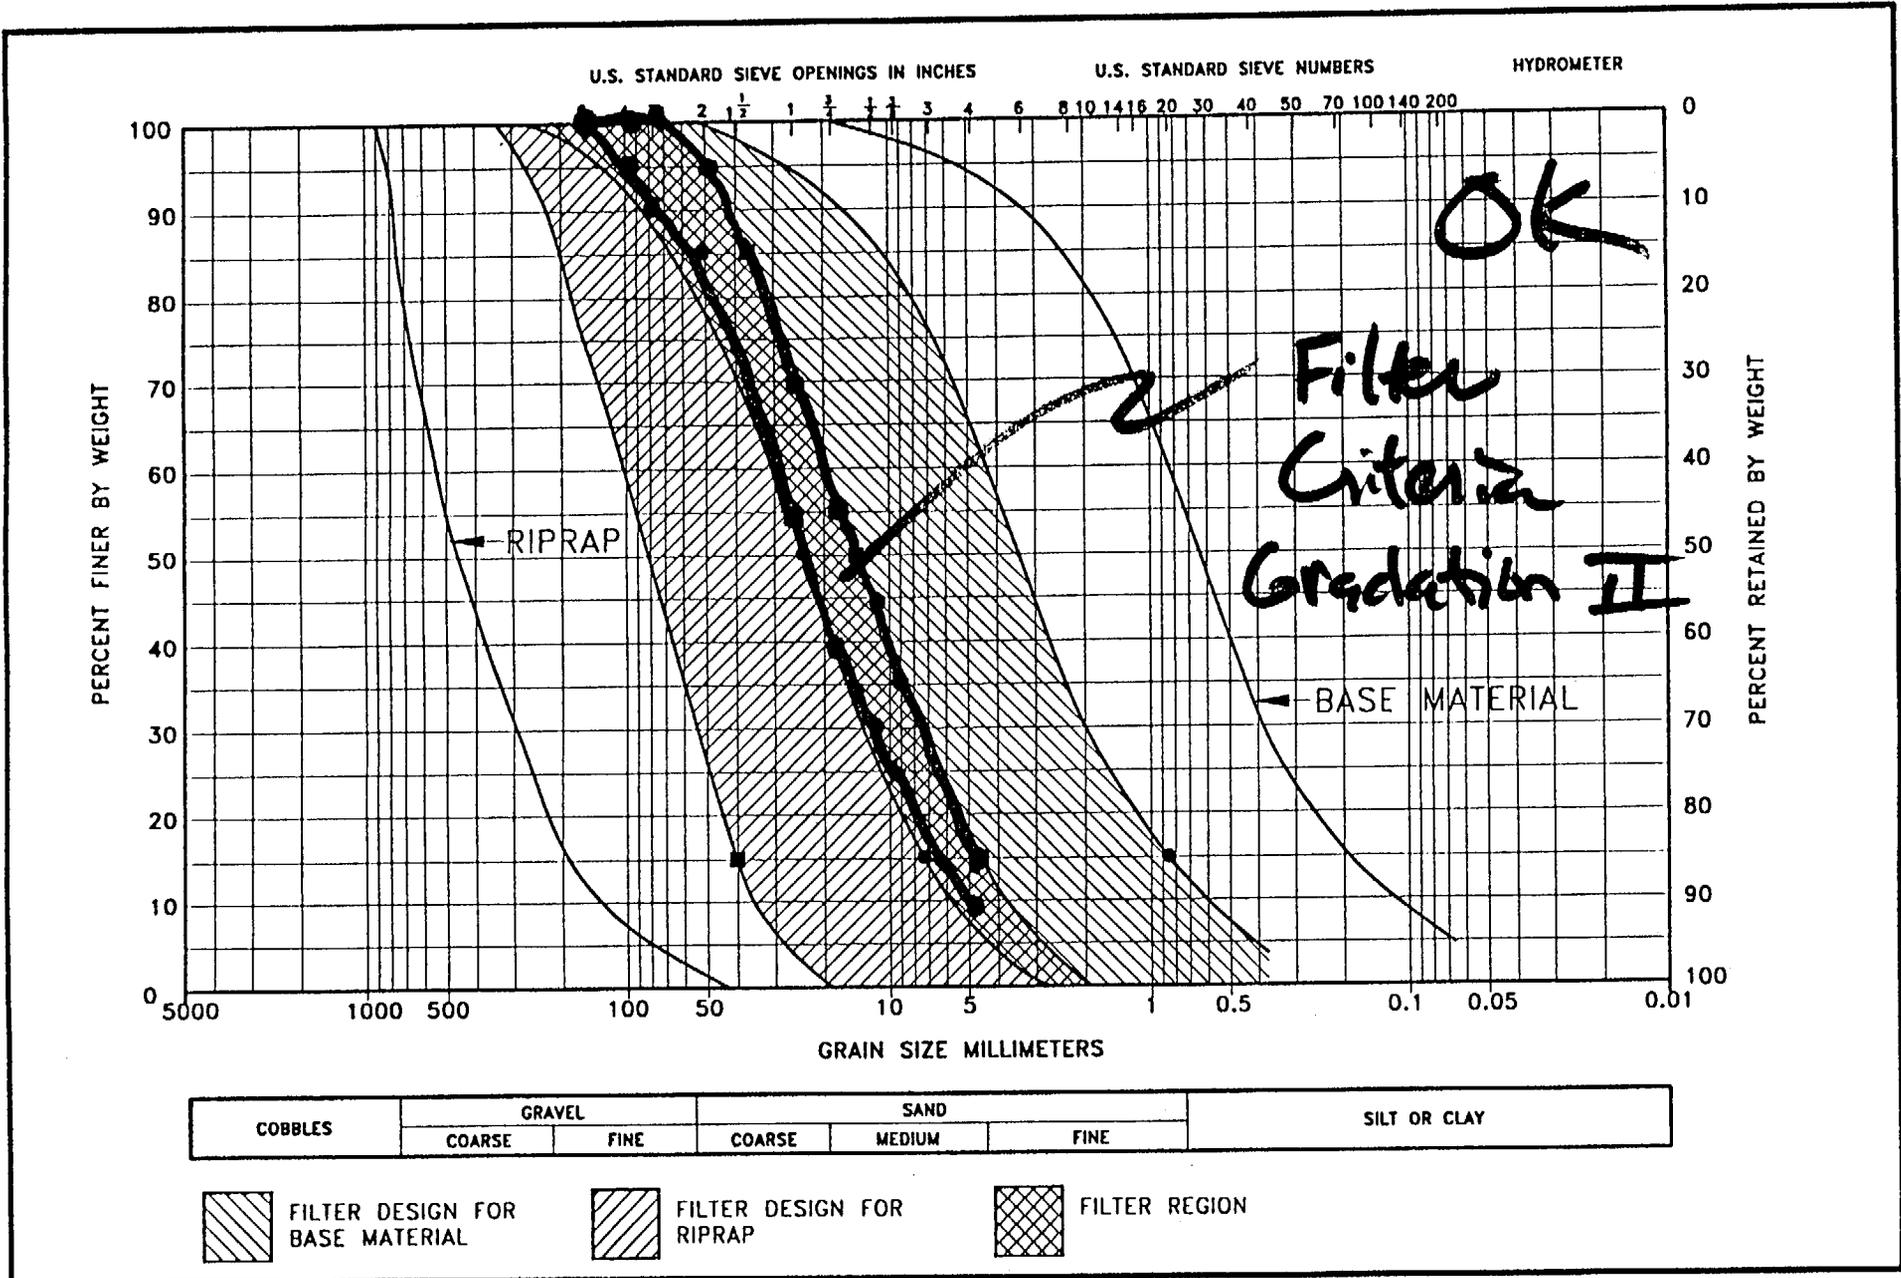
FIGURE 9
 FILTER REGION FOR 18" RIPRAP

OK on Filter layer functioning to protect sand Subgrade assuming d_{85} of sand typically No 10 sieve

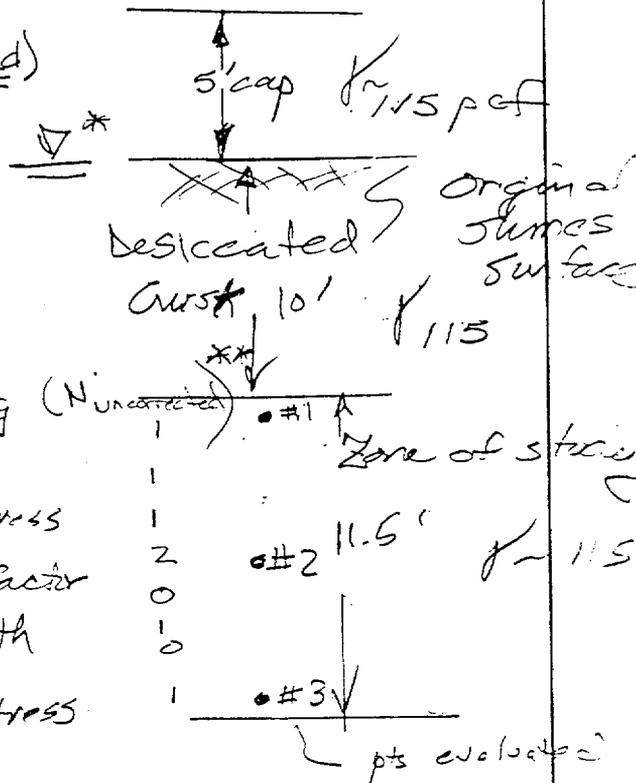
where a_{max} is the peak ground acceleration $\sim 0.07g$ ($N_{uncorrected}$)
 σ_0 ~ is the total stress
 σ'_0 ~ is the effective stress
 r_d ~ is the reduction factor for a_{max} with depth

τ_{ave} ~ Cyclic shear stress

Point	① a_{max}	② r_d^*	③ ① x ②	σ pcf	σ'_0	$\frac{\sigma_0}{\sigma'_0}$	④ $0.65 \times ③ \times ④$	Reduction factor for Earthquake < 7.5	$\frac{\tau_{ave}}{\sigma'_0}$ <small>corrected for Earthquake</small>
1	0.07	0.9	0.063	1725	1100	1.568	0.064	0.8	0.051
2	0.07	0.9	"	2300	1305	1.685	0.069	0.8	0.055
3	0.07	0.9	"	2875	1627	1.767	0.072	0.8	0.058

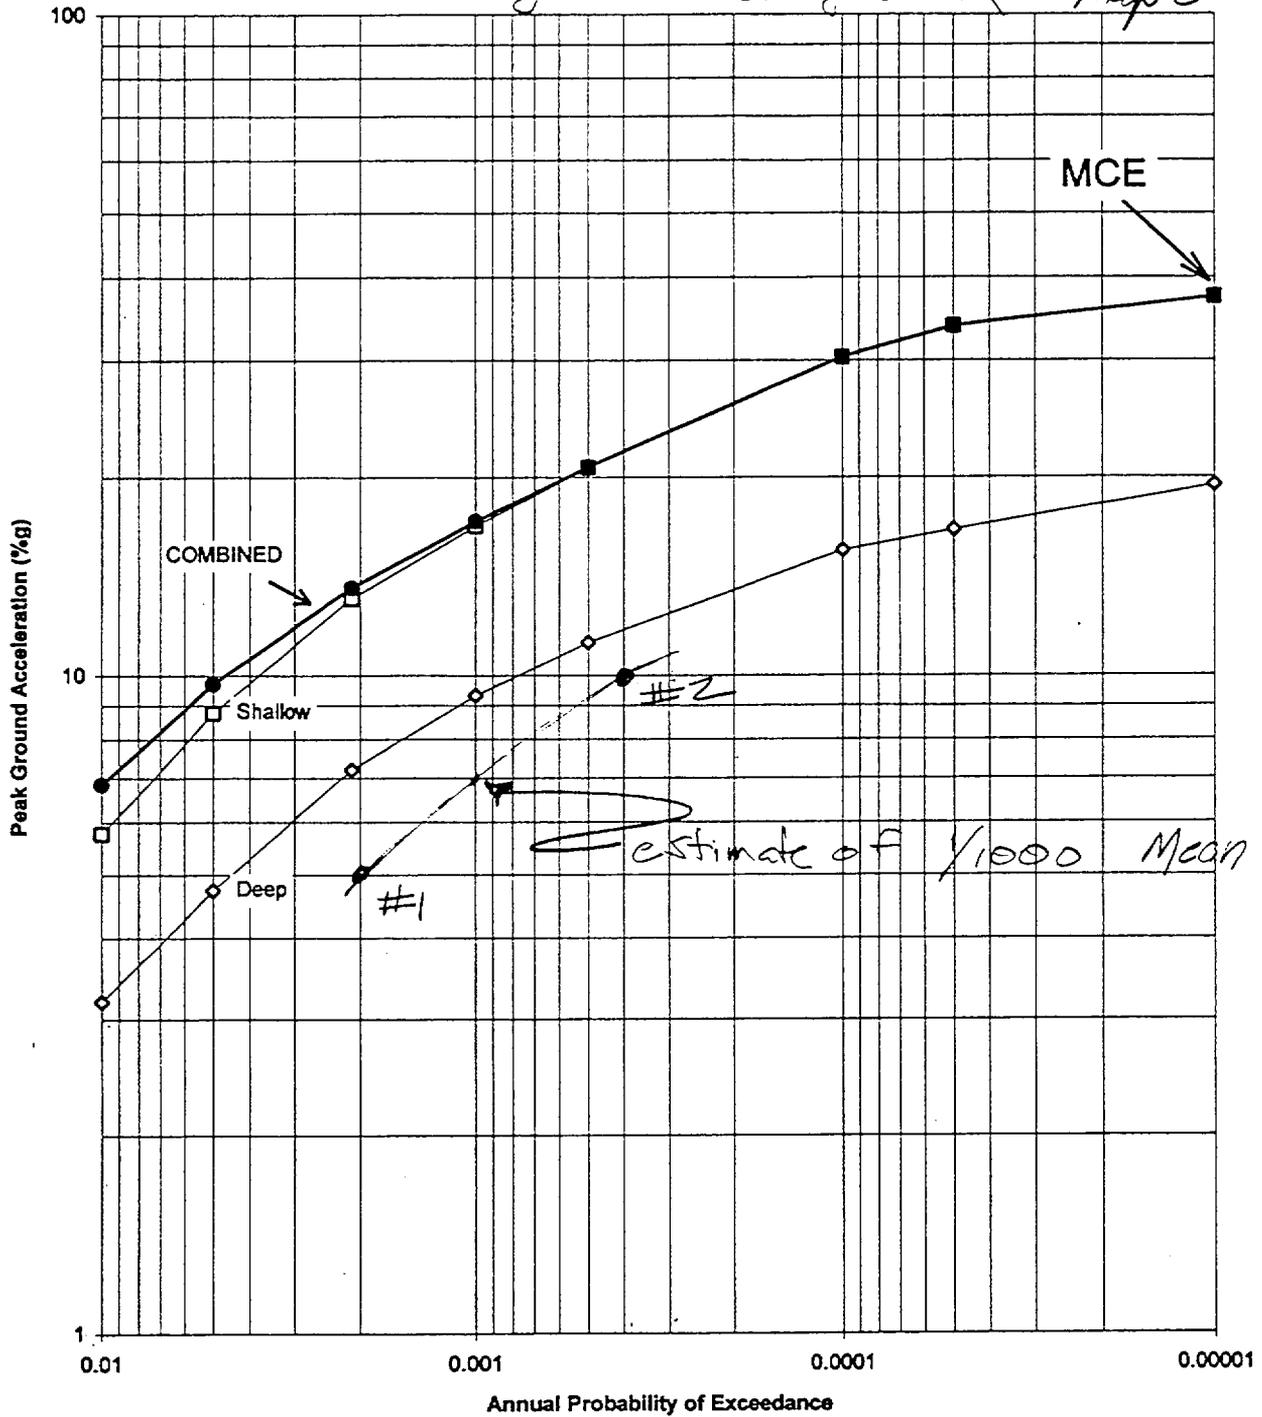
FIGURE 5
SEISMIC HAZARD CURVE

#1 0.3 sec spectral accel.
divided by 2.5 to give
Ap from 1991 NEHRP at
10% chance of exceed.
in 50 years ~ 475 yr
Map 5

#2 0.3 sec spectral acceleration
at 10% chance of exceedance
in 250 years ~ 2475 year event

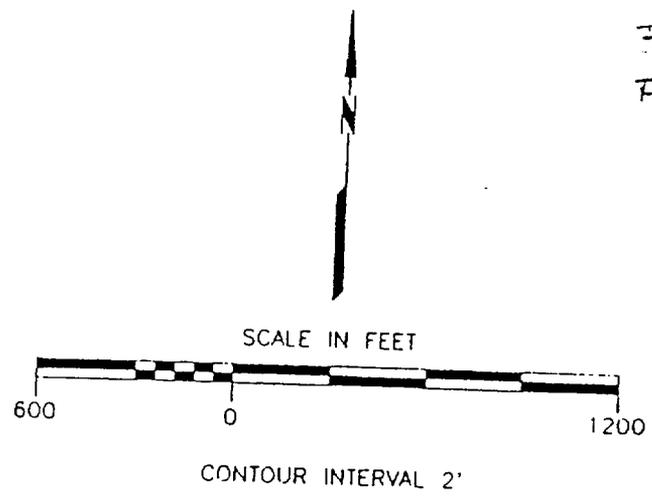
FIGURE 6
REALIGNED DIVERSION CHANNEL LOCATION

PROBABLE FLOW PATH
FROM DIVERSION CHANNEL
