EDO Principal Correspondence Control

2.206 -- Petition for Emergency Enforcement Action
with Regard to Systemic Mismanagement and Lack of
Compliance with NRC at Indian Point 2

PETITION FOR EMERGENCY ENFORCEMENT ACTION (10 CFR 2.206) WITH REGARD TO
SYSTEMIC MISMANAGEMENT AND LACK OF COMPLIANCE WITH NUCLEAR REGULATORY
REGULATION AT INDIAN POINT 2

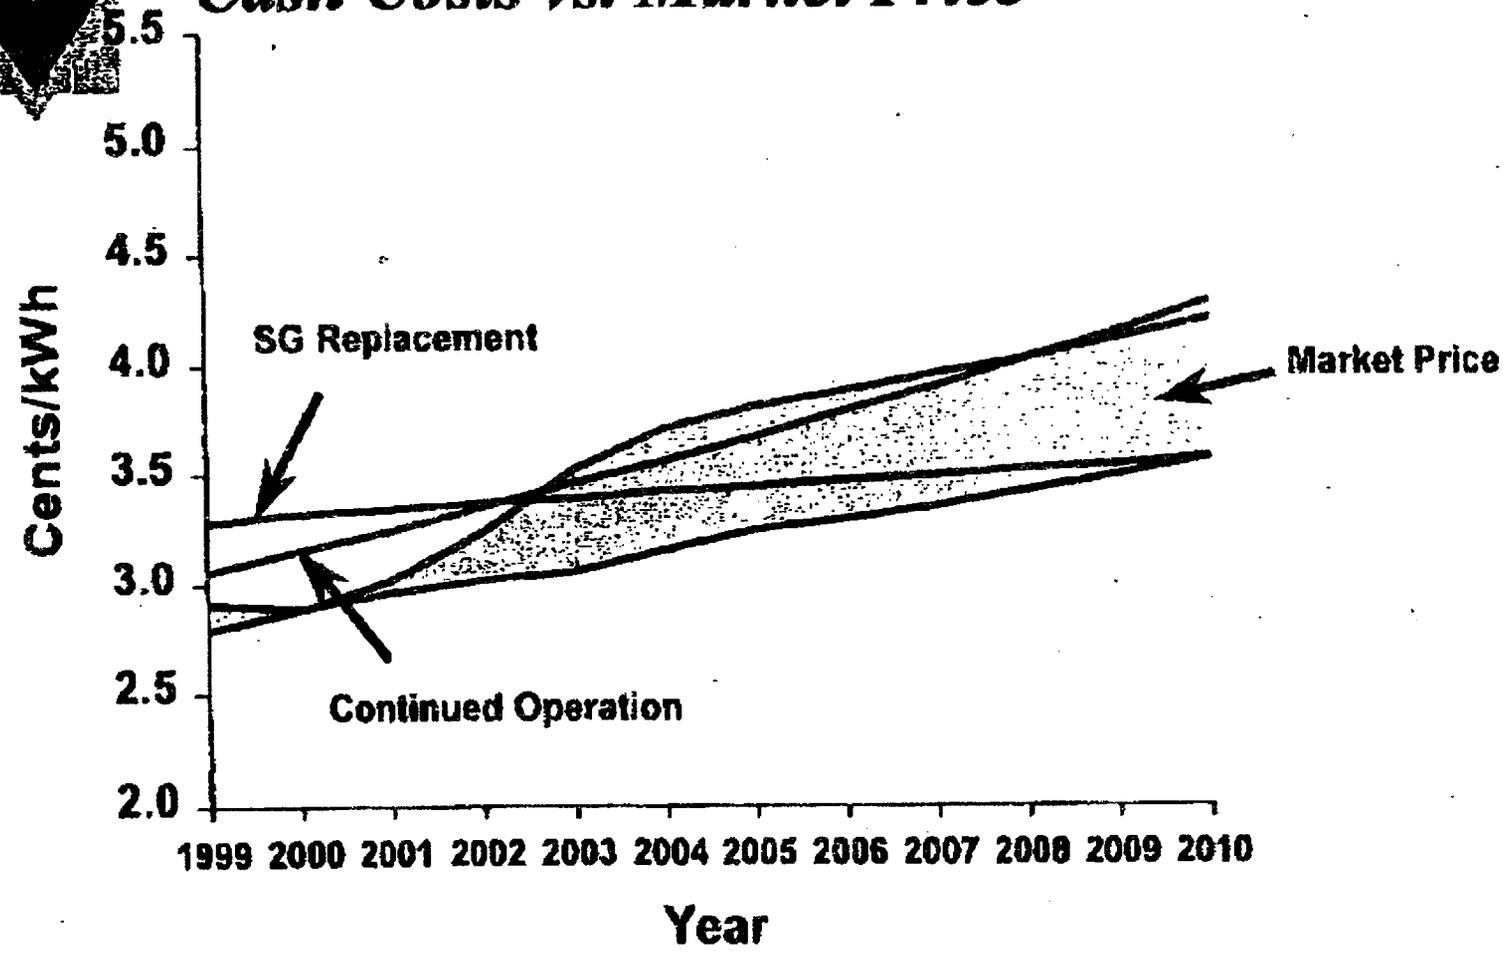
Results ~

Cash Costs vs. Market Price

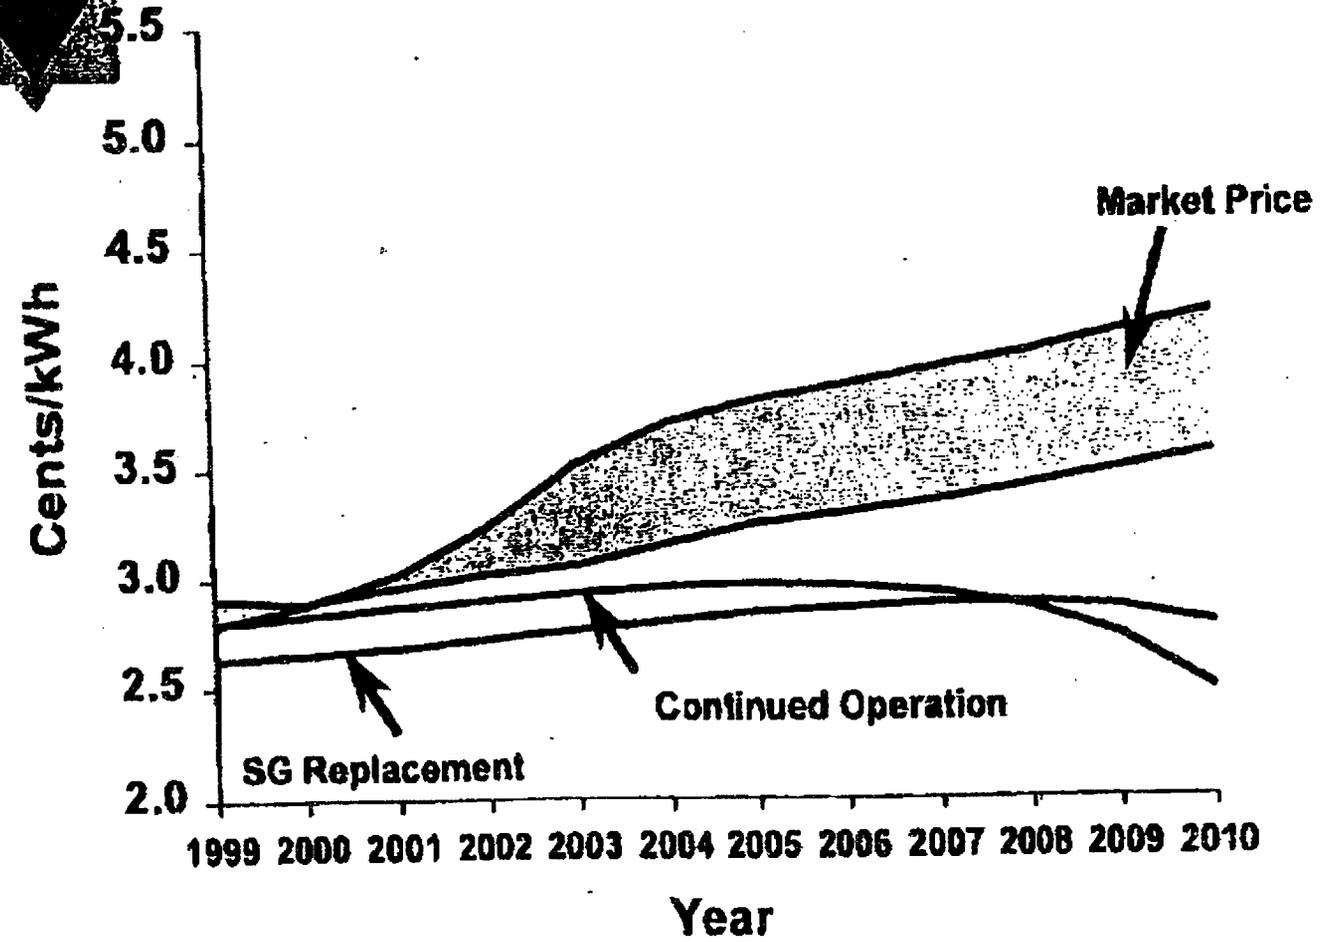
Results ~

"To Go" Costs vs. Market Price (1)

Note 1: "To Go" costs shown are net of the cash costs under shutdown.
