MAP OF NORTH WALL TRENCH T-2  
Private Fuel Storage Facility  
Skull Valley, Utah

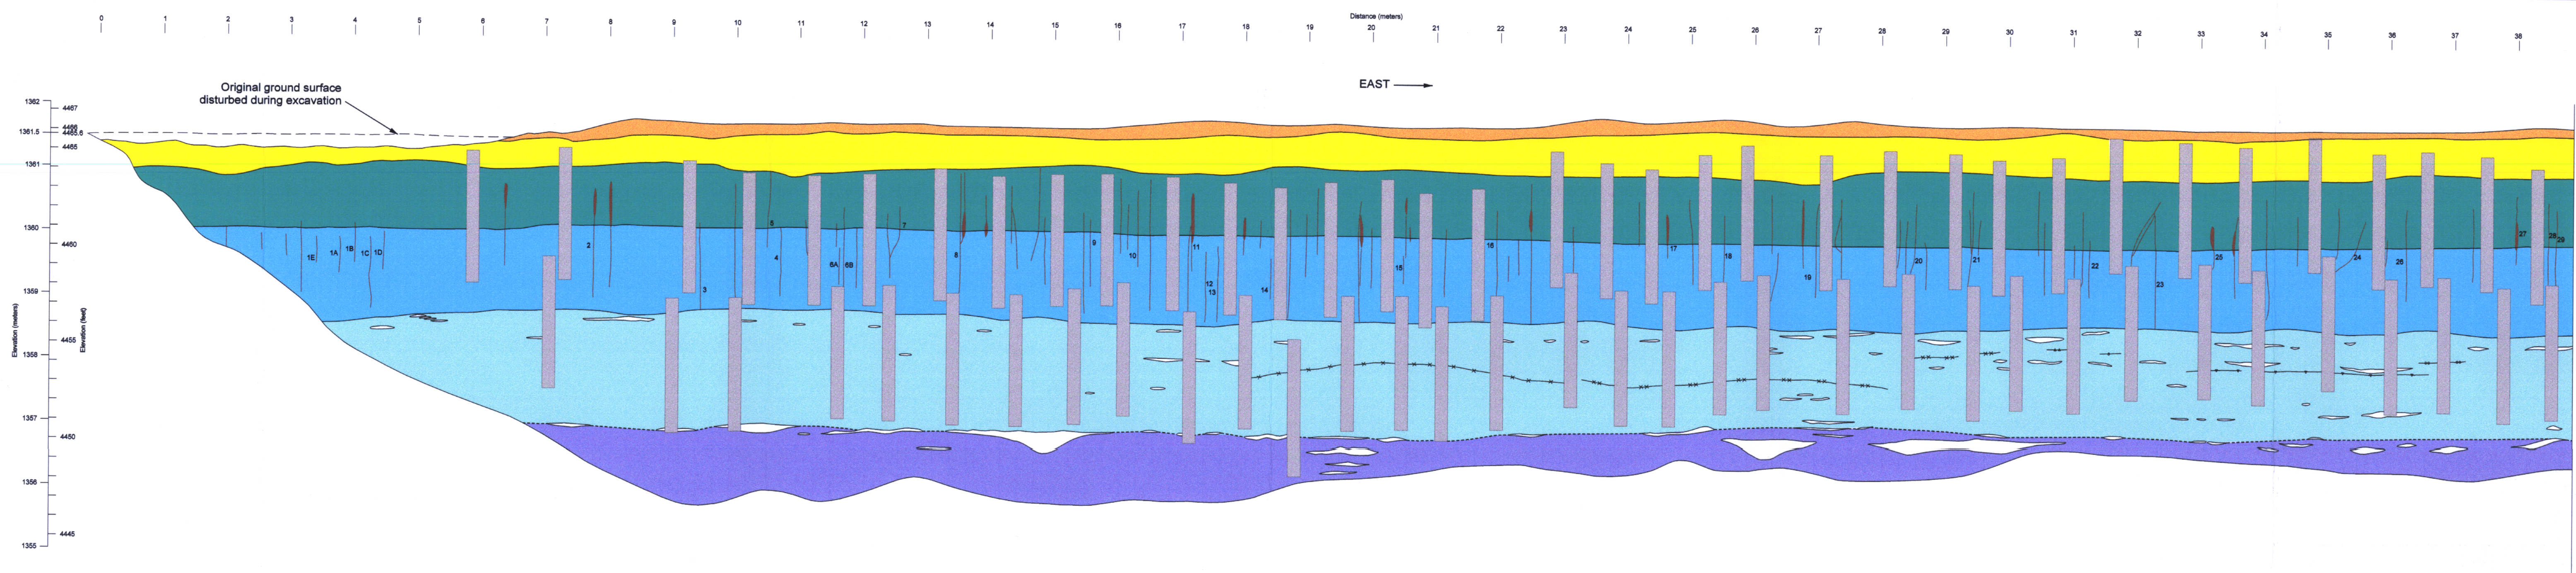
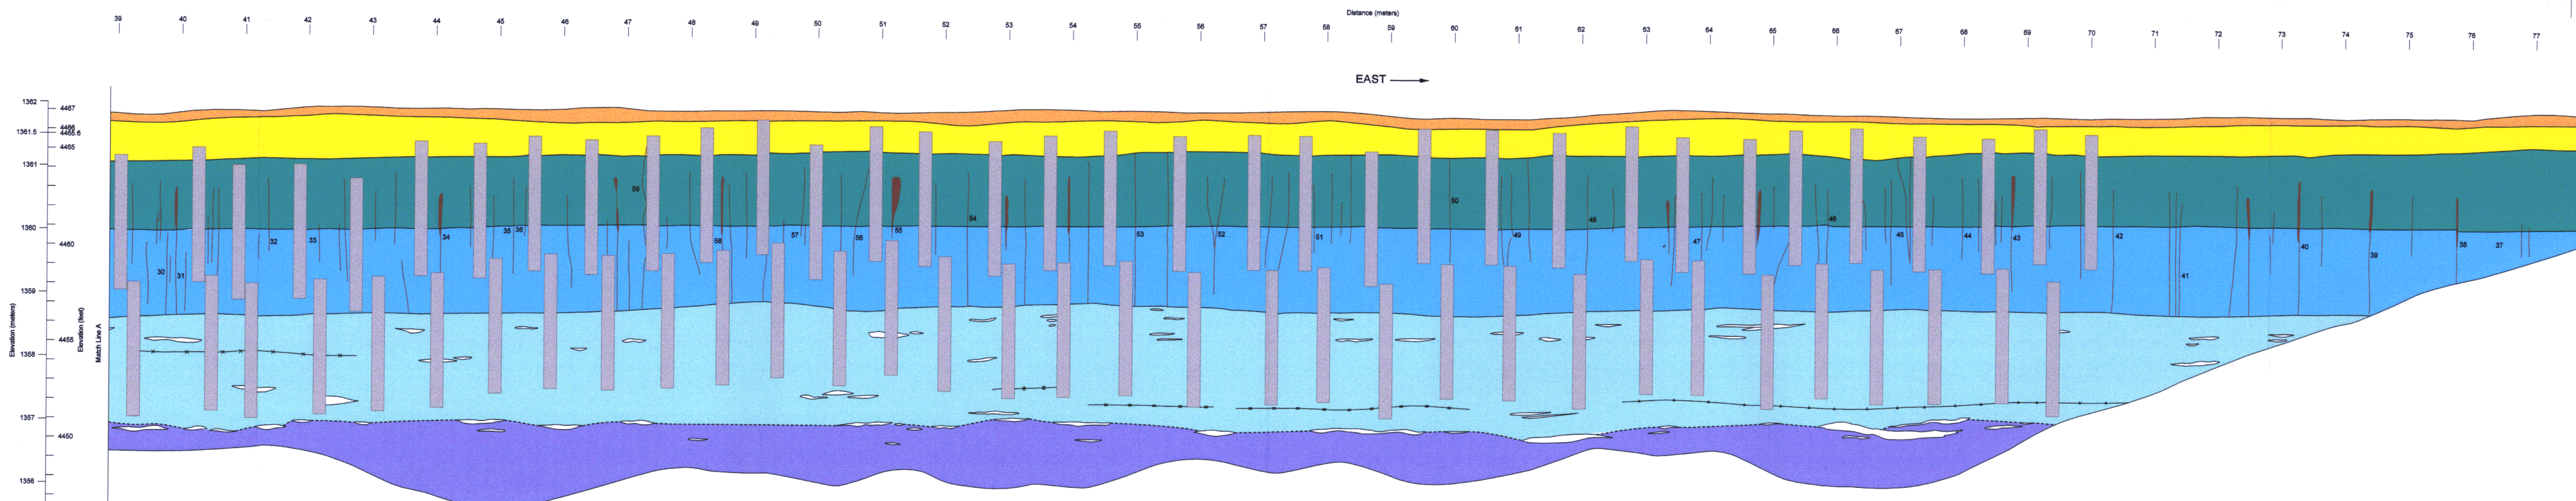
- A/E SOIL HORIZON ON POST-PROVO EOLIAN DEPOSIT  
Grayish brown (10YR5/2.5, d) silty fine SAND to fine sandy SILT; plastic, nonsticky; massive, many pores and root tubules

- EOLIAN DEPOSIT OVERLYING POST-PROVO SOIL  
Brown (10YR 5/3, m) massive, fine sandy SILT in upper part (Eolian Deposit). Lower part of unit is pale brown to brown (10YR 5.5/3, m) sandy clayey SILT; slightly redder on soil ped faces (Cambic B soil horizon developed on Bonneville deep-water sediment

- BONNEVILLE DEEP-WATER (BLOCKY) FACIES  
Light gray to gray (10YR 6/1, m) mottled with white; very fine sandy clayey SILT; irregular coarse angular blocky structure; plastic, sticky; abundant ostracodes; manganese or iron-oxide staining along root tubules; abrupt lower contact

- BONNEVILLE DEEP-WATER (LAMINATED) FACIES  
Pale brown (10YR 6/3, m) fine sandy SILT (sandy marl); fines upwards; well bedded, thinly laminated, laminae commonly <1mm; abundant ostracodes

- POST-STANSBURY TRANSGRESSIVE FACIES  
Alternating light yellowish brown and light brownish gray silty to clayey SAND; well bedded; beds are generally 2 to 5 cm thick; crossbedded; clayey interbeds <2 cm thick; gradational lower contact

- STANSBURY REGRESSIVE FACIES  
Lenses of light gray very fine sand with interbedded silt in upper part of unit (white); generally fines downward, thinly bedded silty and clayey sand at western end of trench below discontinuous sand lenses

- Contact: dotted where gradational
- Fracture; see Table for orientations
- Marker beds; Thin (< 2 m) silty clay and clayey silt beds
- Hydraulic shore

\* Displacements observed only in Bonneville deep-water facies; thin clay layers and bedding in lower Stansbury regressive facies and Post-Stansbury transgressive facies show evidence of no discrete faulting at depth.

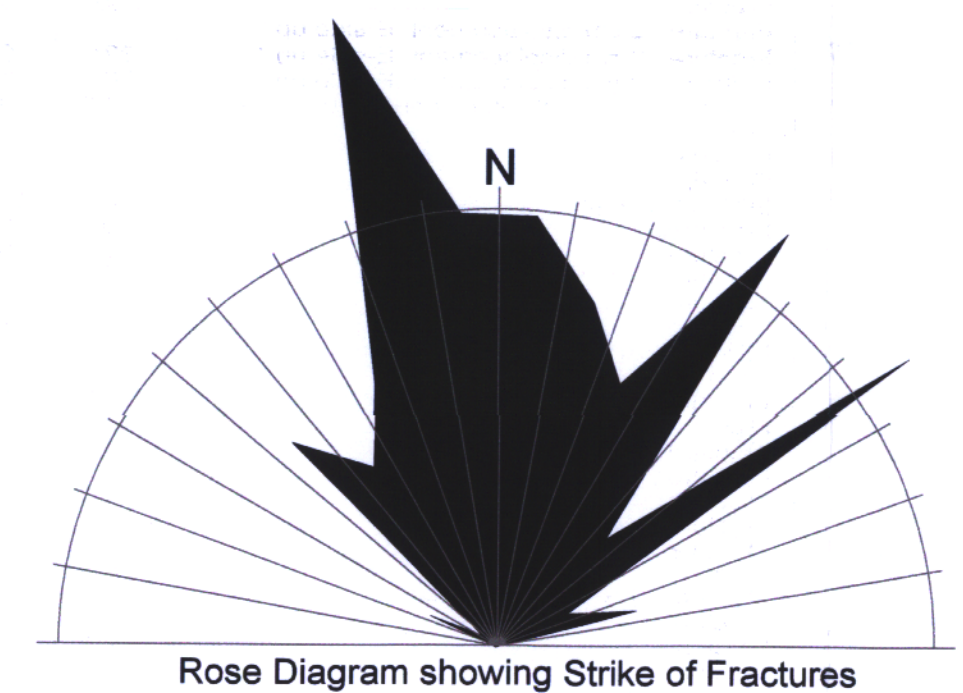
Rose Diagram showing Strike of Fractures

Ident. No.	Description	Strike	Dip
1A	Fracture	15°	86°E
1B	Fracture	328°	88°W
1C	Fracture	52°	88°W
1D	Fracture	8°	90°
1E	Fracture	50°	90°
2	Infilled fractures	352°	84°E
3	Fracture	50°	86°E
4	Fracture	350°	90°
5	Fracture: 2 cm displacement, E-side up *	32°	90°
6A	Fracture: 2 cm displacement, E-side up *	73°	80°E
6B	Fracture: 2 cm displacement, E-side up *	332°	90°
7	Fracture: 2.5 cm displacement, E-side down *	10°	90°
8	Fracture	315°	90°
9	Fracture	44°	87°W
10	Infilled Fracture	314°	88°W
11	Fracture	60°	90°
12	Fracture	58°	90°
13	Fracture	57°	88°W
14	Fracture	34°	85°W
15	Fracture	50°	90°
16	Fracture	24°	86°W
17	Infilled Fracture	23°	88°W
18	Fracture	30°	88°W
19	Fracture	0°	88°W
20	Fracture	340°	87°W
21	Fracture	320°	90°
22	Fracture	285°	90°
23	Fracture	76°	89°NW
24	Fracture	10°	90°
25	Fracture	315°	90°
26	Fracture	340°	90°
27	Fracture: 2.5 cm displacement, E-side up *	10°	90°
28	Fracture	34°	88°E
29	Fracture	330°	90°
30	Fracture	35°	90°

31	Infilled fracture	345°	90°
32	Fractures	20°	90°
33	Fracture	35°	88°E
34	Fracture: 1 cm displacement, E-side up *	0°	88°E
35	Fracture: 2 cm displacement, E-side up *	35°	90°
36	Fracture: 1 cm displacement, E-side up *	30°	88°E
37	Fracture	345°	88°E
38	Fracture: 2 cm displacement, E-side down *	35°	90°
39	Fracture	365°	90°
40	Fracture: 1 cm displacement, E-side down *	20°	90°
41	Fracture	340°	90°
42	Fractures	35°	85°W
43	Fracture	40°	90°
44	Fracture	345°	88°E
45	Fractures	10°	90°
46	Fracture: 2 cm displacement, E-side down *	350°	90°
47	Fracture	345°	87°E
48	Fractures	330°	82°W
49	Fracture	320°	88°W
50	Infilled fractures	5°	84°W
51	Fracture	38°	88°W
52	Fracture	310°	90°
53	Fracture	345°	90°
54	Fracture	50°	90°
55	Fracture	15°	85°
56	Fracture	350°	87°W
57	Fractures	5°	90°
58	Fracture	5°	90°
59	Fracture	5°	90°
