UNITED STATES
NUCLEAR REGULATORY COMMISSION

SUBJECT: CALLAWAY PLANT REFUELING OUTAGE 10 AND NRC INSPECTION
50-483/2000-17

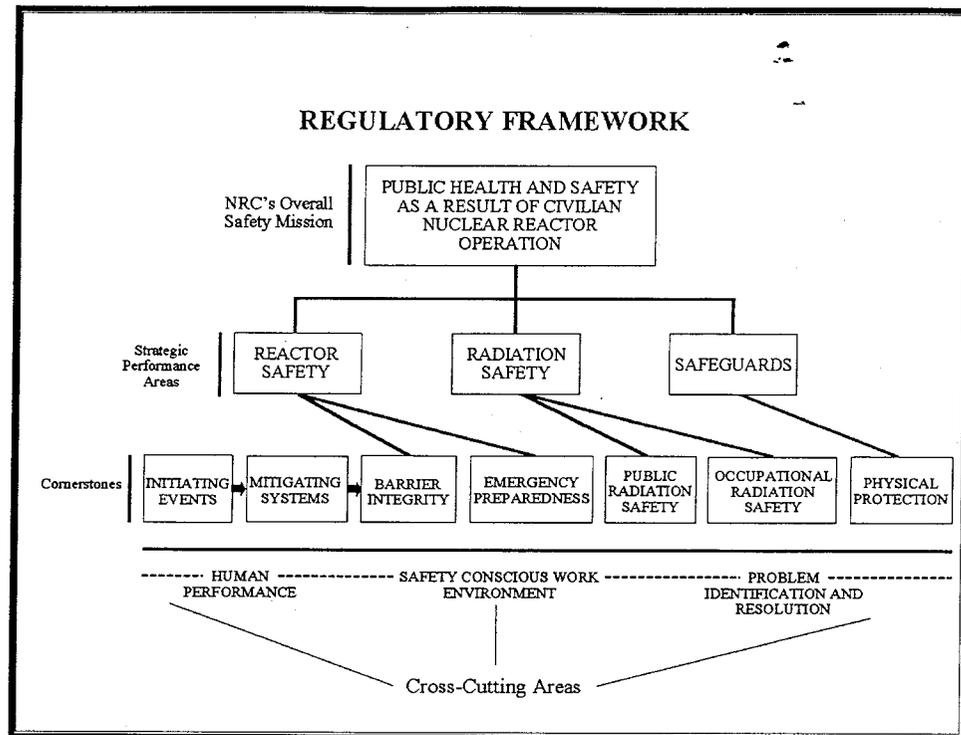
The Cornerstones of Safe Operation

The regulatory framework for reactor oversight is shown in the diagram below. It is a risk-informed, tiered approach to ensuring plant safety. There are three key strategic performance areas: reactor safety, radiation safety, and safeguards. Within each strategic performance area are cornerstones that reflect the essential safety aspects of facility operation. Satisfactory licensee performance in the cornerstones provides reasonable assurance of safe facility operation and that the NRC's safety mission is being accomplished.

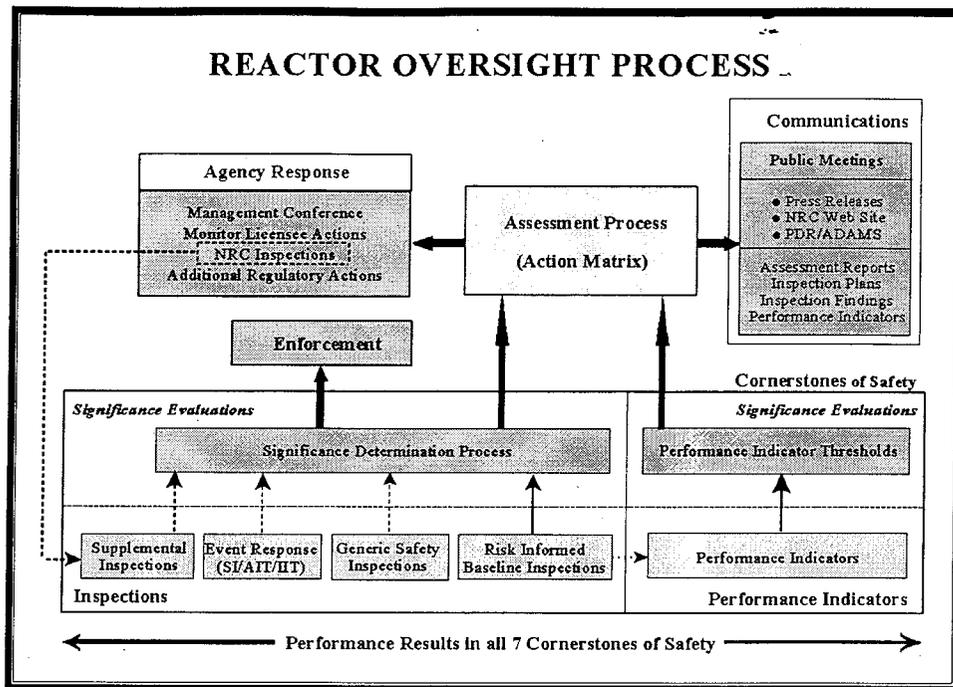
Measuring and Inspecting Nuclear Plant Performance

An overview of the reactor oversight process is shown below. For each cornerstone, NRC develops findings from inspections and licensees collect performance indicator data. Inspection findings are evaluated for safety significance using a significance determination process and performance indicator data is compared against prescribed risk-informed thresholds. The resulting information is then assessed and an appropriate NRC response is determined using the guidelines in an action matrix, which typically includes supplemental inspections for selected issues. Enforcement action is taken on significant inspection findings, as appropriate. NRC communicates the results of its performance assessment and its inspection plans and other planned actions in publically available correspondence, on its web site, and through public meetings with each licensee.

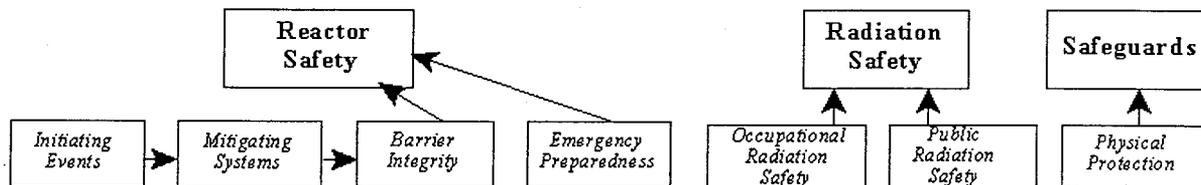
Plant X 4Q/1999 Performance Summary

Unplanned Scrams (G)	Emergency AC Power System Unavailability (Y)	Reactor Coolant System Specific Activity (G)	Drill/Exercise Performance (U)	Occupational Exposure Control Effectiveness (G)	EETS/ODCM Radiological Effluent (G)	Protected Area Equipment (I)
Scrams With Loss of Normal Heat Removal (G)	High Pressure Injection System Unavailability (G)	Reactor Coolant System Leakage (W)	ERD Drill Participation (G)			Personnel Screening Program (G)
Unplanned Power Changes (Y)	Heat Removal System Unavailability (W)		Alert and Notification System (W)			FED/Personnel Reliability Program (G)
	Residual Heat Removal System Unavailability (G)					
	Safety System Functional Failures (G)

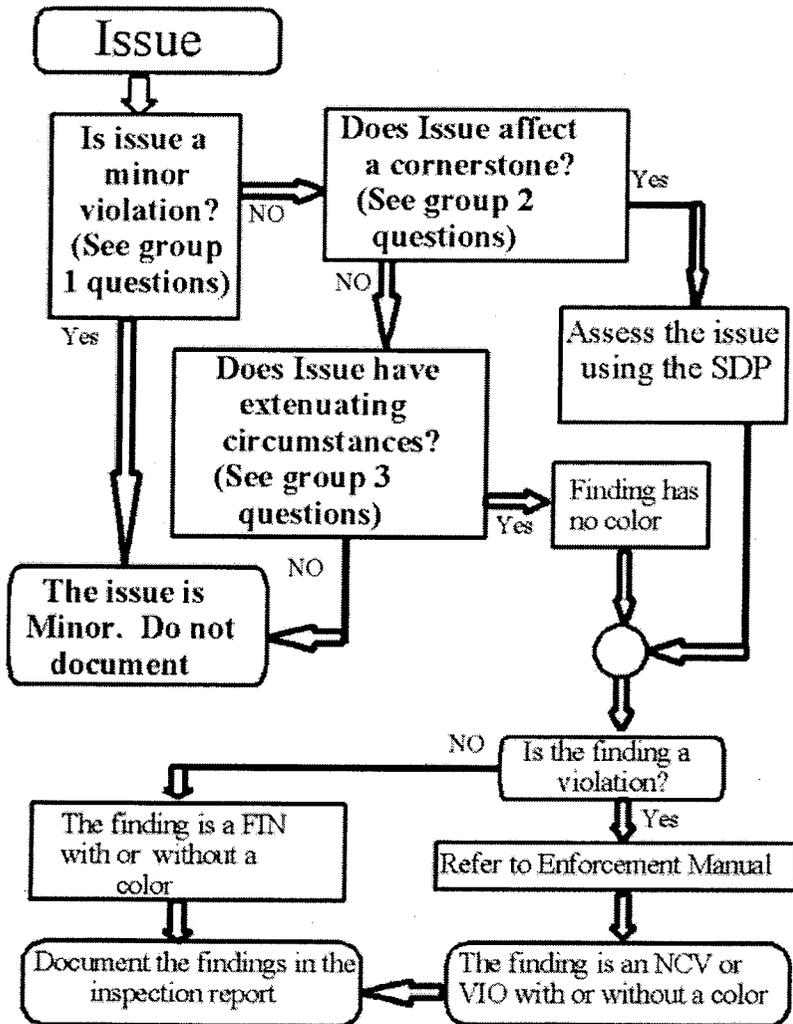
Extenuating Circumstances	Group 3 Questions
Does the issue involve willfulness, including discrimination?	
Does the issue have potential for impacting the NRC's ability to perform its regulatory function?	
Is documenting this issue necessary to close an open item, licensee event report or allegation?	
Does the associated technical information relate directly to an issue of agency-wide concern, i.e. a generic safety issue?	
Does the issue provide substantive information regarding cross cutting issues?	
Is the finding a violation?

If all the answers to the above questions are "No", the issue does not have extenuating circumstances and would not normally be documented.
