OG-01-018

Project No. 686  
WCAP-15338

Subject: Westinghouse Owners Group  
Transmittal of WCAP-15338, "A Review of Cracking Associated  
with Weld Deposited Cladding in Operating PWR Plants (MUHP-  
6110)

The reports concludes that underclad cracks are of no concern relative to structural integrity of the reactor vessel for a period of 60 years.

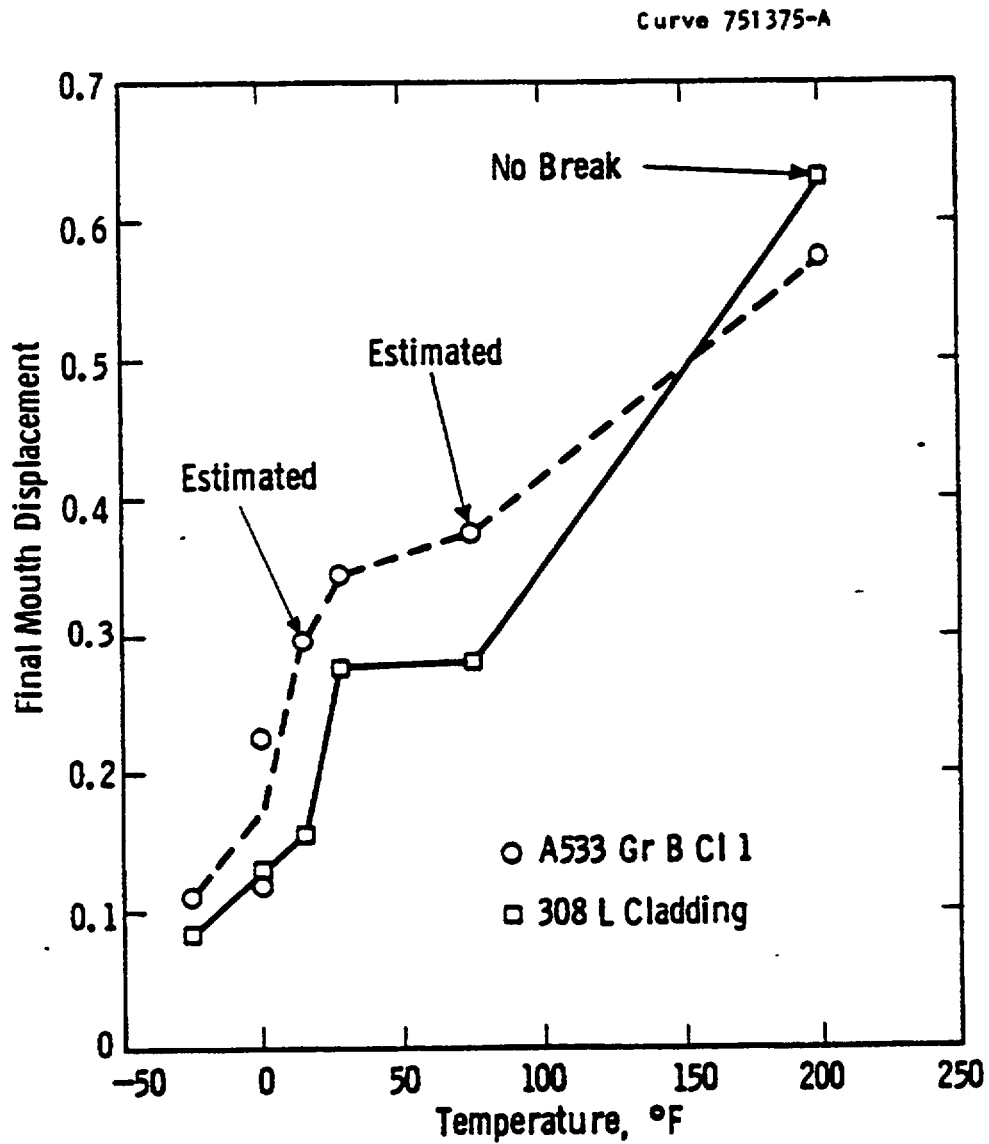
Figure 4-3. Final Mouth Displacement Versus Temperature for A533 Gr B Cl 1 and 308 L Clad Bend Bar Specimens

This means that the effect of the cladding on fracture behavior vanishes at temperatures above the transition temperature of the base metal. This conclusion is further proven by the two bend bar results at 200°F (93°C), where the clad specimen failed to experience unstable fracture at a mouth displacement greater than that sustained by a failed unclad specimen (Figure 4-3).

The clad residual stress measurements provide an explanation for the fracture behavior observed in the bend bar tests. There is a clearly observable effect of the cladding in the transition region of fracture behavior as shown in Figure 4-3. In this region, the cladding residual stresses have a small but measurable impact on the critical crack mouth opening values, which are a measure of the fracture resistance of the component.
