State of New Jersey  
DEPARTMENT OF ENVIRONMENTAL PROTECTION  
DIVISION OF ENVIRONMENTAL QUALITY  
CN 415  
Trenton, N.J. 08625-0415  
(609) 987-6402  
Fax (609) 987-6390

Thank you for your letter dated June 6, 1991. We have reviewed the NRC's rationale for not licensing various areas and materials on the Heritage Minerals, Inc. (HMI) property and other historical information including material provided by Jack Lord, Vice President of HMI, on materials processing at the site.

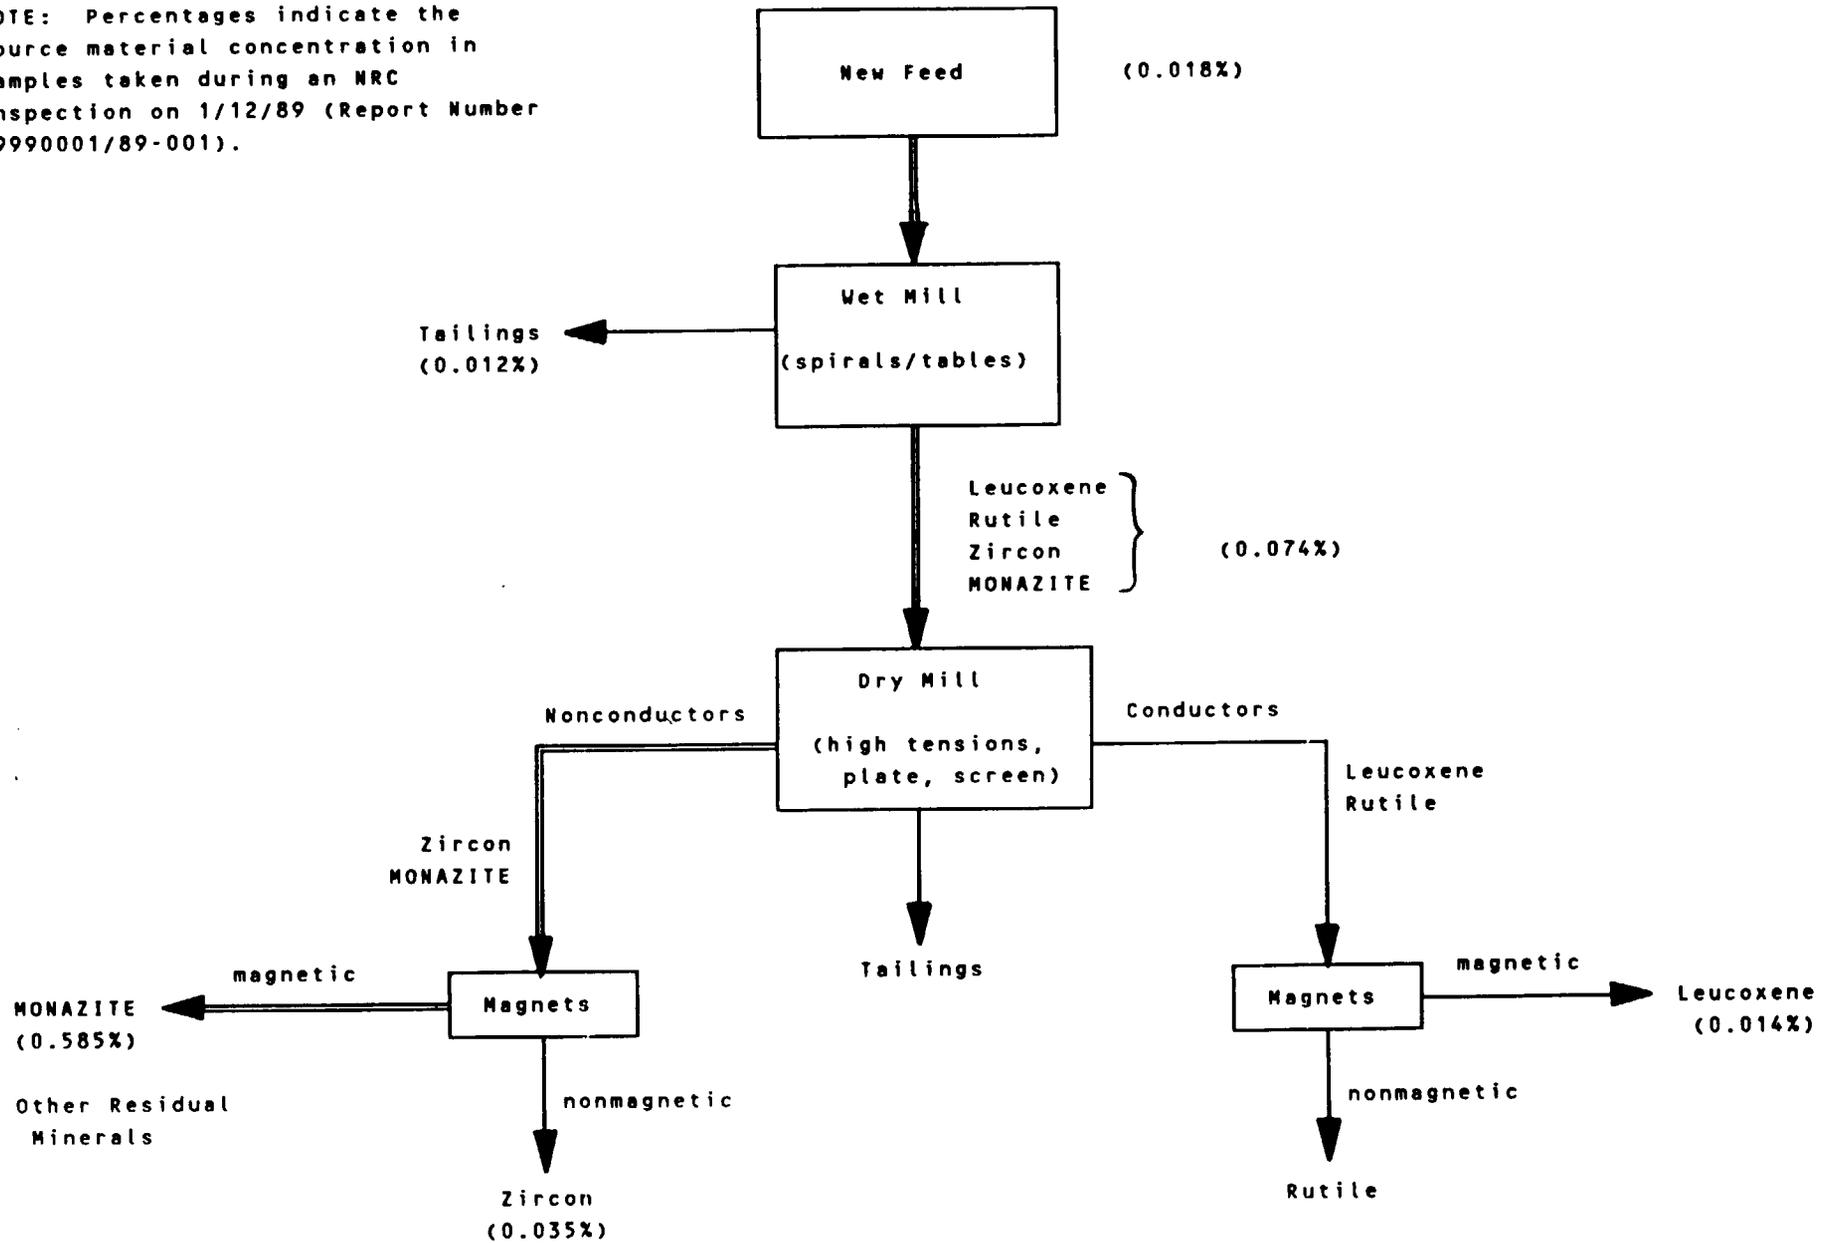
ATTACHMENT 1

NOTE: Percentages indicate the source material concentration in samples taken during an MRC inspection on 1/12/89 (Report Number 99990001/89-001).

Taken from the Heritage Minerals, Inc. Mineralogical Flowsheet dated 2/26/88
