LOUIS ALLIS
Beloit Power Systems

Subject: Reference Telcon on 4/21/82 at 4:26 p.m.
Between Nick Jackiw of NRC and Rick Haisler,
Manager, Quality Assurance of BPS

On 4/20/82 Beloit Power Systems received a communication from Colt Industries expressing concern over the BPS procedure for torquing the stud/nut combination holding the BPS generator spider to the Colt generator shaft on BPS generator S/N 700510R2. This communication is submitted as Attachment (1).

The application of this stud/nut design is shown on Colt Industries Drawing Number 11871439 Attachment (2) submitted for your information.

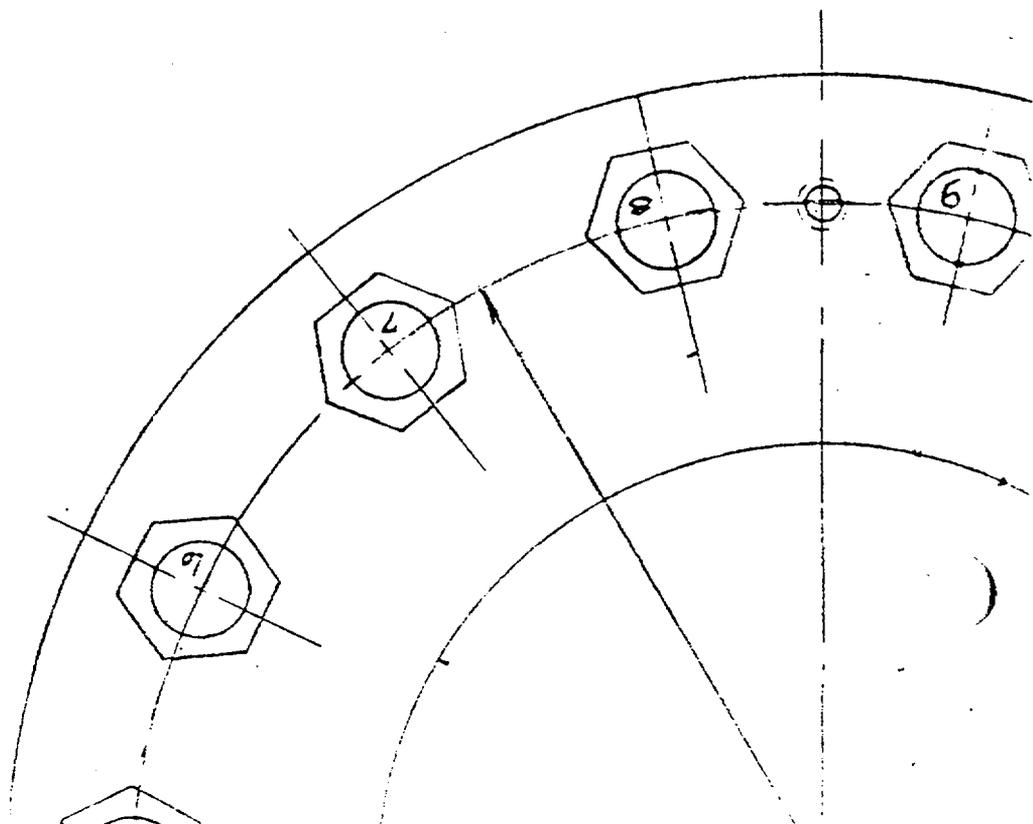
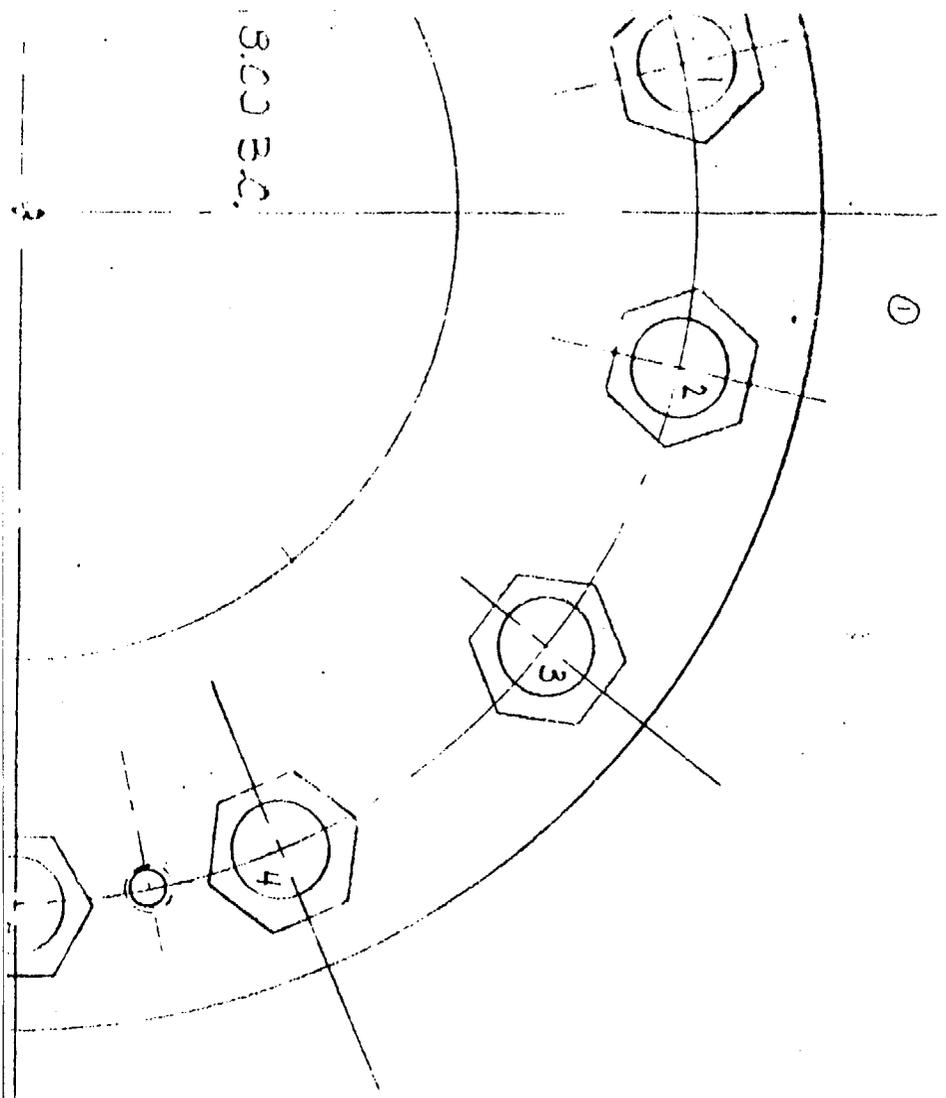
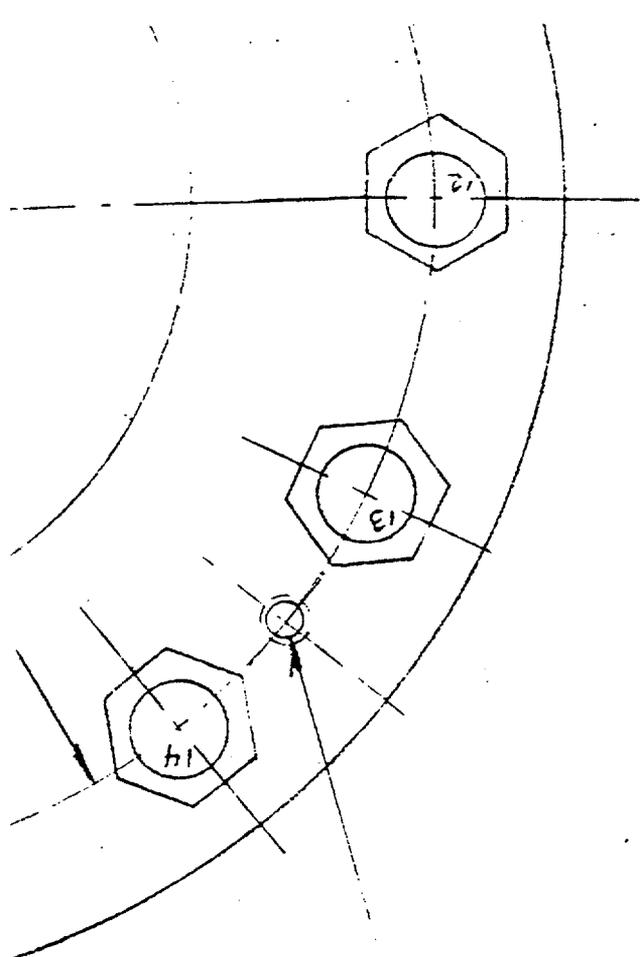
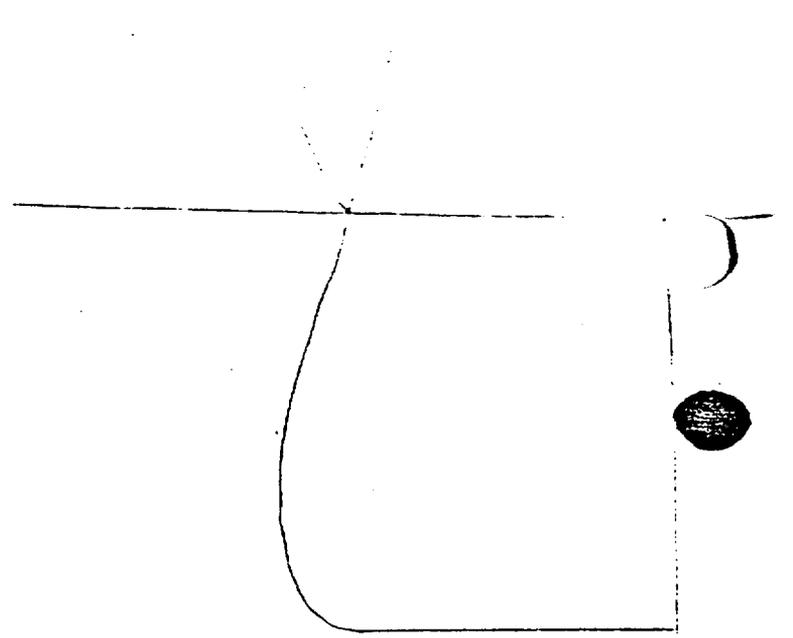
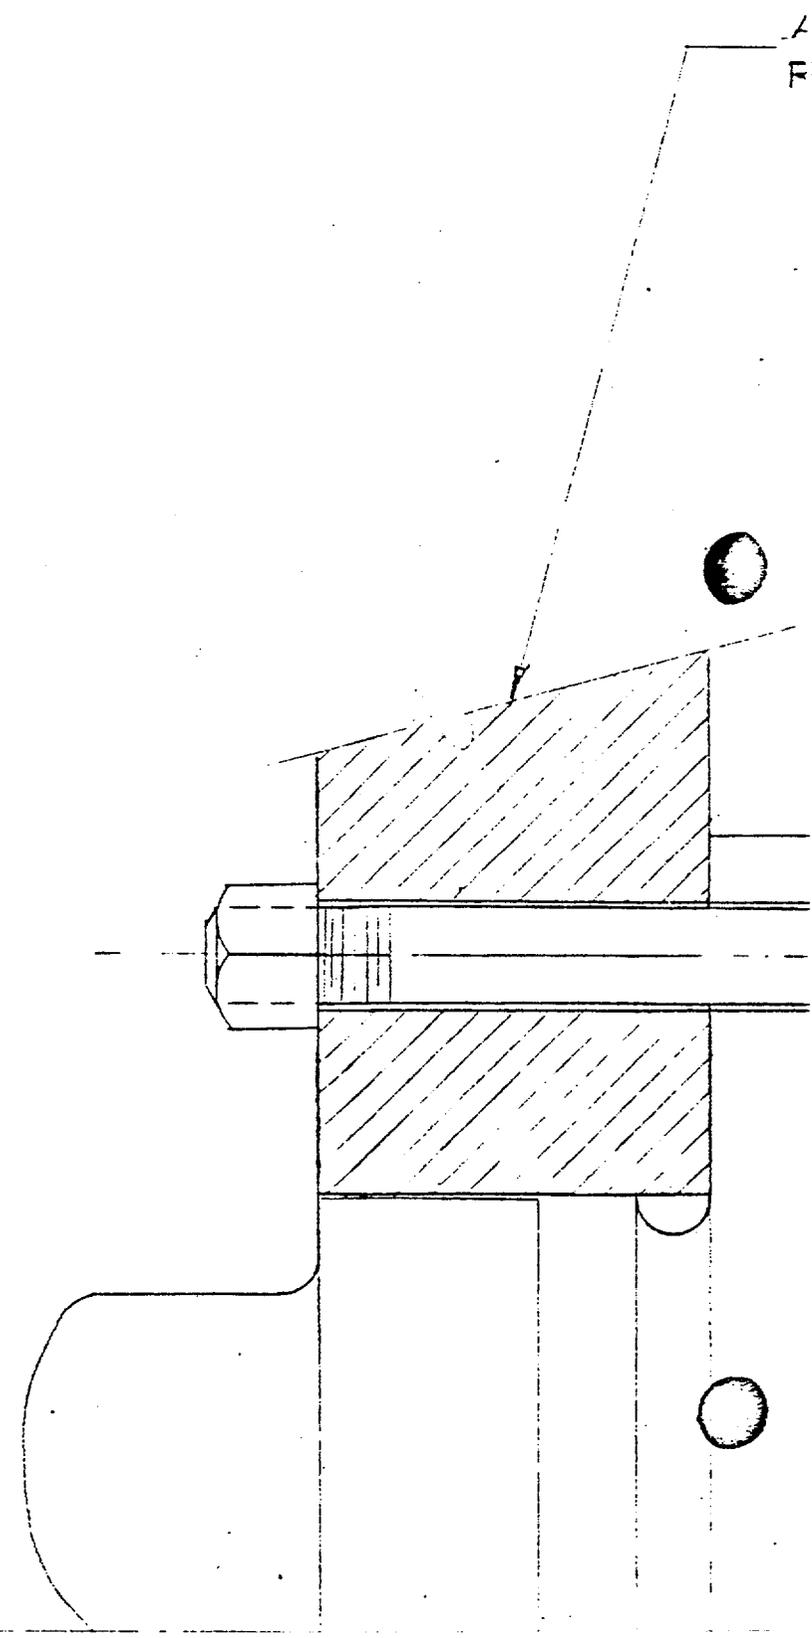
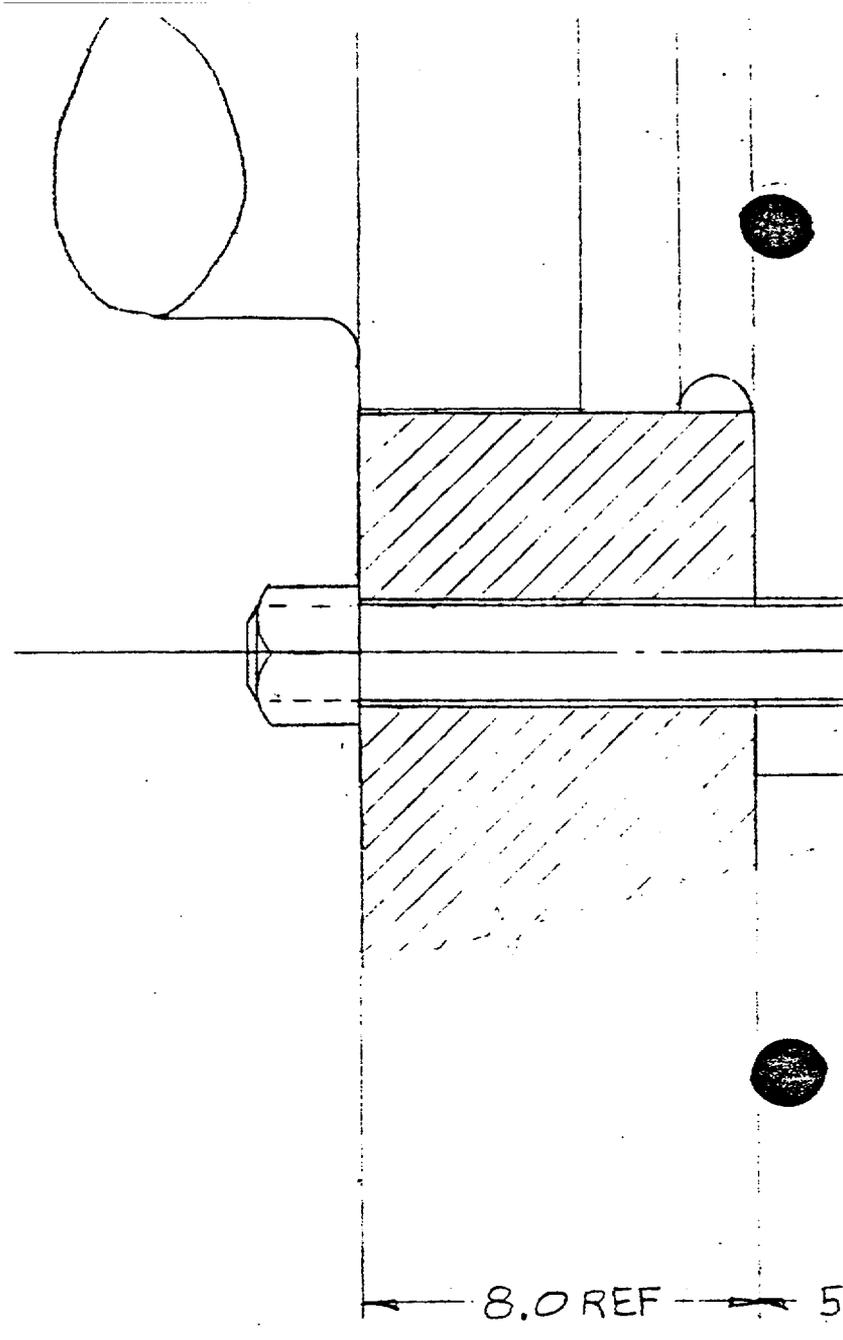
1 FOR ROTOR REMOVAL ONLY

— SHAFT FLANGE

The 700512R2 stud/nut assembly was torqued on 10/19/81 to the limits as specified by the Colt Industries Dwg. #11871439 and witnessed by personnel from Bechtel, Colt Industries and BPS. Results are tabulated on Attachment (3).
