UNITED STATES
NUCLEAR REGULATORY COMMISSION

FACILITY: Sequoyah Nuclear Plant, Unit 1

SUBJECT: SUMMARY - APRIL 11, 2001, MEETING REGARDING SEQUOYAH UNIT 1
STEAM GENERATOR INSPECTION PLAN FOR CYCLE 11 REFUELING
OUTAGE

Steam Generator Inspection
Unit 1 End of Cycle 11
Less Than 2 Volt Dents

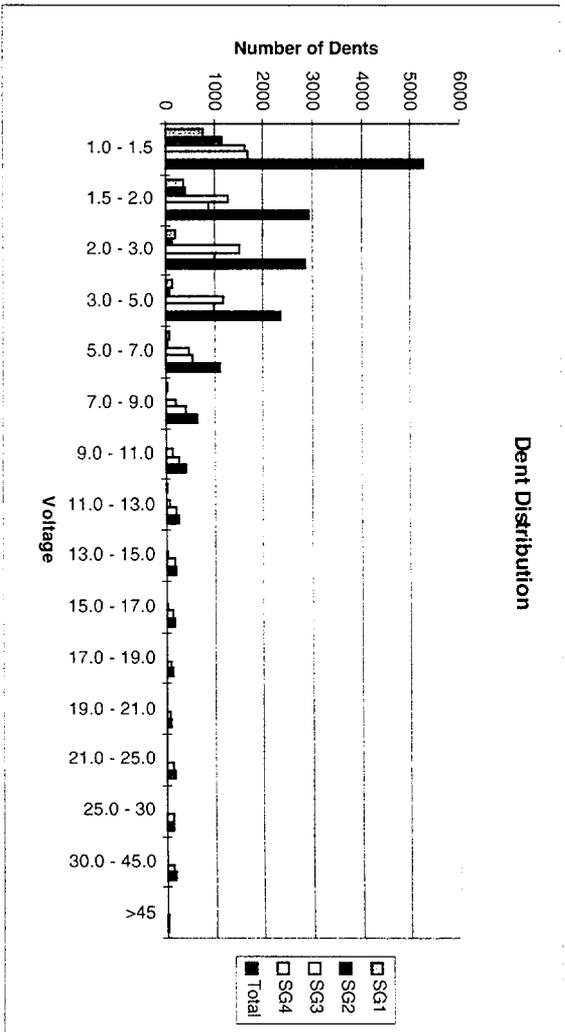
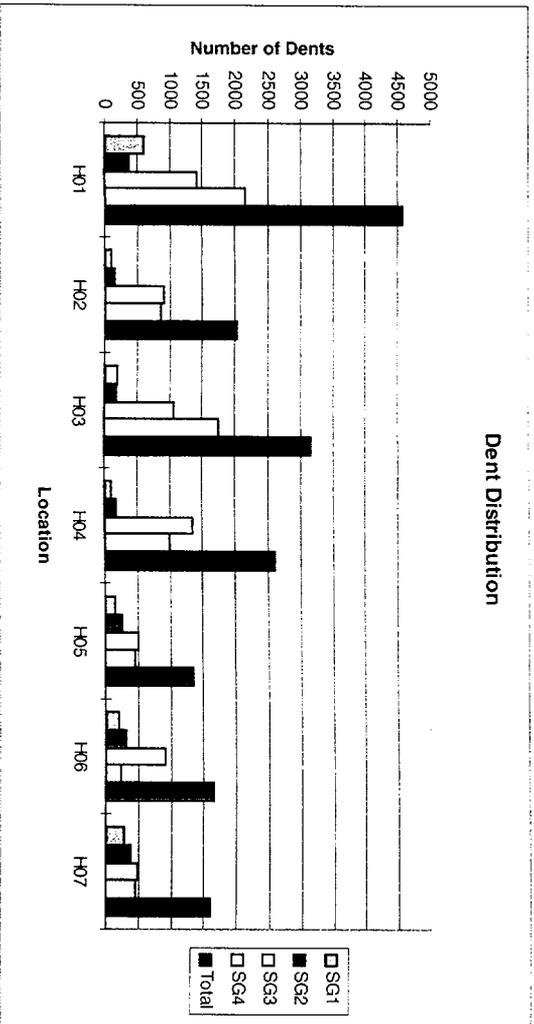
Population of Dented Intersections

- **After the U1C10 inspection, the population of dents below 2 volts were evaluated**
 - Due to NRC's concerns, a population of dents below 2 volts was defined
 - The population below 1 volt is inconclusive and subjective as to whether a dent exists or not

- **The new threshold for Sequoyah Unit 1 will be 1 volt**
 - Dented intersections greater than or equal to 1 volt will be inspected in all 4 steam generators
 - ✦ *15,774 dent inspections with plus point compared to base scope of 8,360 at end of Cycle 10*
 - No circumferential crack has been identified in a dent less than 1.5 volt
- **Bobbin calls will continue to be plus point inspected regardless of dent voltage**
 - 1,647 additional plus point exams were performed end of Cycle 10

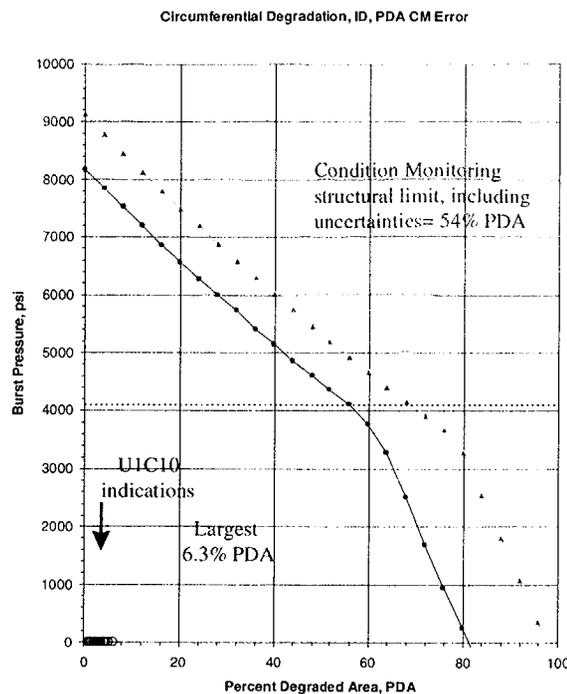
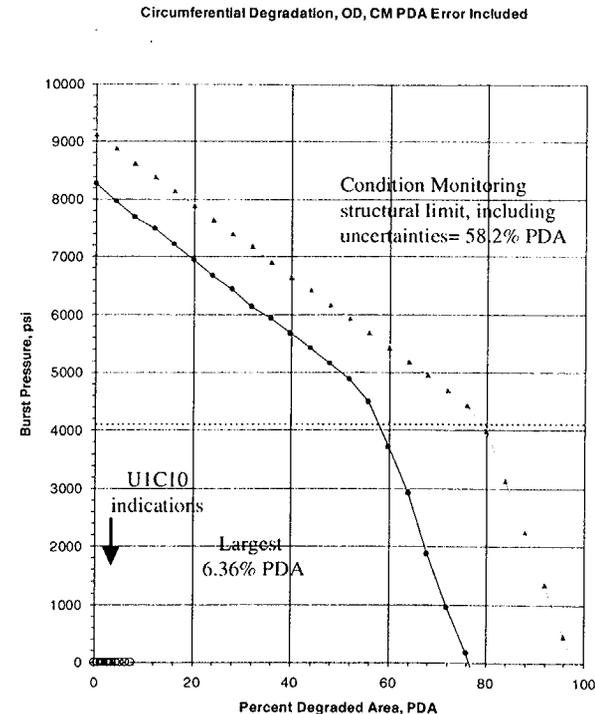
- Approximately 5,000 additional intersections will be inspected to validate end of Cycle 10 operational assessment methodology, assumptions, and conclusions
 - No indications are predicted to have PDAs large enough to challenge structural integrity

- **Approximately 5,000 additional intersections will be inspected to validate end of Cycle 10 operational assessment methodology, assumptions, and conclusions**
 - Between 100 and 150 indications were assumed unidentified during the end of Cycle 10 inspection
 - ☛ *Calculated accident-induced leakage remained well below allowable 1 gpm*
- **Expansion will be necessary if operational assessment is invalidated by structural or leakage concerns**
 - Plan will be developed when data is compiled
 - NRR will be informed of the expansion decision

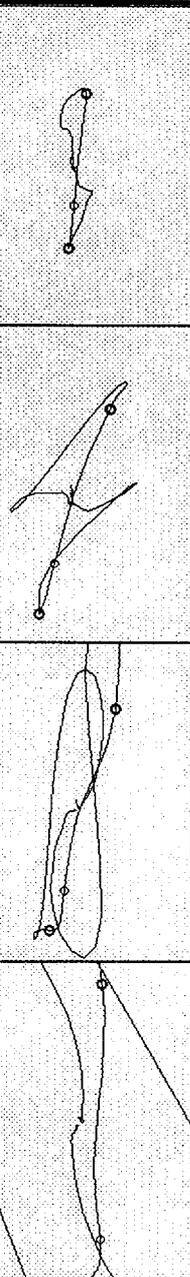
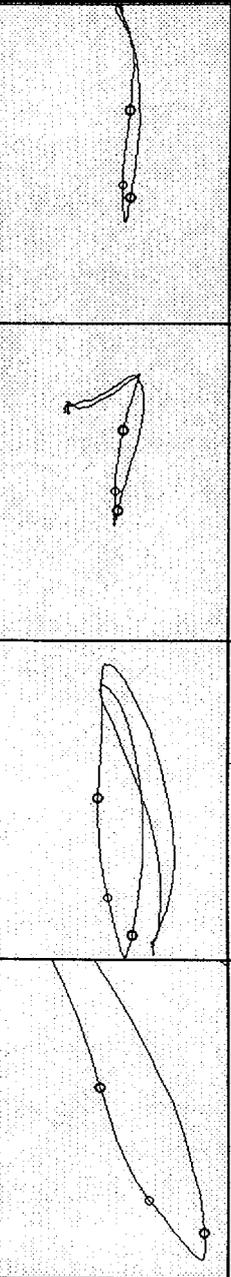
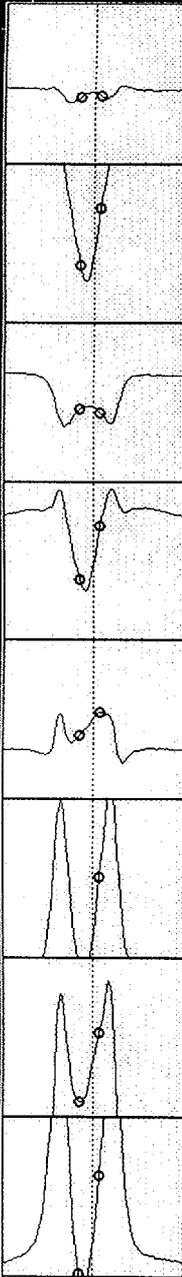
P1	400	G2	C1	Diff	1	400	G2	C1	Diff	3	200	G2	C1	Diff	5	100	G2	C1	Diff
0.57 v/d	span 41	rot 21			0.43 v/d	span 30	rot 23			0.59 v/d	span 42	rot 154			0.39 v/d	span 27	rot 248

Vpp	HkR	Vpk	Gn	180	Vpp	HkR	Vpk	Gn	180	Vpp	HkR	Vpk	Gn	180	Vpp	HkR	Vpk	Gn	180
3.74 volts	186 deg	0			3.96 volts	199 deg	0(P1:Vpp)			5.82 volts	197 deg	0(P1:Vpp)			5.16 volts	187 deg	0(P1:Vpp)

P2	400	G2	C5	Hs1	2	400	G2	C5	Hs1	4	200	G2	C5	Hs1	5	100	G2	C5	Hs1
0.42 v/d	span 30	rot 18			0.50 v/d	span 35	rot 8			0.55 v/d	span 40	rot 137			0.43 v/d	span 31	rot 215

Vpp	HkR	Vpk	Gn	180	Vpp	HkR	Vpk	Gn	180	Vpp	HkR	Vpk	Gn	180	Vpp	HkR	Vpk	Gn	180
1.54 volts	359 deg	46(P1:Vpp)			1.74 volts	4 deg	4(P1:Vpp)			3.32 volts	345 deg	4(P1:Vpp)			3.29 volts	325 deg	4(P1:Vpp)

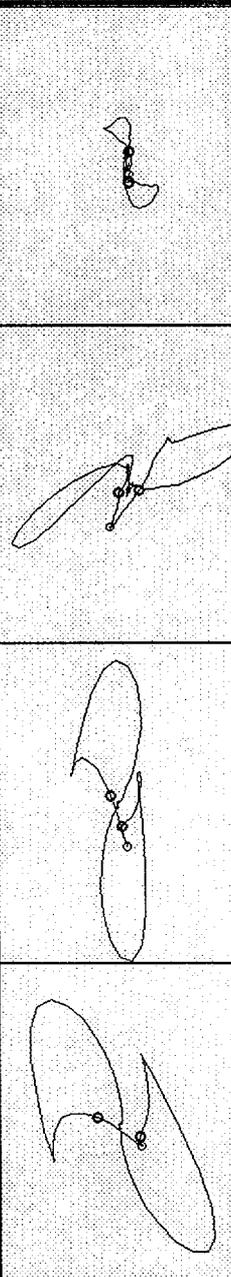
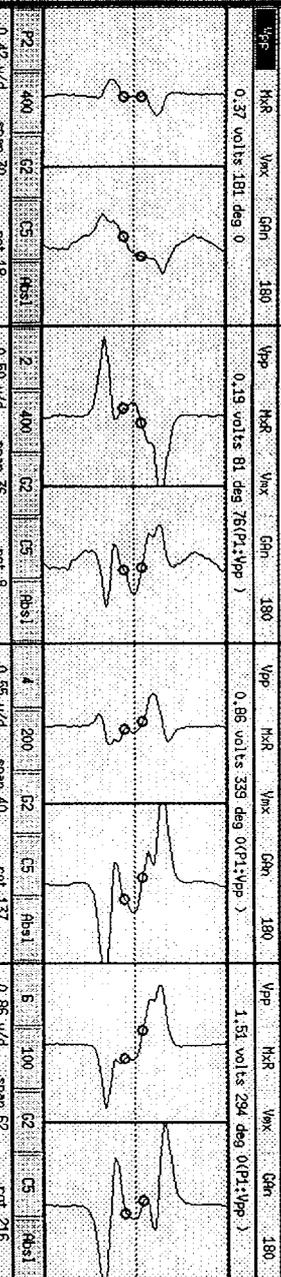
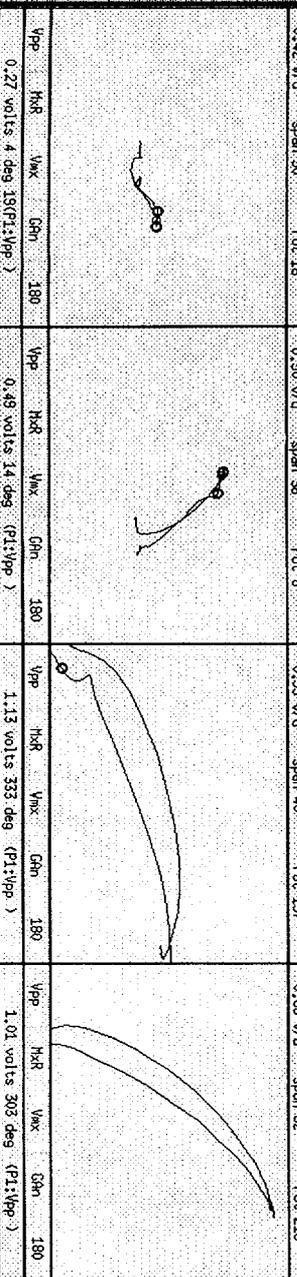
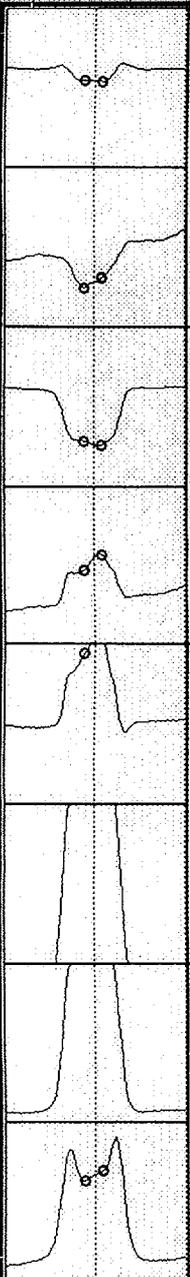
P1	400	G2	C1	Diff	1	400	G2	C1	Diff	3	200	G2	C1	Diff	5	100	G2	C1	Diff
0.28 V/d	span 20	rot 21			0.21 V/d	span 15	rot 23			0.59 V/d	span 42	rot 164			0.77 V/d	span 55	rot 248

0.37 volt
