FACILITY: Sequoyah Nuclear Plant, Unit 1

SUBJECT: REVISED SUMMARY OF APRIL 11, 2001, MEETING REGARDING
SEQUOYAH UNIT 1 STEAM GENERATOR INSPECTION PLAN FOR
CYCLE 11 REFUELING OUTAGE

Steam Generator Inspection
Unit 1 End of Cycle 11
Less Than 2 Volt Dents

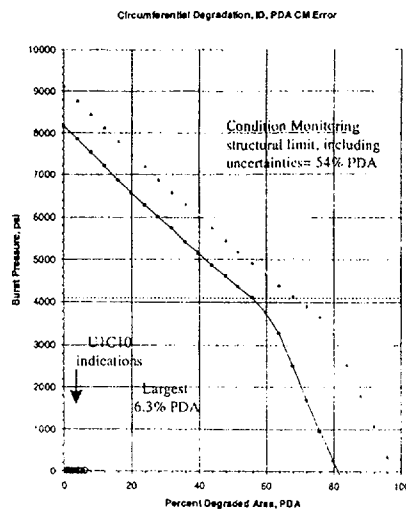
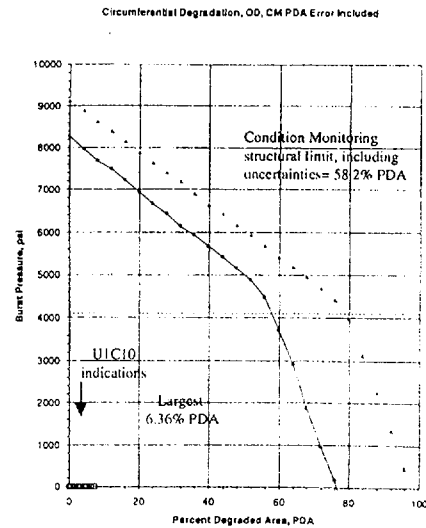
- Approximately 5,000 additional intersections will be inspected to validate end of Cycle 10 operational assessment methodology, assumptions, and conclusions
 - No indications are predicted to have PDAs large enough to challenge structural integrity

- **Approximately 5,000 additional intersections will be inspected to validate end of Cycle 10 operational assessment methodology, assumptions, and conclusions**
 - Between 100 and 150 indications were assumed unidentified during the end of Cycle 10 inspection
 - *Calculated accident-induced leakage remained well below allowable 1 gpm*
- **Expansion will be necessary if operational assessment is invalidated by structural or leakage concerns**
 - Plan will be developed when data is compiled
 - NRR will be informed of the expansion decision
