1. Order for Modification of License
2. Safety Evaluation of Mechanical Plugs to be Inserted into the Bypass Holes of the Vermont Yankee Nuclear Power Station
3. Safety Evaluation of Mechanical Plugs to be Inserted into the Bypass Holes of the Duane Arnold Energy Center Reactor

**SAFETY EVALUATION OF MECHANICAL PLUGS TO BE
INSERTED INTO THE BYPASS HOLES
OF THE DUANE ARNOLD ENERGY CENTER REACTOR**

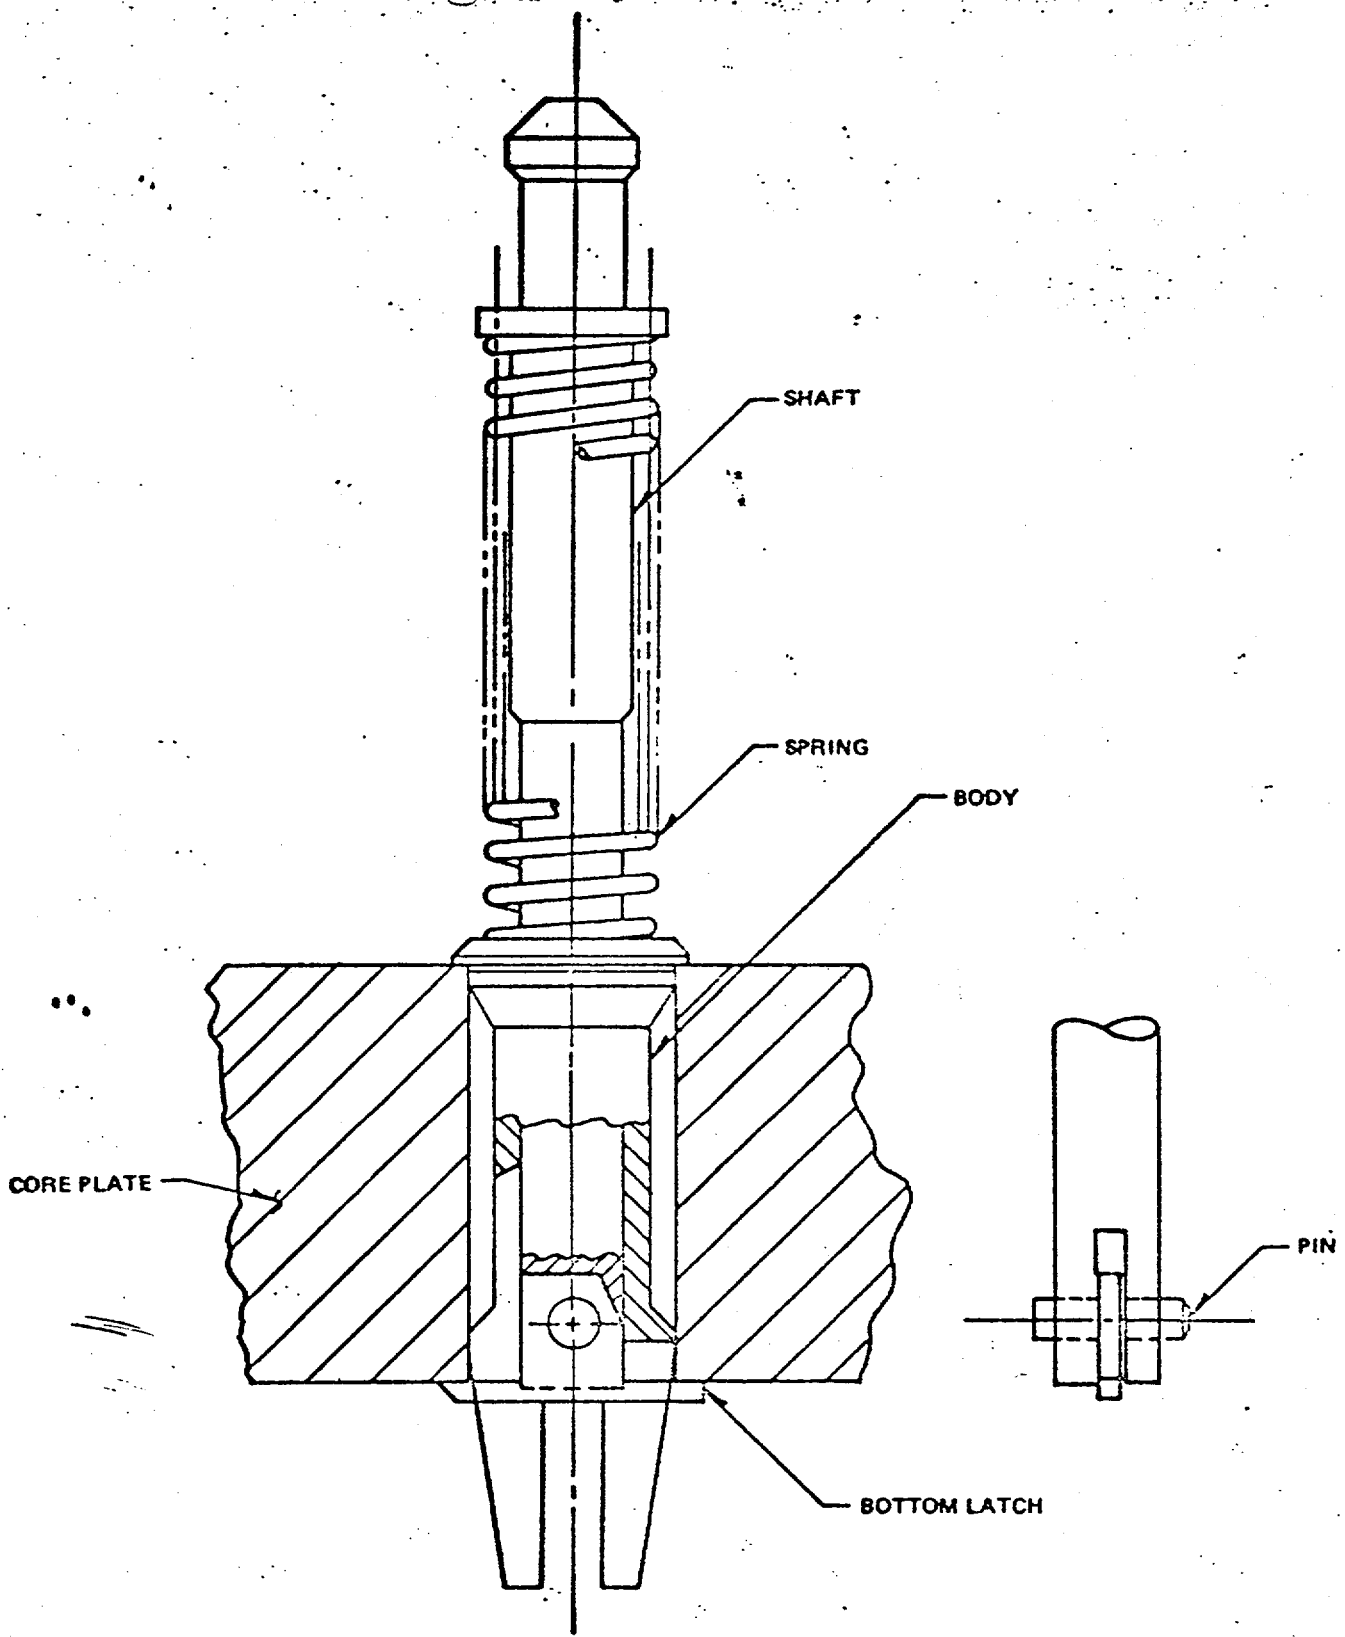
Figure 1. Plug Installed in Core Plate

The plug consists of five basic parts, as shown in Figure 1. Identical plugs have previously been installed at Vermont Yankee, Pilgrim, and Duane Arnold. The body provides a means of guiding the device into the bypass flow holes as well as a shoulder to support the plug and form a seal against water flow. The shaft extends through the body. A knob is provided at the top of the shaft to provide a means of grabbing the plug during installation and extraction. At the bottom, the latch is attached to the shaft by a pin. The latch is free to rotate during installation. The spring acts against the body and shaft during normal operation to provide the force necessary to offset the pressure differential acting on the body.

A correlation between BWR channel box wear and lower core plate bypass flow holes has led to the development of a mechanical plug to fill these holes (Figure 1).

The core plate plug consists of two stainless steel parts (body and shaft) which are connected by an Inconel spring. The shoulder of the body rests on the top of the core plate along the rim of a one-inch bypass hole and is pressed down by the spring. An equal and opposite force is applied on the shaft. A stainless steel latch is connected to the bottom of the shaft by means of a pin. This latch is free to rotate about the pin and latches the shaft to the core plate. The spring exerts a minimum load of 38 lbs on the body and latch and a maximum of 46 lbs (with the worst tolerance combination).
