§ 54.3 Definitions.

Hatch Approach to Address Environmental Fatigue

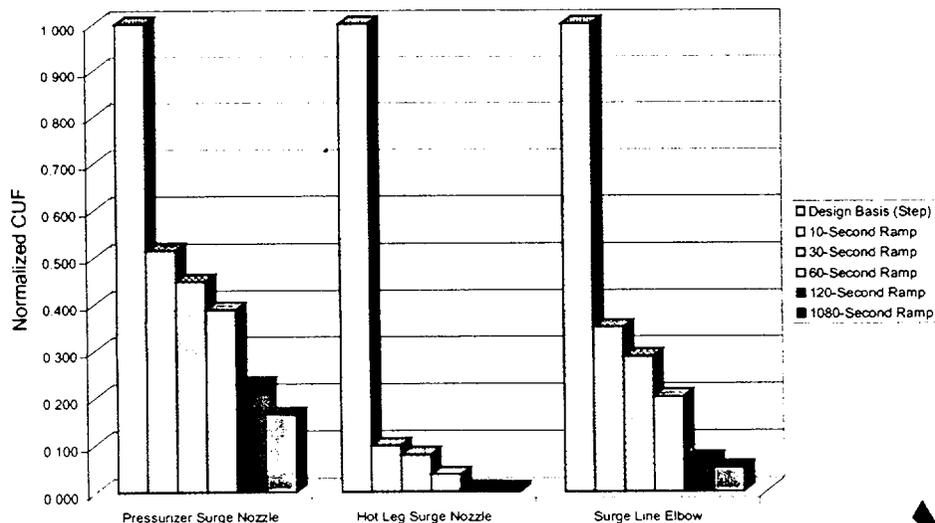
Figure 1: Sensitivity of Plant Operation Relative to Design Transients

- Plant comparisons -- Hatch vs. BWR study plant
 - » No plant data available for Hatch
 - » Limited transient data for other BWRs available
 - ◆ Doesn't address the Hatch issue
 - » Parametric studies were performed
 - ◆ Pressurizer surge line results from Calvert Cliffs study (see Figure 1)
 - ◆ Additional BWR results (see Figure 2)
 - ◆ Demonstrate plant operational variations are insensitive to design basis conservatisms
- Conclusion: Compared to design basis severity, any operational differences between Hatch and Generic BWR are insignificant

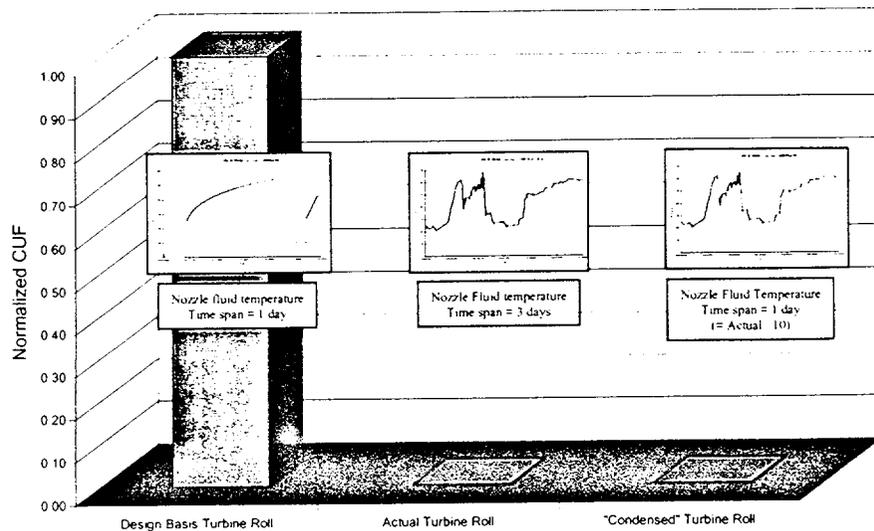
Figure 2: Sensitivity of Plant Operation Relative to Design Transients
