Cable Insulation Resistance Measurements Made During the EPRI-NEI Cable Fire Tests

Prepared by
Francis J. Wyant, Steven P. Nowlen

Sandia National Laboratories
Albuquerque, New Mexico 87185-0744

Prepared for:
Probabilistic Risk Assessment Branch
Office of Nuclear Regulatory Research
U.S. Nuclear Regulatory Commission
Washington, DC 20555
NRC Job Code Y6037

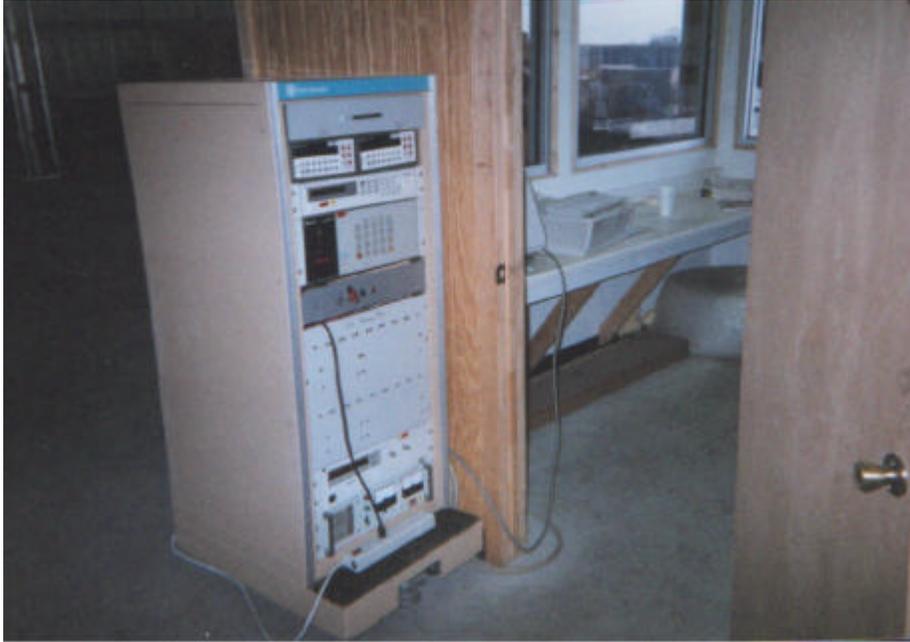
Figure 3-9. Front view of the IR Measurement system instrument rack.

Figures 3-9 and 3-10 show the IR Measurement system rack front and rear views, respectively. Part of the computer for the system can be seen through the doorway to the right of the instrument rack in Figure 3-9.

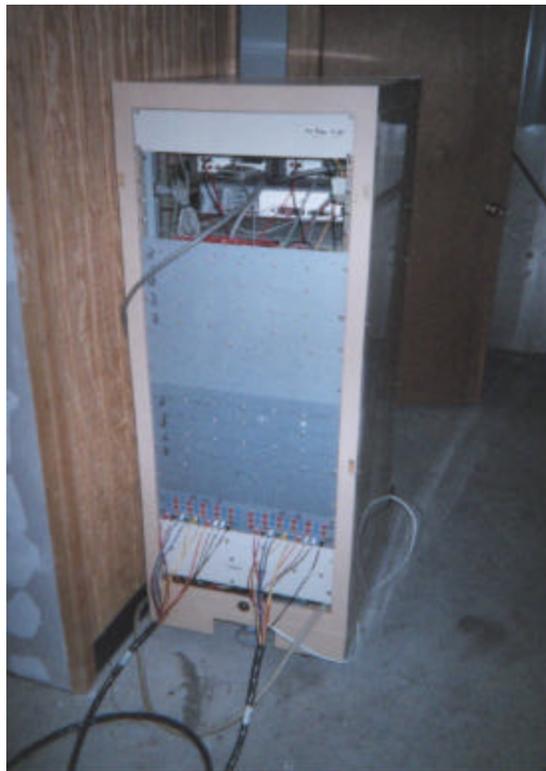
Figure 3-10. Rear view of the IR Measurement system instrument rack.

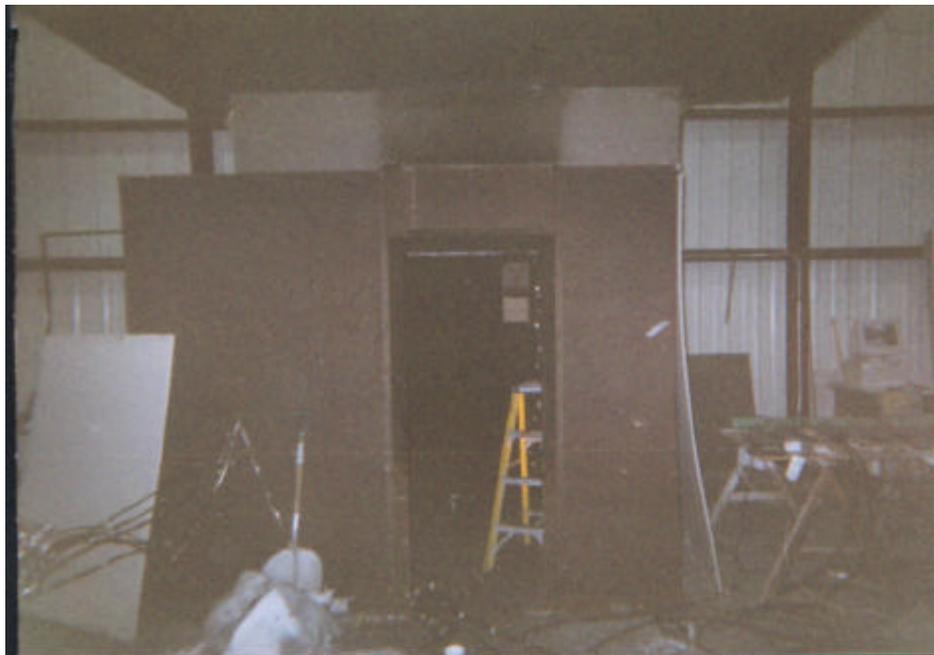
Figure 4-1. Fire test cell.

All of the 18 fire tests described here were conducted in a steel chamber measuring 10' x 10' x 8' (3x3x2.4 m LxWxH) illustrated in Fig. 4 -1. The chamber has an opening (door) ~30" (76 cm) wide by 7' (2.1 m) high in the center of one wall. The exposure fire was generated by flowing propane gas through a 12"x12" (30x30 cm) diffusion burner (a "sand burner", see Fig. 4-2). The fire intensity was controlled by the flow rate of the propane through the burner and ranged from 70 to 350 kW.

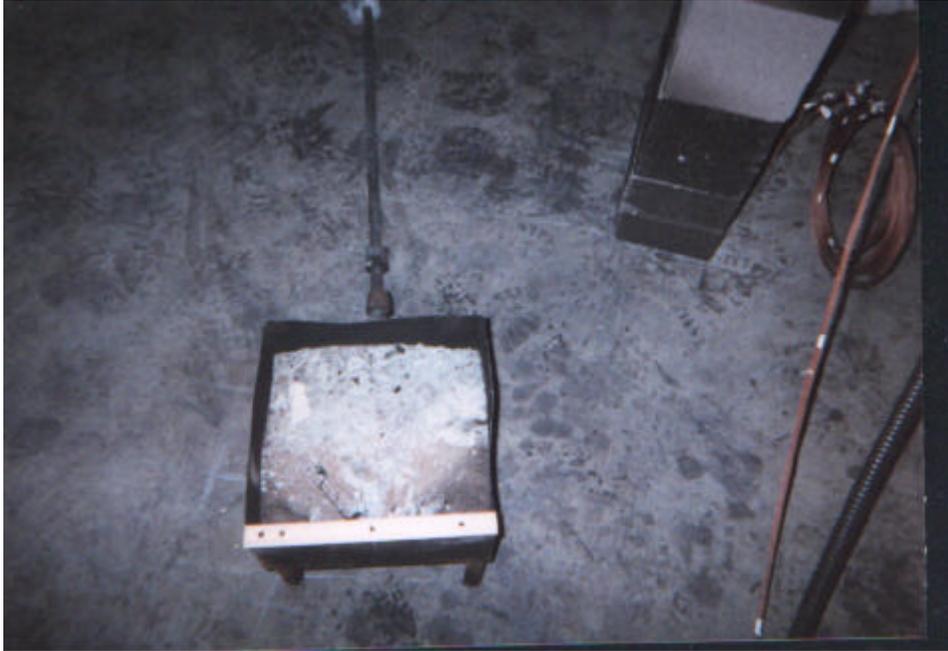
Figure 4-2. Diffusion burner (12"x12").

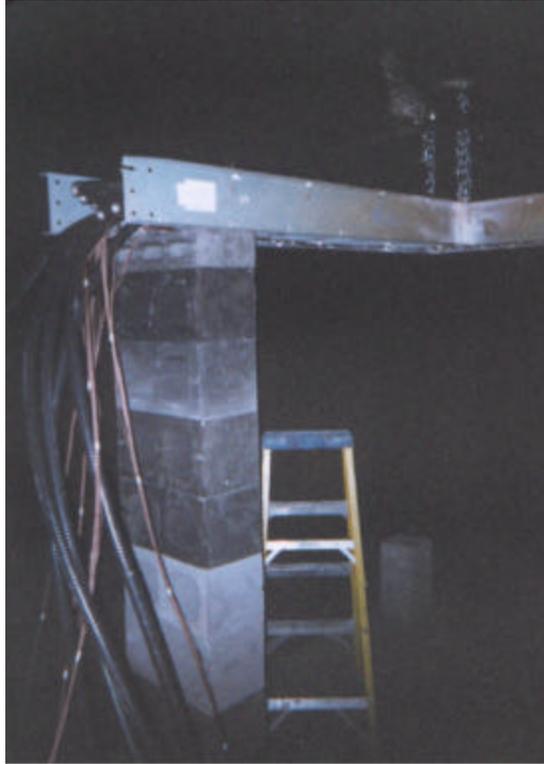
Figure 4-4. Tray, with cables, installed in fire test cell.

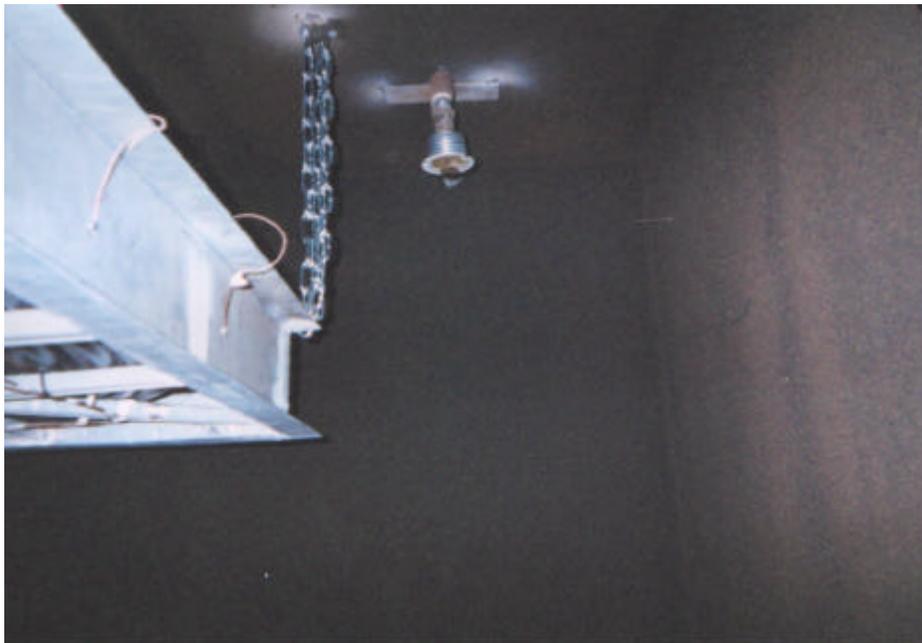
Figure 4-7. Water sprinkler head inside fire test cell.

A water sprinkler head (Fig. 4-7) was located in the top of the test cell to provide water spray at the corner of the tray following flame extinguishment. The water spray was conducted for one minute at the end of most tests.
