NUREG/CR-xxxx
SAND2001-xxxx

Cable Insulation Resistance Measurements Made During the EPRI-NEI Cable Fire Tests

Prepared by
Francis J. Wyant, Steven P. Nowlen

Sandia National Laboratories
Albuquerque, New Mexico 87185-0744

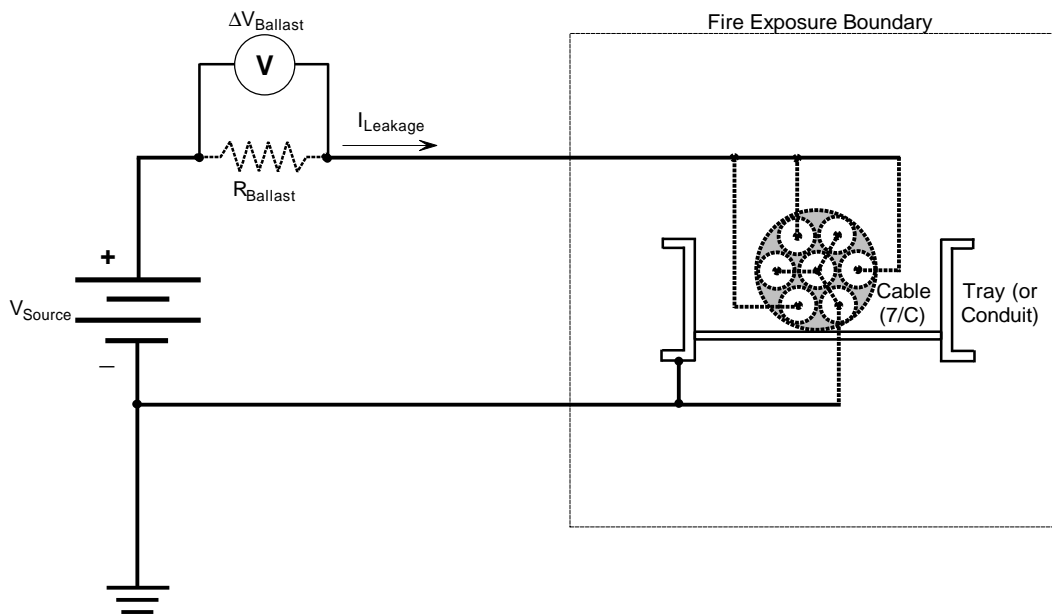
Figure 2-3. A single voltage source system applied to a multiconductor cable without a switching system. Note that the individual conductors are ganged into two groups, one group energized and the second grounded. IR is determined for the energized conductors only and then only as a group.

grounding the other four. In this case, the leakage current path would be from any of the conductors in the energized set to either ground directly or any one of the grounded conductors. Typically, the selection of the energized subset of conductors would be based on the physical configuration of conductors within the cable. The energized conductors would be selected so that, to the extent possible, each physically adjacent conductor pair would involve one energized and one grounded conductor. This approach has been used in a number of past cable fire testing programs, and is illustrated in Figure 2-3 for a seven-conductor cable.

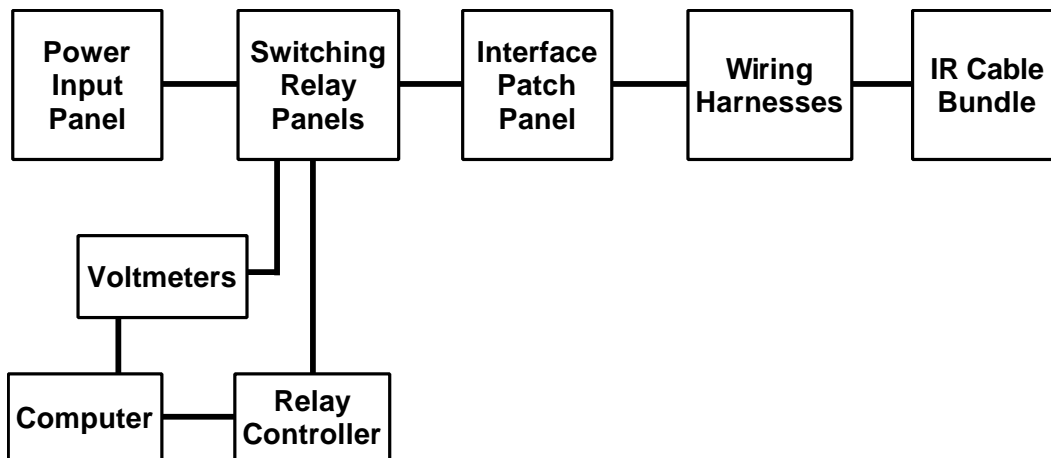
Figure 3-6. IR Measurement system block diagram of functional areas.

Figure 3-6 provides a block diagram identifying the principal functional areas of the IR measurement system. A schematic diagram of the complete system is provided in Figure 3-7. Each of the functional areas is described in some detail in the following sections.

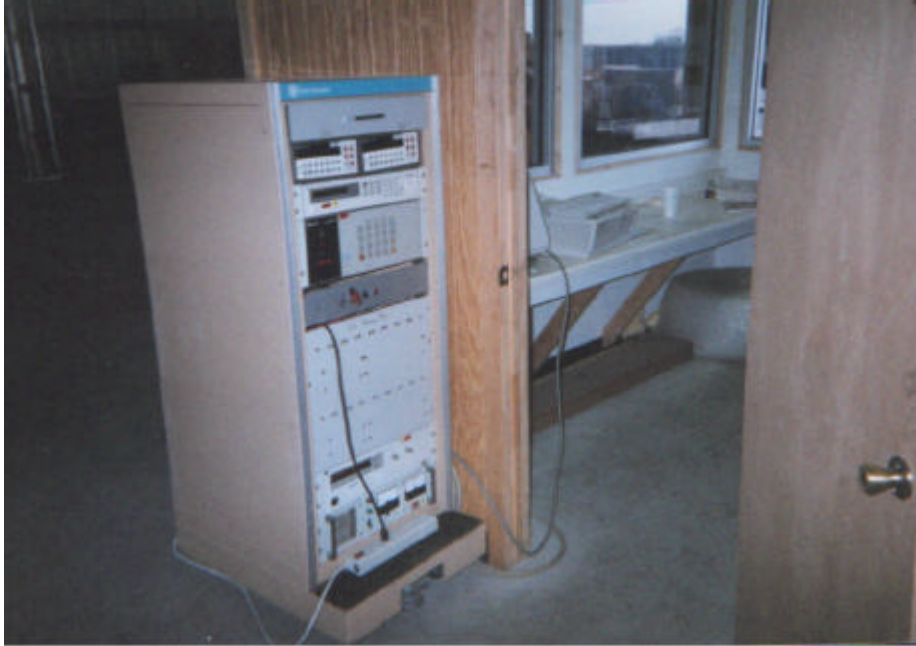
Figure 3-9. Front view of the IR Measurement system instrument rack.

Figures 3-9 and 3-10 show the IR Measurement system rack front and rear views, respectively. Part of the computer for the system can be seen through the doorway to the right of the instrument rack in Figure 3-9.

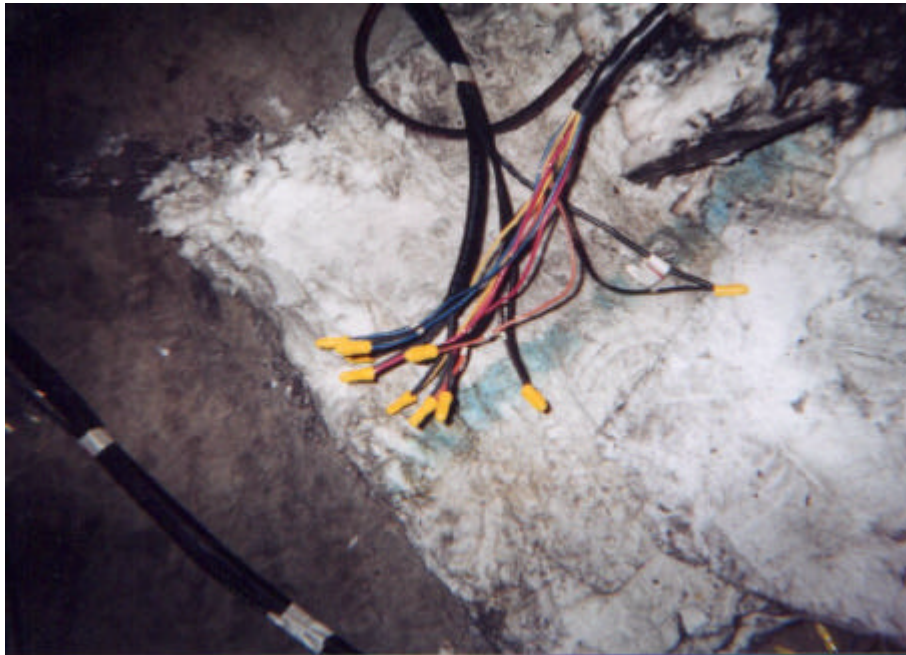
Figure 3-11. IR Measurement system "In" wiring harness connection to the test cable bundle.

Connection of the wiring harnesses to the test cable during the EPRI-NEI tests was accomplished using commercially available wire nuts (See Fig. 3-11). It is important that each end of a specific conductor in the test cable be connected to the corresponding conductors in both wiring harnesses. For example, the conductors marked "1" in each wiring harness needed to be connected to the ends of the same conductor in the test cable. This also applied to the conductors marked "2" through "10" in the harnesses. Proper connections are checked by performing a continuity check of the pairs of harness conductors at the patch panel ends of the wiring harnesses.

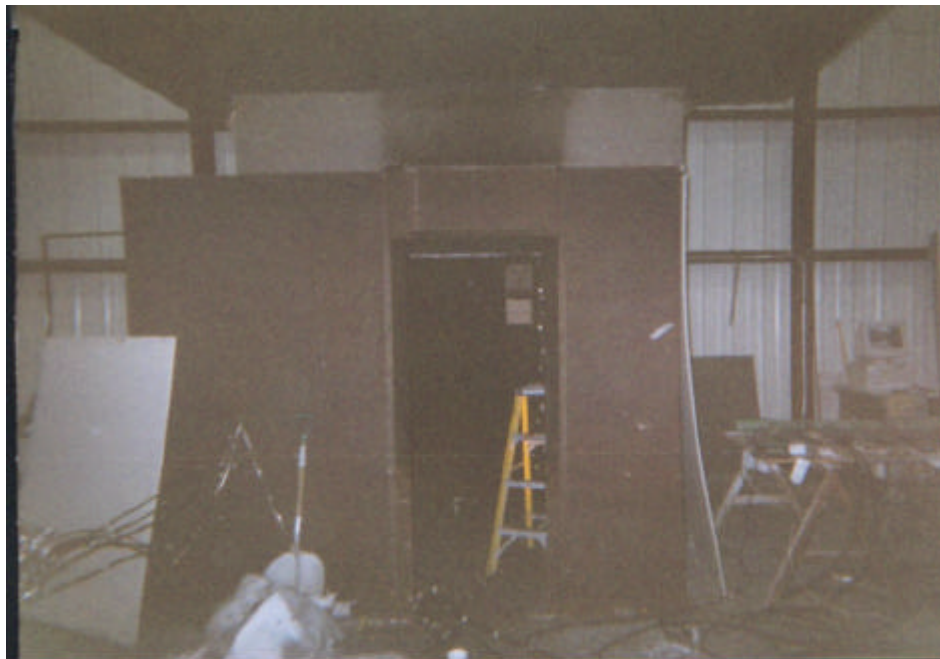
Figure 4-1. Fire test cell.

All of the 18 fire tests described here were conducted in a steel chamber measuring 10' x 10' x 8' (3x3x2.4 m LxWxH) illustrated in Fig. 4 -1. The chamber has an opening (door) ~30" (76 cm) wide by 7' (2.1 m) high in the center of one wall. The exposure fire was generated by flowing propane gas through a 12"x12" (30x30 cm) diffusion burner (a "sand burner", see Fig. 4-2). The fire intensity was controlled by the flow rate of the propane through the burner and ranged from 70 to 350 kW.

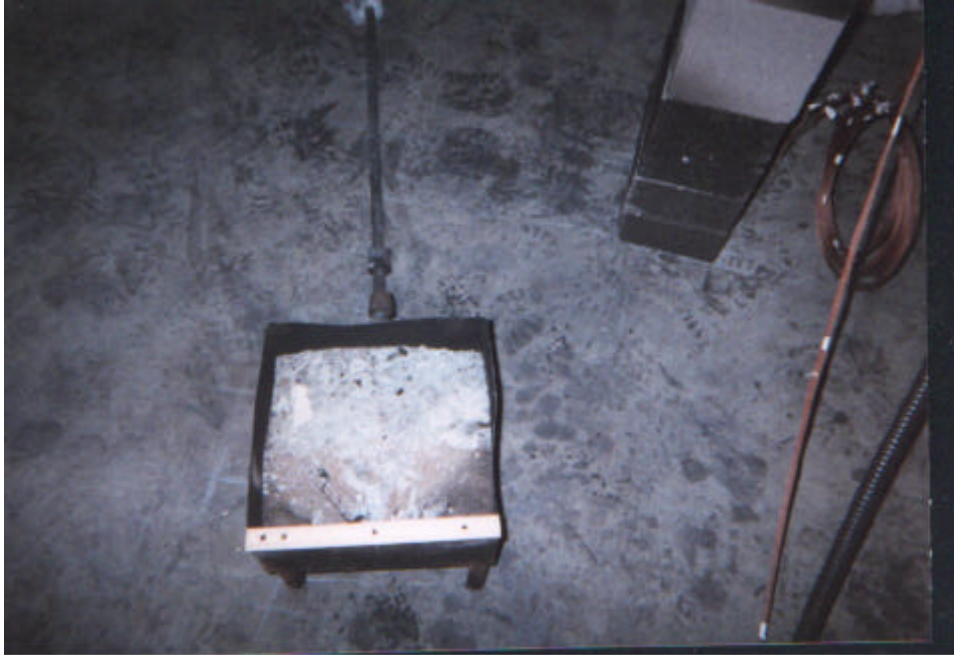
Figure 4-2. Diffusion burner (12"x12").

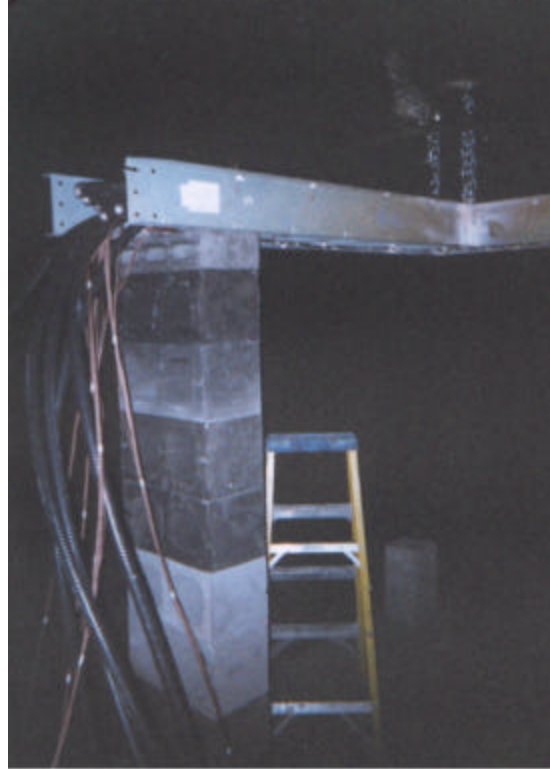
Figure 4-4. Tray, with cables, installed in fire test cell.

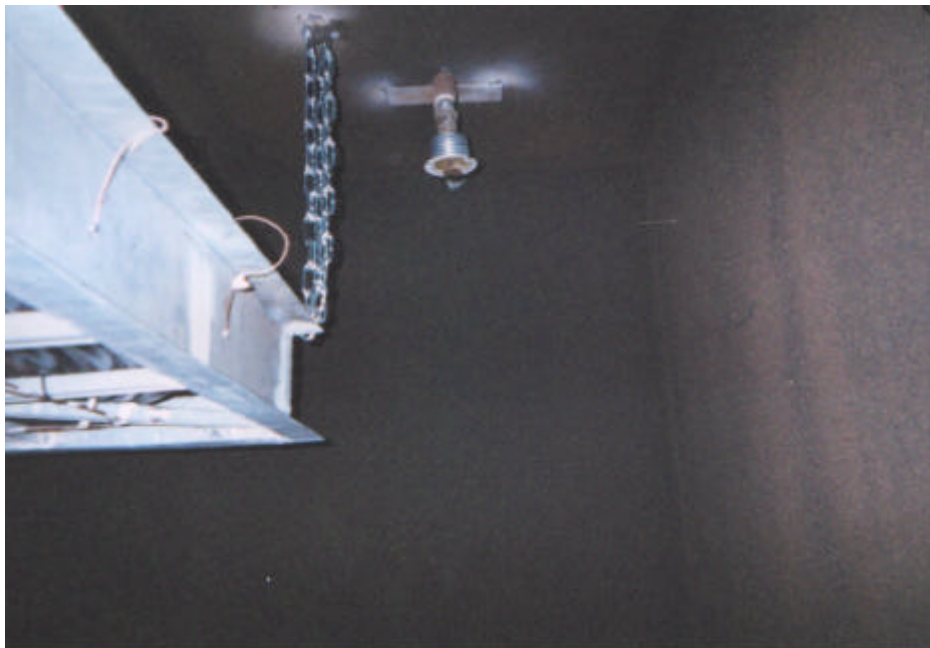
Figure 4-7. Water sprinkler head inside fire test cell.

A water sprinkler head (Fig. 4-7) was located in the top of the test cell to provide water spray at the corner of the tray following flame extinguishment. The water spray was conducted for one minute at the end of most tests.

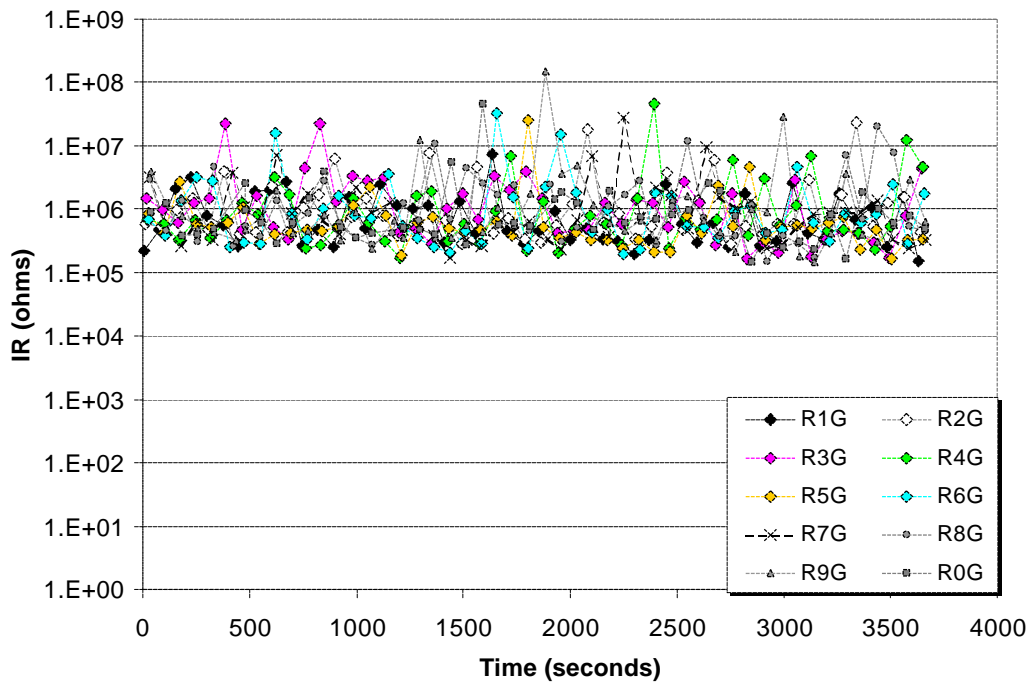
The insulation resistance change over time of each individual conductor to ground is shown in Figure 5-7. Here again, it appears that the 70 kW fire did not cause sufficient damage to the cable to change the IR. Figure 5-8 shows a plot of how the leakage currents for conductors 1 & 2 changed in their relationship to one another and to ground as the test progressed. Based solely on the results of the IR measurements made during Test #2, it appears that the IR cable experienced virtually no damage and would not have been able to cause any device actuation or blown fuses.

Figure 5-7. Conductor-to-Ground Insulation Resistances Obtained during Test #2.
