Subject: 10CFR21 Reporting of Defects and Non-Compliance -
Engine Systems, Inc. Report No. 10CFR21-0082, Rev. 2

Woodward electronic controls with electrolytic capacitors

**10CFR21 REPORTING OF DEFECTS
AND NON-COMPLIANCE**

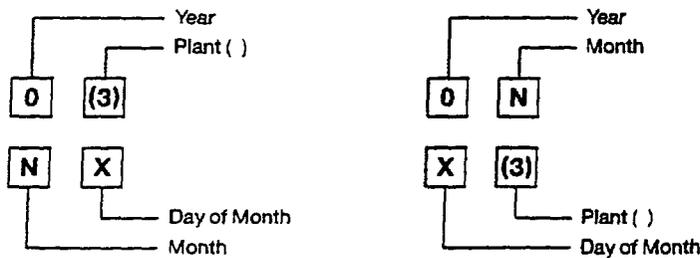
Radial

The following are examples of typical date codes for United Chemi-Con products.

ESI recommends replacing the control's electrolytic capacitors every 5-7 years from the manufacture date of the capacitor. The capacitor manufacture date is identified by a date code stamped on the capacitor (refer to the Capacitor Date Coding information on page 3). In addition, the electrolytic capacitors of controls in storage must be reformed every 18-24 months (this supercedes ESI service alert 059801 for EGA controls). Reforming is accomplished by applying rated voltage to the control's input power terminals for a period of 24 hours. Controls in service normally have input power continuously applied (or as a minimum, input power is applied during periodic surveillance testing of the prime mover) and therefore, a separate reforming operation is not required.

- 0 = Last Digit of Year (0 = 2000)
- N = Month: 1-9 = January to September
 O = October
 N = November
 D = December
- X = Day of Month: A-Z = 1 to 26
 a-e = 27 to 31
- 07 = Manufacturing Line Number
