September 4, 2001

Docket Nos: 50-315
50-316

Donald C. Cook Nuclear Plant Units 1 and 2
NUCLEAR REGULATORY COMMISSION (NRC) BULLETIN 2001-01:
CIRCUMFERENTIAL CRACKING OF REACTOR PRESSURE VESSEL
HEAD PENETRATION NOZZLES
(TAC numbers MB2624 and MB2625)

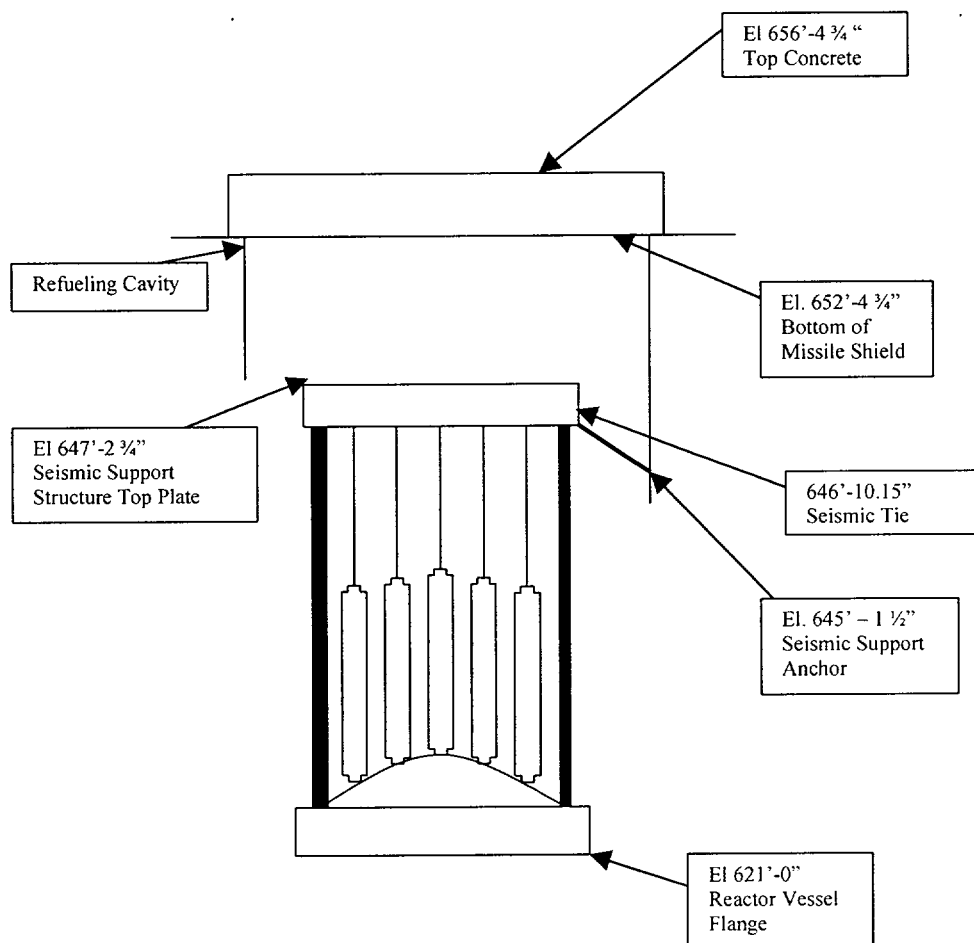
The following sketch provides the relative elevation of the various components.

The insulation used for the reactor head is metallic reflective. It is 3 inches thick and made of Type 304 stainless steel. The configuration is as follows. The outer circumference covers the outer row of VHPs. This is connected to vertical panels that extend up 17 inches. This then connects to a set of flat panels that cover the remaining VHPs. There is a 1.5 inch clearance between the underside of the insulation and the top of the head.

The Control Rod Drive Mechanism (CRDM) is the assembly that positions the control rods in accordance with signals from the rod control system. The assembly consists of the pressure tube, which is attached to the VHP nozzle. Inside the pressure tube is the control rod drive shaft. This shaft is latched to the control rods to control reactor power. Surrounding the pressure tube is the electromagnetic coil stack. This provides the motive force to move the control rods. The CRDM assembly is screwed on the VHP and is seal-welded to prevent leakage. The CRDM housings are constructed from Type 304 stainless steel tubing, and Types CF8 and F8 cast stainless steel.

Encircling the reactor head and extending approximately 90 inches is the shroud. This shroud provides the ducting for the head ventilation system. The air is fed into the shroud by external ductwork, which is attached to the shroud. Outside the shroud is a radiation shield that extends approximately 8 feet up from the reactor head. This shield reduces the radiation dose of the workers during refueling preparations.
