December 6, 2001

I am responding to your letter to Mr. Dennis Rathbun, Director of the NRC's Office of Congressional Affairs, in which you forwarded the concerns of Ms. Barbara Cornett about the structural integrity of control rod drive mechanism nozzles and other vessel head penetration (VHP) nozzles in U.S. commercial nuclear power plants. Ms. Cornett forwarded her concerns to you August 29, 2001, in an e-mail. In her e-mail, Ms. Cornett referred to an August 27, 2001, article by Mr. David Lochbaum, of the Union of Concerned Scientists, in which Mr. Lochbaum criticized the NRC for apparently failing to ensure the structural integrity of VHP nozzles in U.S. commercial pressurized water reactors (PWRs). Mr. Lochbaum specifically criticized the NRC for apparently ignoring the issue of stress corrosion cracking in the VHP nozzles of U.S. PWRs and for failing to require NRC-licensed utilities to replace the upper heads of their reactor pressure vessels. Mr. Lochbaum made his article available to the public by placing the article on the World-Wide-Web at <http://www.ucsusa.org/index.html>. In her e-mail to you, Ms. Cornett stated that she had found the issue discussed in Mr. Lochbaum'

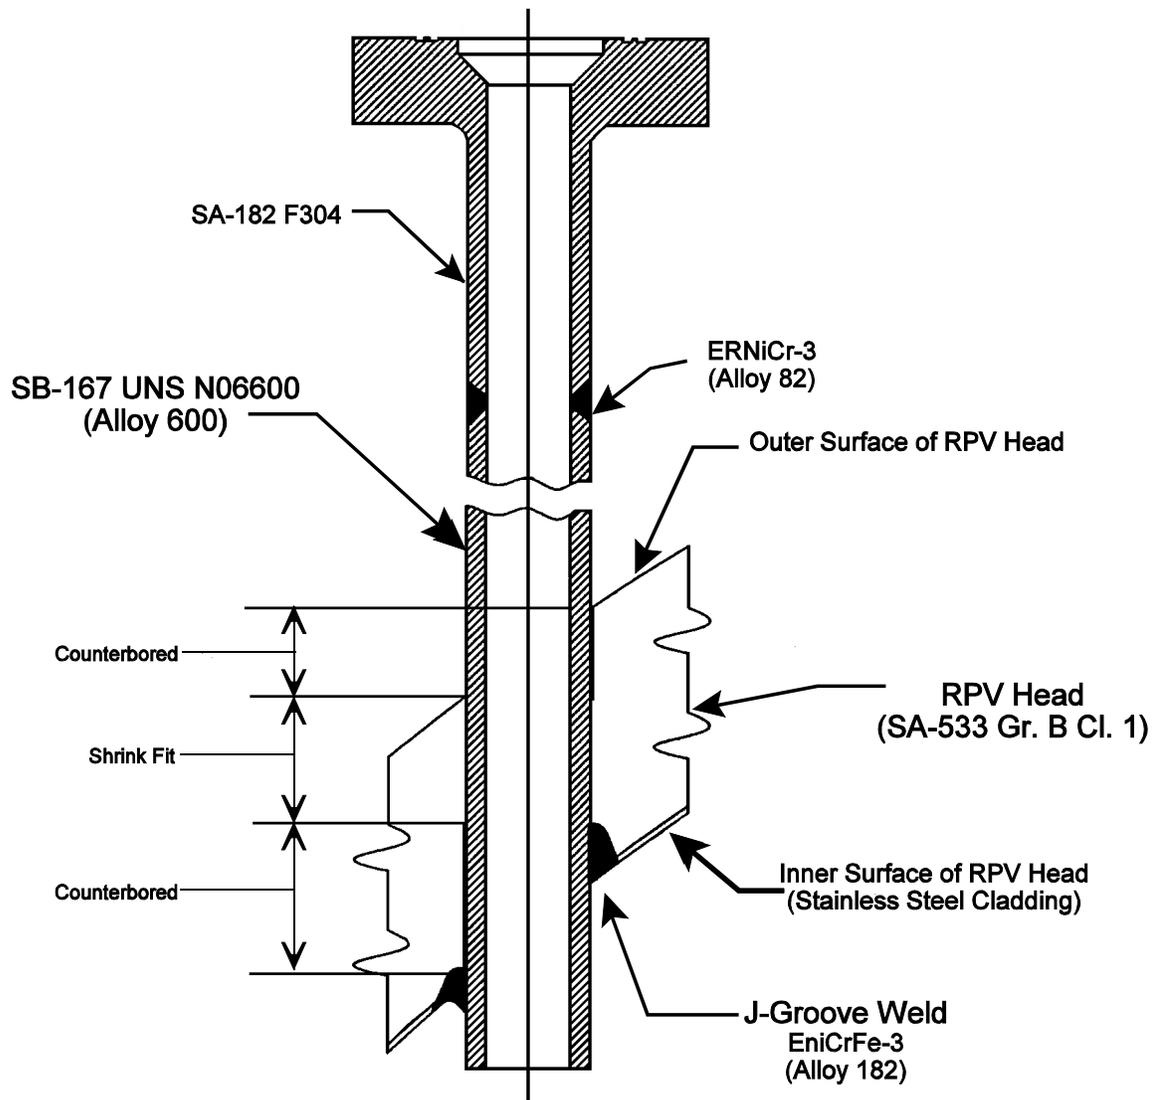
Figure 1. Schematic of Typical CRDM Nozzle Penetration

The vessel head penetration (VHP) nozzles of commercial U.S. pressurized water reactors (PWRs) are fabricated from Inconel 600 (also known as Alloy 600), a material that has been demonstrated to be susceptible to cracking induced primarily by age, temperature, and stress corrosion. These nozzles are part of the reactor coolant pressure boundary, which is one of three principle barriers to the release of radioactive fission products. The VHP nozzles are joined to the reactor vessel head by J-groove welds that only partially penetrate through the head thickness (Refer to Figure. 1). Stress corrosion cracking of a VHP nozzle or the weld connecting the nozzle to the vessel head can lead to leakage from the pressure boundary. If undetected and uncorrected, this type of degradation could potentially propagate to failure of the nozzle and result in a small-break loss-of-coolant accident (LOCA) for the plant. While this is not a desirable consequence, all commercial nuclear power plants are designed to accommodate certain postulated failures, including a VHP nozzle failure. All plants have emergency core cooling systems that will quickly inject coolant into the reactor and maintain it in a safe condition.
