SUBJECT: DRAFT NUREG-XXXX, TECHNICAL ASSESSMENT, GENERIC
ISSUE 186: POTENTIAL RISK AND CONSEQUENCES OF HEAVY
LOAD DROPS IN NUCLEAR POWER PLANTS

This study was initiated in response to candidate generic issue 186, *"Potential Risk and Consequences of Heavy Load Drops in Nuclear Power Plants."* The attached report documents the results of a systematic and comprehensive study of crane operating experience at U.S. nuclear power plants.

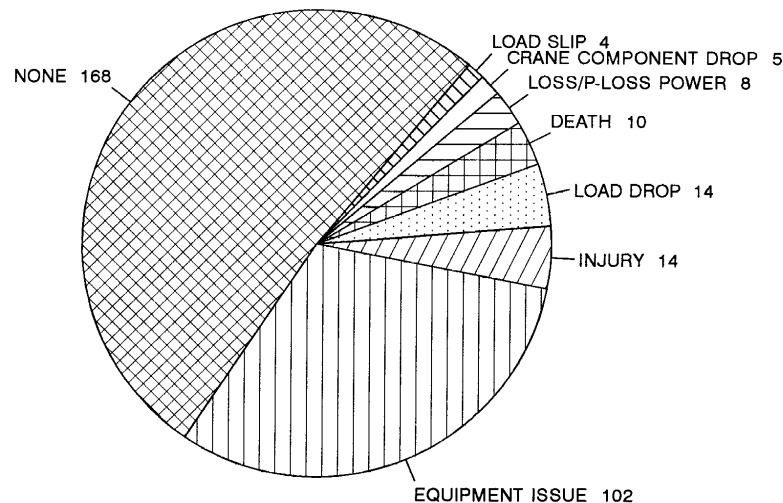
Since a load drop could also result in damage to plant equipment, more than one category could be affected. Consequently, one crane event may result in more than one piece of equipment being damaged, or more than one death or injury. Of the 297 crane issues, the total number of “outcomes” total 324. Figure 6, *Number of crane issues by category (1968-1999)* indicates the number of crane issues or events for each category, and not the quantity of items affected for each category.

Figure 6:
crane issues by
(1968-1999)

Number of
category
