Review of Industry Responses to NRC Generic Letter 97-06 on Degradation of Steam Generator Internals

Brookhaven National Laboratory

**U.S. Nuclear Regulatory Commission
Office of Nuclear Reactor Regulation
Washington, DC 20555-0001**

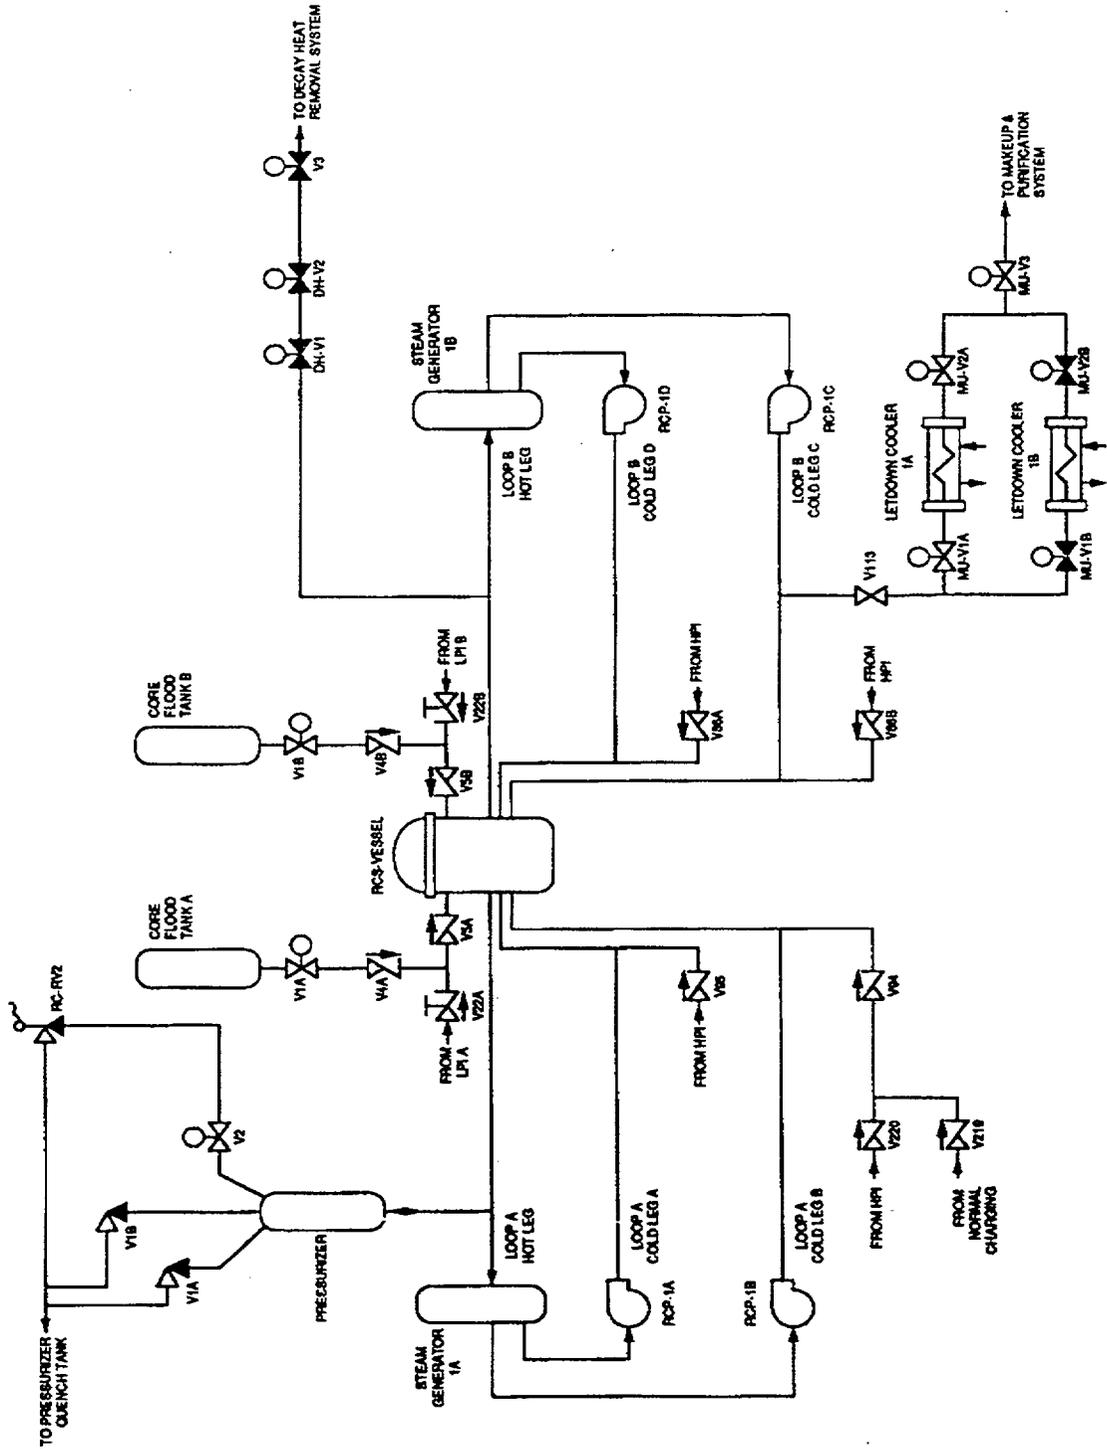
Figure 3.1 Three Mile Island 1 Reactor Coolant System Showing Location of Components

This section discusses the two groups of plants that have steam generators manufactured by B&W. The first group contains five sites and seven reactor units whose nuclear steam supply systems (NSSS) were designed and supplied by B&W. All of these B&W plants have two Reactor Coolant System loops, each with two Reactor Coolant Pumps, and one once-through steam generator (OTSG). A typical arrangement is shown in Figure 3.1. Thus each unit has two OTSGs. Figure 3.2 shows a diagram of a B&W OTSG.

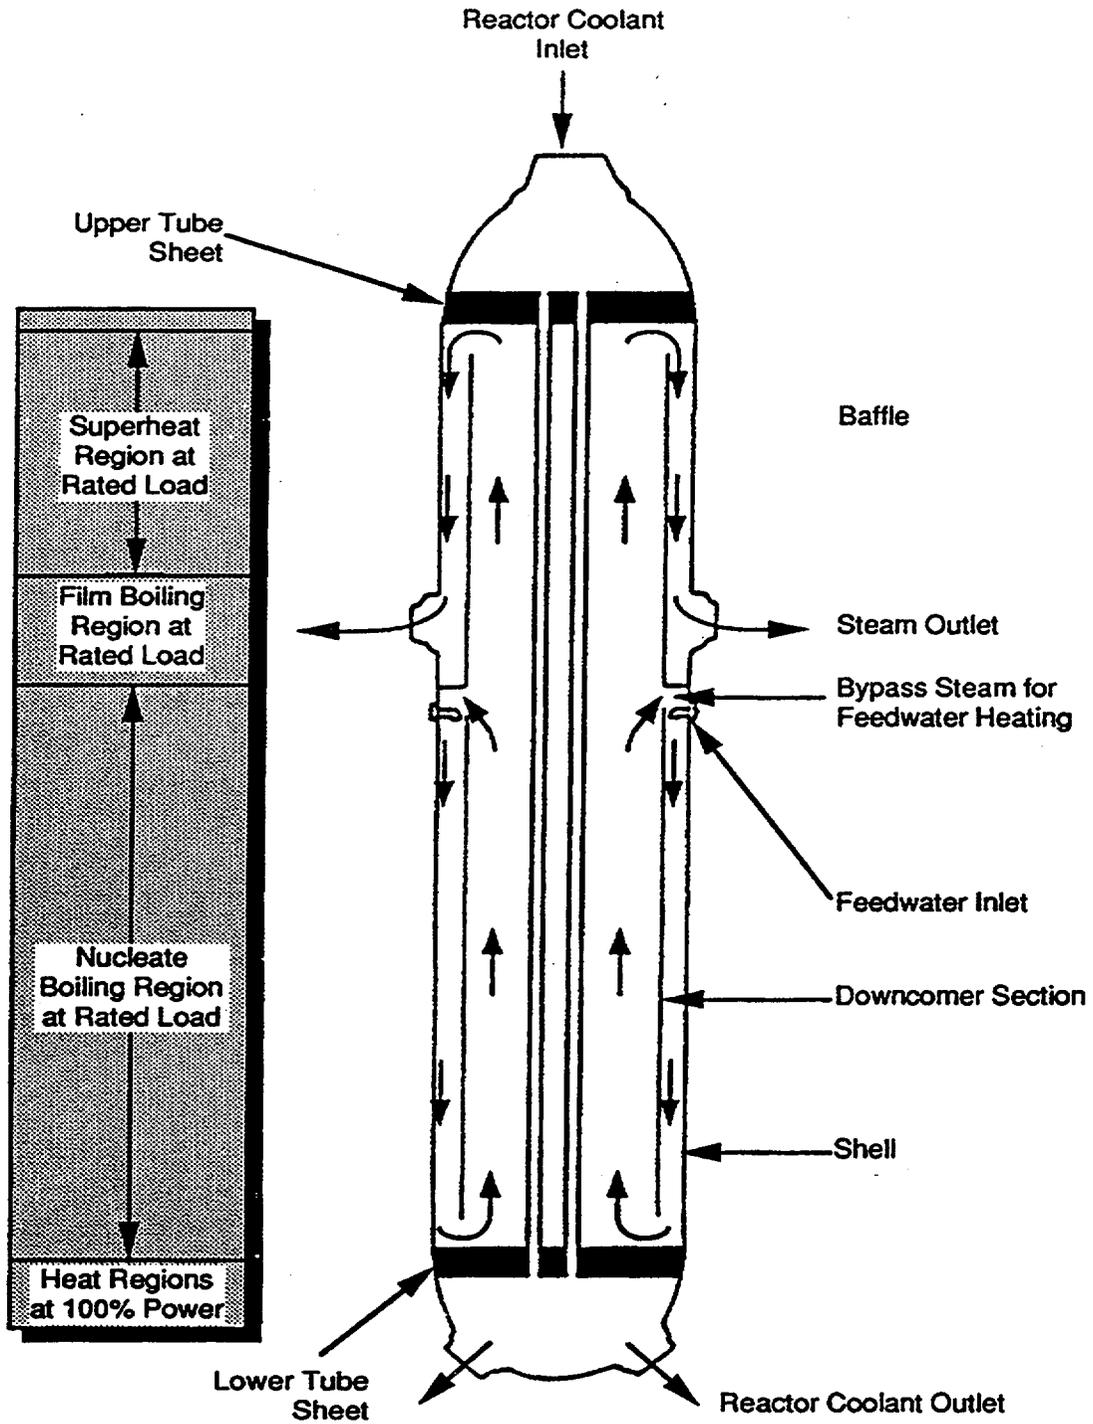
Figure 3.2 B&W 177 Plant Once-through Steam Generator

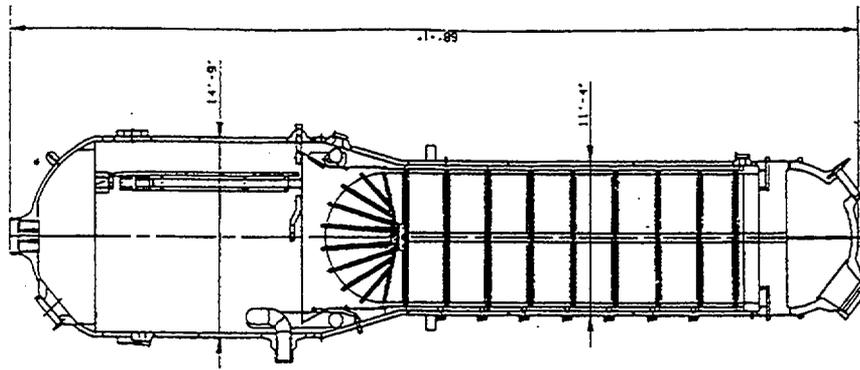
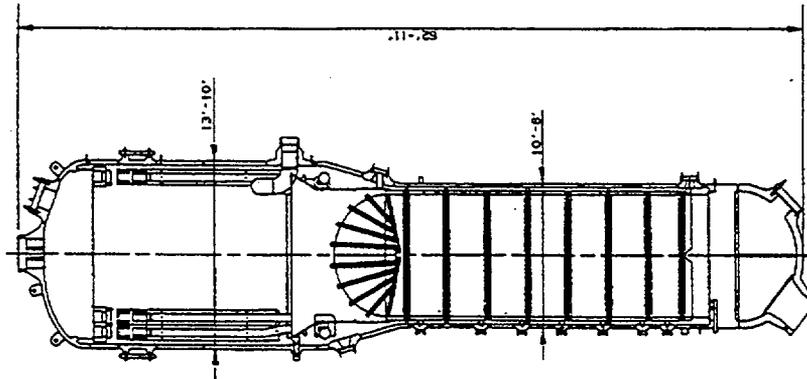
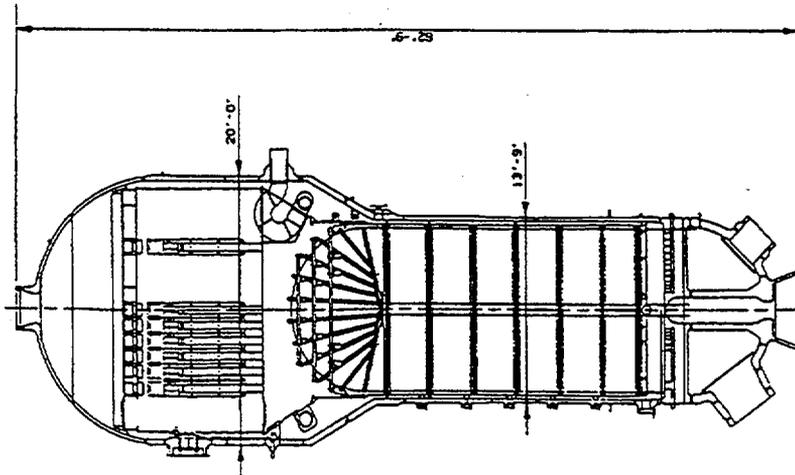
CATAWBA UNIT 1, McGUIRE UNITS 1 & 2
 BYRON UNIT 1, & BRAIDWOOD UNIT 1
 (APPROX. 400 TON DRY WEIGHT)

GINNA
 (315 TON DRY WEIGHT)

MILLSTONE UNIT 2
 ST. LUCIE UNIT 1
 (APPROX. 540 TON DRY WEIGHT)

Figure 3.3 Arrangements of B&W Replacement Steam Generator

The second group of plants includes eight sites and nine reactor units. All have replaced their original steam generators with enhanced ones designed and manufactured by B&W International of Canada. Unlike the first group, these replacement steam generators (RSGs) are B&W recirculating steam generators. Figure 3.3 illustrates the RSGs used in U.S. plants. They incorporate design features to mitigate many problems experienced with the original models. Based on the licensee submittals at the time of this review, this report addresses the seven plants (except Braidwood 1 and Cook 1) in this group with RSGs in-service. Table 3.1 below lists all the plants included in these two groups.

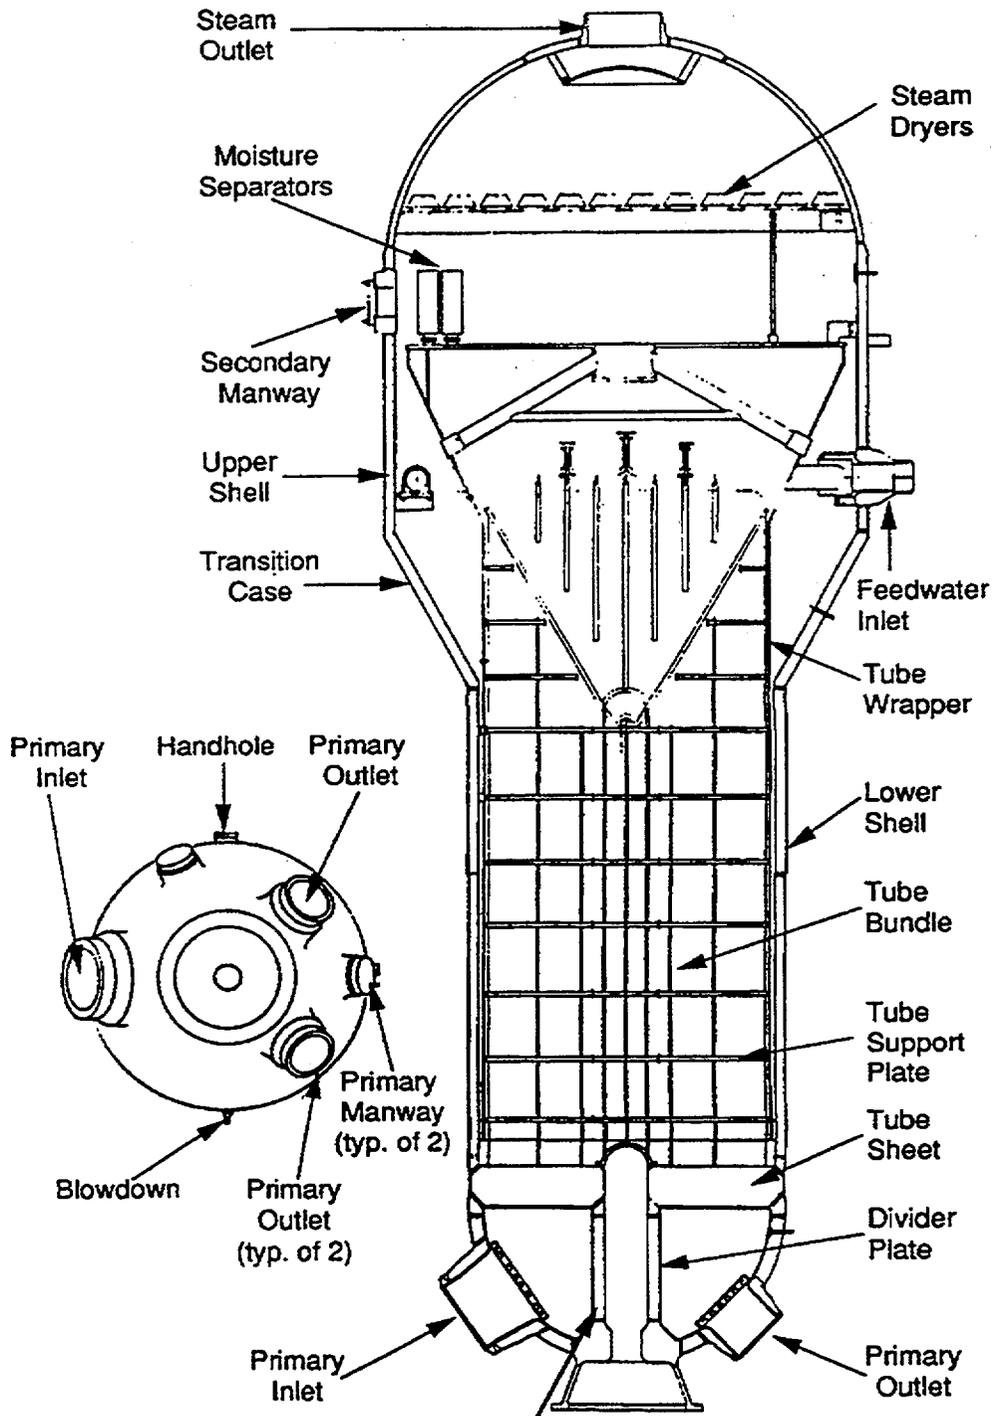
Figure 4.2 Combustion Engineering Recirculating Steam Generator
(Typical for 2-Loop System 69 Plants)

The CE steam generators have a vertical U-tube design, with integral moisture separators and steam dryers. All current CE plants contain two primary loops, each with one steam generator and two reactor coolant pumps (Figure 4.1). The most recent CE plant design is Palo Verde, and is called CE System 80. In the pre-System 80 plants, the feedwater inlet nozzle enters the SG above the level of the tube bundle (Figure 4.2). These SGs do not have an economizer. The System 80 SG unit is larger than the pre-System 80 designs, with feedwater entering both the downcomer and the economizer of the SG (Figure 4.3).

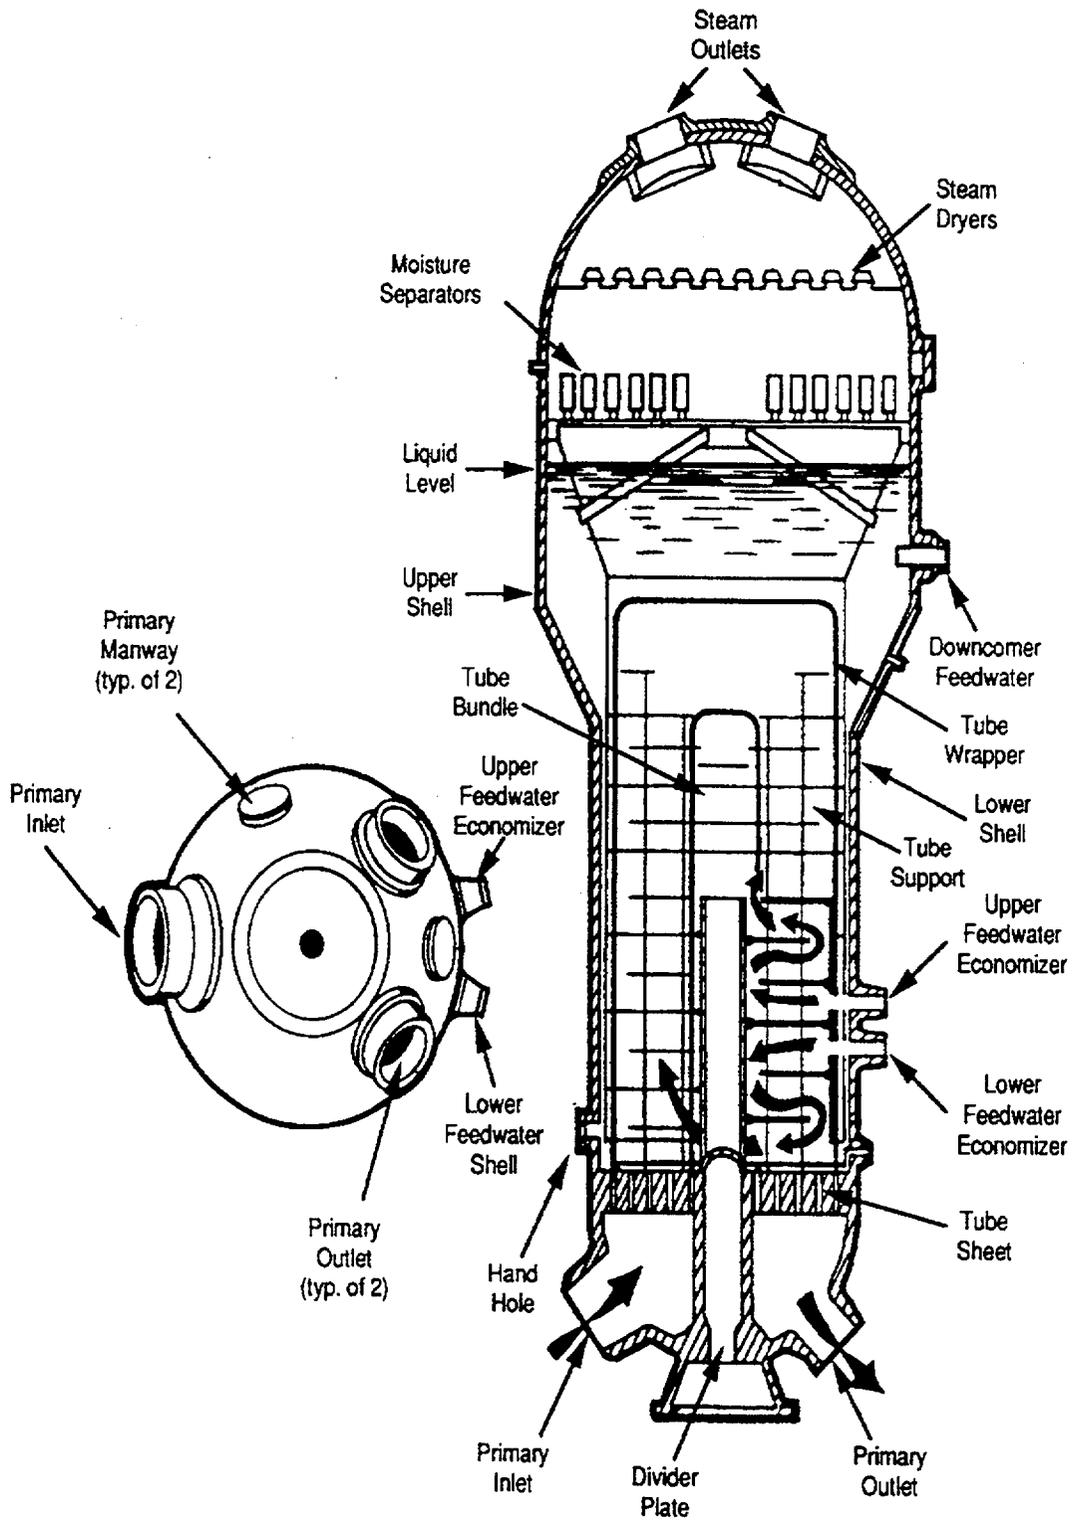
Figure 4.3 Combustion Engineering Recirculating Steam Generator
(Typical for System 80 Plants)

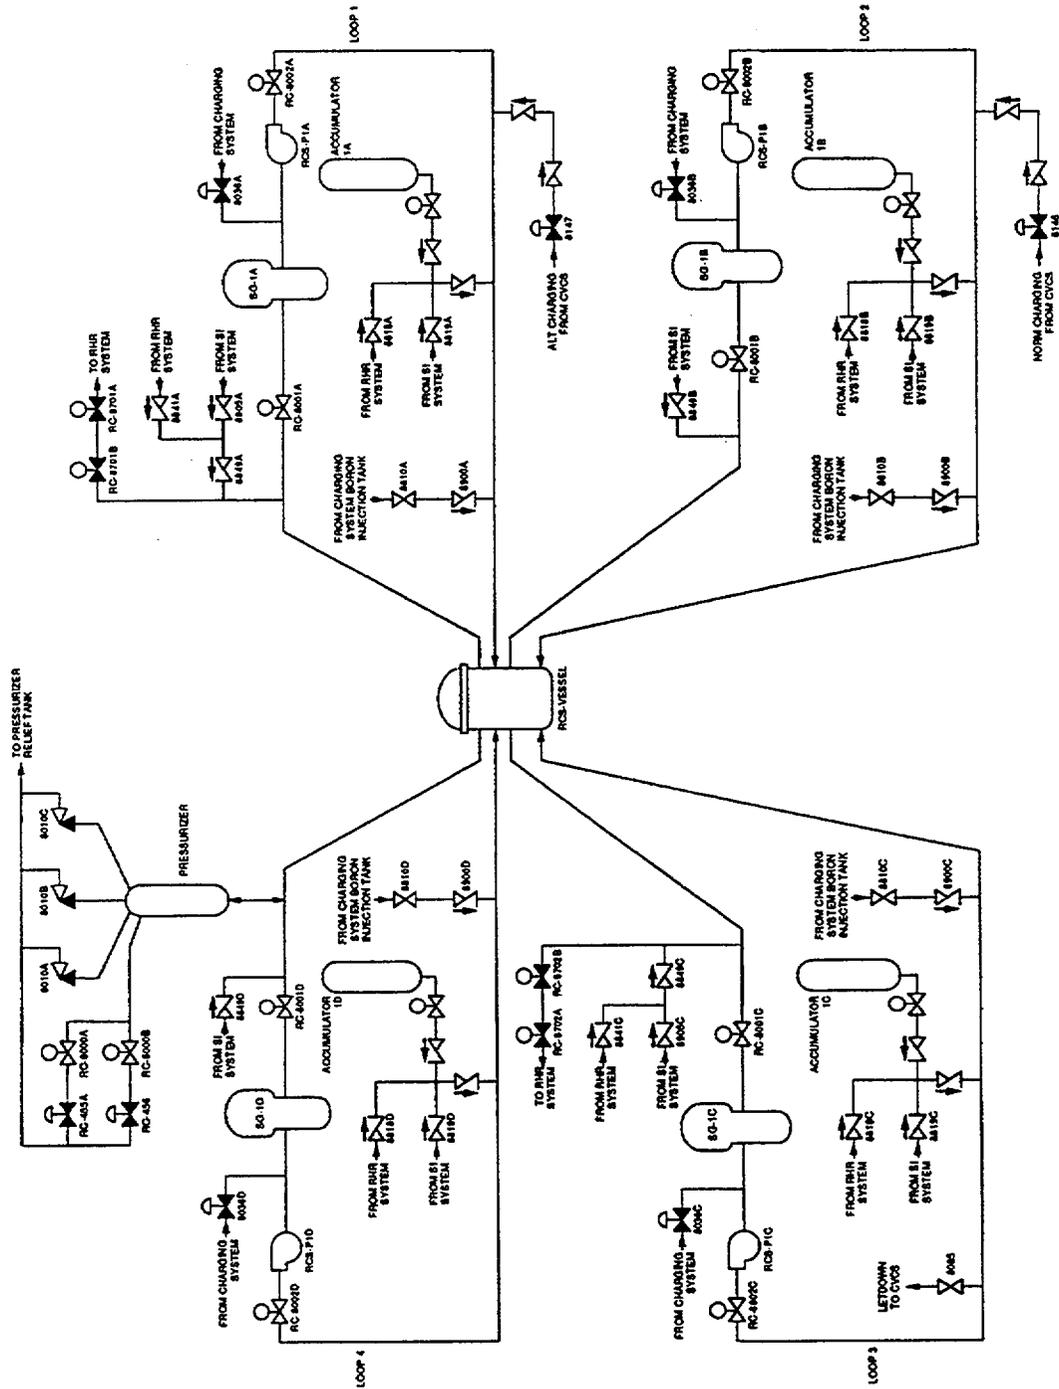
Figure 5.1 Braidwood Unit 1 Reactor Coolant System (4 Loops)

WOG evaluated all its SG models in two groups. The first group includes the 51-series SGs consisting of Westinghouse models 51, 51M, 51F, and 54F discussed in WCAP-15002 (Ref. 21) and WCAP-15031 (Ref. 22). These evaluations address the EdF causal factors in the GL. The 51-series SG designs are the most similar to the EdF units described in the GL. Westinghouse also included two other replacement SG designs, the Delta 47 and Delta 75 in these evaluations because of a stated "similarity in design." The second group includes W SG models 44F, F, D3, D4, D5, and E2, discussed in WCAP-15093 (Ref. 23) and WCAP-15104 (Ref. 24). Table 5.1 lists the PWRs having Westinghouse steam generators and gives the model, number of SGs, and pertinent comments. Depending on the number of loops in reactor primary system design, each plant may have two to four SGs in service (see Figures 5.1 and 5.2 for examples of the primary system design).

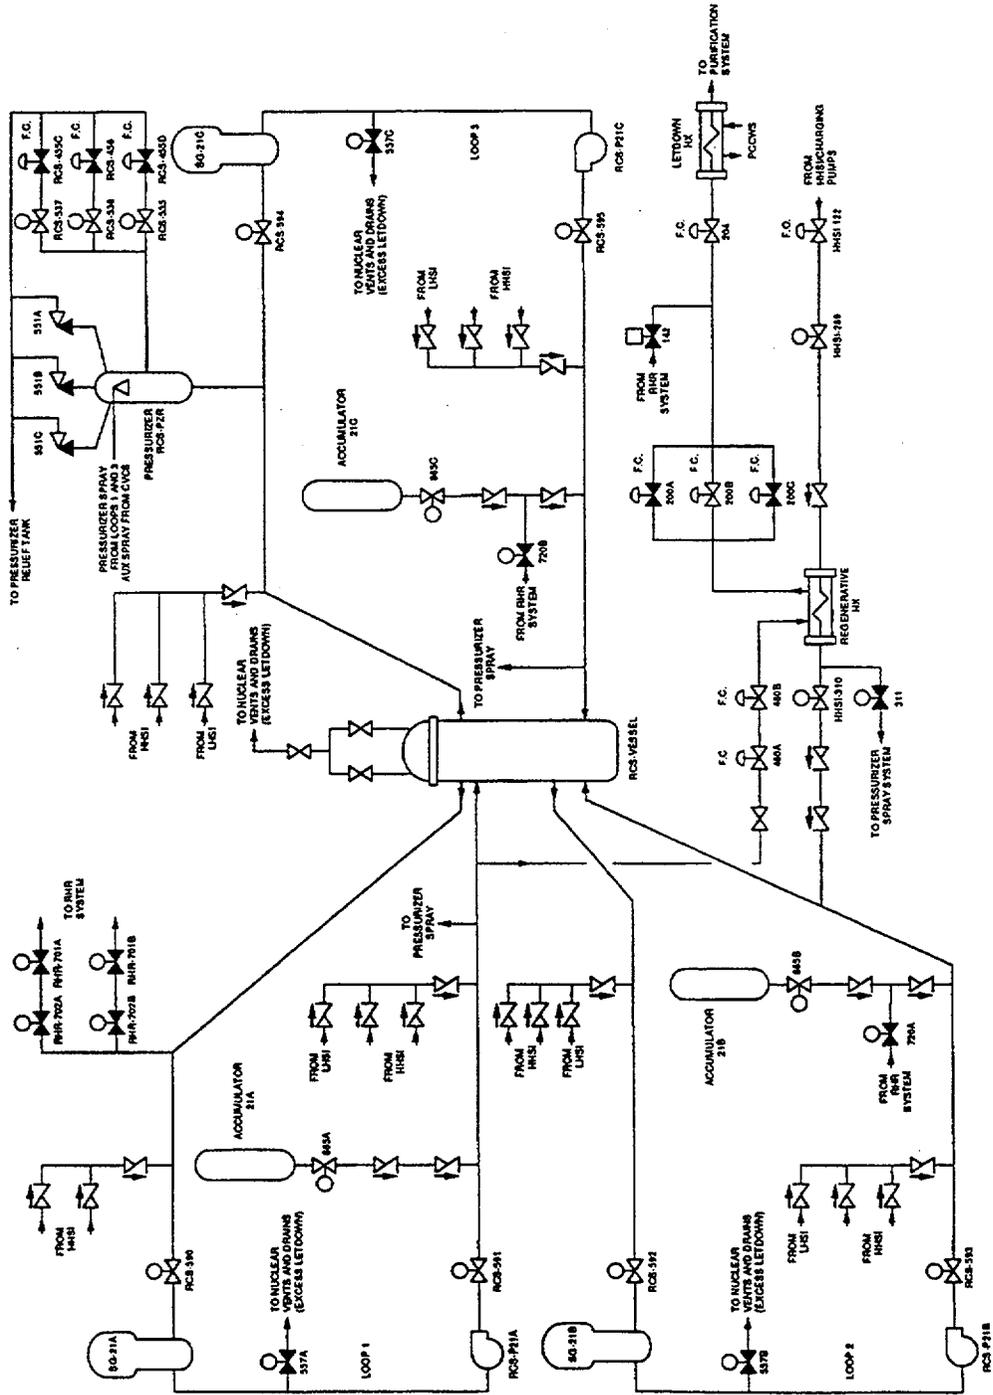
Figure 5.2 Beaver Valley 2 Reactor Coolant System (3 Loops)

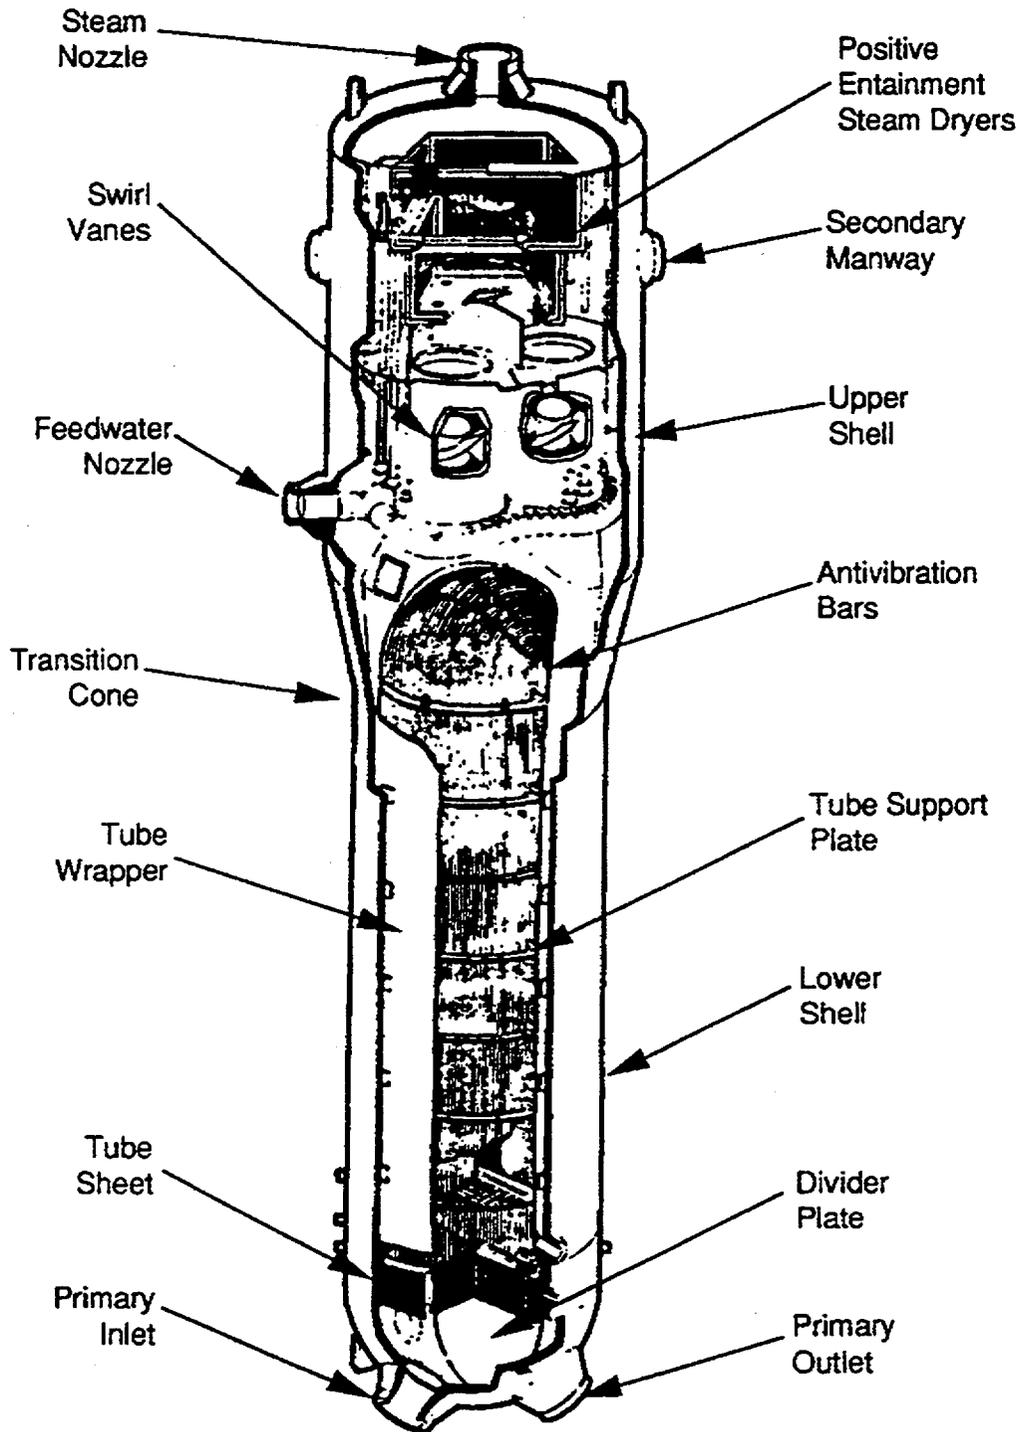
Figure 5.3 Westinghouse Recirculating Steam Generator
(Typical of Models 44 and 51)

This group of SGs are the most similar among the Westinghouse models to the EdF units described in the GL (see Figure 5.3). The 51 series SGs include W models 51, 51M, 51F, and 54F and, because of a stated similarity in design, WOG also included models Δ47 and Δ75 for evaluating the susceptibility to degradation types outlined in the GL. Table 5.1 lists 20 plants which are currently using one of these W-models. These models all have the feed ring design. Since this evaluation took place, Cook 1 replaced its model 51 SGs with B&W recirculating SGs in 2000. Out of the 19 plants (excluding Cook 1), 12 have W models 51 and 51M which are designed with carbon steel drilled round hole TSPs, with flow holes. The remaining 7 plants have models 51F, 54F, Δ47, and Δ75 with stainless steel and trefoil or quatrefoil broached type TSPs. One additional plant, Indian Point 2 had W model 44 SGs which have similar TSPs and feed ring components to that of the model 51 and 51M.

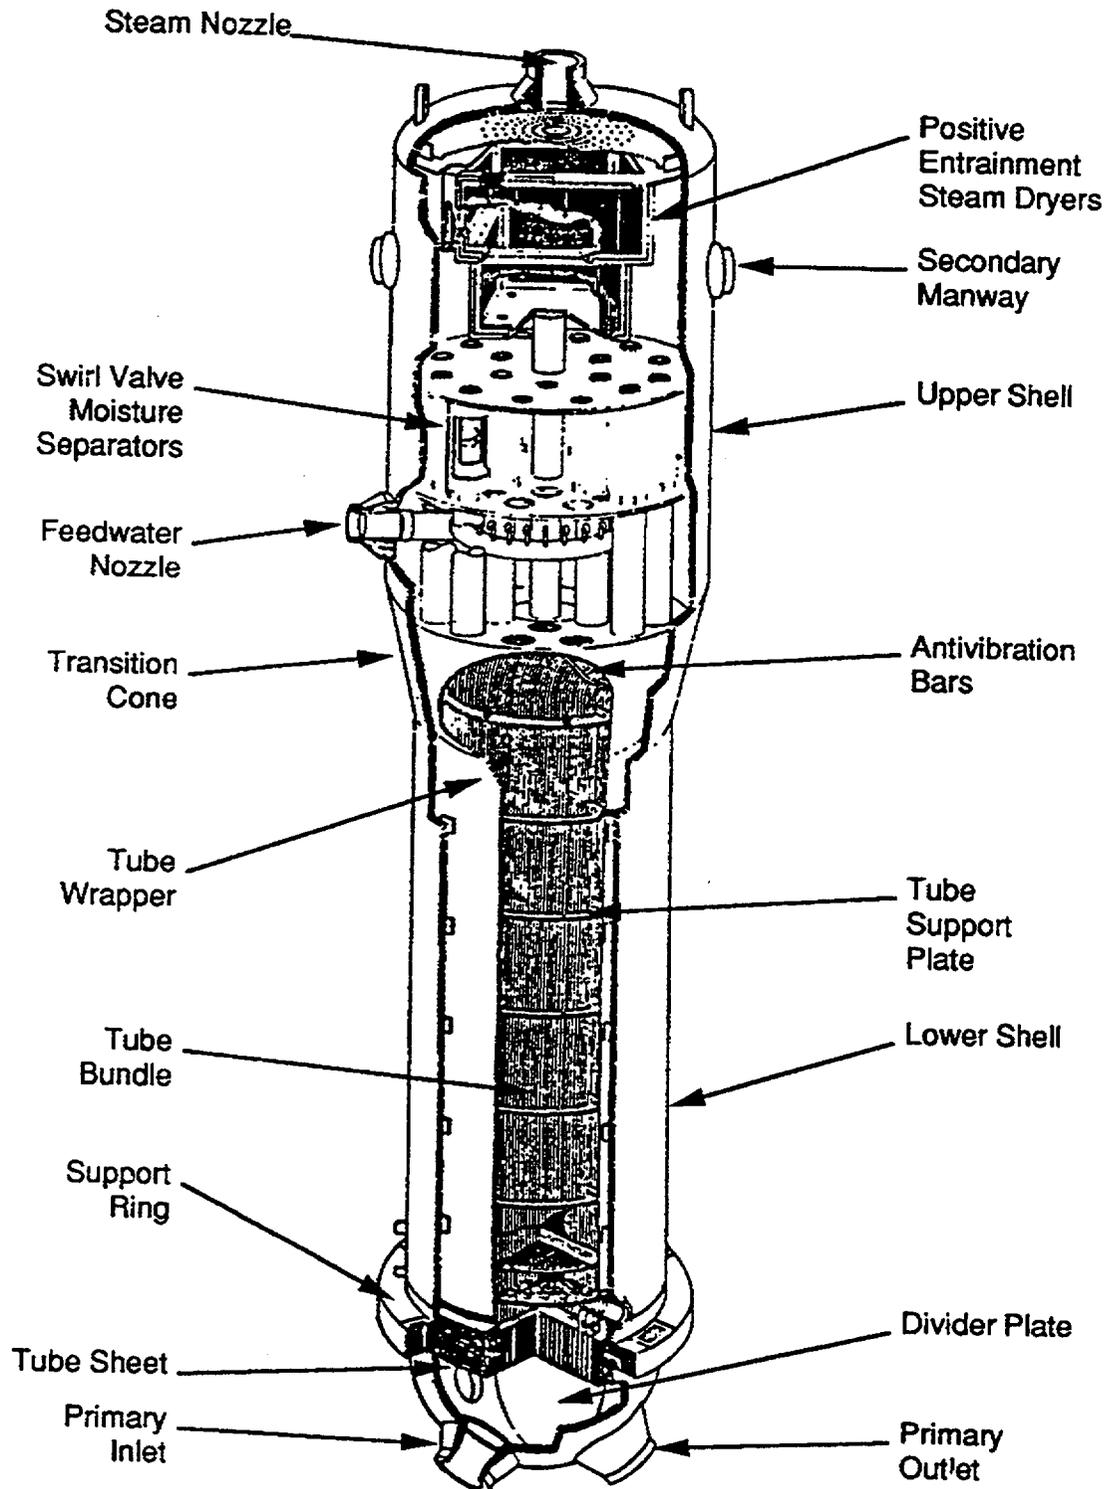
Figure 5.4 Westinghouse Recirculating Steam Generator
(Typical of Model F)

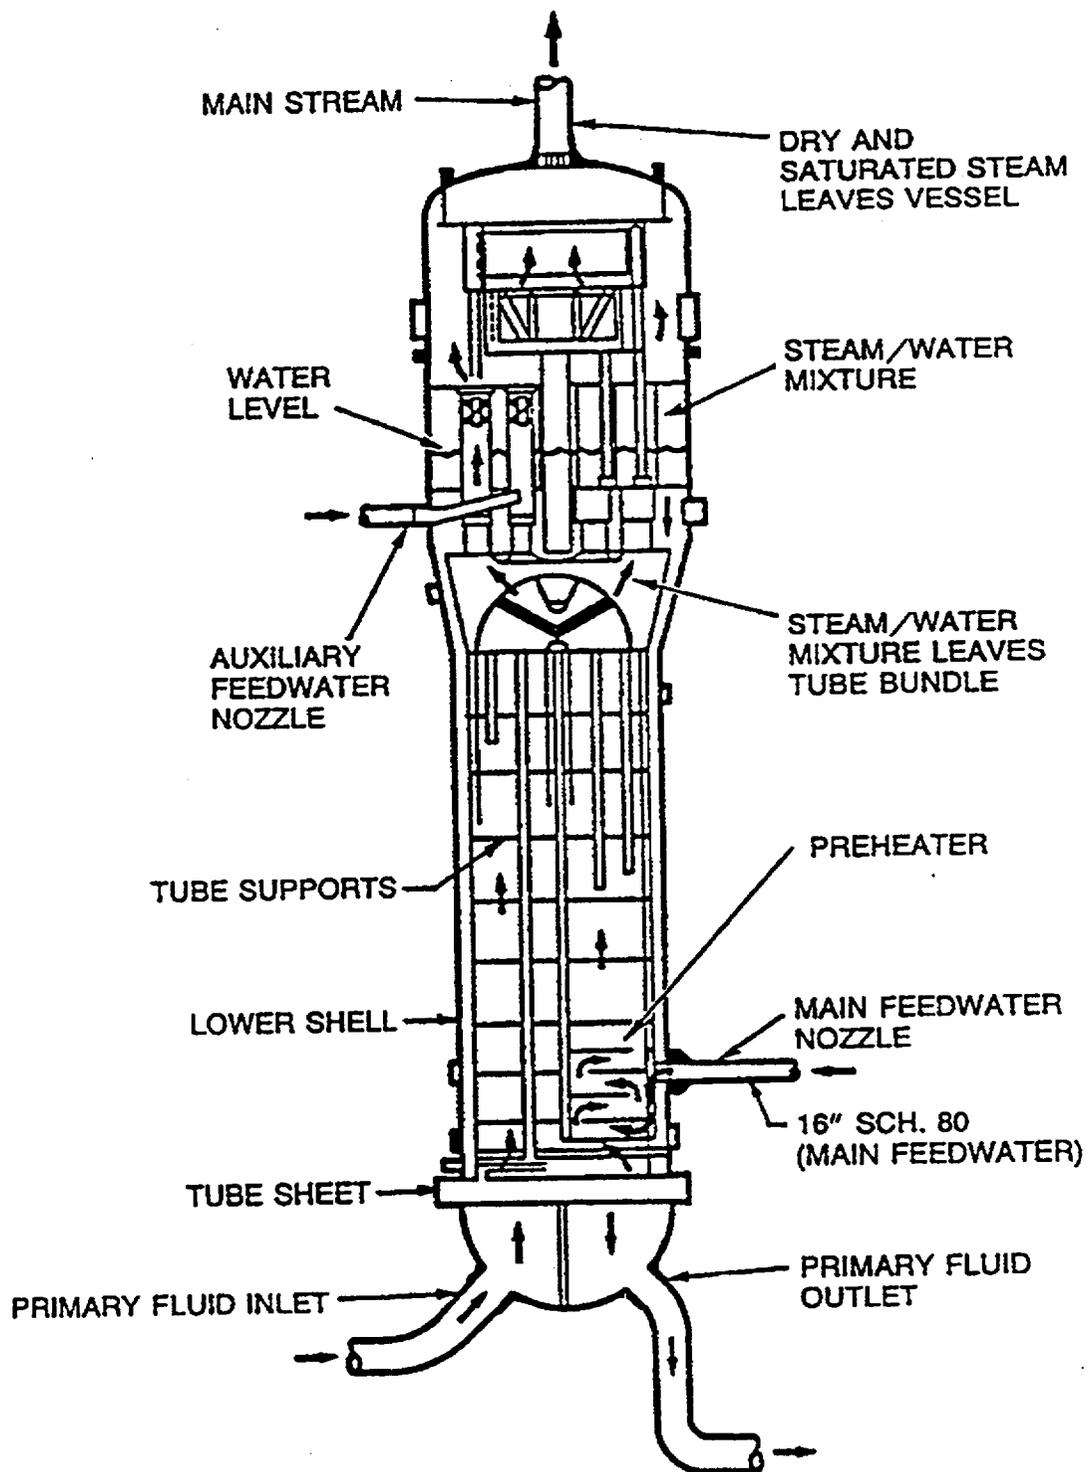
Figure 5.5 Westinghouse Recirculating Steam Generator
(Typical of Model E Preheat Unit)
