**VIRGINIA ELECTRIC AND POWER COMPANY
RICHMOND, VIRGINIA 23261**

VIRGINIA ELECTRIC AND POWER COMPANY
NORTH ANNA POWER STATION UNIT 2
RESPONSE TO REQUEST FOR ADDITIONAL INFORMATION
THIRD INTERVAL INSERVICE INSPECTION PROGRAM

In a letter dated June 13, 2001 (Serial No. 01-328), Virginia Electric and Power Company (Dominion) submitted the inservice inspection (ISI) program for the third interval for North Anna Unit 2, including the associated relief requests.

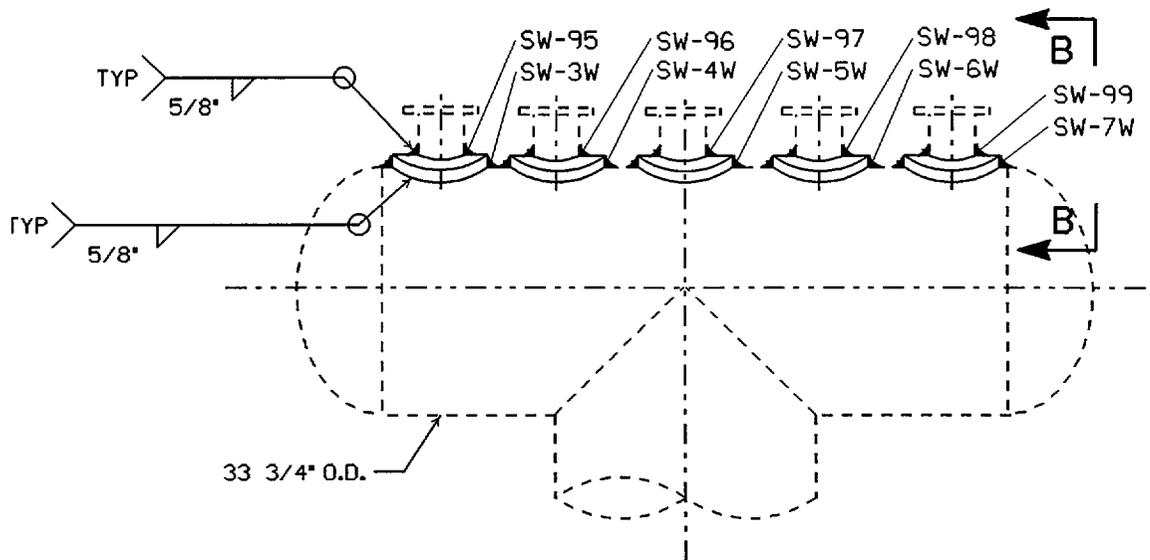
DETAIL A

Response: The following two "Detail Sections" were taken from drawing 12050-WMKS-101A-1, which is referenced in the request for relief. They are typical of the three sets of branch connections included in NDE-001.
