Docket Numbers 50-266 And 50-301
Point Beach Nuclear Plant, Units 1 and 2
Licensee Event Report 266/2001-006-00
Appendix R Requirements Not Satisfied For Unanalyzed
Fire Induced Damage To The Auxiliary Feedwater System

LICENSEE EVENT REPORT (LER)

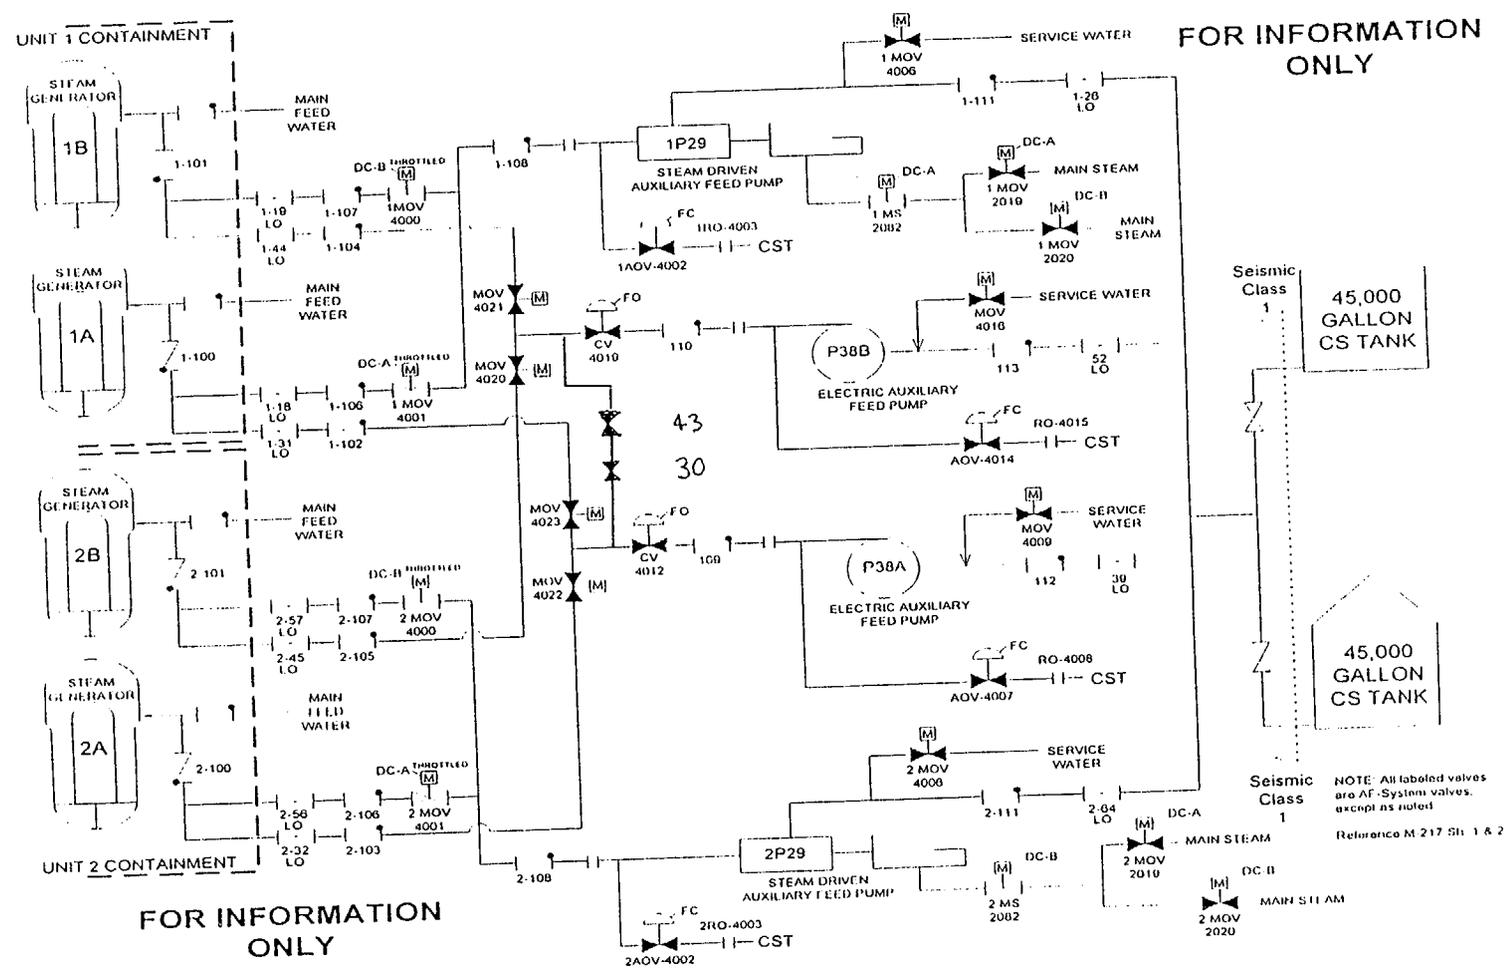
Figure 1-1
AFW System - Major Flow Paths

The SSA credits manually aligning the "A" MDAFP for Unit 2 for a North side fire and manually aligning the "B" MDAFP for Unit 1 for a South side fire. Power cables for all four discharge valves (AF-4020, 4021, 4022 and 4023) are routed in this room. One discharge valve will remain free of fire damage for either a South side or a North side fire.

For a south side fire the "B" MDAFP is relied upon to provide feed water flow to the Unit 1A steam generator via the AFW cross-connect valves (AF-43 and AF-30). Feed water flow via this discharge path requires manual valve alignment; therefore, this path is not available automatically. The normal discharge paths for this pump are through valves AF-04020 and AF-04021, which feed the Unit 2B and Unit 1B steam generators, respectively. The Unit 2 steam generator 2B AFW supply valve (AF-04020) remains free of fire damage, but does not open with a Unit 1 trip. Thus, the fire of concern was one that damages the power and control cables to valve AF-04021, leaving both of the normal discharge valves closed and the pump running. Should the AFWS recirculation valve AF-4014 close, the pump will be left without a flow path. Since the control cables that could close the "B" MDAFP recirculation valve (AF-4014) are located on the south side, there is an additional concern for fire-induced damage causing that recirculation valve to close. For a fire starting in this vicinity, it is possible that the valves for the "B" MDAFP are failed closed and the pump starts on the Unit 1 Trip, thus potentially damaging the pump for a fire in the south side of the room.

For a North side fire the "A" MDAFP is relied upon. The Unit 1 steam generator 1A discharge valve (AF-04023) remains free of fire damage. Thus, the fire of concern will be one that damages the power supply to steam generator 2A discharge valve (AF-4022). Should the "A" MDAFP recirculation valve close (AF-04007), the pump will be left without a flow path. In this fire scenario AF-4022 fails while in the closed position, valve AF-4007 fails close on loss of IA, AF-4023 remains closed because Unit 1 does not trip and the "A" MDAFP starts on a unit 2 trip. This could potentially damage the pump for a fire in the north side.
