SUBJECT: AMENDMENT NO.128 TO FACILITY OPERATING LICENSE NO. DPR-43 -  
 KEWAUNEE NUCLEAR POWER PLANT (TAC NO. M95302)

The amendment revises KNPP TS 4.2.b, "Steam Generator Tubes," its associated bases, and Figure TS 4.2-1 by redefining the pressure boundary for Westinghouse mechanical hybrid expansion joint (HEJ) steam generator (SG) tube sleeves.

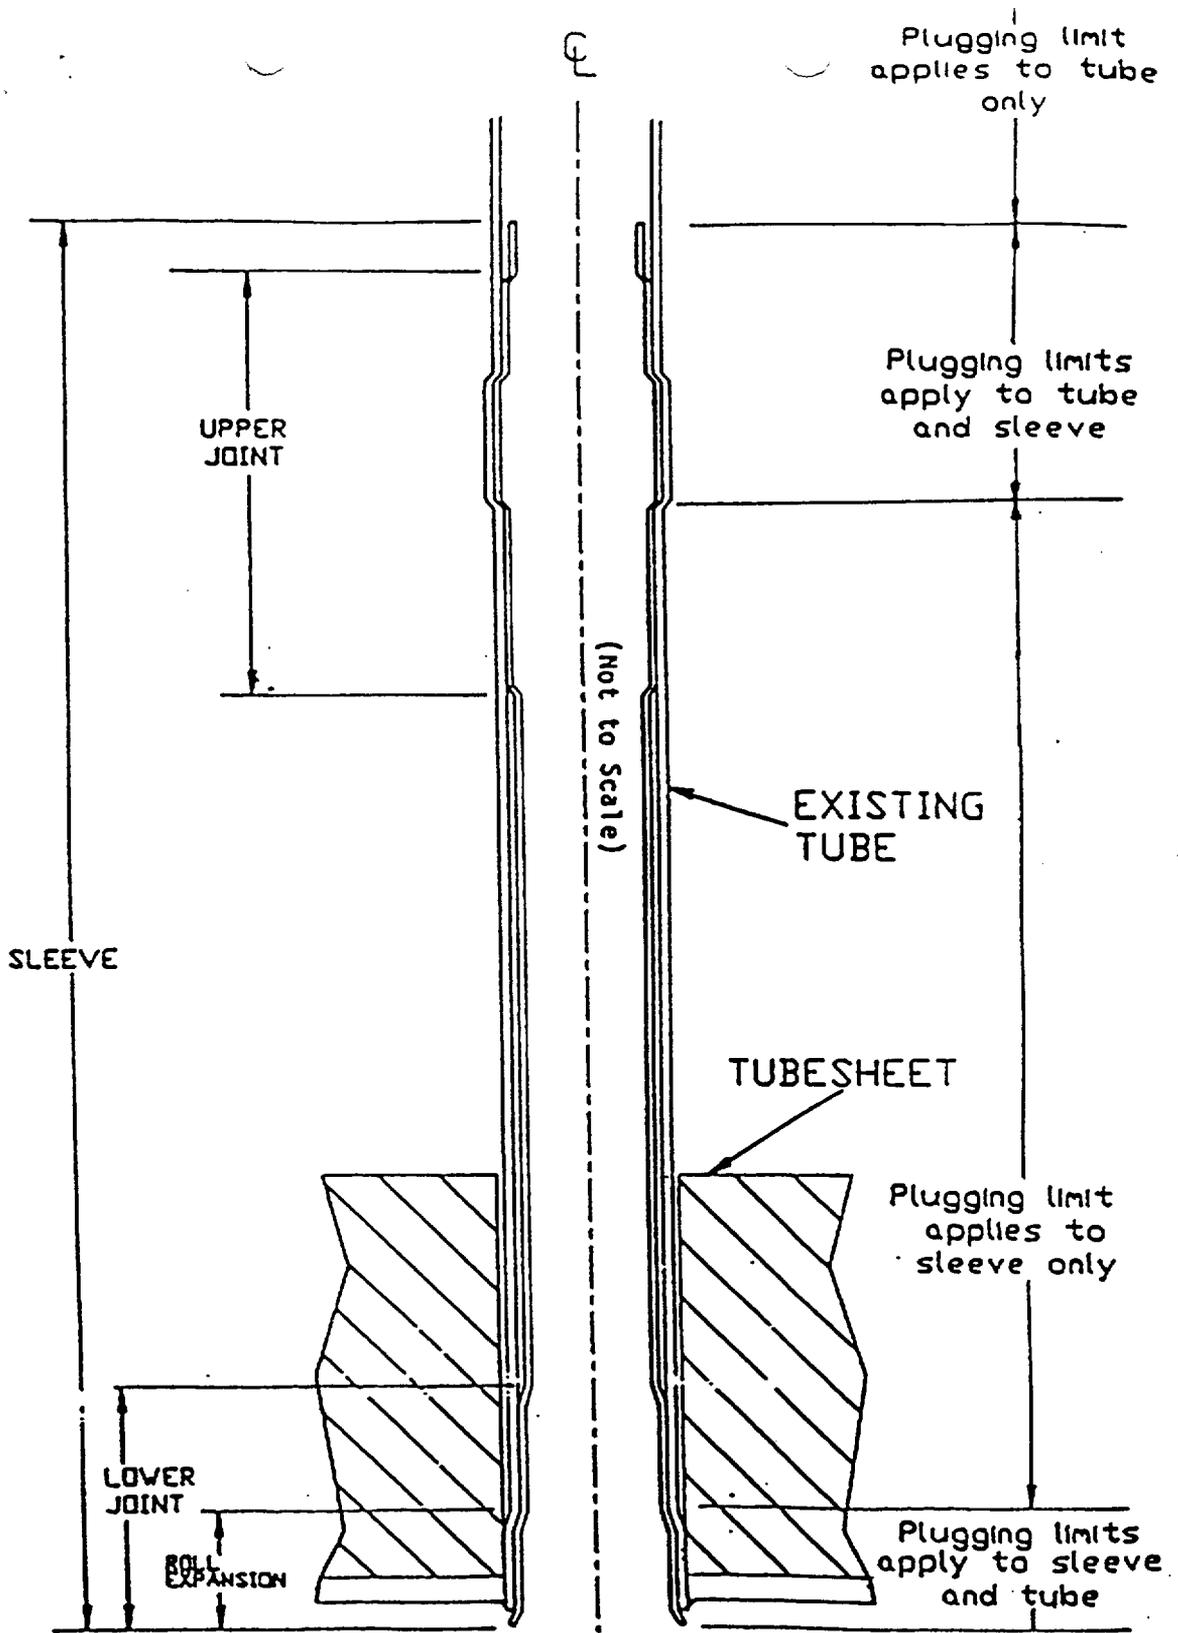
\* Refer to TS 4.2.b.4.b

Application of Plugging Limit for a Westinghouse Mechanical Sleeve
