Site Observational Work Plan for the Durango, Colorado, UMTRA Project Site

January 2002

Prepared by the
U.S. Department of Energy
Grand Junction Office

Project Number UGW-511-0006-10-000
Document Number U0143200

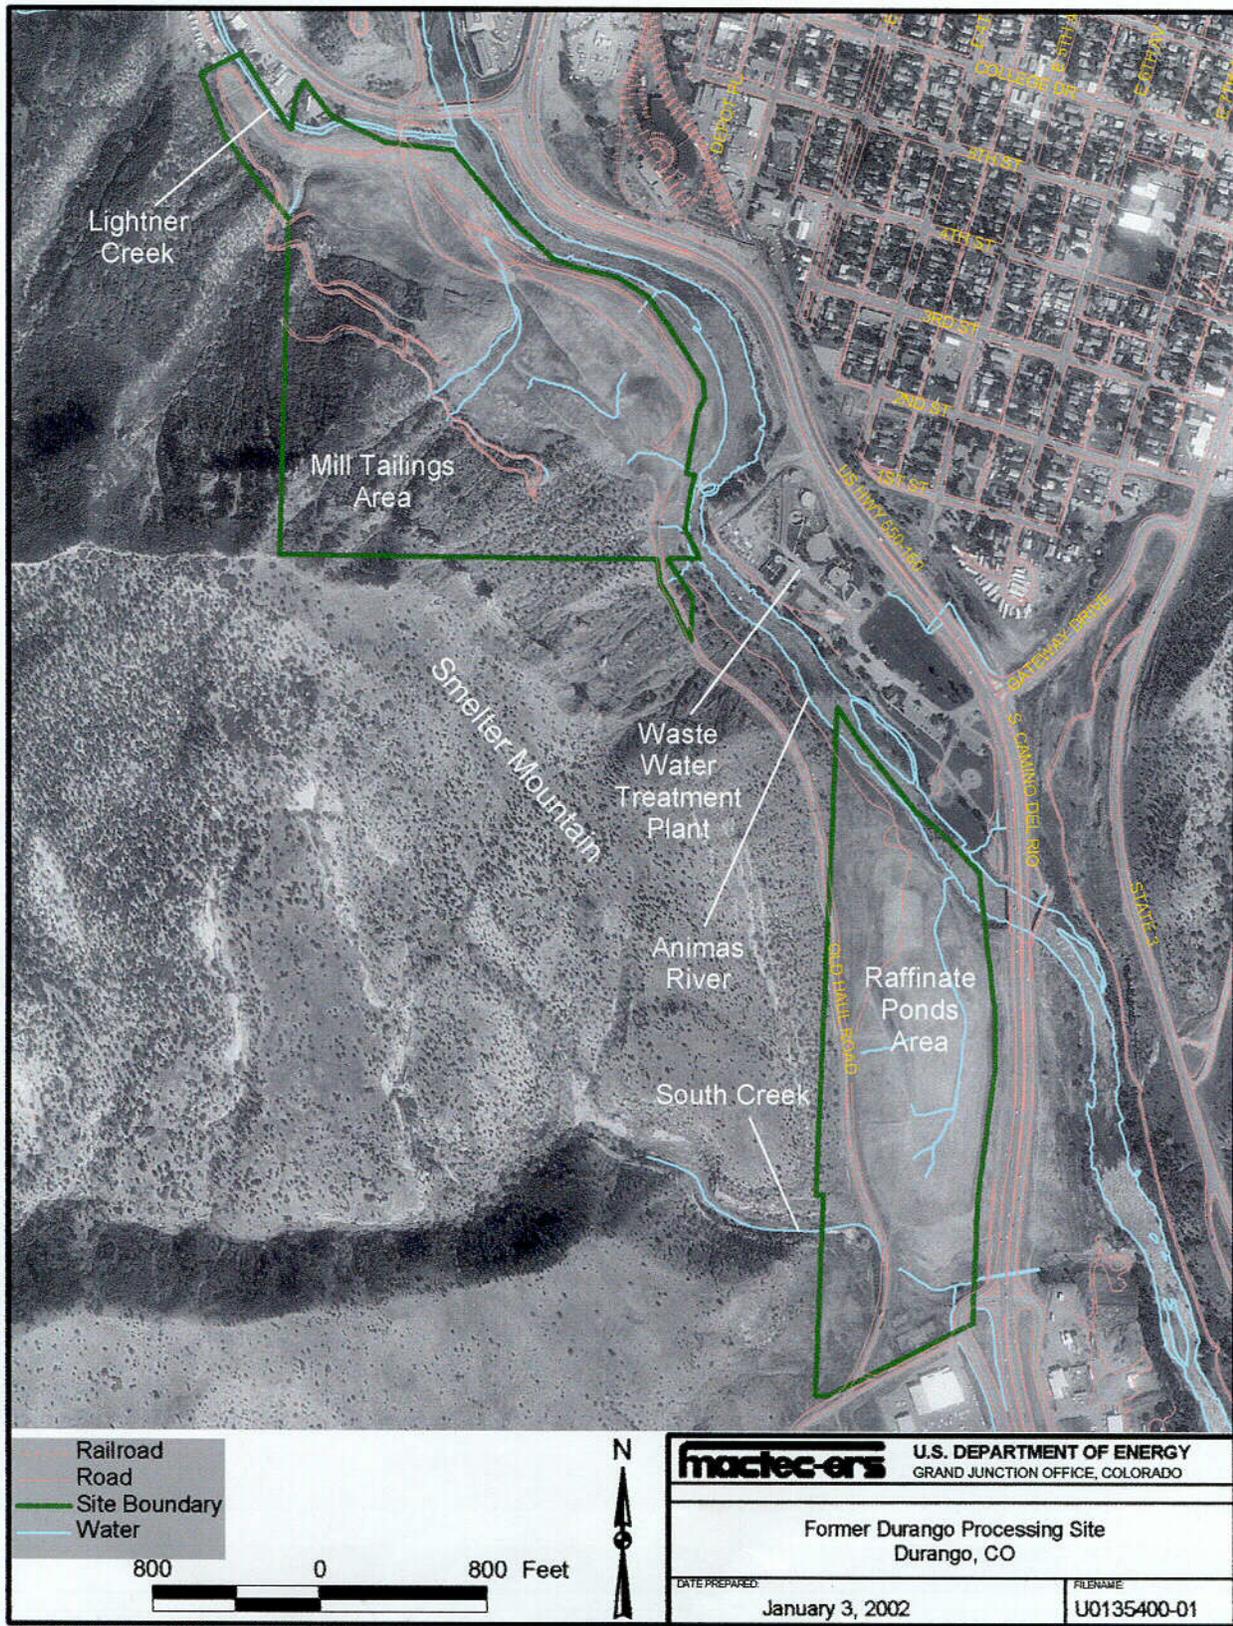
Figure 3-1. Durango UMTRA Project Site

The Durango UMTRA Project site lies outside the city limits, about 0.25 mile from the central business district of Durango (Figure 3-1). The mill was constructed in 1941 to produce vanadium; uranium production began in 1943. Ore was delivered to the mill from various mines in the Uravan mineral belt. An overview of the site's physical setting and climate, a history of the former milling operation, a summary of surface remediation, land use and water use is presented in the following sections.

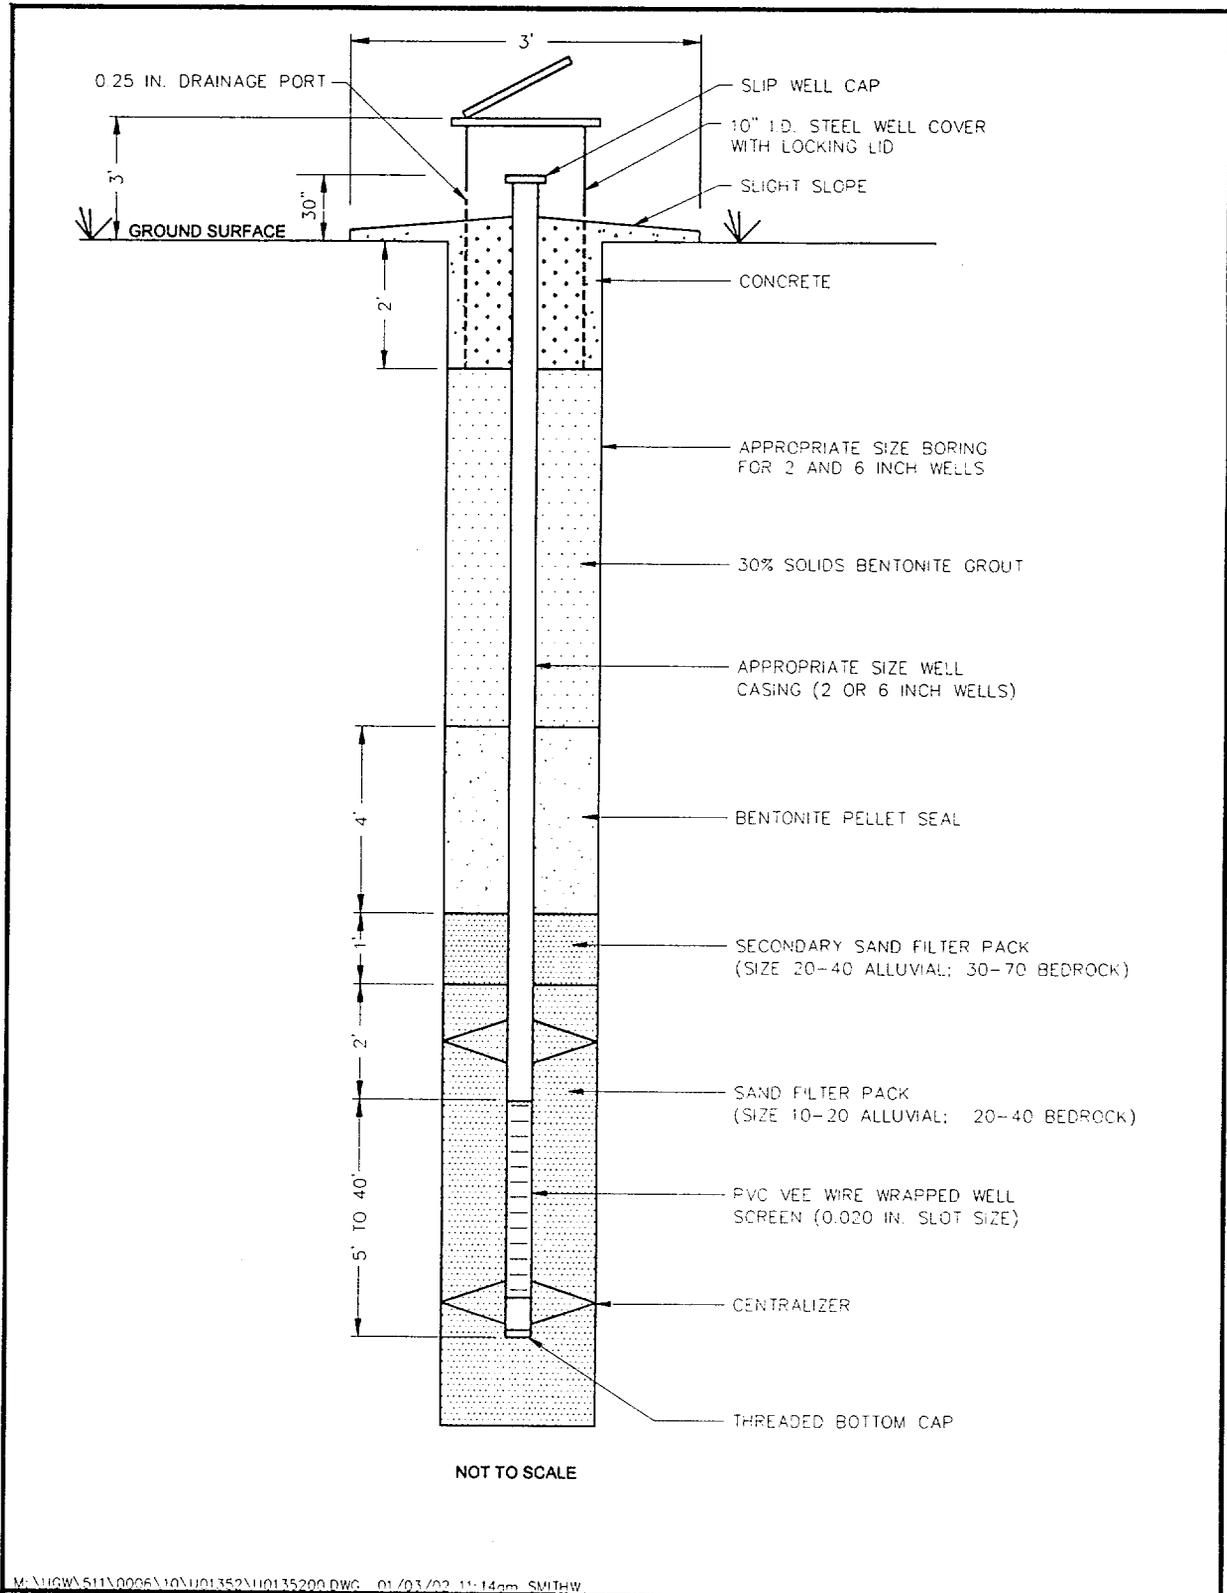
Figure 4-1. Typical Well Completion Diagram

After installation of the monitor wells, the top of each casing was surveyed for elevation and location coordinates. Completion diagrams and lithologic descriptions for each well installed during the 2000 field investigation are provided in Appendix A and summarized in Table 4-1. Figure 4-1 shows a construction diagram of a typical monitor well installed during the Durango field investigation.

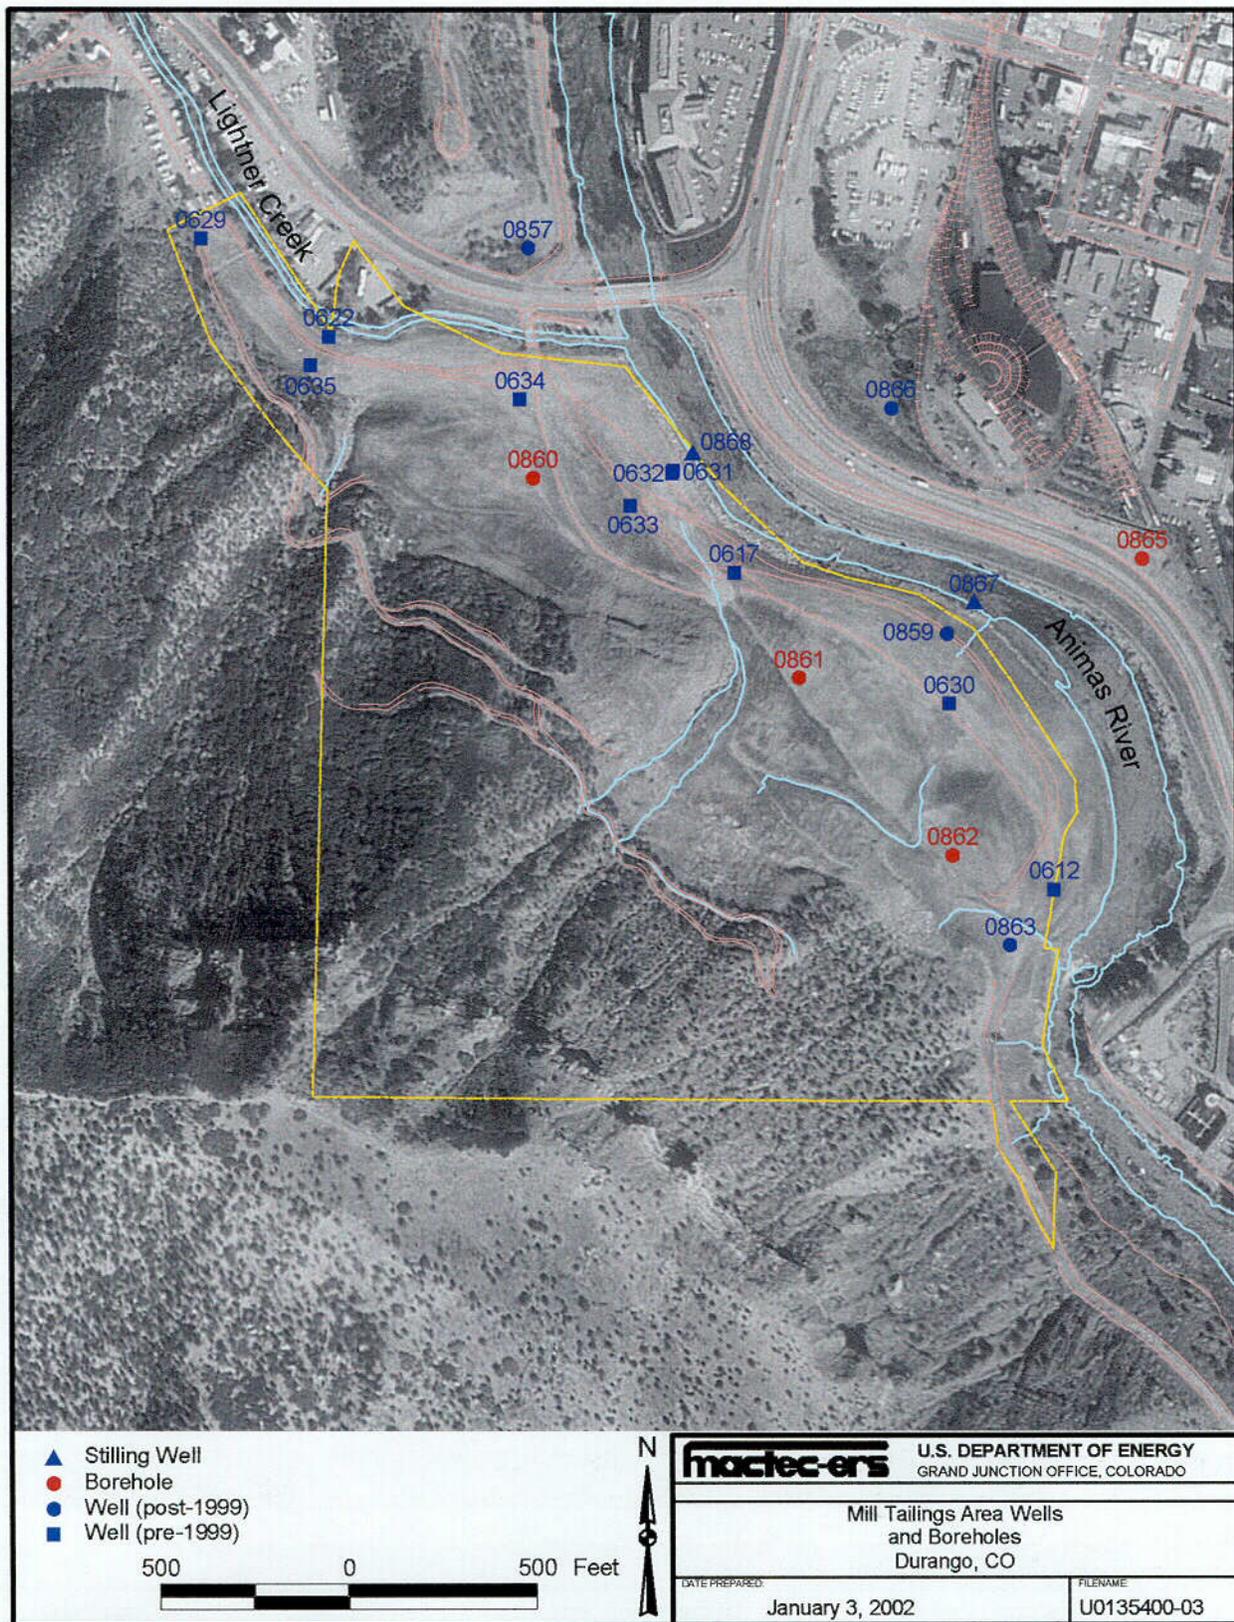
Figure 4-2. Mill Tailings Area Wells and Boreholes

Four monitor wells and two stilling wells were installed at the mill tailings area during the field investigation (Figure 4-2). In addition, five locations were drilled and soil samples were collected, but wells were not installed. All alluvial wells were completed using 2-inch inside diameter (i.d.), flush-joint, threaded, poly vinyl chloride (PVC) casing and wire-wrapped screen (0.02-inch slot size). All the alluvial monitor wells were screened over the entire saturated thickness, which was 20 ft or less. Two wells (0859 and 0863) were installed on site to characterize the nature and extent of ground water contamination and to determine the hydrologic properties of the aquifers.

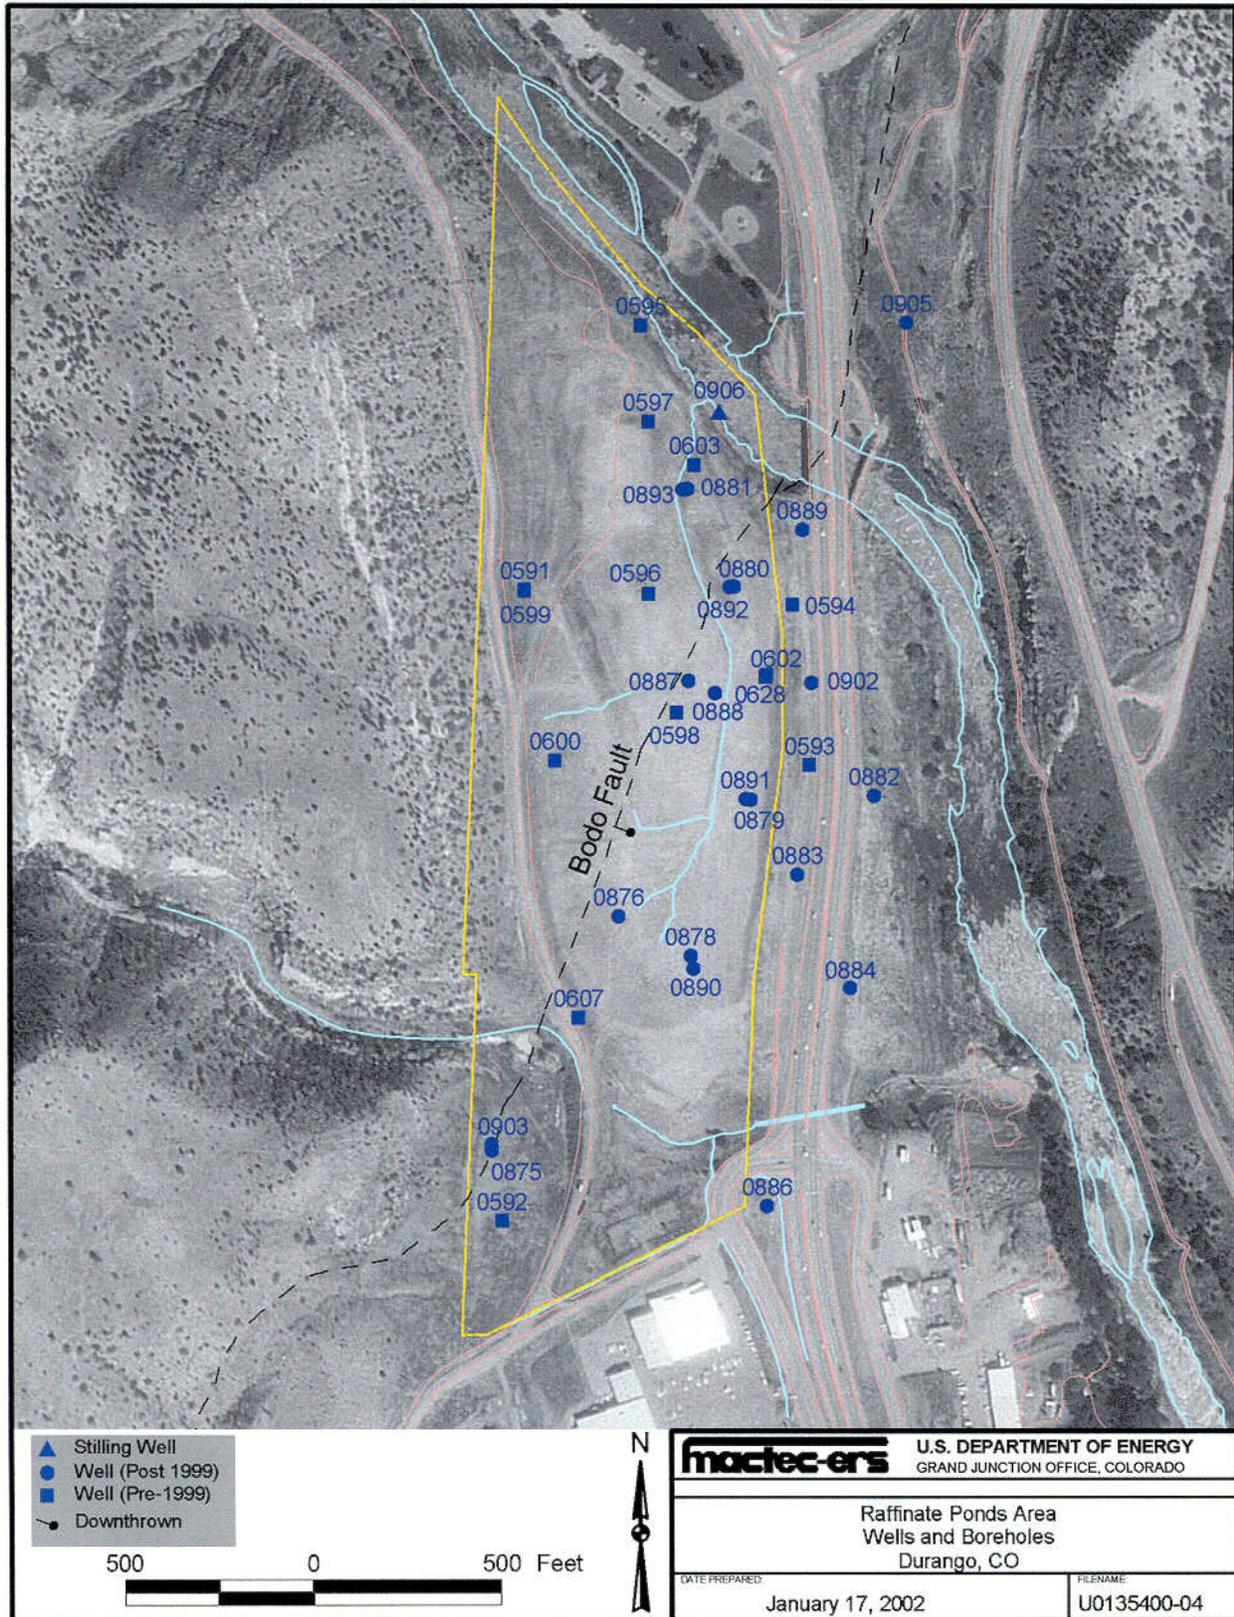
Figure 4-3. Raffinate Ponds Area Wells and Boreholes

Eleven wells were installed on site, and seven wells were installed off site to characterize the nature and extent of ground water contamination and to determine the hydrologic properties of the aquifers. Twelve wells were completed in the Menefee Formation, three wells were completed in the Point Lookout Sandstone, and three wells were screened across the Bodo Fault zone, which traverses the raffinate ponds area (Figure 4–3).

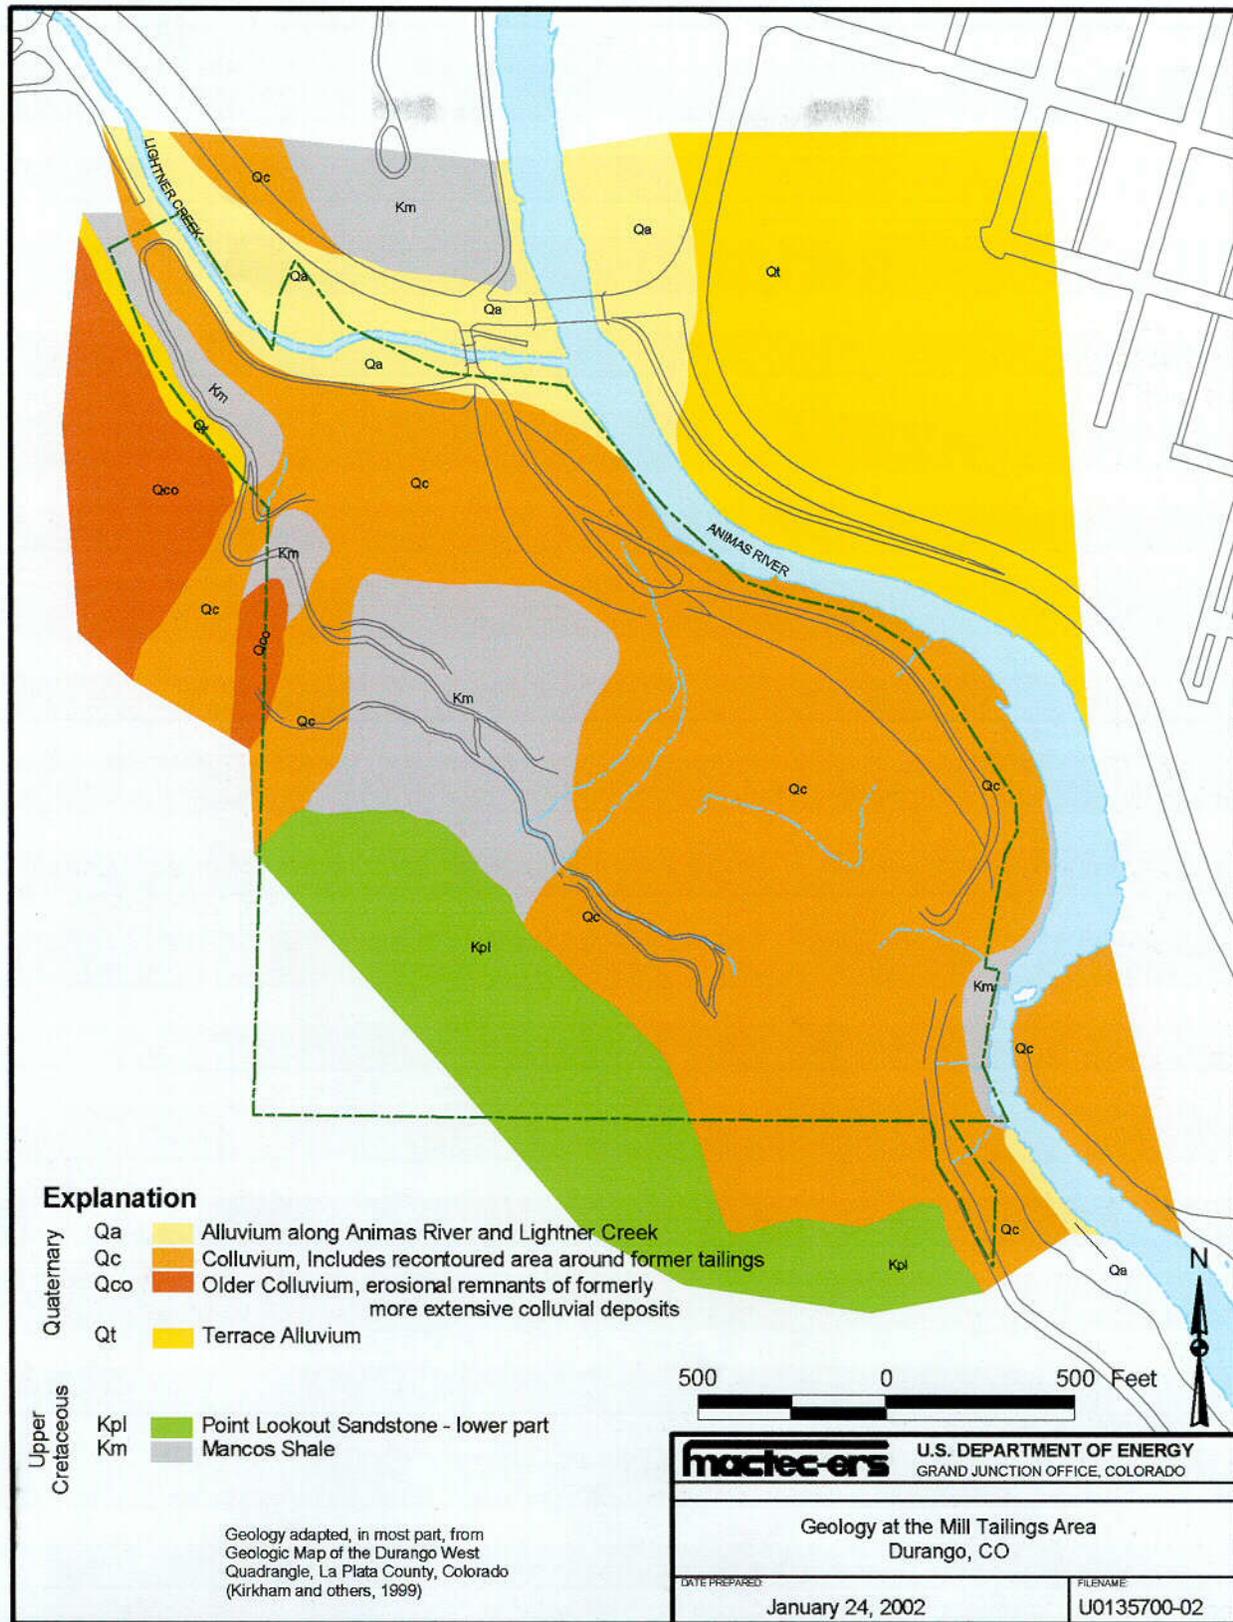
Figure 4-4. Geology at the Mill Tailings Area

Figure 4-4 is a geologic map of the mill tailings area. This map, compiled mainly from Kirkham and others (1999), shows the area to be underlain by the upper part of the gray, marine Mancos Shale. The presence of scattered gypsum crystals in the calcareous Mancos Shale verifies its high content of sulfate; the shale is also widely known for its high selenium content. Several hundred feet up the north slope of Smelter Mountain above the site is the gradational contact of the overlying Point Lookout Sandstone, in the lower part of which thin sandstone beds are interbedded with shale. The Mancos and Point Lookout are covered in most places in the mill tailings area by recent (active) and old (inactive) colluvial deposits emplaced by gravity and sheetwash. Drilling of boreholes in this site area for monitor wells in fall 2000 confirmed earlier interpretation of geologic conditions.

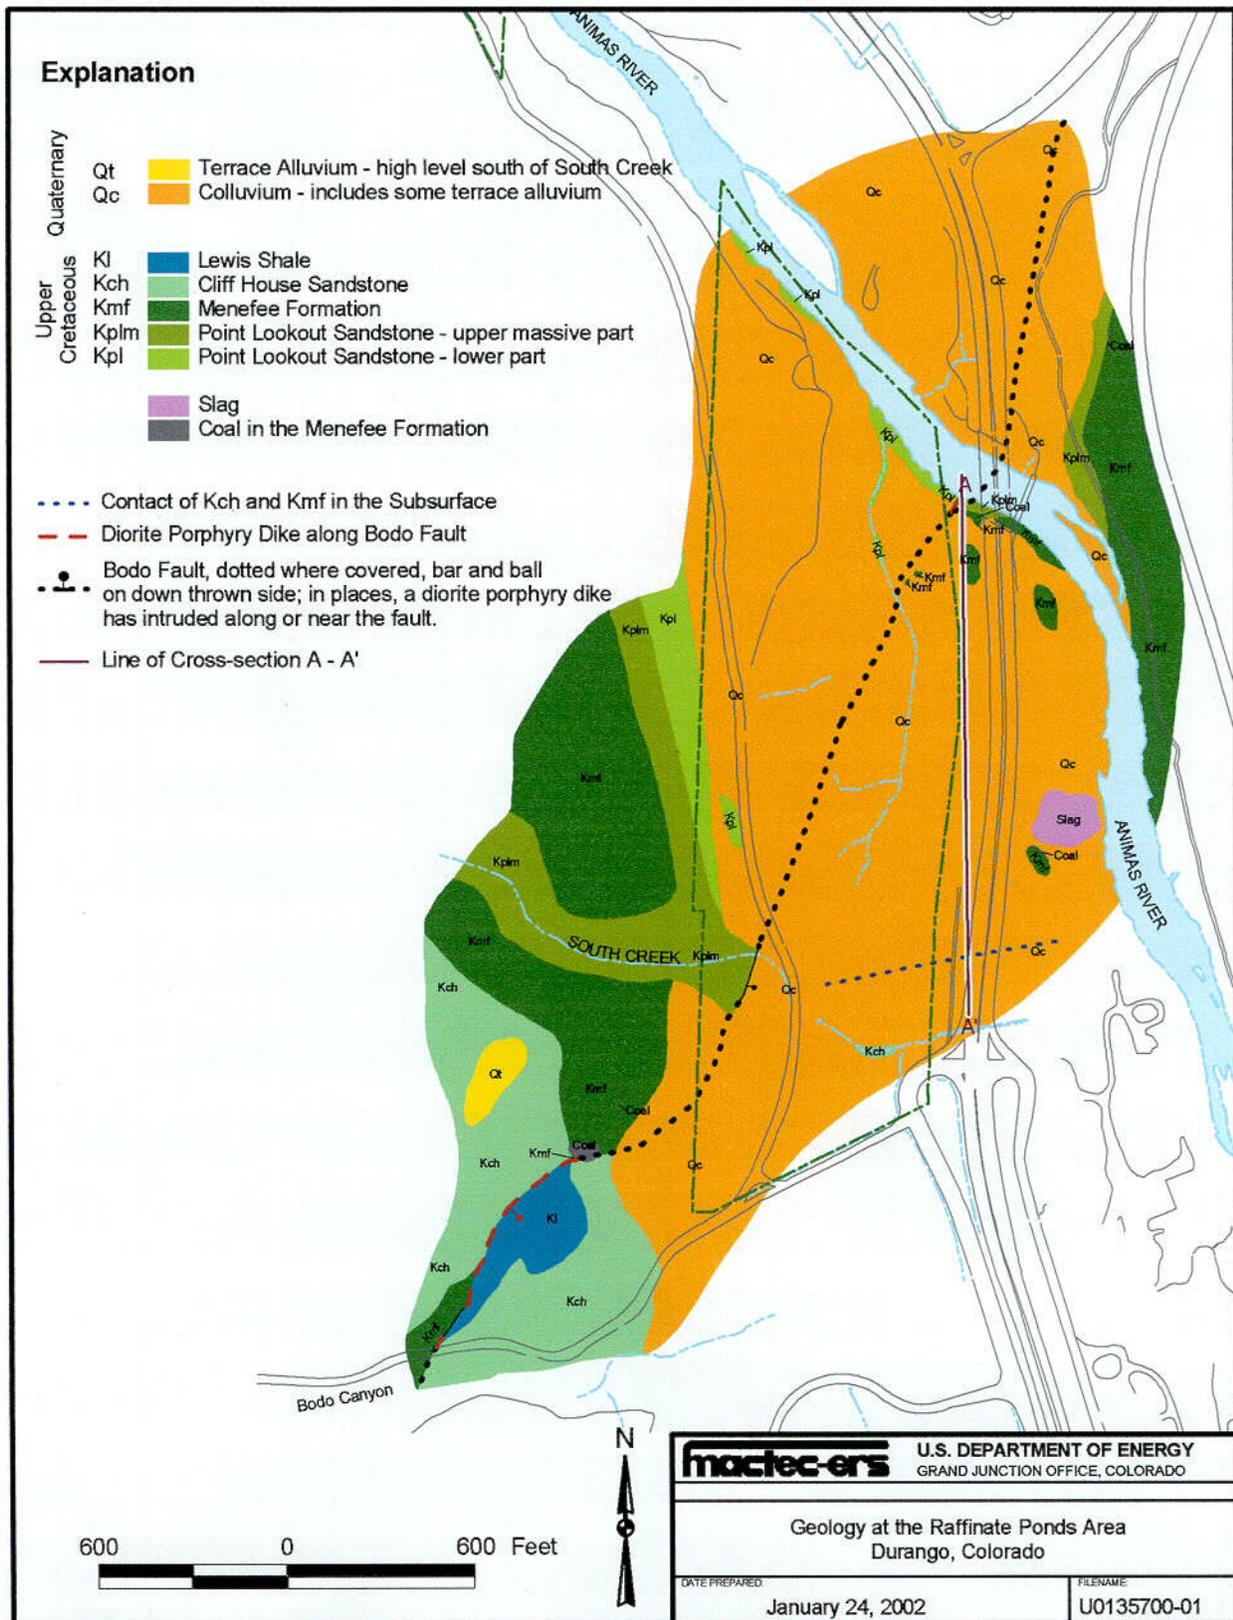
Figure 4-5. Geology at the Raffinate Ponds Area

Figure 4-5 is a geologic map of the more stratigraphically varied and structurally complex raffinate ponds area. Bedrock units slightly younger than those at the mill tailings area are exposed at the raffinate ponds area. These units are part of the Mesaverde Group and include, in ascending order, the Point Lookout Sandstone, the Menefee Formation, and the Cliff House Sandstone. Just southwest of the area, along the Bodo Fault in Bodo Canyon, a small area of Lewis Shale (overlying the Cliff House Sandstone) outcrops. The Bodo Fault, named on the map by Kirkham and others (1999), cuts diagonally through the raffinate ponds area and has a displacement of about 200 ft. Generally, in this area the Point Lookout Sandstone is in the footwall (west, or upthrown, side) of the fault, and the Menefee Formation is in the hanging wall (east, or downthrown, side) of the fault. Except for bedrock outcrops along the steep east flank of Smelter Mountain and along some of the west bank of the Animas River, most of the area is covered by Quaternary colluvial material or fill material emplaced during reclamation.

Stratigraphic descriptions of bedrock formations in the site area are provided in the Bendix (DOE 1983) and BOR (1990) reports. Bedrock mapping units used in preparation of the geologic map (Figure 4-5) were adopted mainly from the new Colorado Geological Survey maps by Kirkham and others (1999) and Carroll and others (1999). A large-scale (1 inch = 200 ft), more detailed geologic map of the area shown in Figure 4-5 is provided as Plate 2.

The Point Lookout Sandstone represents an eastward prograding shoreline between the sea in which the Mancos Shale was deposited and the coastal plain where the Menefee Formation was accumulating (Kirkham and others 1999). The Point Lookout is subdivided into two units, a lower part and an upper massive part. The lower part is 250 to 300 ft thick and consists of interbedded thin sandstone and shale beds. Sandstone beds are less than 1 ft thick and are more frequent in the upper part of the unit; shale beds are gray, fossiliferous, bioturbated, and slightly carbonaceous, and become more predominant in the lower part of the unit. The few exposures of the lower Point Lookout in the area are west of the Bodo Fault along the bank of the Animas River and in a small north-flowing tributary drainage (Figure 4-5).

The upper massive part of the Point Lookout Sandstone is mainly composed of two thick, light gray to yellowish gray, fine- to medium-grained sandstone beds, each about 35 ft thick. A carbonaceous shale and siltstone bed several feet thick with limonite concretions separates the two sandstone beds. Total thickness of the upper Point Lookout is 75 to 80 ft, and it forms two distinctive cliffs along the east side of Smelter Mountain. Other exposures in the site area are just west of the Bodo Fault in the canyon of South Creek where several old quarries mined the sandstone, on the south abutment of the U.S. Highways 160 and 550 bridge just east of the Bodo Fault, and east of the Animas River on the slope above well 0905 (Plate 2). The topmost sandstone is typically bleached nearly white because of the reducing environment of the basal coal bed of the Menefee Formation lying immediately above. The relationship of the Point Lookout Sandstone to the Bodo Fault and the overlying Menefee Formation is shown in the 1,700-ft-long, north-south cross section (Plate 3) along the east side of the raffinate ponds area. The location of this cross section A–A' is shown in Figure 4–5.

The lower Cliff House Sandstone consists of red brown (rust-colored) fine- to medium-grained sandstone beds with abundant fossil burrows. This formation represents a transgressive shallow marine barrier island beach front environment (Kirkham and others 1999). The contact between the Cliff House Sandstone and Menefee Formation is covered; its approximate position is about 200 ft north of South Creek (Figure 4–5).

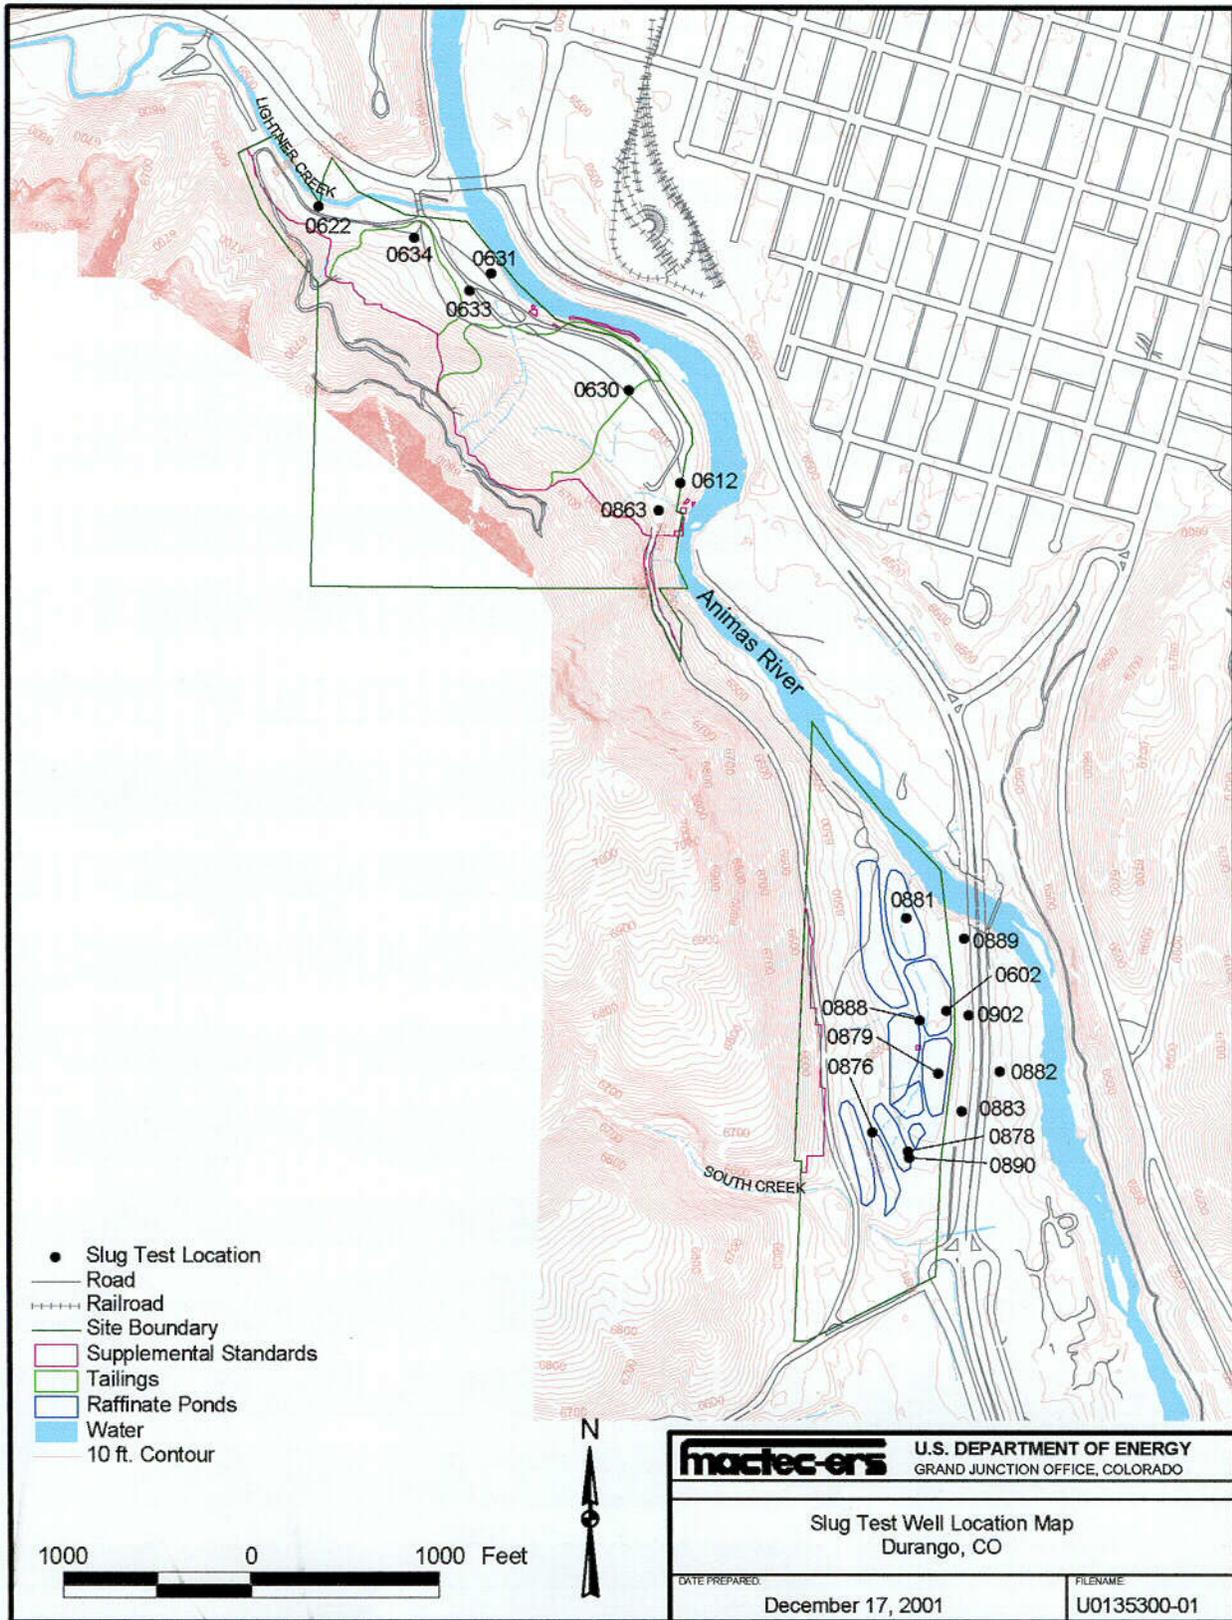
Figure 4-6. Slug Test Well Location Map

Table 4-2 presents the results of the MACTEC-ERS slug tests for the former mill tailings area and the raffinate ponds area. As shown in Table 4-2, the hydraulic conductivity ranged from 1 to 28 ft/day for the Animas River alluvium and was 66 ft/day for the Lightner Creek alluvium. Table 4-2 also shows that the hydraulic conductivity of the Menefee Formation ranges from a minimum of 0.003 ft/day at well 0902 to 5.3 ft/day for the duplicate test at well 0882. Hydraulic conductivity of the Point Lookout Sandstone was low at locations 0881 and 0889 where it was measured by MACTEC-ERS. Slug test and packer test results described by BOR (Appendix F) indicate that the Point Lookout Sandstone has a uniformly low hydraulic conductivity.

Within the Bodo Fault, the slug test for well 0888 indicates a hydraulic conductivity of 6.4 ft/day. This result for the Bodo Fault confirms earlier tests by Bendix (DOE 1983) when a value of 4.4 ft/day was determined. The slug test results indicate that the Bodo Fault is a potential conduit for ground water flow at the site.

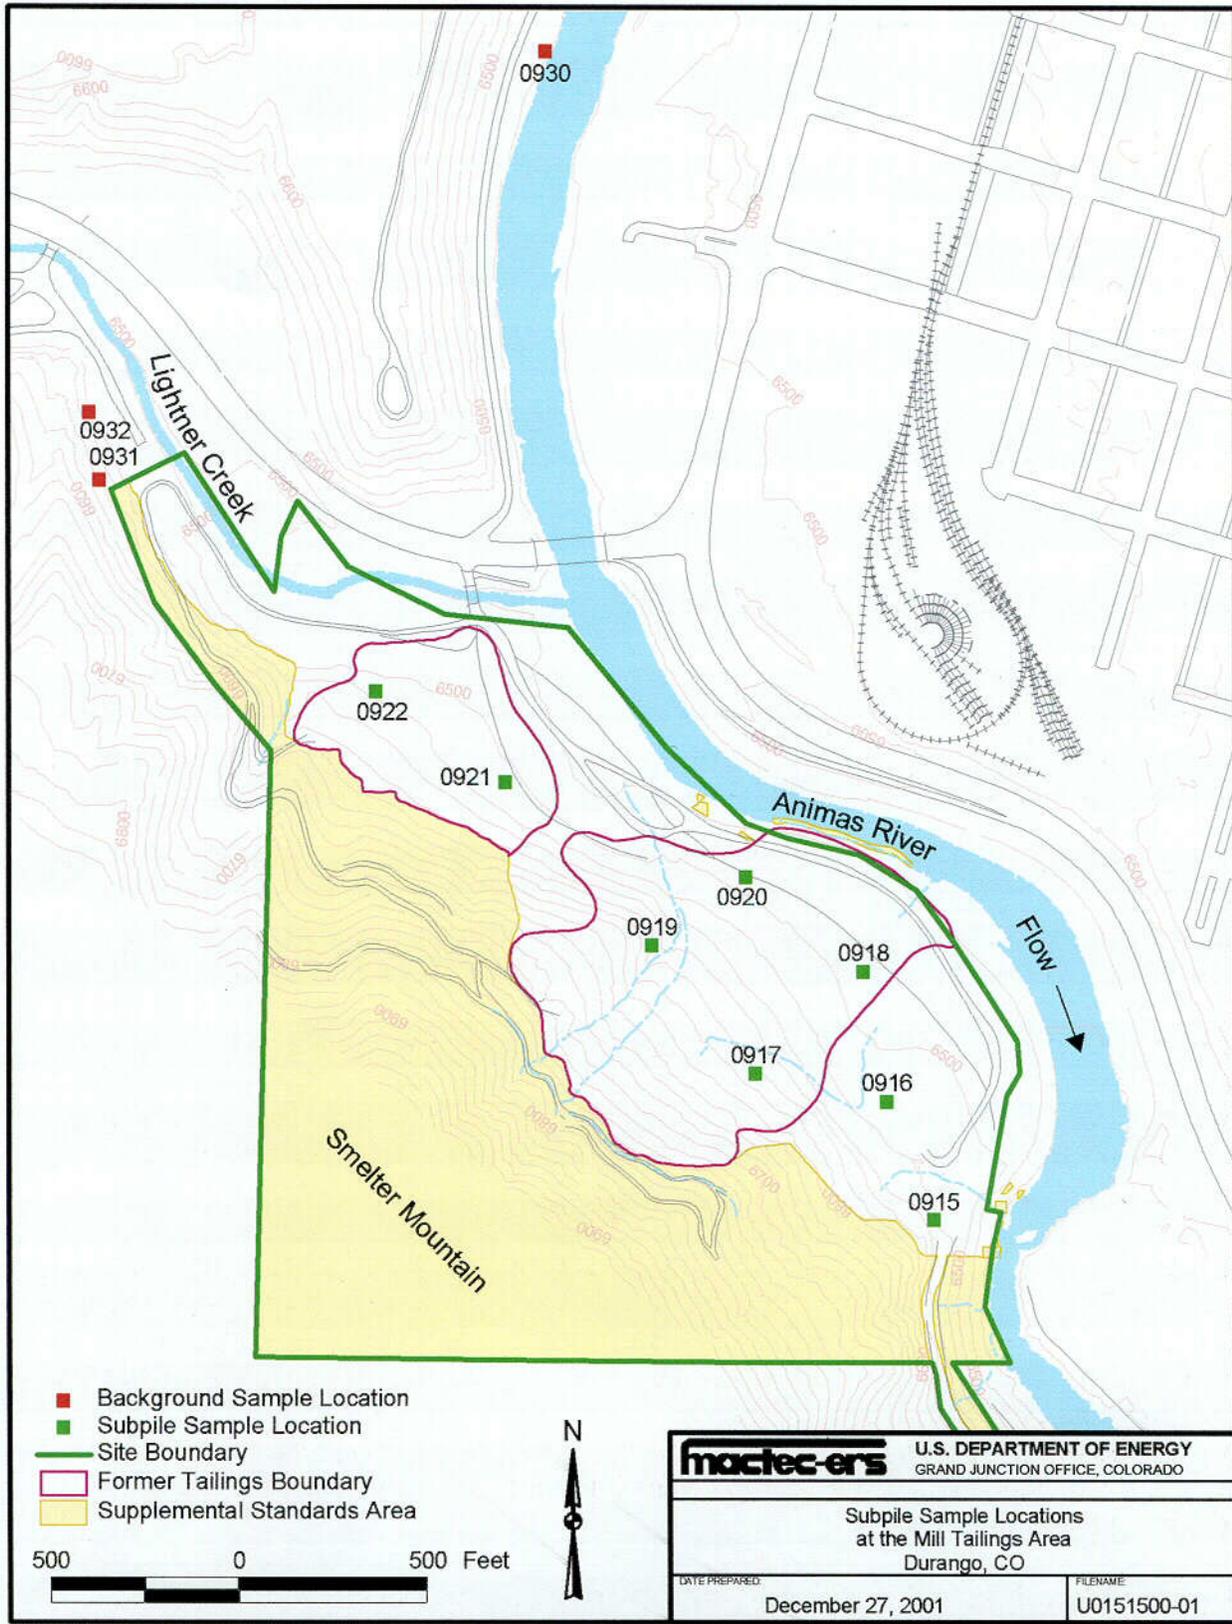
Figure 4-7. Subpile Soil Sample Locations at the Mill Tailings Area

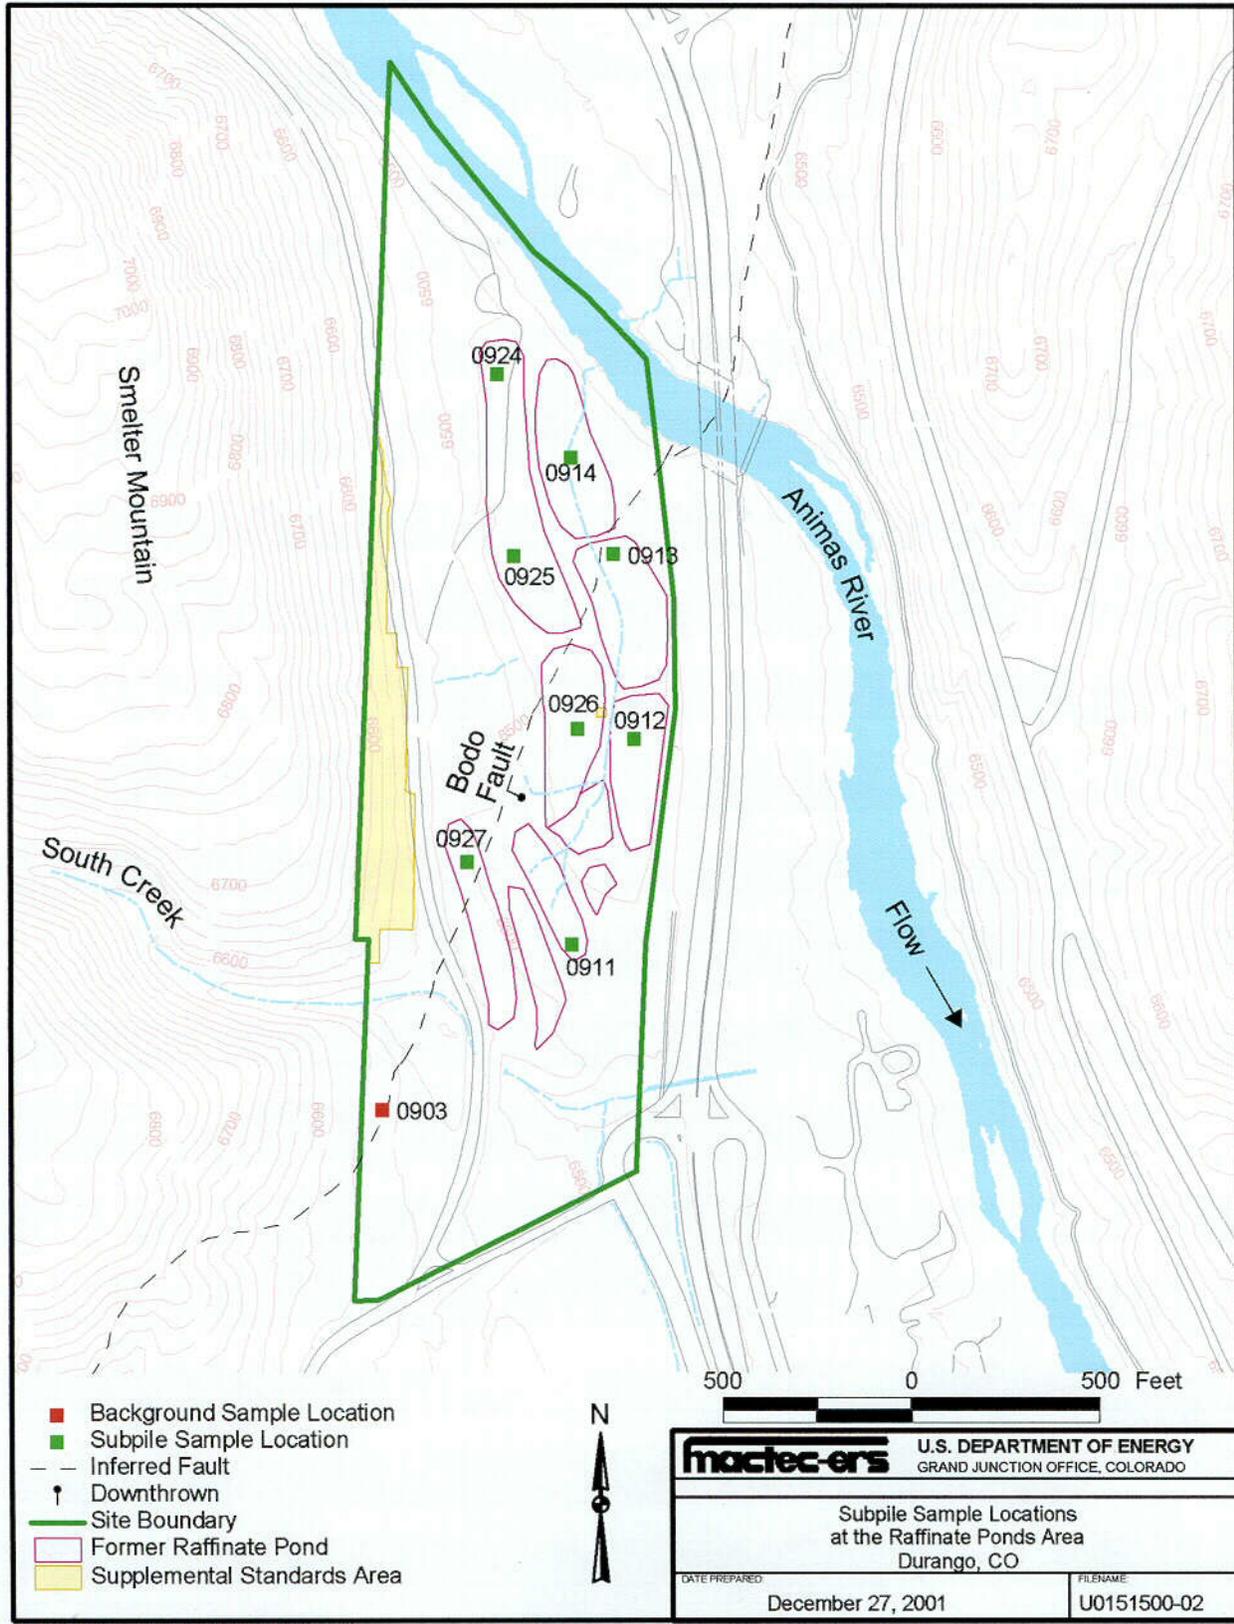
Figure 4-8. Subpile Soil Sample Locations at the Raffinate Ponds Area

Twenty samples were collected from nine locations (Figure 4-8). Two samples were collected from each location except location 0903, where four background samples were collected at depths of 4 ft, 14 ft, 23 ft, and 28 ft. Two samples, 0913-4 ft and 0914-3 ft, were rock core samples and were crushed to obtain the required less than 2- millimeter (mm) fraction. The lithology of the samples is similar, except in samples 0913-4 ft and 0914-3 ft. Sample 0913-4 ft was collected as a consolidated core sample of unweathered, medium-grained, light-gray sandstone from the Menefee Formation. Sample 0914-3 ft was collected as a consolidated sample of shale from the Point Lookout Sandstone. The remaining samples have similar

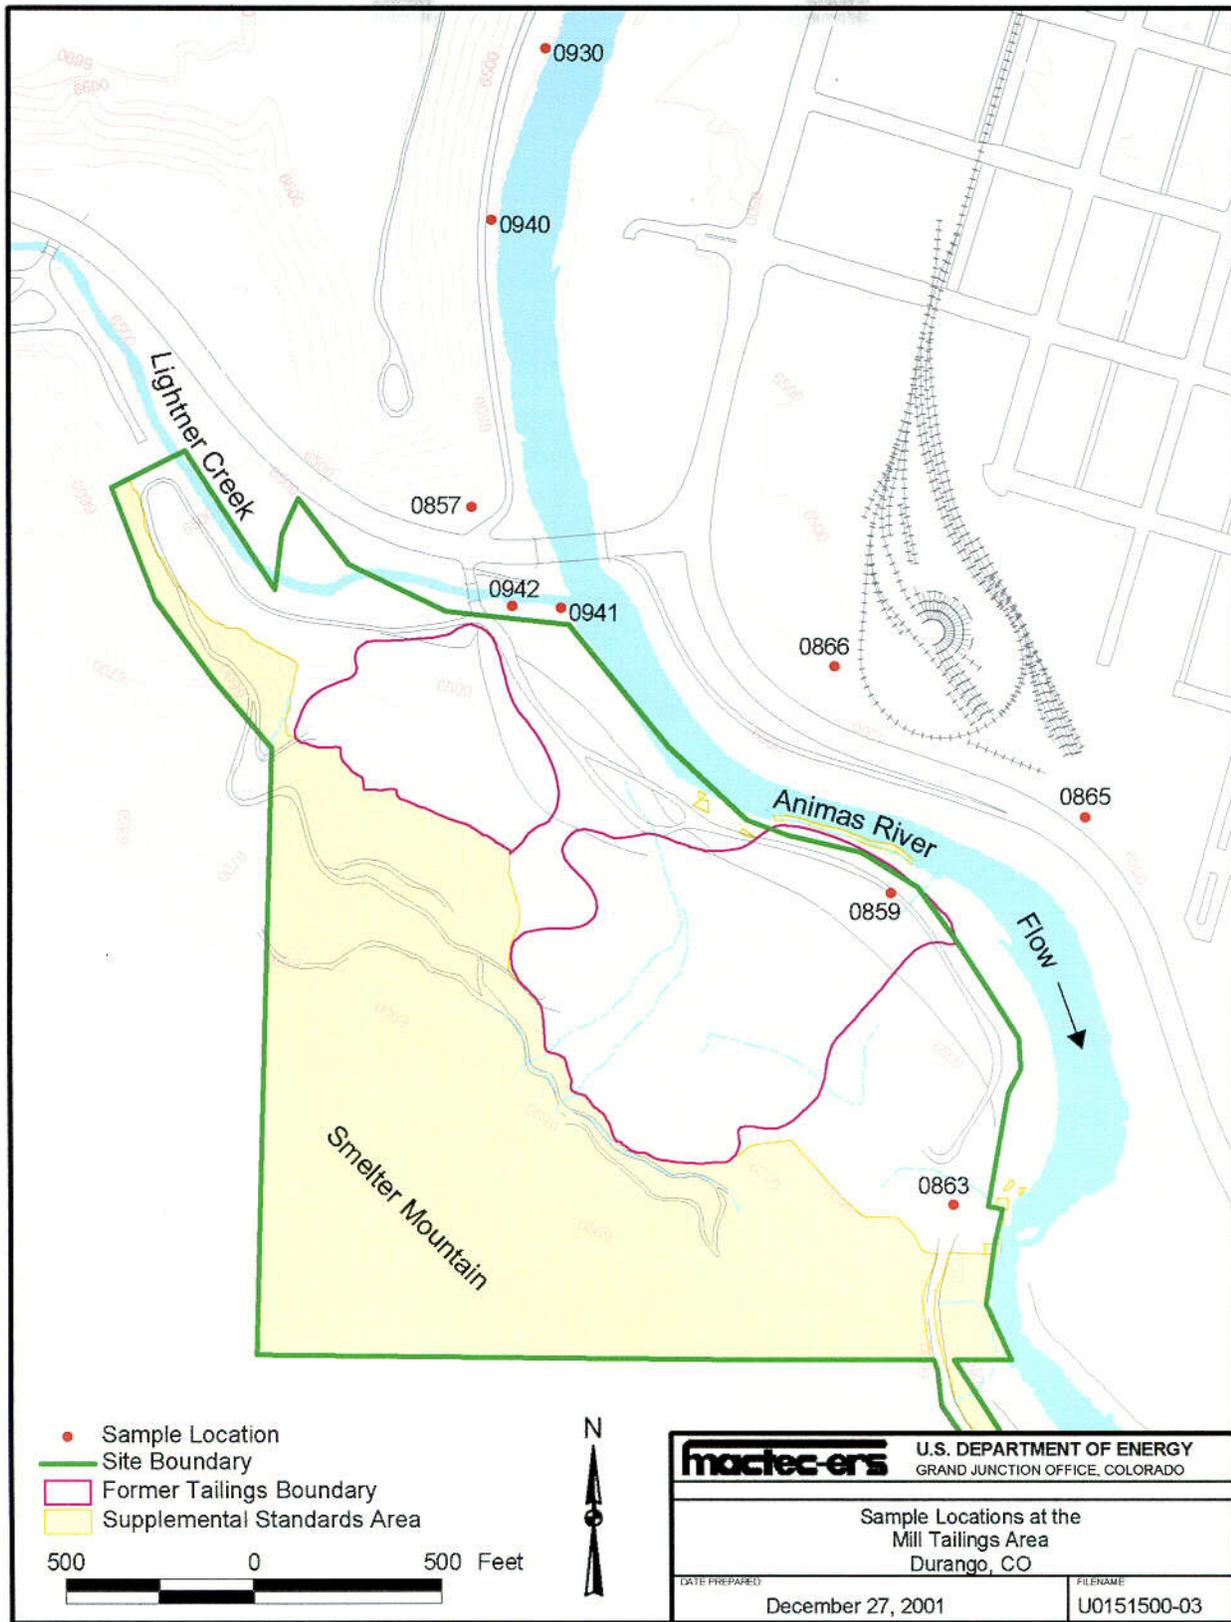
Figure 4-9. Distribution Coefficient Sample Locations at the Mill Tailings Area
