Site Observational Work Plan for the Durango, Colorado, UMTRA Project Site

January 2002

Prepared by the
U.S. Department of Energy
Grand Junction Office

Project Number UGW-511-0006-10-000
Document Number U0143200

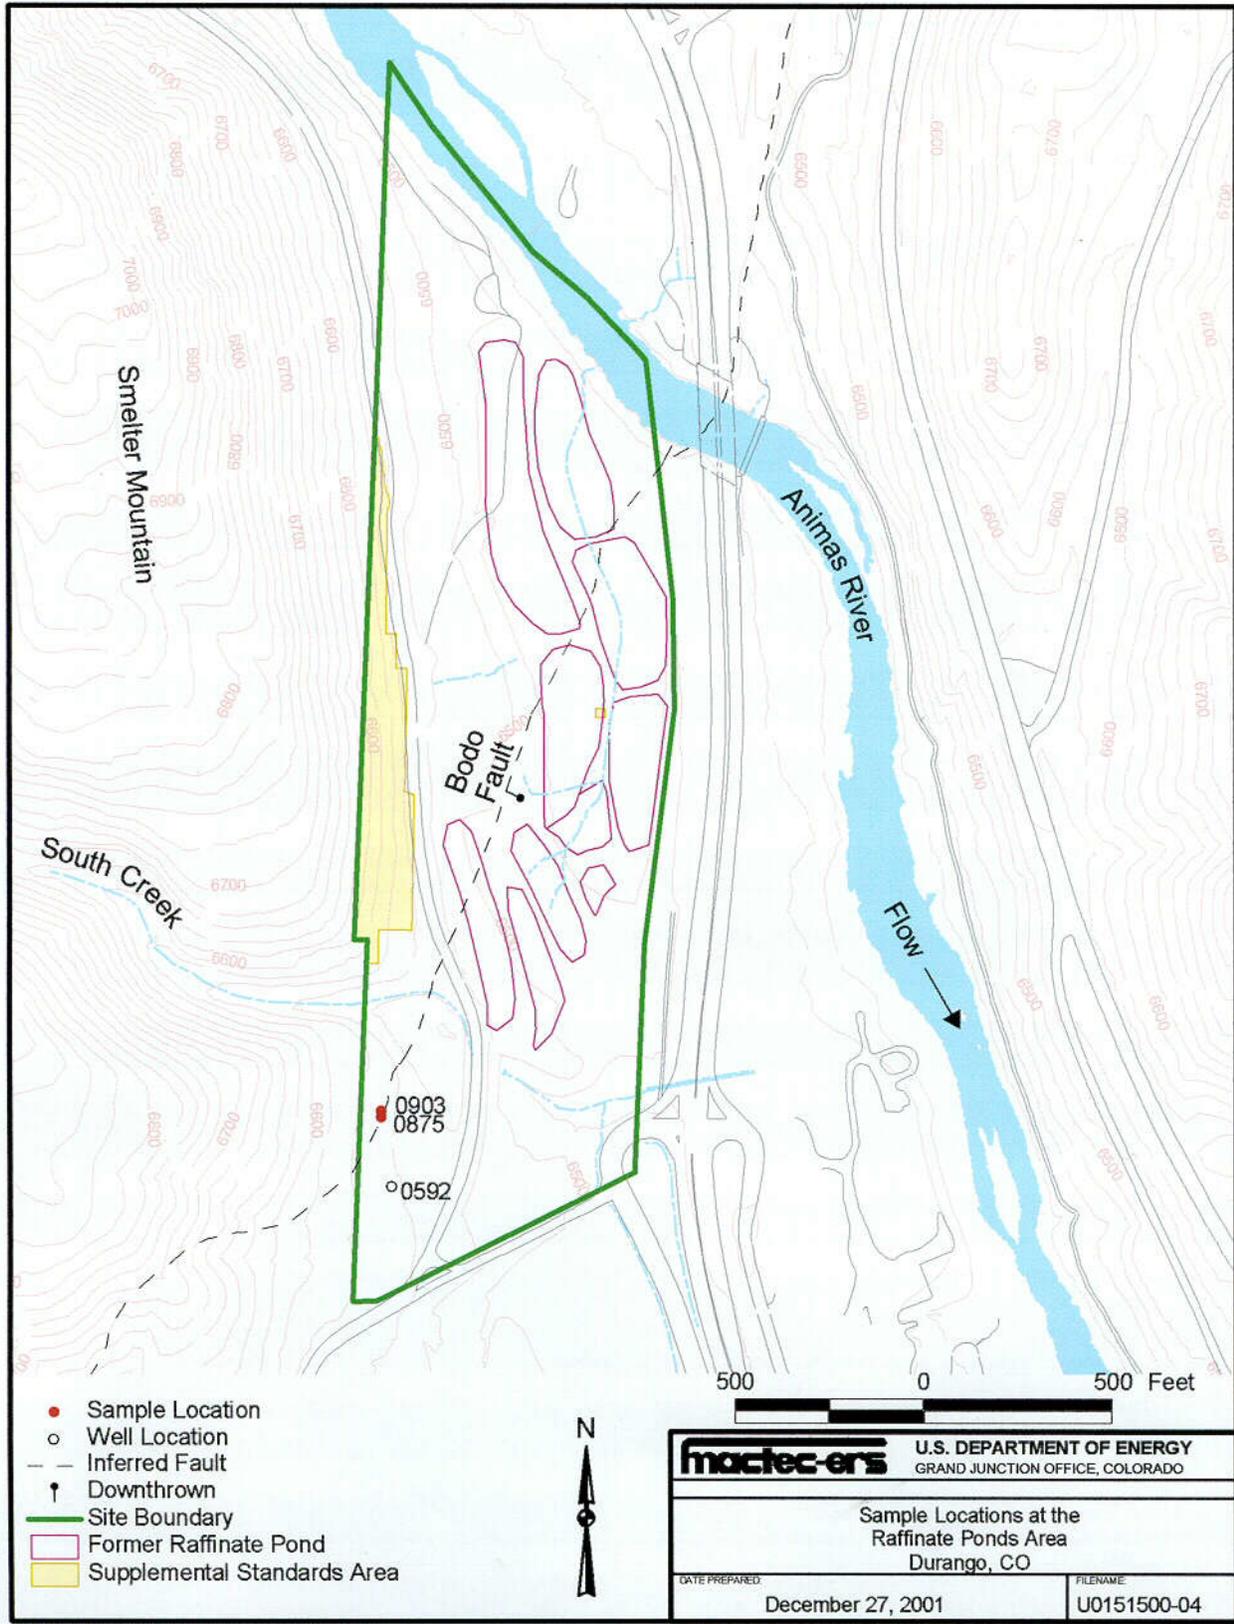
Figure 4-10. Distribution Coefficient Sample Locations at the Raffinate Ponds Area

In Rounds 1 and 2, solid samples from the raffinate ponds area were leached with water from well 0592 (Figure 4–10). In Round 3, the samples were leached with laboratory prepared synthetic ground water. The pH and oxidation-reduction potential (ORP) of the water from well 0592 when it arrived at the ESL was 7.55 and –322 millivolts (mV), respectively, and it had a very strong sulfur odor. By the end of the Round 1 determinations, the pH was 7.00, the ORP was –135 mV, and the sulfur odor had decreased. These changes indicate a change in redox conditions in the water affected the stability of the control solutions. As a result, the final round of determinations, Round 3, were conducted using synthetic ground water to ensure stable redox conditions.

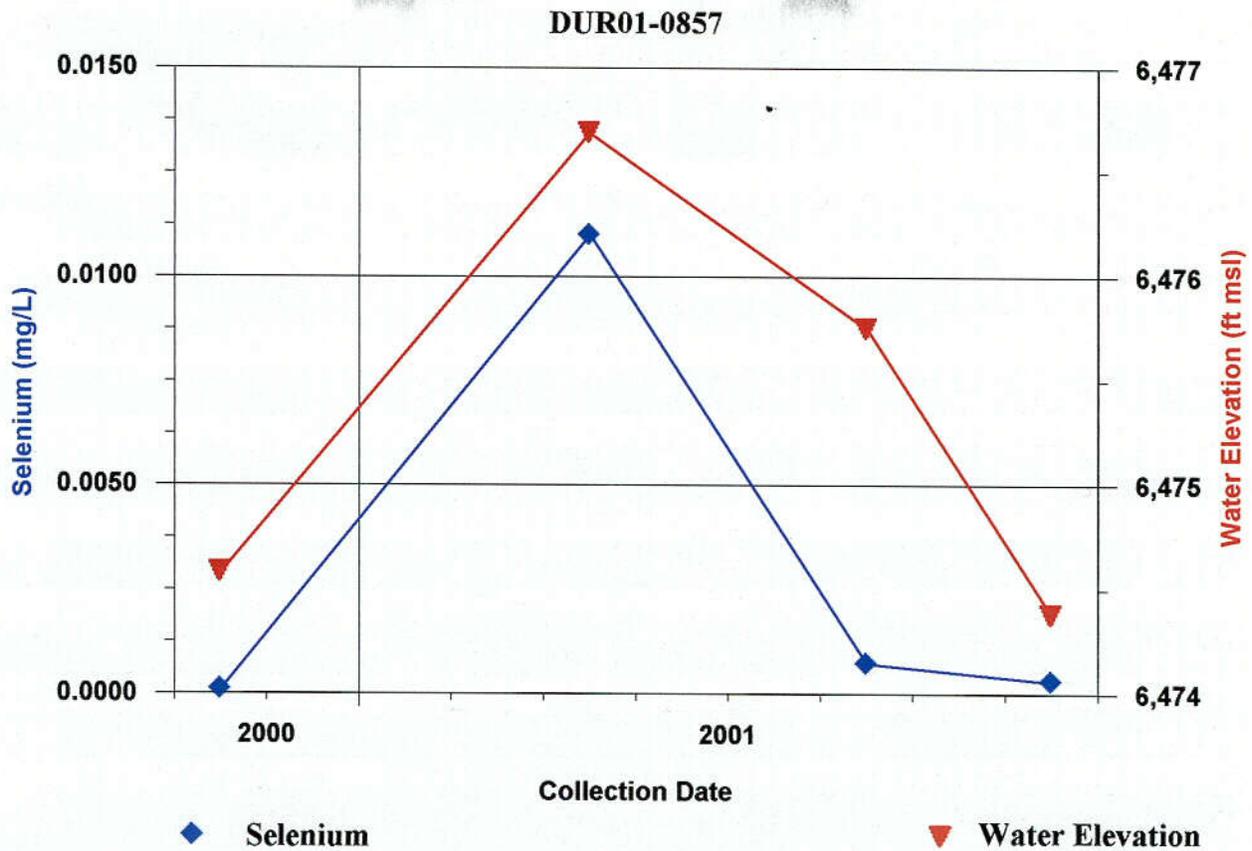
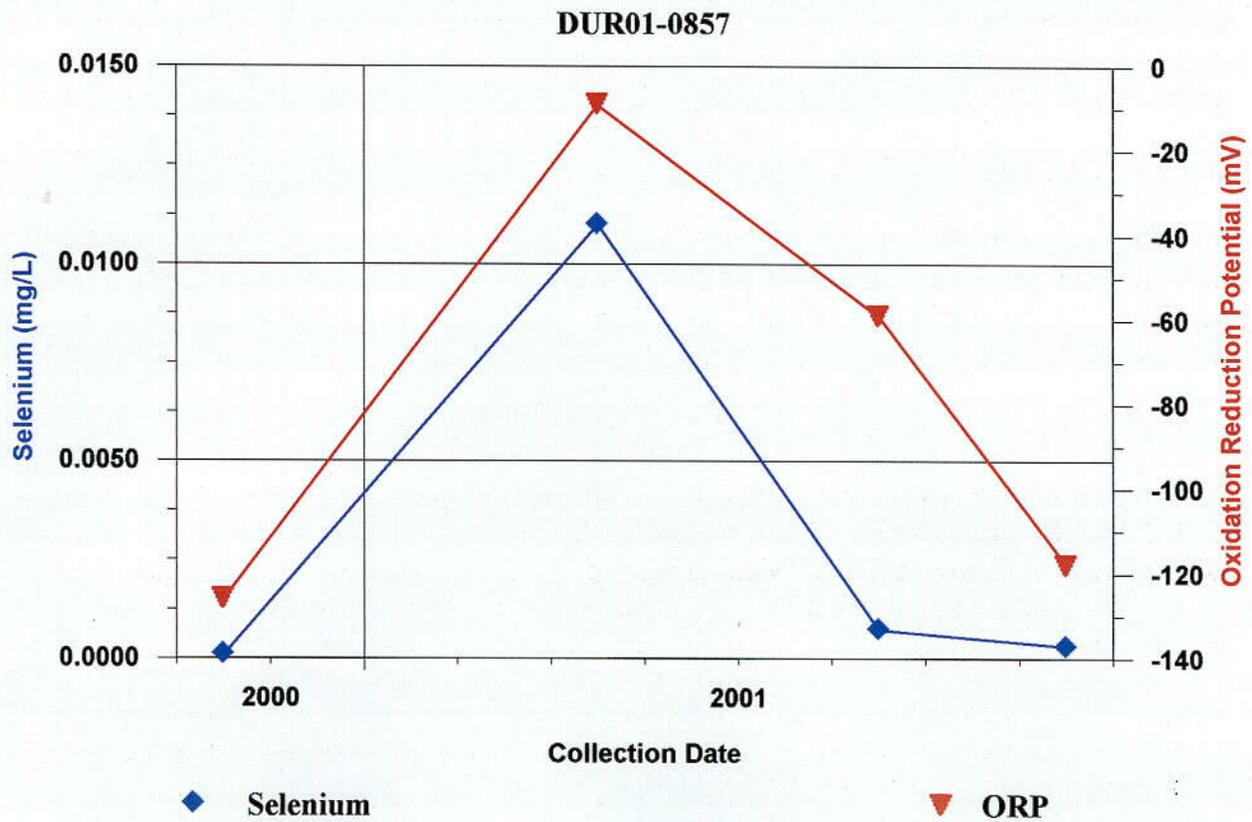
Figure 4-12. Selenium, ORP, and Water Levels at Durango Mill Tailings Area Background Well 857

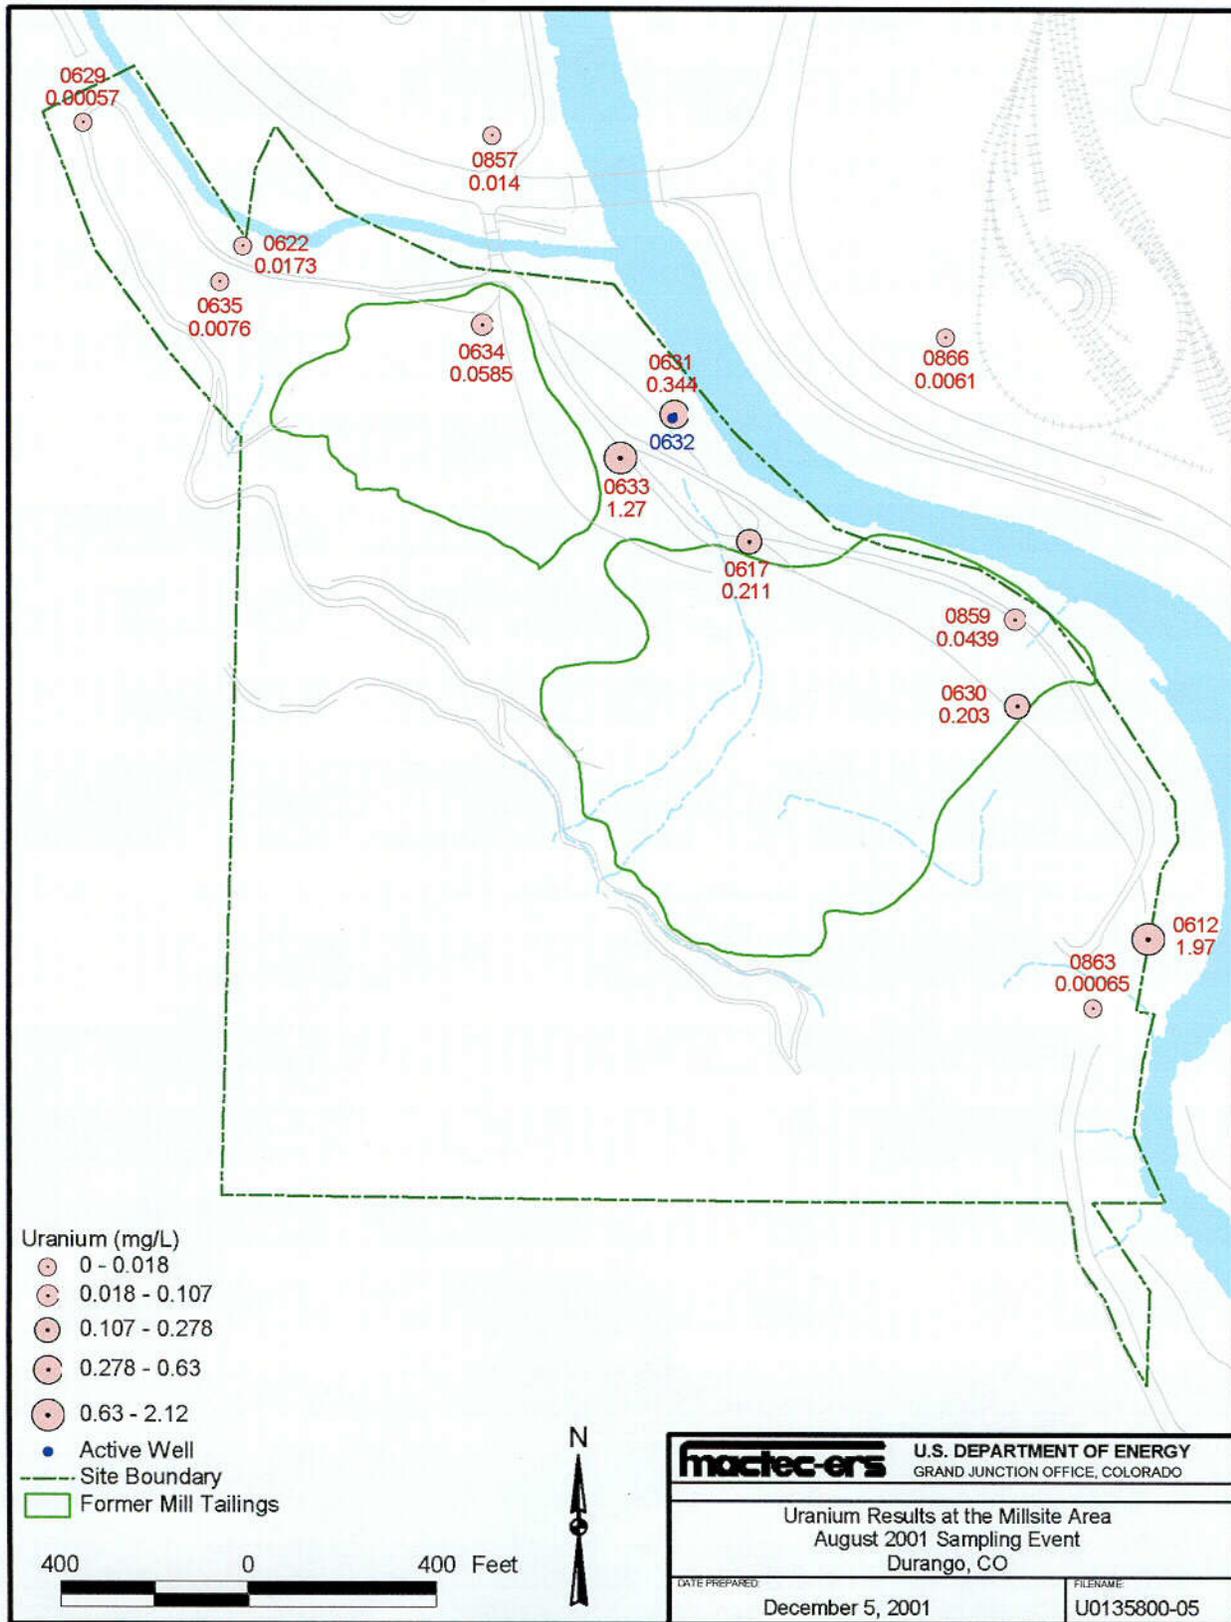
Figure 4-13. Uranium Concentrations in Alluvial Ground Water at the Mill Tailings Area, August 2001

Figure 4-13 through Figure 4-16 are spot plots of on-site and background alluvial wells showing concentrations of contaminants that exceed the MCL. These data are based on the sampling conducted in August 2001.

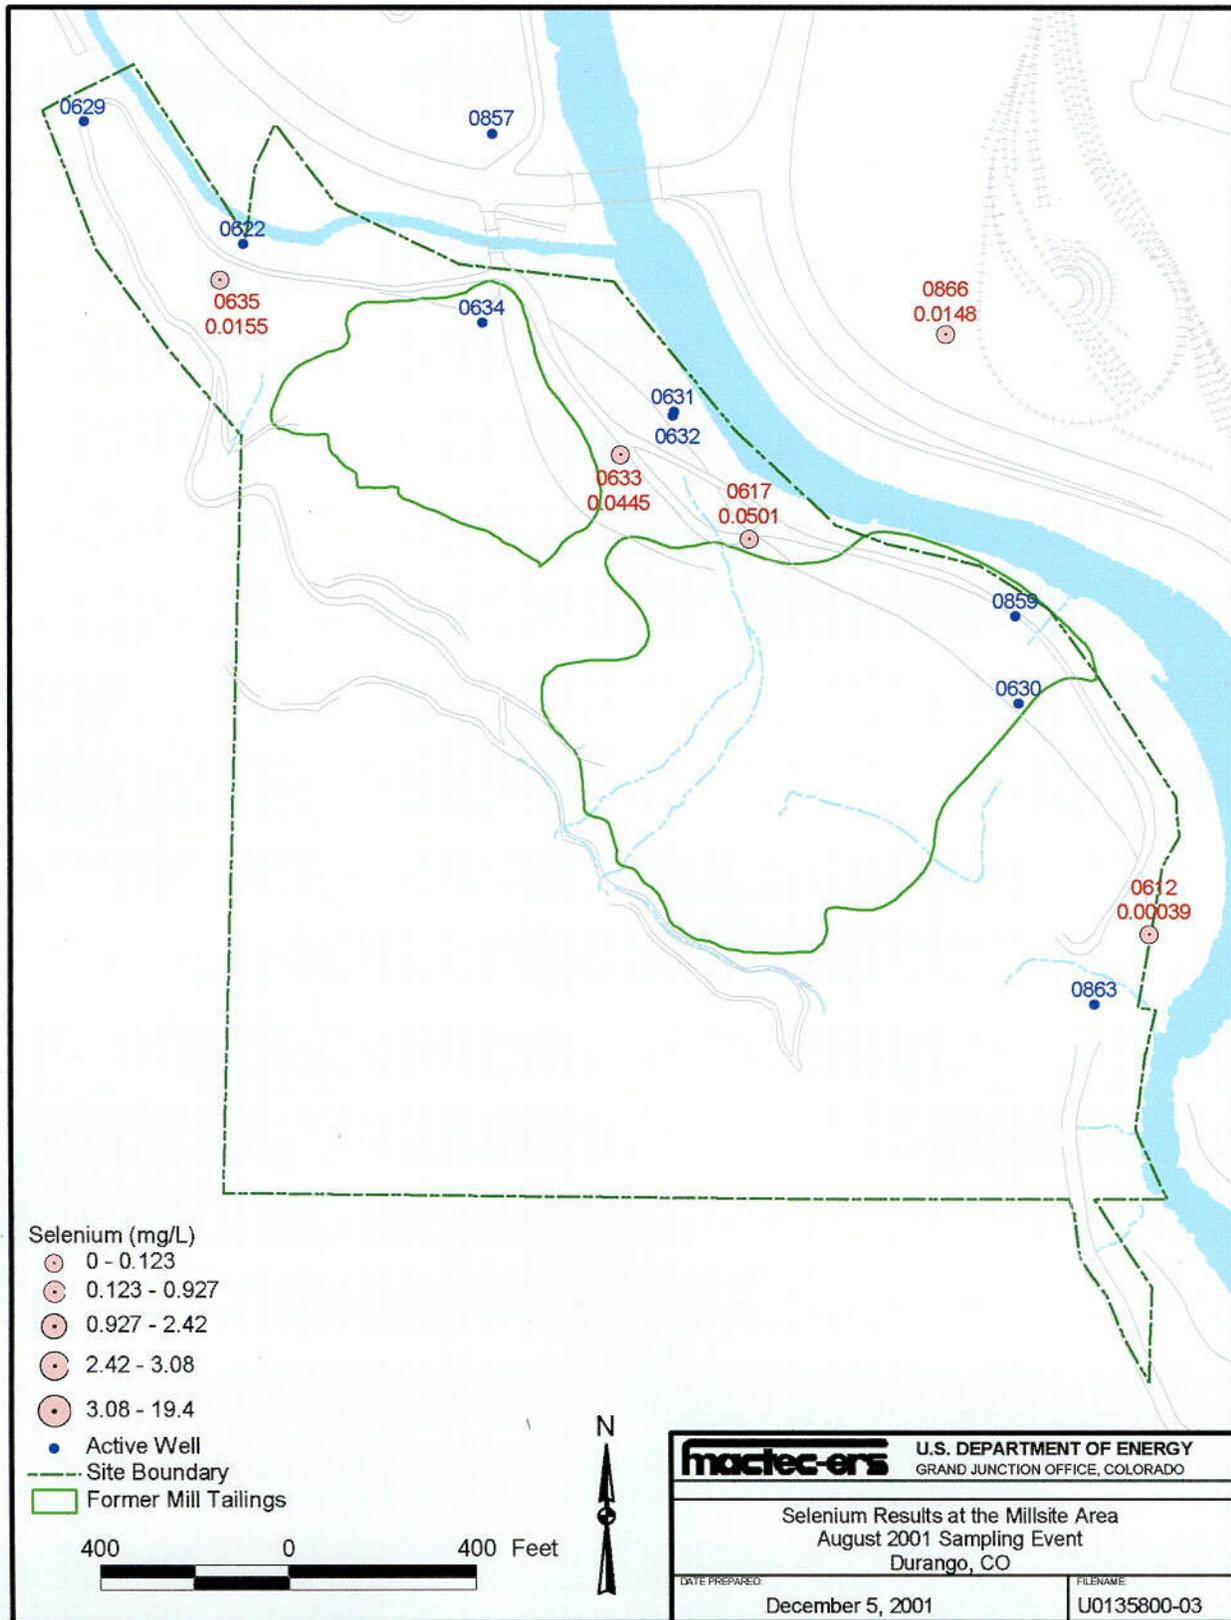
Figure 4-14. Selenium Concentrations in Alluvial Ground Water at the Mill Tailings Area, August 2001

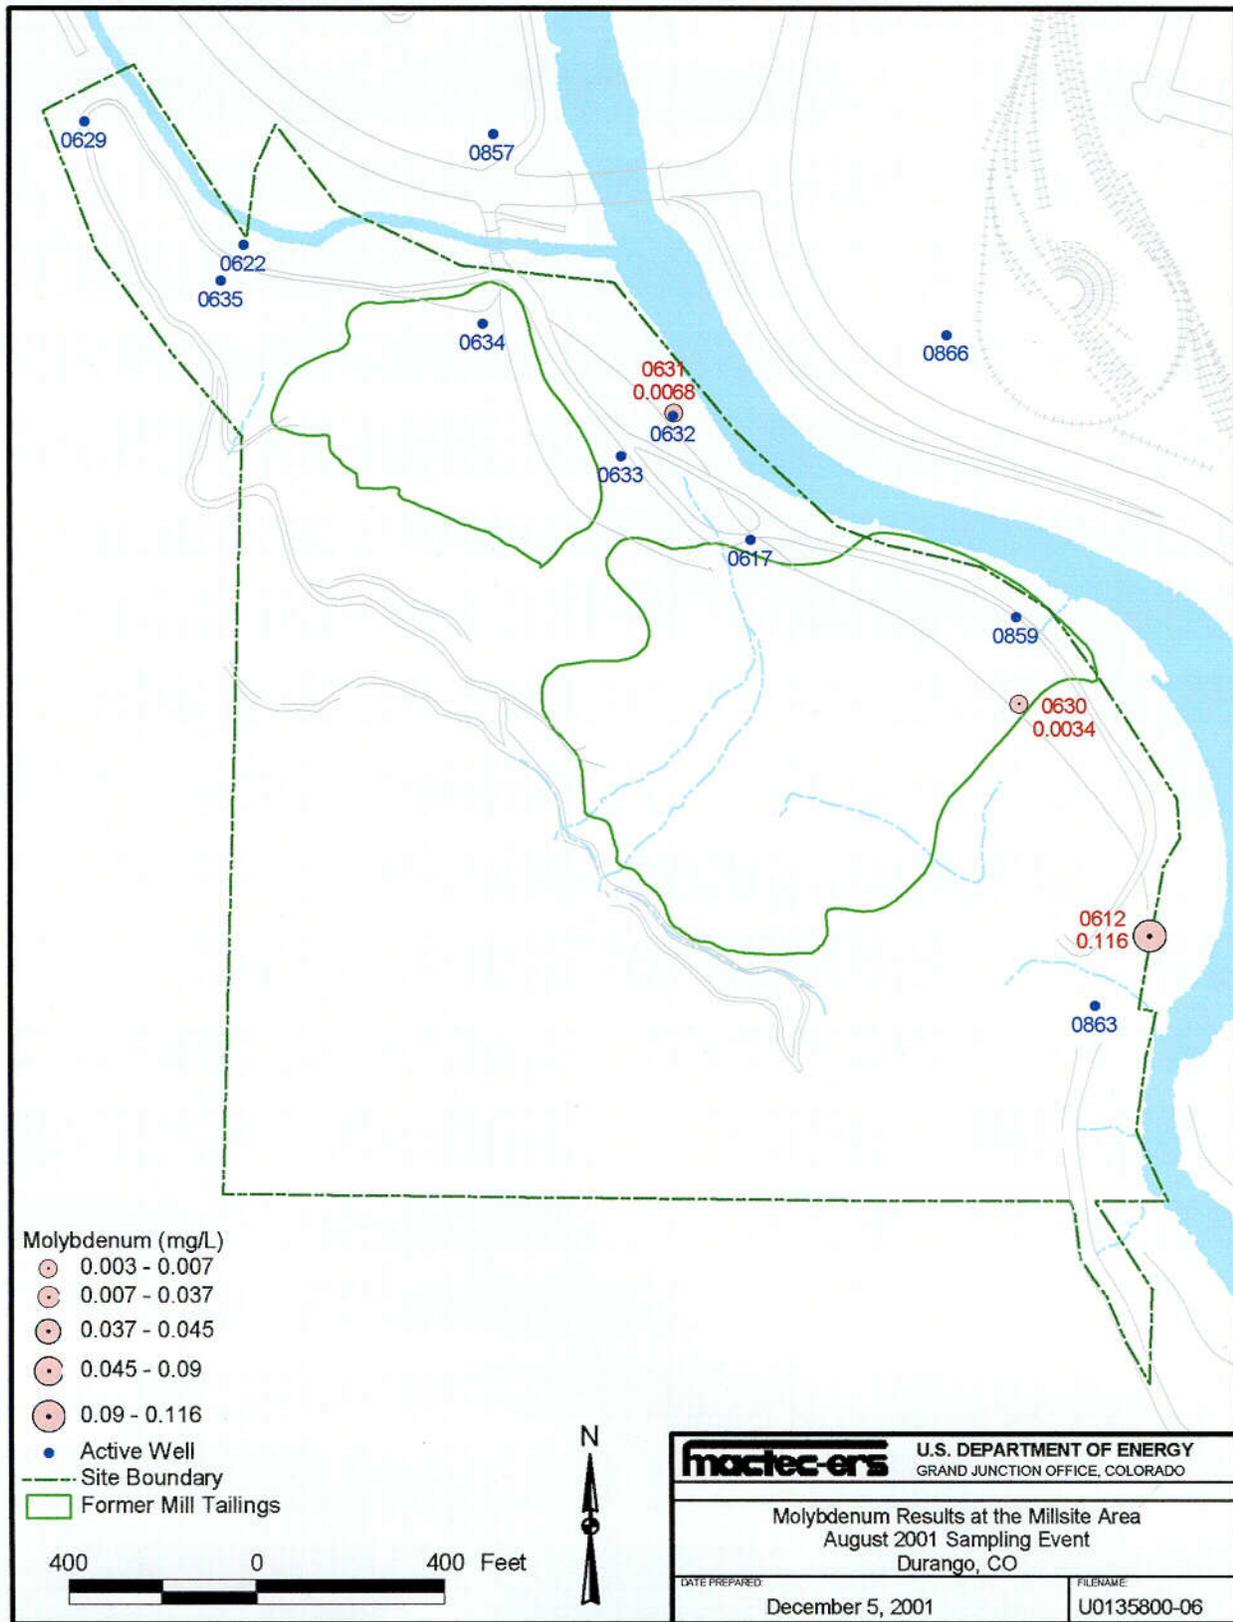
Figure 4-15. Molybdenum Concentrations in Alluvial Ground Water at the Mill Tailings Area, August 2001

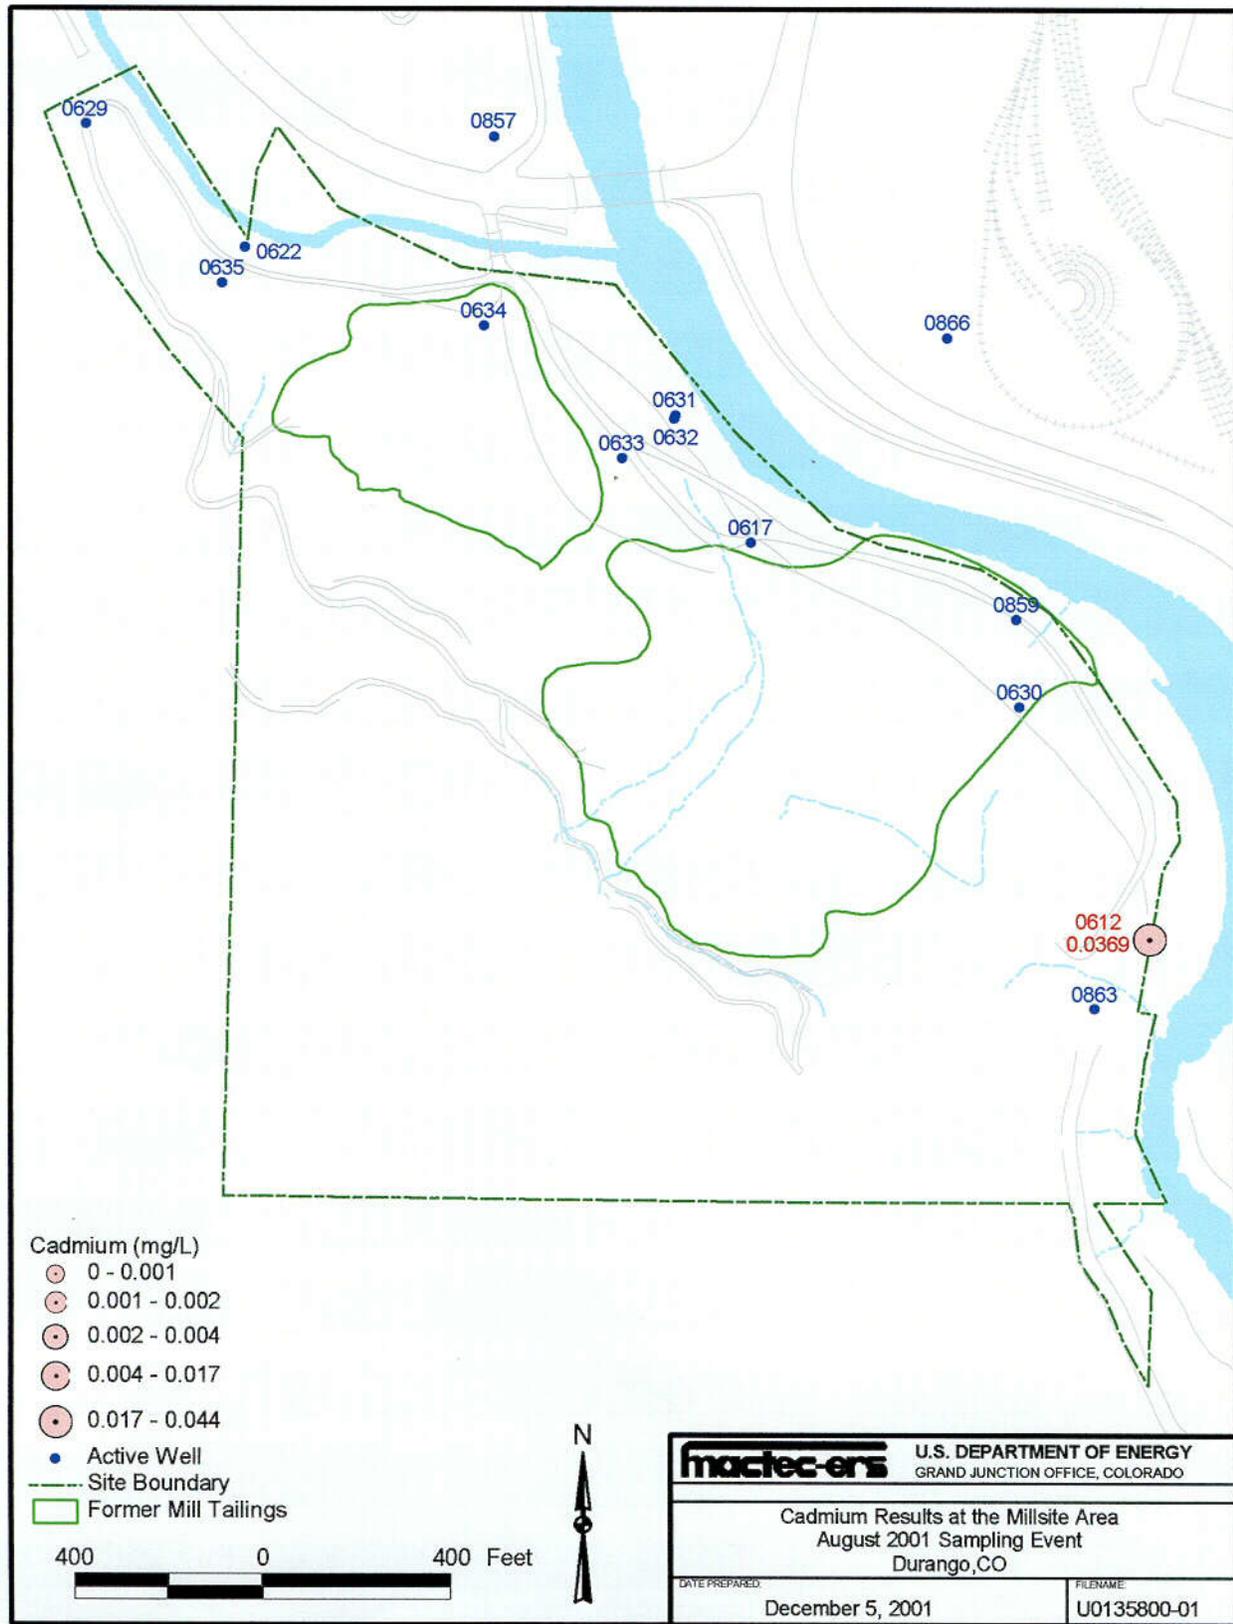
Figure 4-16. Cadmium Concentrations in Alluvial Ground Water at the Mill Tailings Area, August 2001

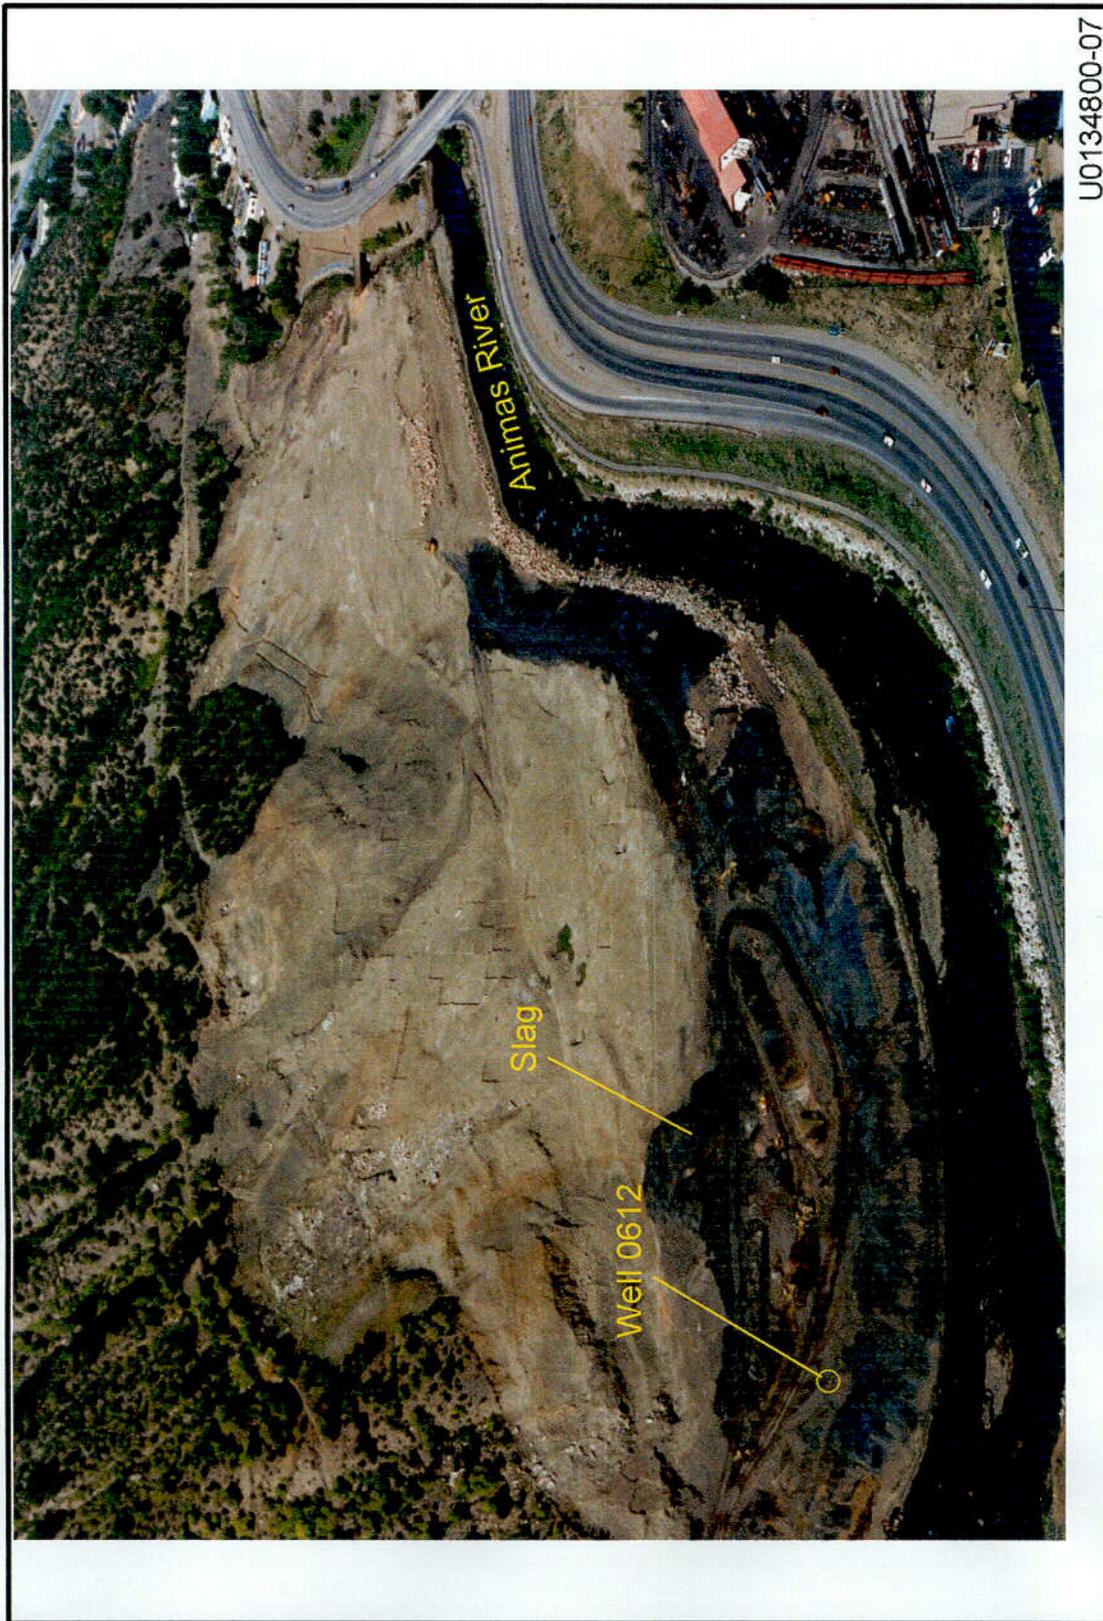
Figure 4-18. Occurrence of Lead Smelter Slag and Well 0612 Location at the Mill Tailings Area

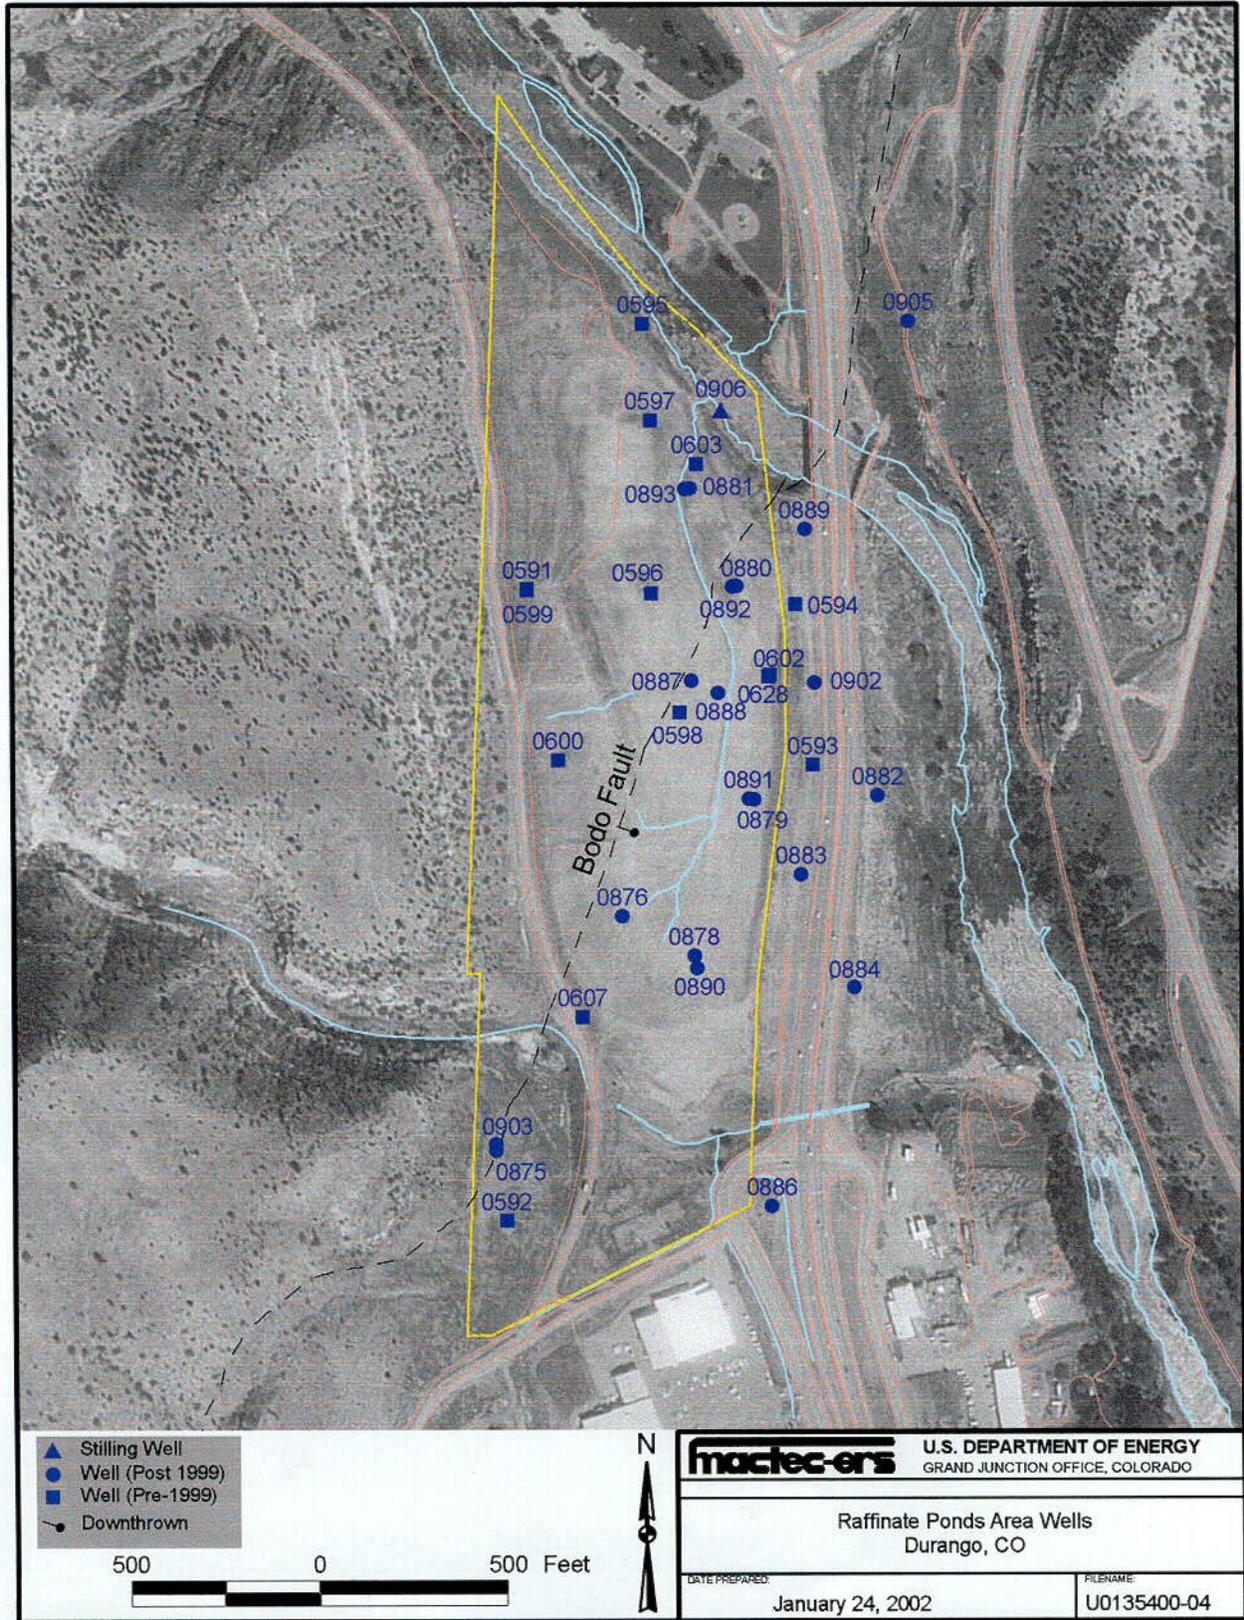
Figure 4-19. Raffinate Ponds Area Wells

At the raffinate ponds area, samples were collected from background bedrock well locations 0592, 0599, 0875, 0886, and 0903 (Figure 4–19). Eighteen on-site wells and seven off-site downgradient wells were sampled. Monitor wells 0891, 0893, and 0905 were not routinely sampled because these wells are either dry or purge dry and do not recover. Surface water sampling results for the raffinate ponds area is presented in Section 4.6.4.

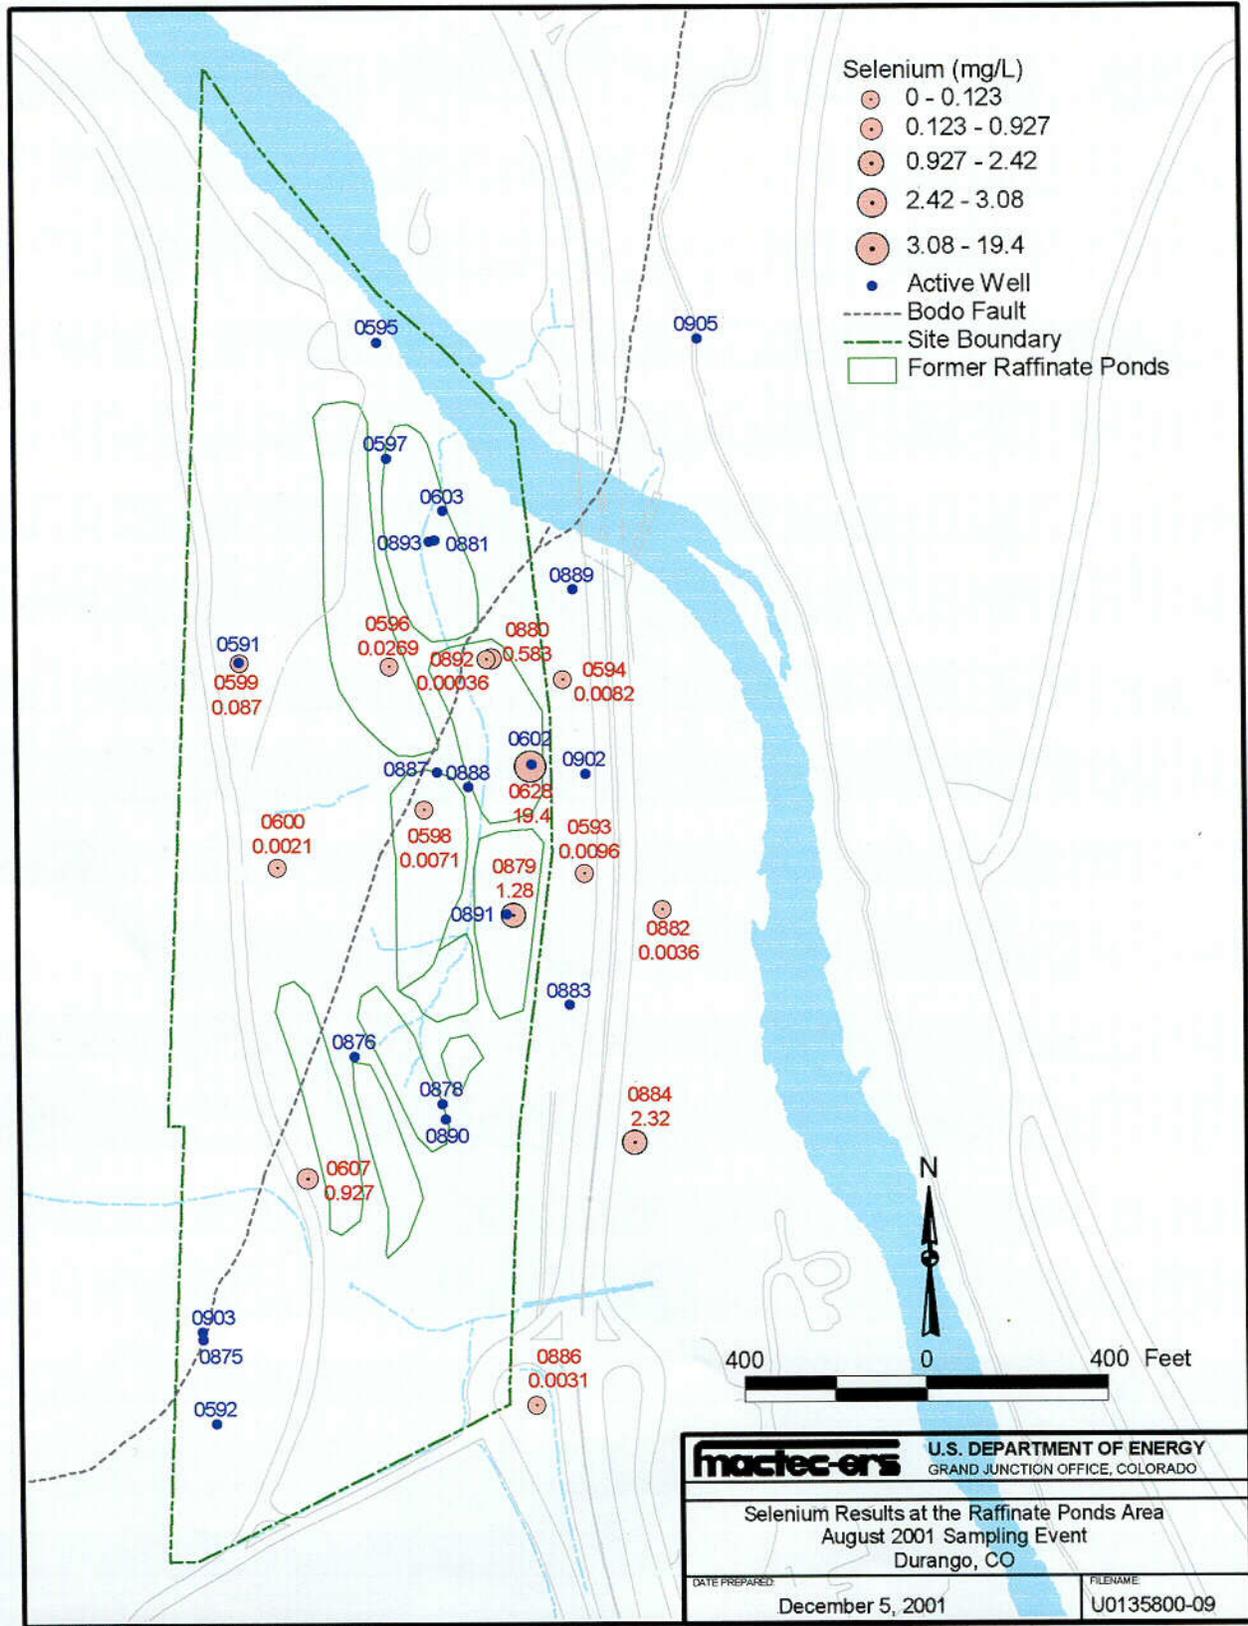
Figure 4-21. Selenium Concentrations in Ground Water at the Raffinate Ponds Area, August 2001

Figure 4–21 and Figure 4–22 are spot plots of on-site and downgradient bedrock well locations showing concentrations of selenium and uranium based on the sampling conducted in August 2001. As shown, uranium above the MCL occurs at well 0598, which is completed in the Bodo Fault zone. However, uranium concentrations in adjacent wells 0887 and 0888 are below background concentrations. Monitor well 0887 is completed in the Point Lookout Sandstone and screened at the same depth as well 0598. Monitor well 0888 is completed in the Bodo Fault zone and screened approximately 40 ft below the screened depth of well 0598 in the Bodo Fault. At monitor well 0598 (Figure 4–23) the concentration of uranium has been steadily decreasing since remediation was completed in 1991 and is nearing the MCL of 0.044 mg/L. Figure 4–23 and Figure 4–24 are time-concentration plots of uranium results at the raffinate ponds area.

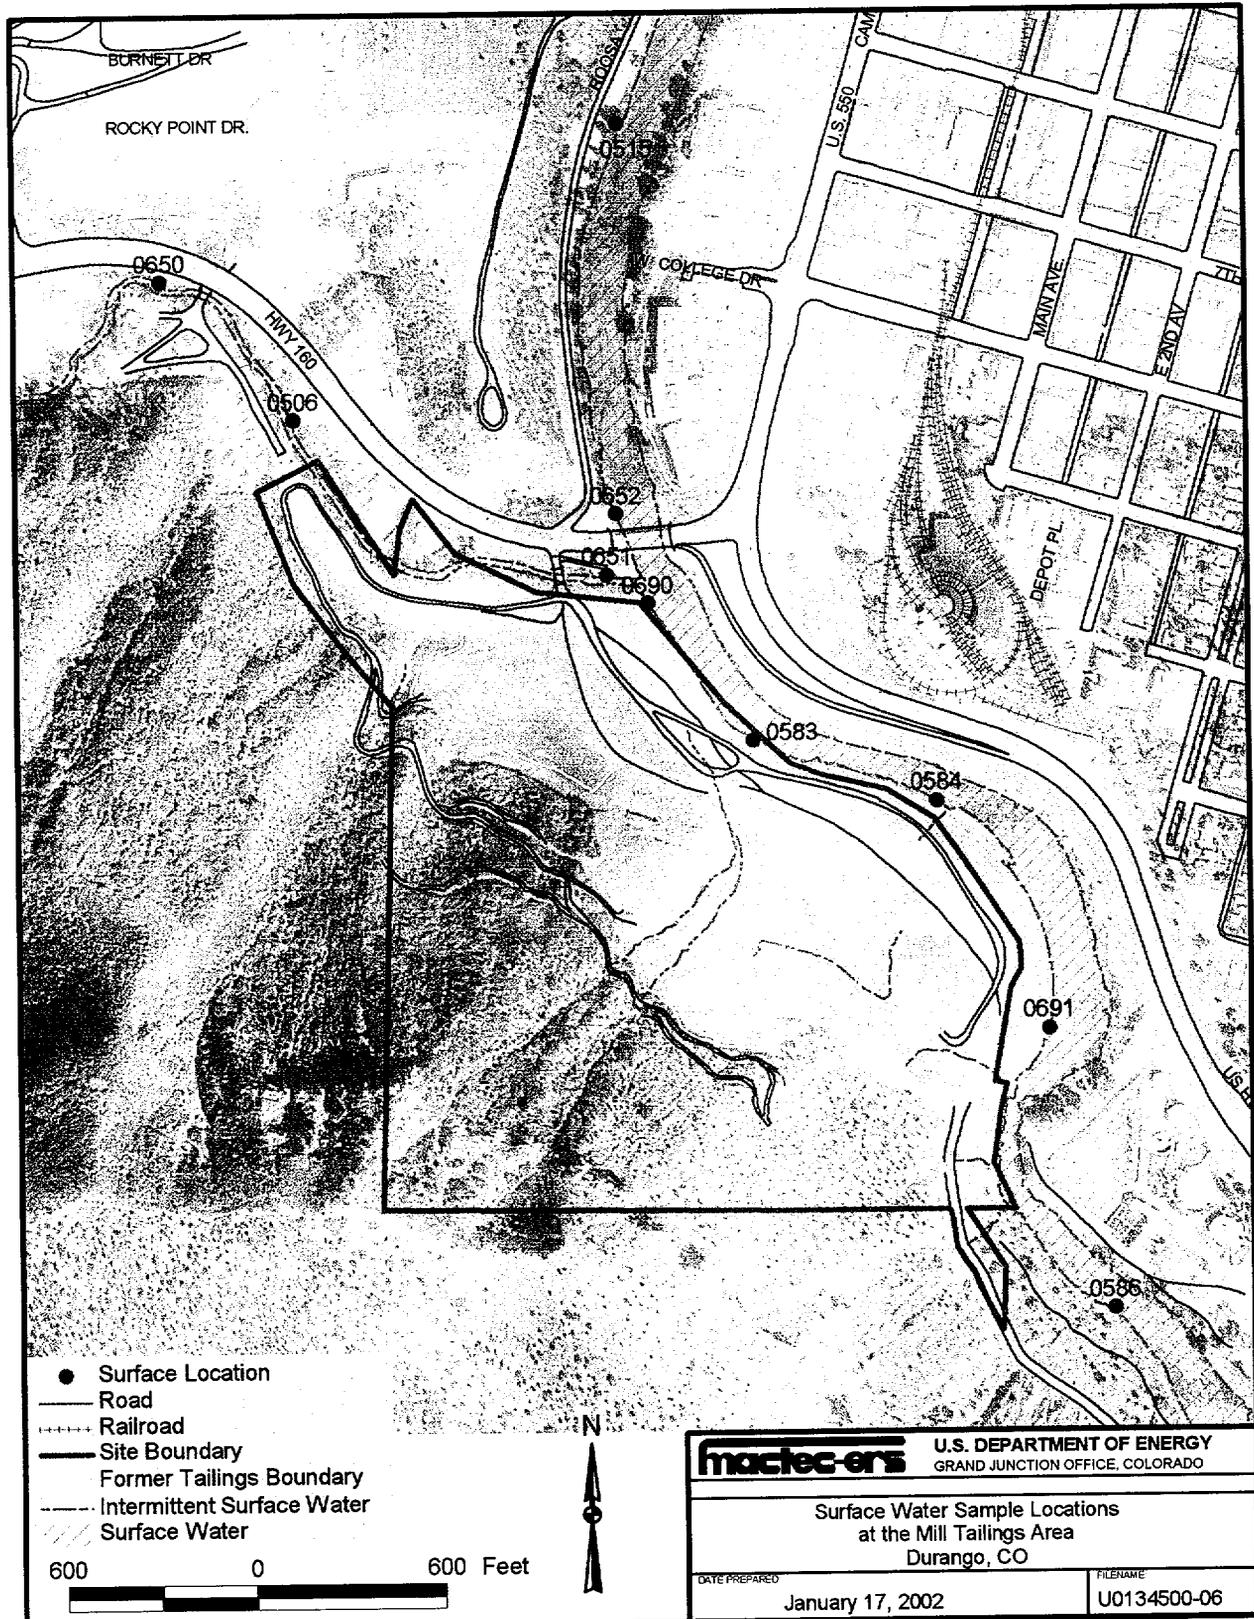
Figure 4-25. Surface Sample Locations at the Mill Tailings Area

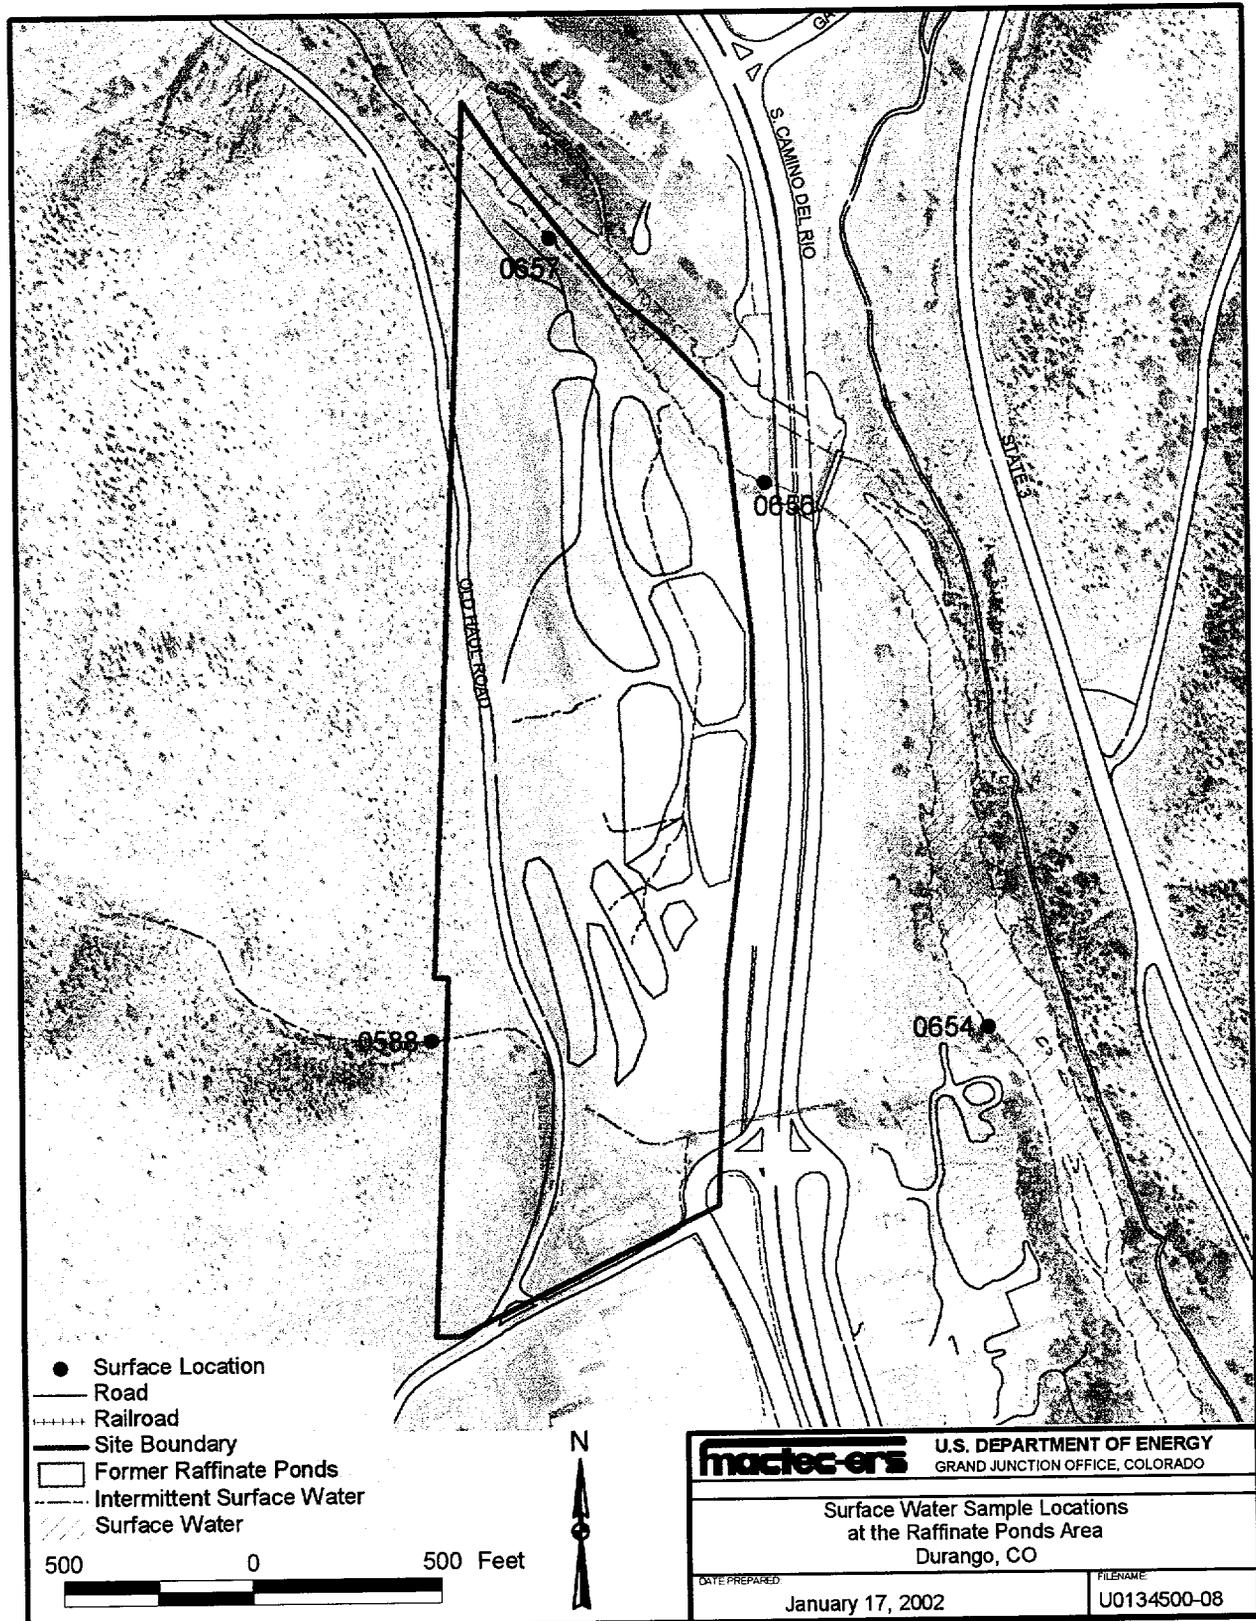
Figure 4-26. Surface Locations at the Raffinate Ponds Area

At the raffinate ponds area, surface water was sampled along South Creek, from one location upgradient of the site (0588). The Animas River was sampled at two locations adjacent to the site (0656 and 0657), and at one downgradient location (0654). Because of the proximity of the mill tailings area to the raffinate ponds area, the Animas River sample locations 0515 and 0652 were used to establish background for both sites. Raffinate ponds area surface water sample locations are shown in Figure 4–26.
