Site Observational Work Plan for the Durango, Colorado, UMTRA Project Site

January 2002

Prepared by the
U.S. Department of Energy
Grand Junction Office

Project Number UGW-511-0006-10-000
Document Number U0143200

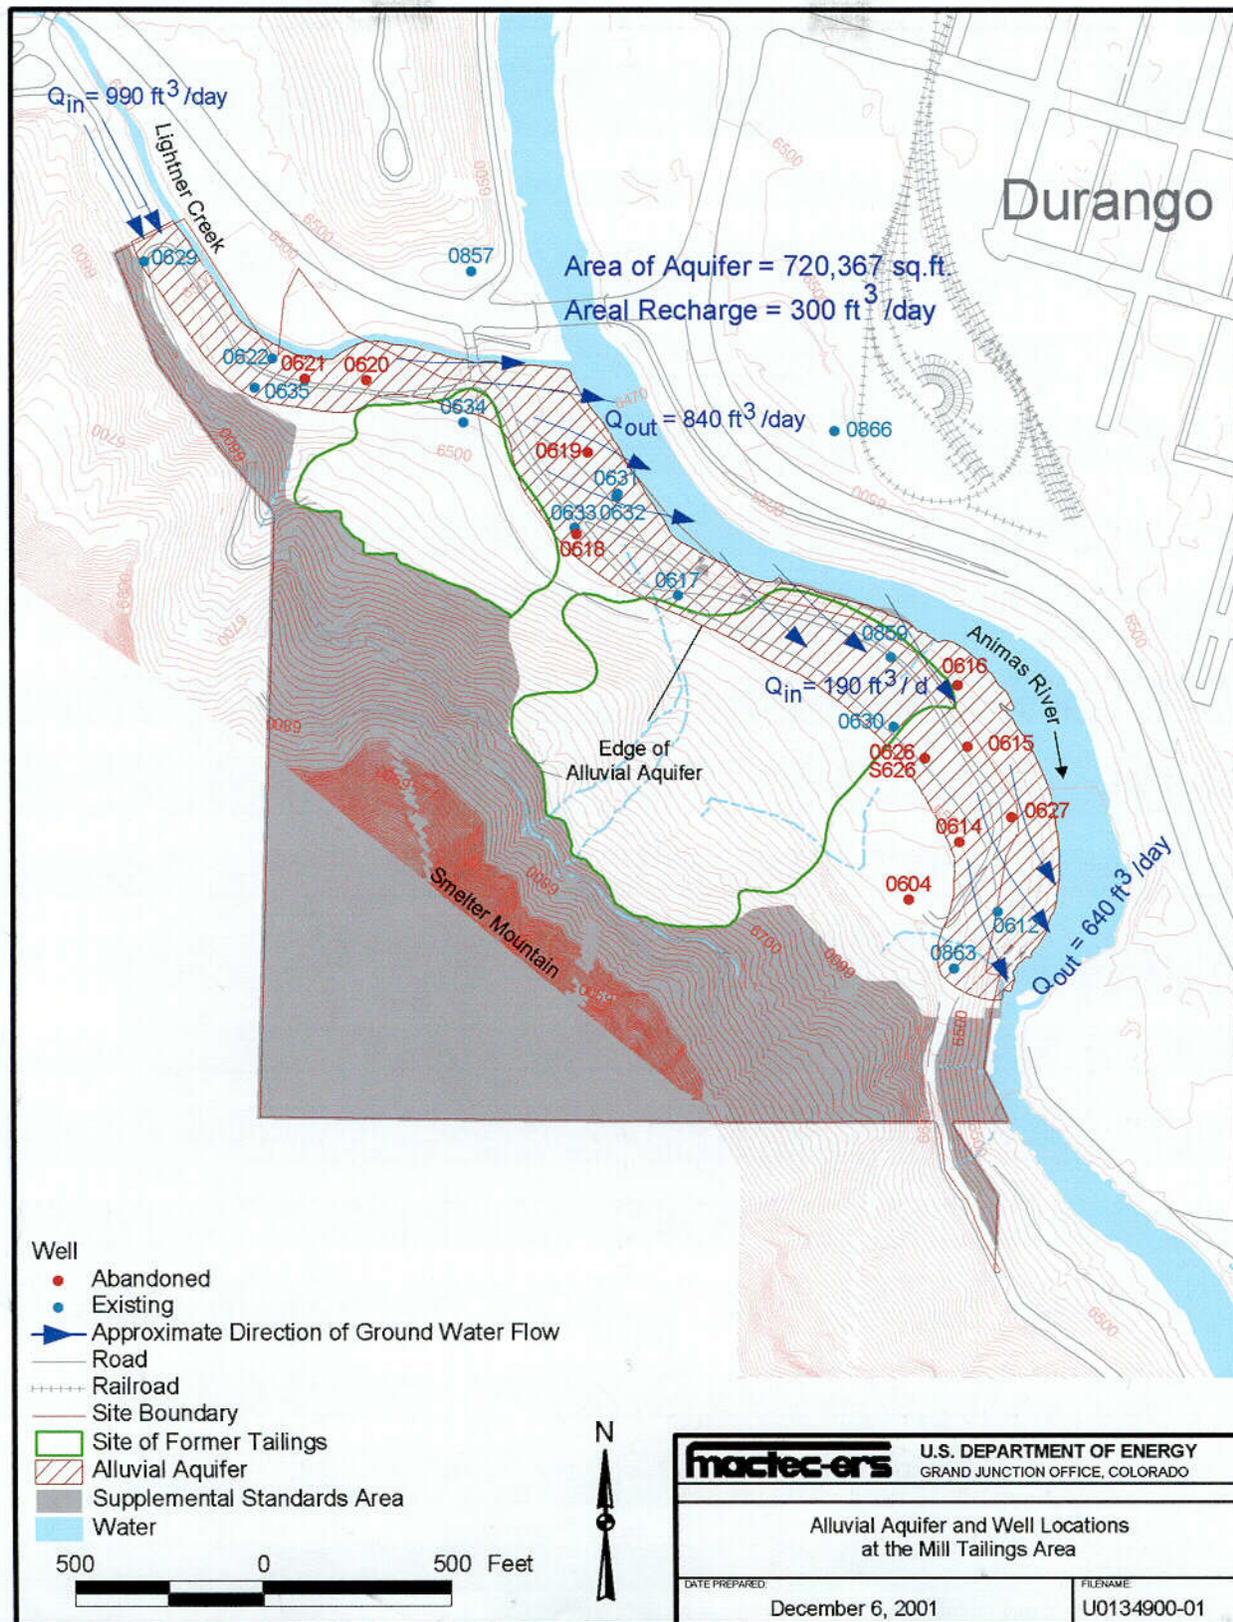
Figure 5-1. Alluvial Aquifer and Well Locations at the Mill Tailings Area

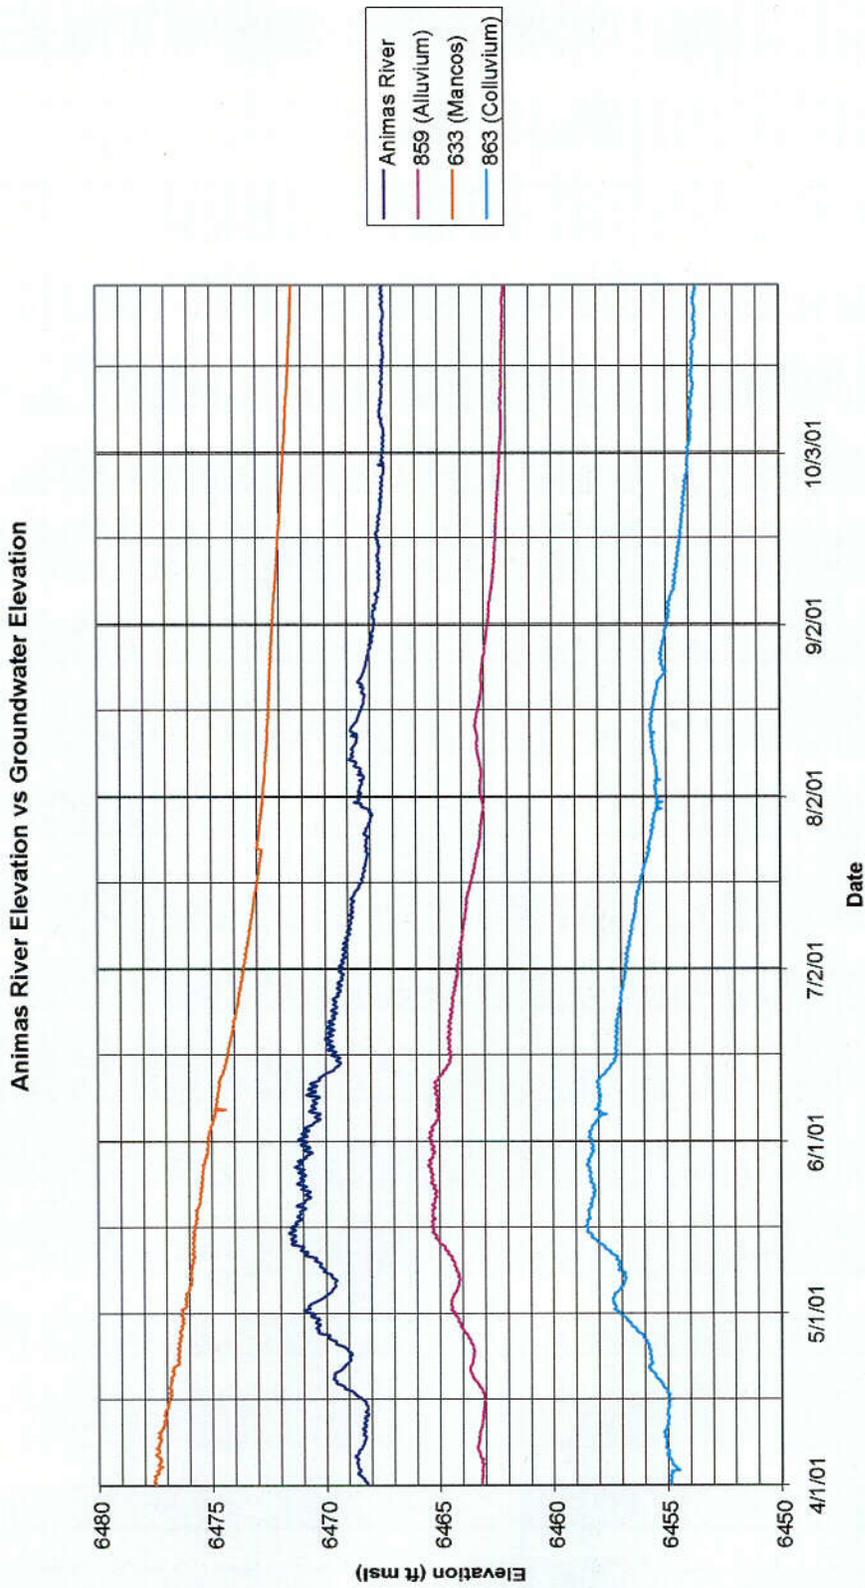
Figure 5-2. Animas River Elevation versus Ground Water Elevation

Wells 0863, 0859, and 0633 (completed in the colluvium, alluvium, and Mancos Shale, respectively) were equipped with dataloggers to monitor groundwater fluctuations between April and November, 2001. This data set is compared to the fluctuations of the Animas River stage in Figure 5-2. For comparison, the actual river elevation shown in Figure 5-2 is not as important as the fluctuation pattern shown, since the elevation is representative at only one point (stilling well 0876) along the Animas River.

Ground water in the colluvium and alluvium exhibit the same fluctuation pattern as displayed by the Animas River stage, confirming that water in these two units are hydraulically connected to the river. Ground water in the Mancos Shale onsite does not exhibit the same pattern. As shown in Figure 5-2, the Mancos Shale ground water surface does not show a definite peak in mid-May like the colluvium and alluvium units, suggesting the Mancos shale ground water flow system is impacted by a source other than the Animas River.

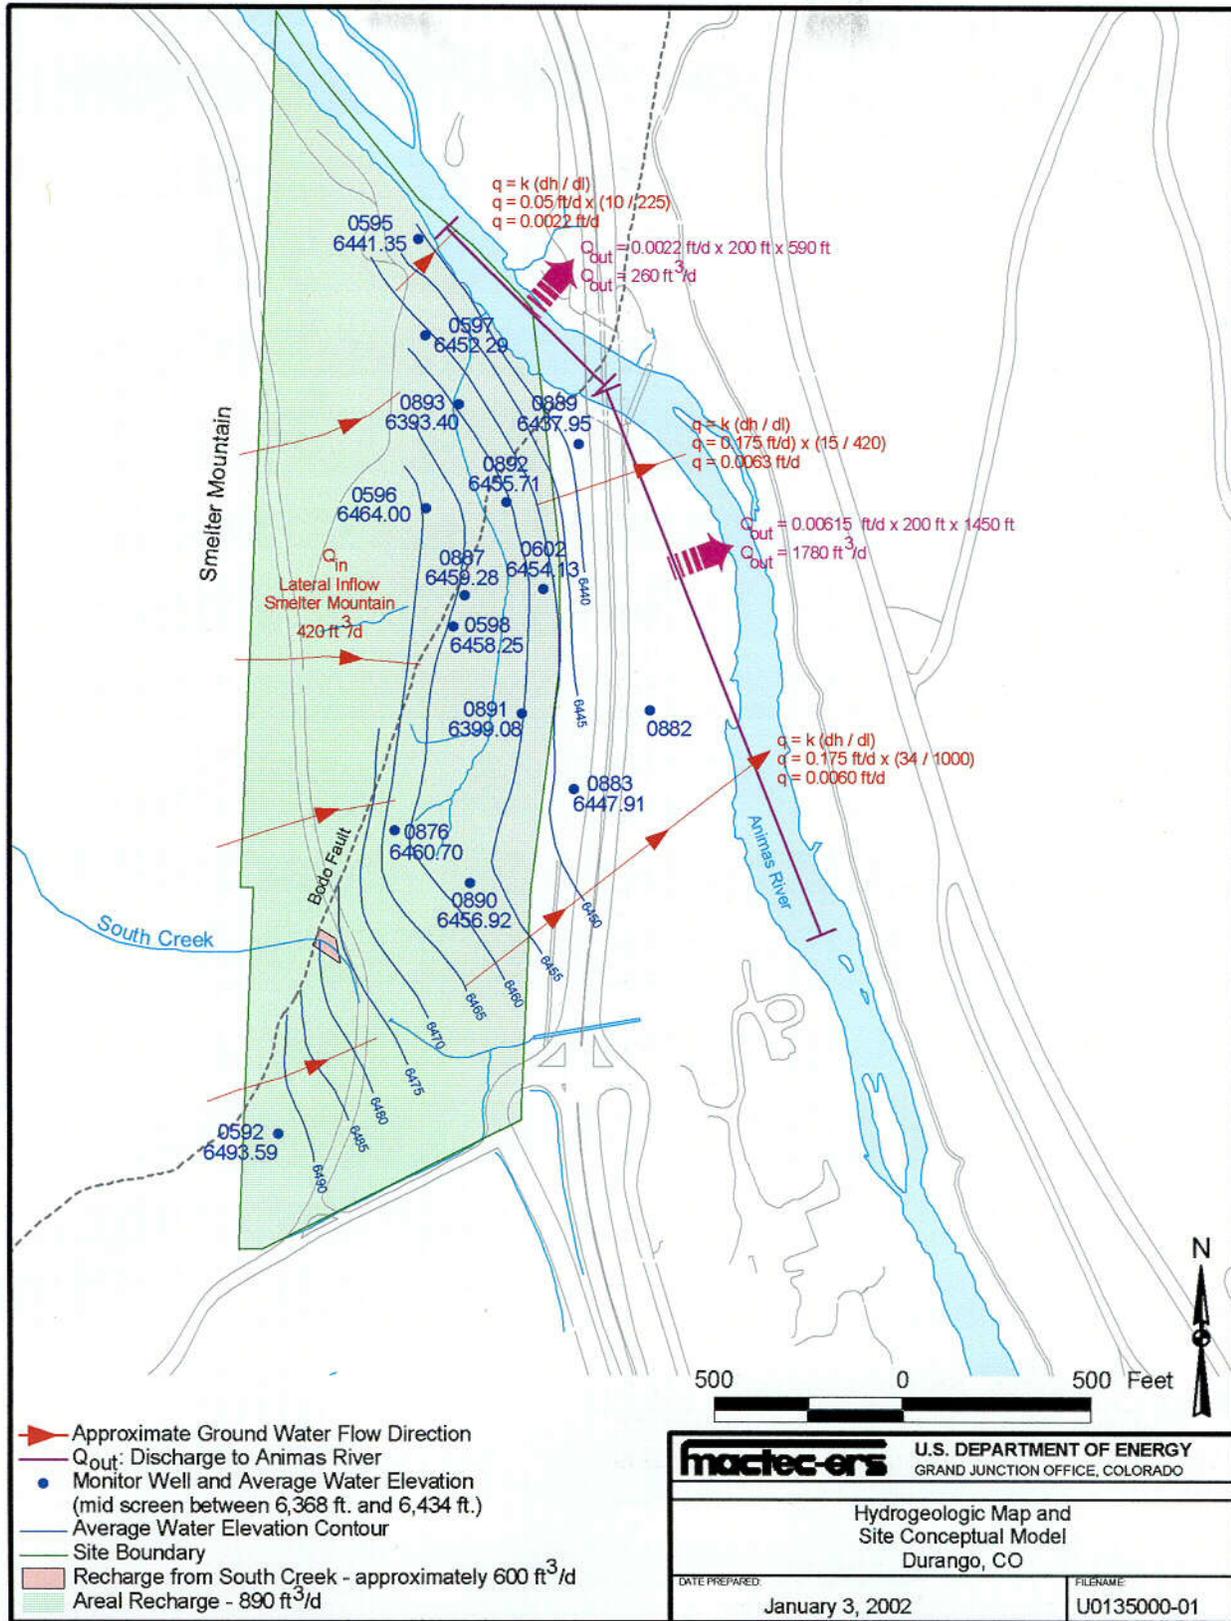
Figure 5-3. Hydrogeologic Map and Site Conceptual Model of the Raffinate Ponds Area

The water budget for the raffinate ponds area is estimated from the hydraulic properties of the bedrock units and interpretations of geologic logs. Figure 5-3 presents a hydrogeologic map showing the water budget components for the raffinate ponds area. Components of the water budget are described in the following sections and summarized in Table 5-4.

The thickness of the bedrock flow system is assumed to be approximately 200 ft. Wells screened in the middle elevations of the bedrock were used to estimate the ground water discharge to the Animas River. As shown on Figure 5-3, the hydraulic gradient through the Point Lookout Sandstone sections is approximately 0.044 (10/225). The width perpendicular to flow through the Point Lookout Sandstone is approximately 590 ft. Hydraulic conductivity of the Point Lookout Sandstone is 0.05 ft/day (Appendix F, MACTEC-ERS Calculation U0133300). Ground water discharge through the Point Lookout Sandstone from the site is estimated as

The specific discharge is estimated at two locations in Figure 5-3 based on a hydraulic gradient through the Menefee Formation of between 0.034 and 0.036. The total discharge through the Menefee Formation is then estimated based on a width perpendicular-to-flow of approximately 1,450 ft. Median hydraulic conductivity of the Menefee Formation is 0.175 ft/day (Appendix F,

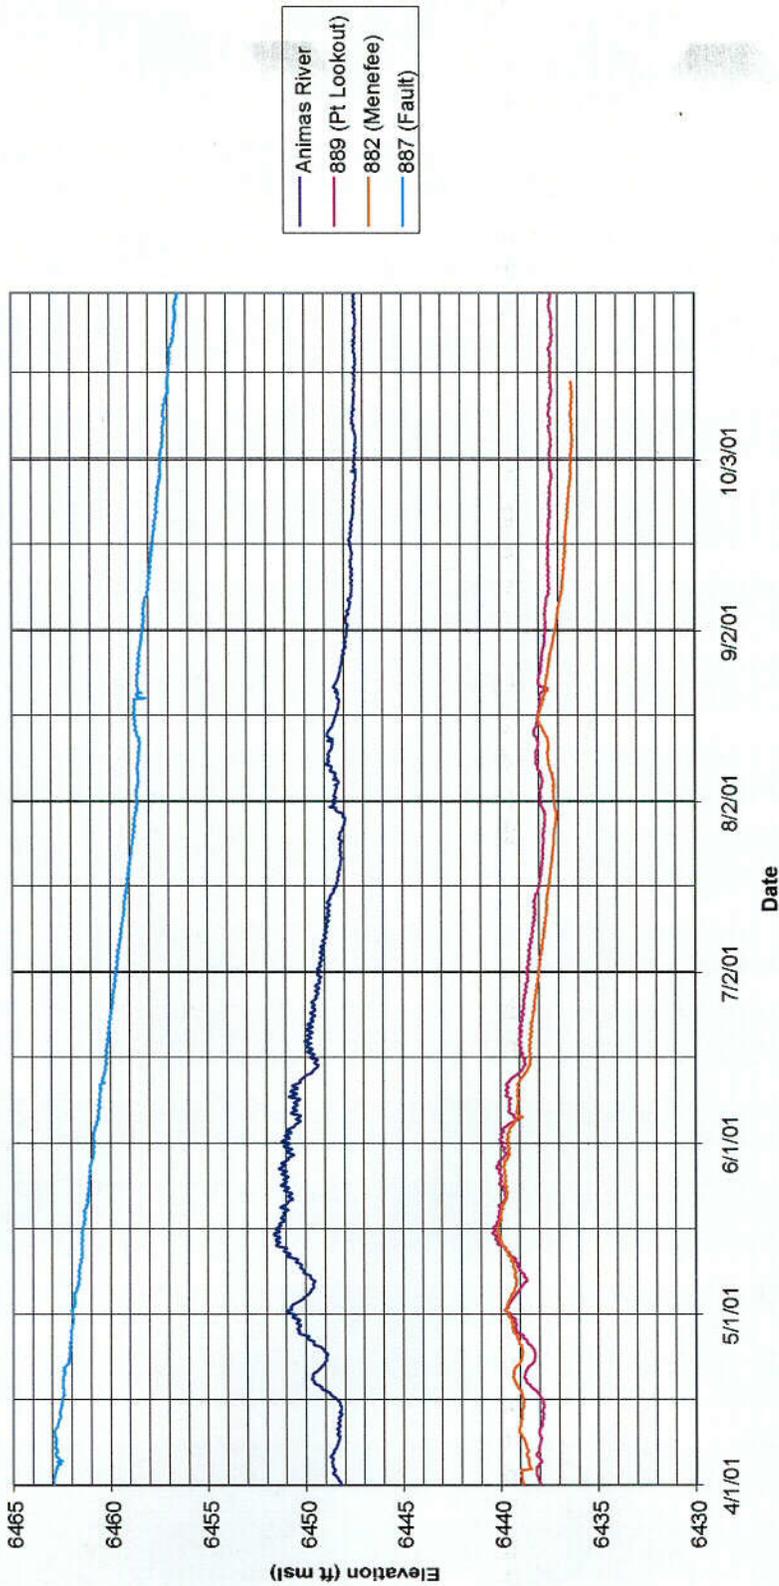
Animas River Elevation vs Groundwater Elevation

Figure 5-4. Animas River Elevation versus Ground Water Elevation

Figure 5-4 shows the comparison of the ground water fluctuations of the various aquifers at the raffinate ponds area to the Animas River. Dataloggers installed in wells 0889, 0882, and 0887 provided ground water surface elevations from wells completed in the Point Lookout Sandstone, Menefee Formation, and the Bodo Fault, respectively. The data presented for the Animas River were collected from stilling well 0906.

The data presented in Figure 5-4 suggests ground water flow in the Point Lookout Sandstone and Menefee Formation is hydraulically connected to the Animas River. The ground water fluctuation pattern provided by the well completed in the Bodo Fault zone does not match the pattern provided by the Animas River, suggesting the ground water flow system associated with the fault zone is impacted by a source other than the Animas River.

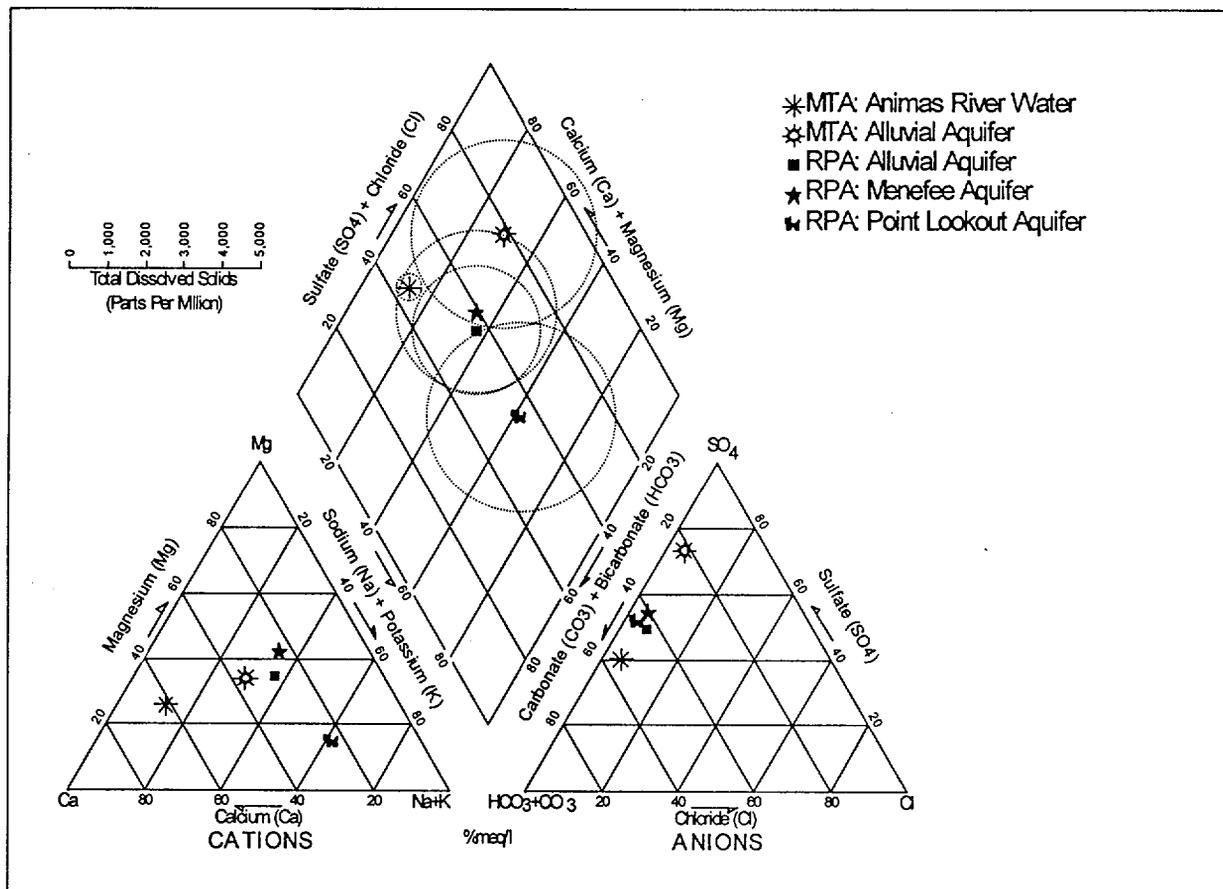
Figure 5-5. Piper Diagram for Mill Tailings Area (MTA) and Raffinate Ponds Area (RDA) Background Ground Water and Animas River Water using Mean Concentrations

The average major ion concentrations of Animas River water are plotted on the Piper diagram presented in Figure 5-5. Surface water samples were collected from locations 0506, 0515, 0652, and 0650. Surface water is a calcium-bicarbonate type with concentrations ranging from 93 to 440 mg/L. The mean pH is 7.96 and the water has a mean iron concentration of 0.0486 mg/L, which indicates the water is oxidizing. Concentrations of the following 13 analytes were less than or equal to the detection limit: ammonium, antimony, arsenic, cadmium, copper, lead, molybdenum, selenium, thallium, vanadium, lead-210, radium-228, and thorium-230 (Table 5-5).

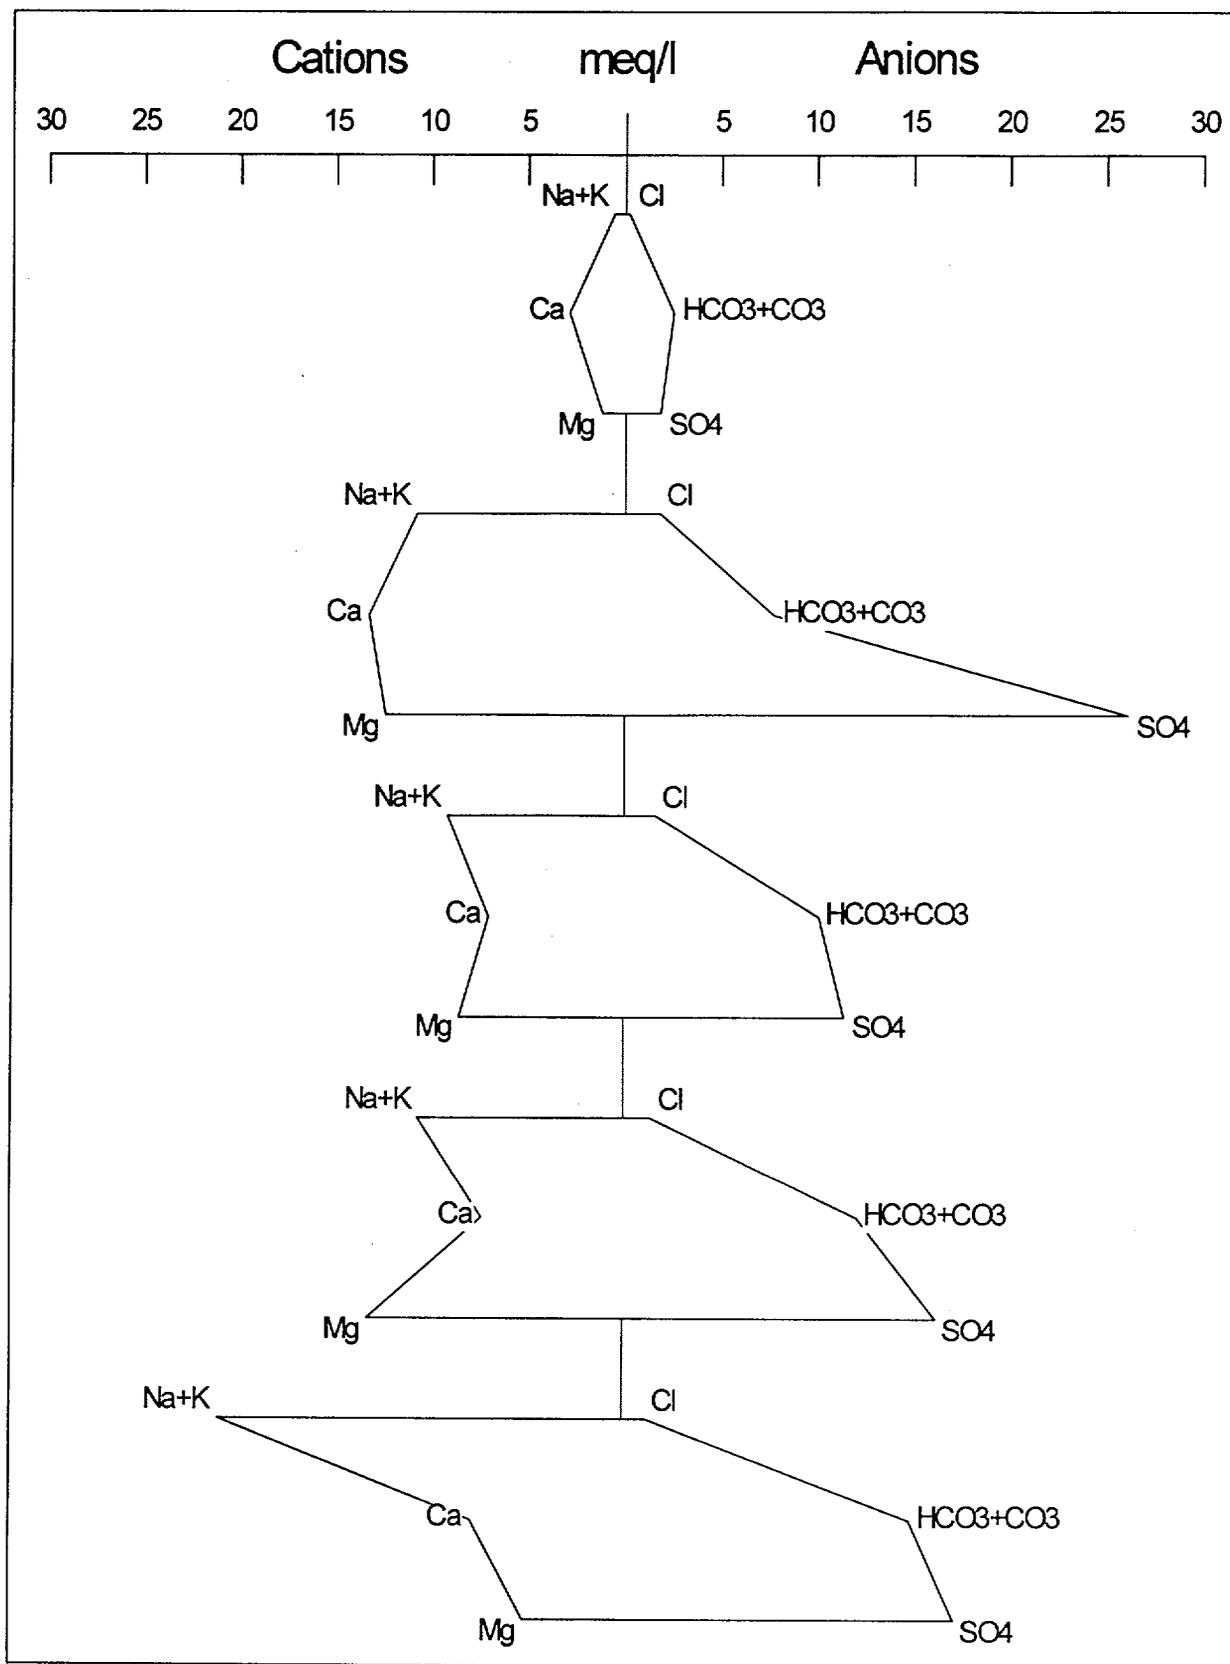
Figure 5-6. Stiff Diagram for Mill Tailings Area (MTA) and Raffinate Ponds Area (RPA) Background Ground Waters and Animas River Water using Mean Concentrations

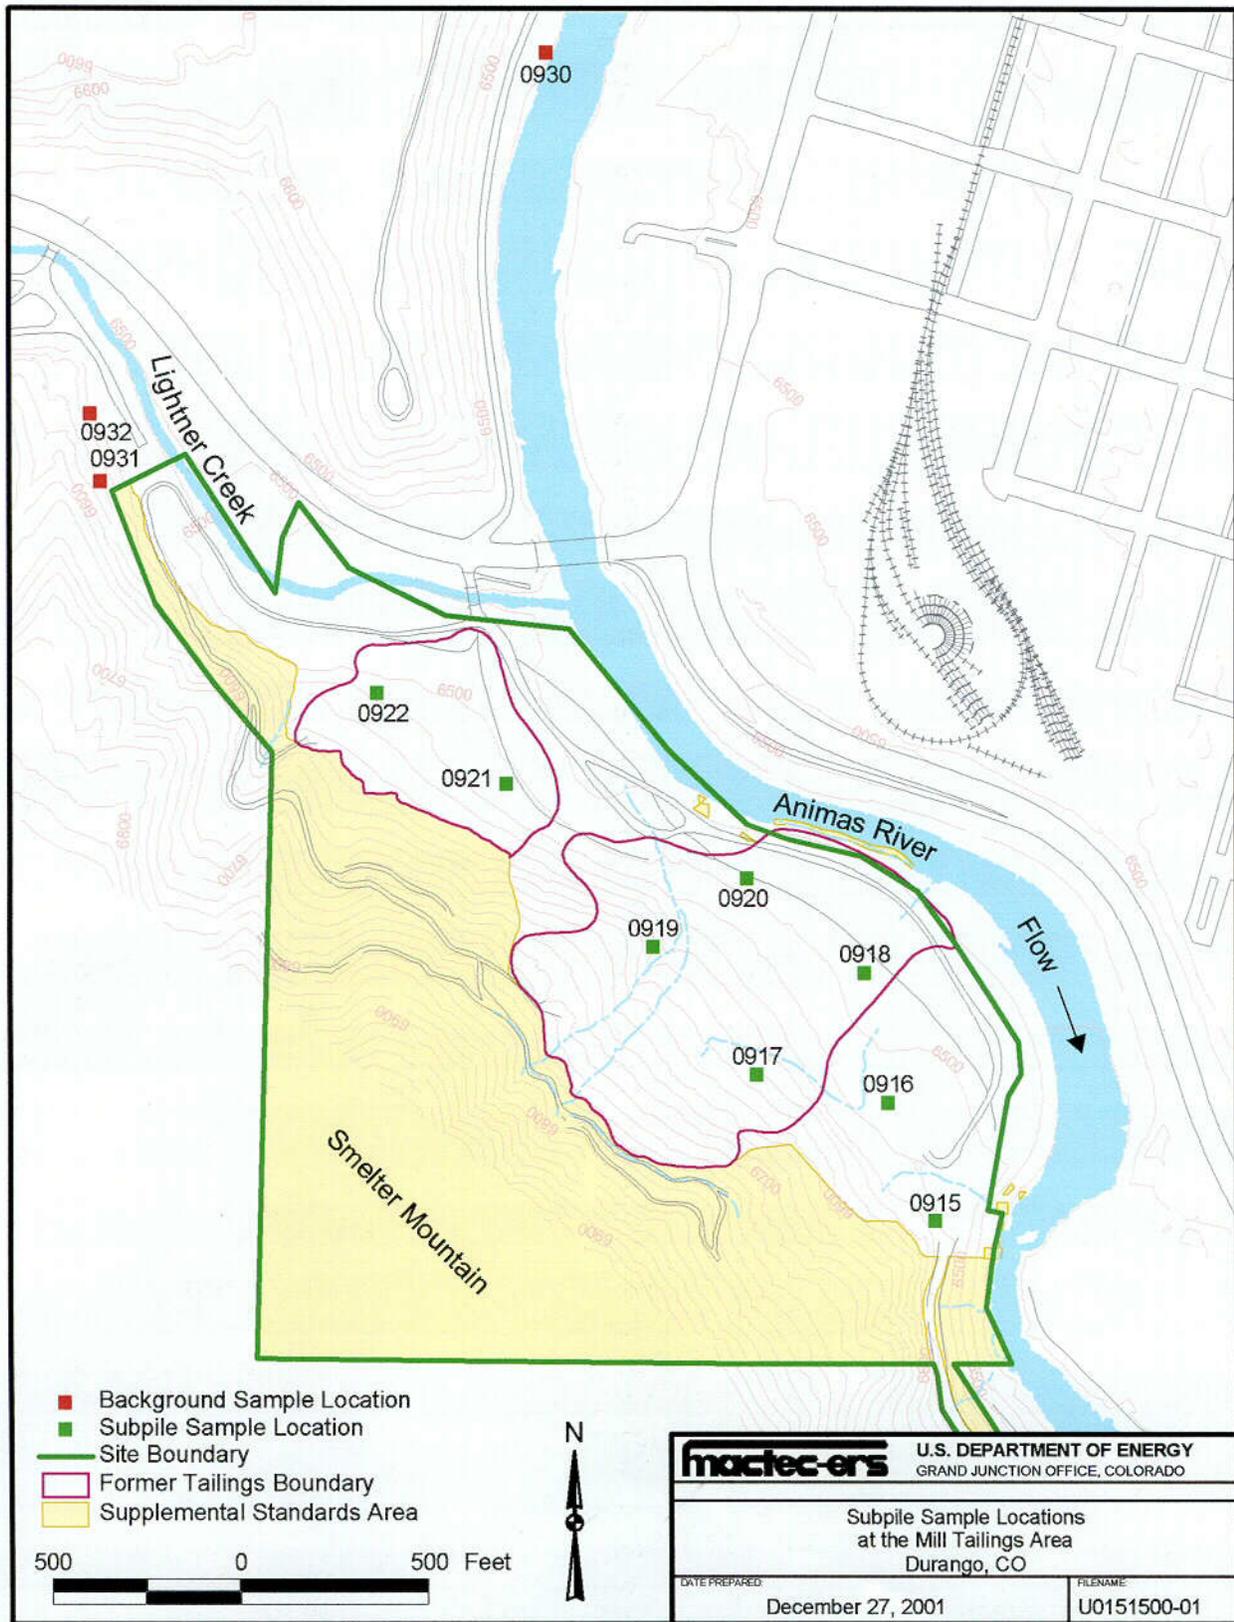
Figure 5-7. Subpile Soil Sample Locations at the Mill Tailings Area

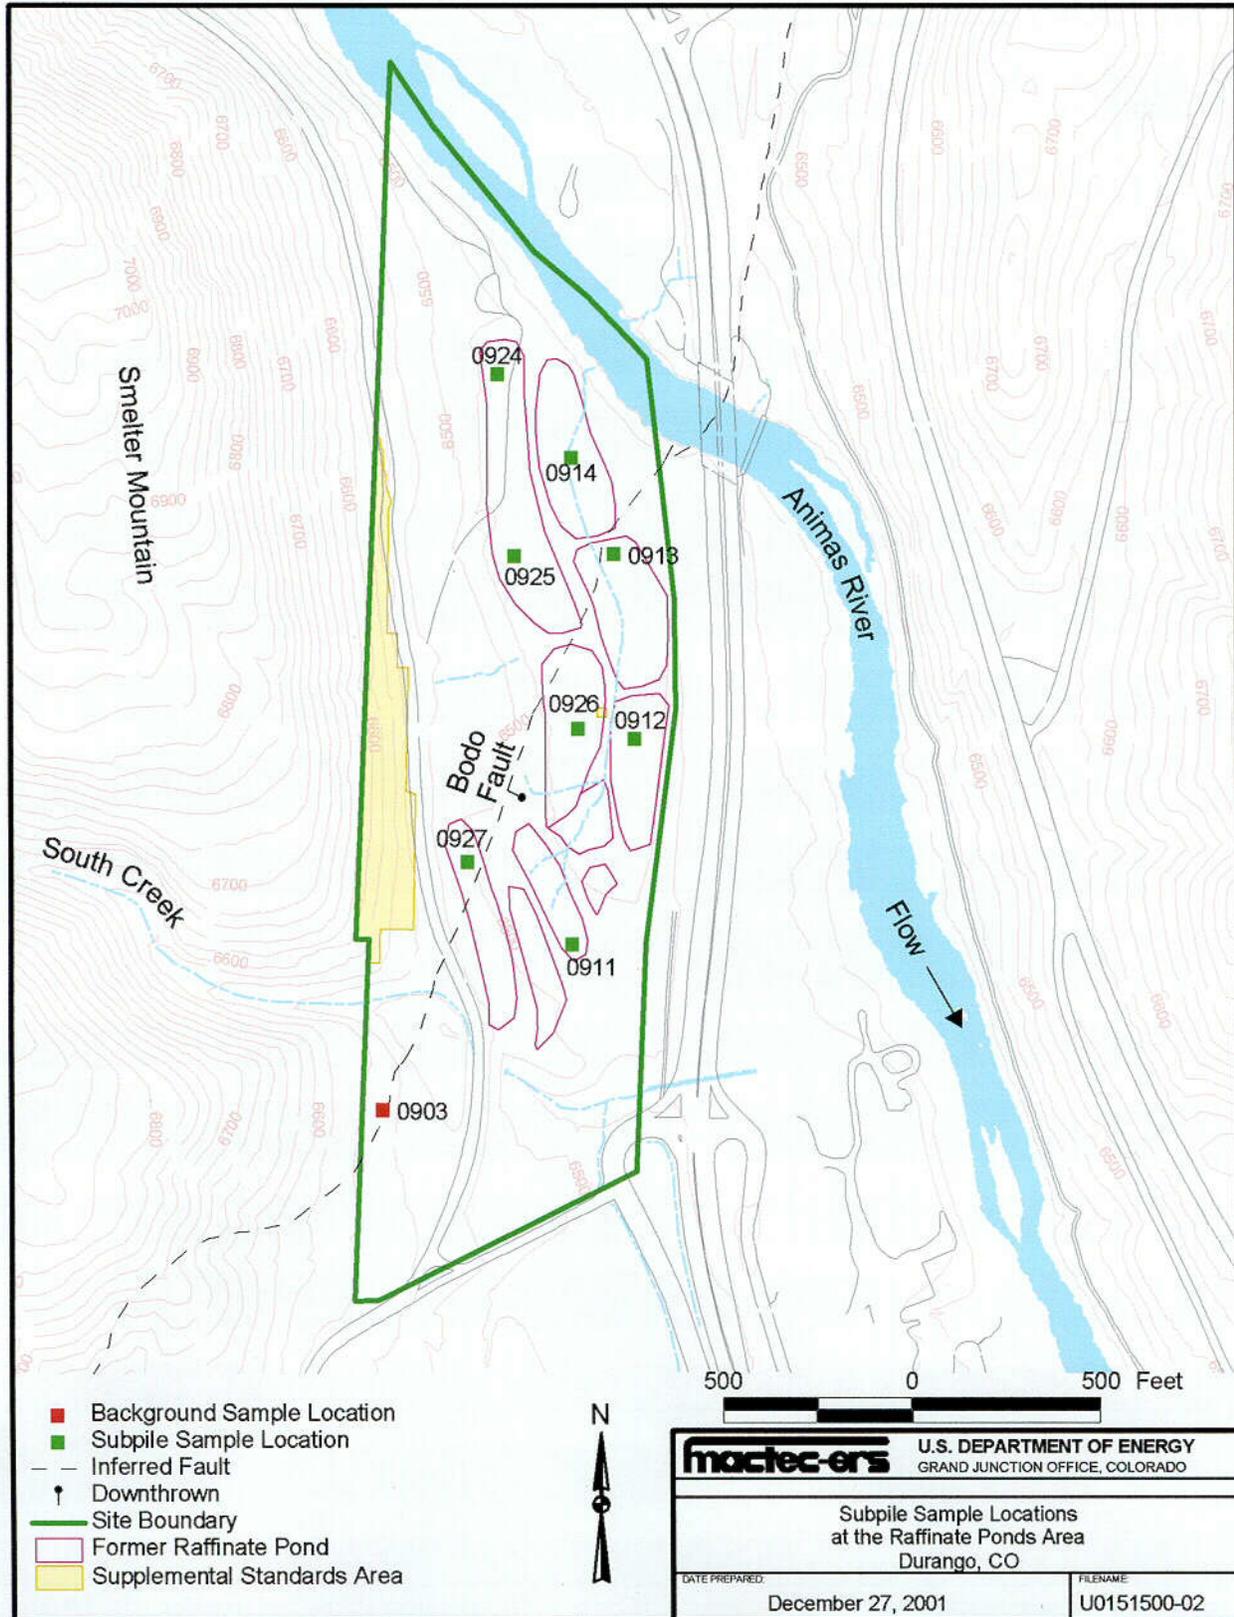
Figure 5-8. Subpile Soil Sample Locations at the Raffinate Ponds Area

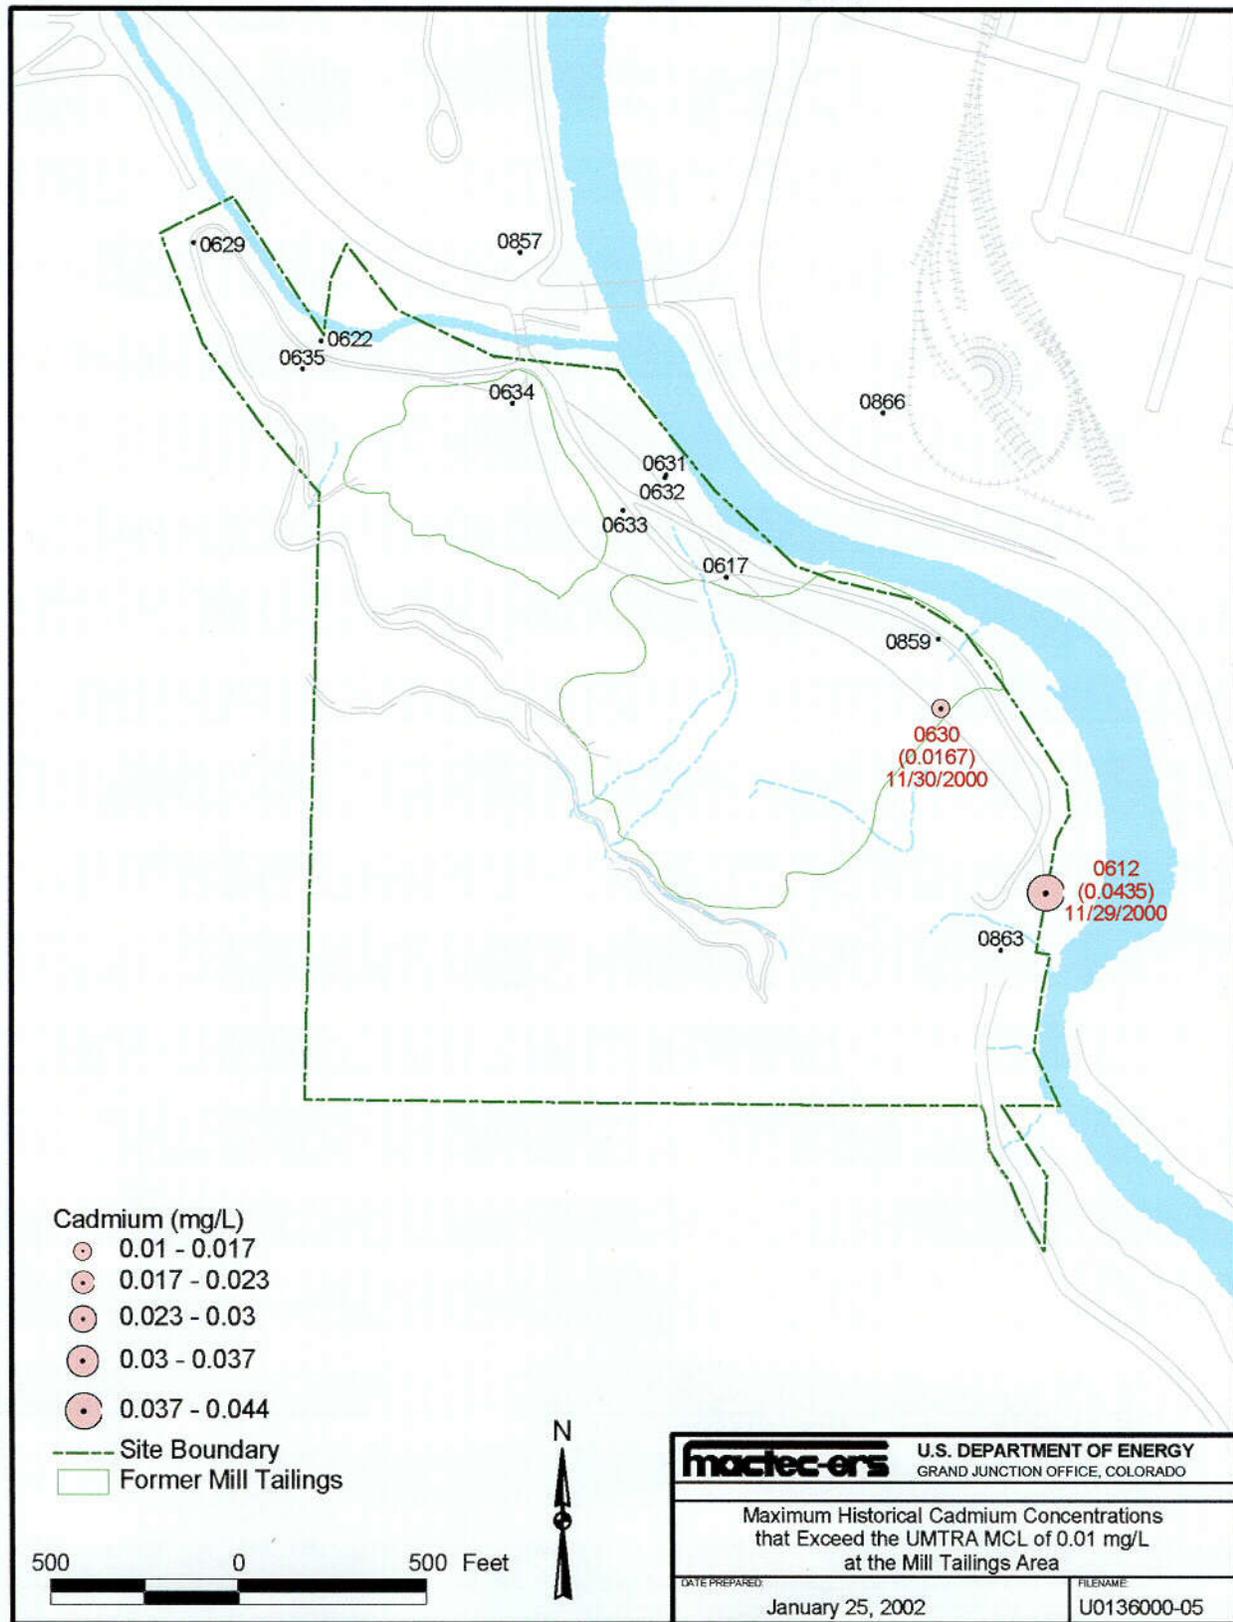
Figure 5-9. Maximum Historical Concentrations of Cadmium at the Mill Tailings Area

Cadmium concentrations in well 0612 exceeded the 0.01 mg/L MCL; the highest value was in the November 2000 sample (Figure 5–9). From 1999 through August 2000 concentrations ranged from 0.0258 to 0.0435 mg/L. The only other location where cadmium concentration has exceeded the MCL is at well 0630, where the concentration of 0.0167 mg/L, was detected in a sample from the November 2000 sampling. The lead concentrations in all samples from June 1999 through August 2001 were below the 0.05 mg/L MCL and were below the detection limit (Figure 5–10). Concentrations of manganese have exceeded the human health risk-based level of 1.7 mg/L seven times at 0612 and two times at location 0630 from June 1999 through August 2001 (Figure 5–11). The 0.1 mg/L MCL for molybdenum was exceeded five times at well location 0612 (Figure 5–12). Molybdenum concentrations ranged from 0.116 to 0.150 mg/L. Selenium concentrations exceeded the MCL at well locations 0612, 0617, 0622, 0630, 0633, 0635, 0857, and 0866, which is the background well (Figure 5–13). Uranium concentrations exceed the MCL of 0.044 mg/L at seven locations: 0612, 0617, 0630, 0631, 0633, 0634, and 0859 (Figure 5–14).

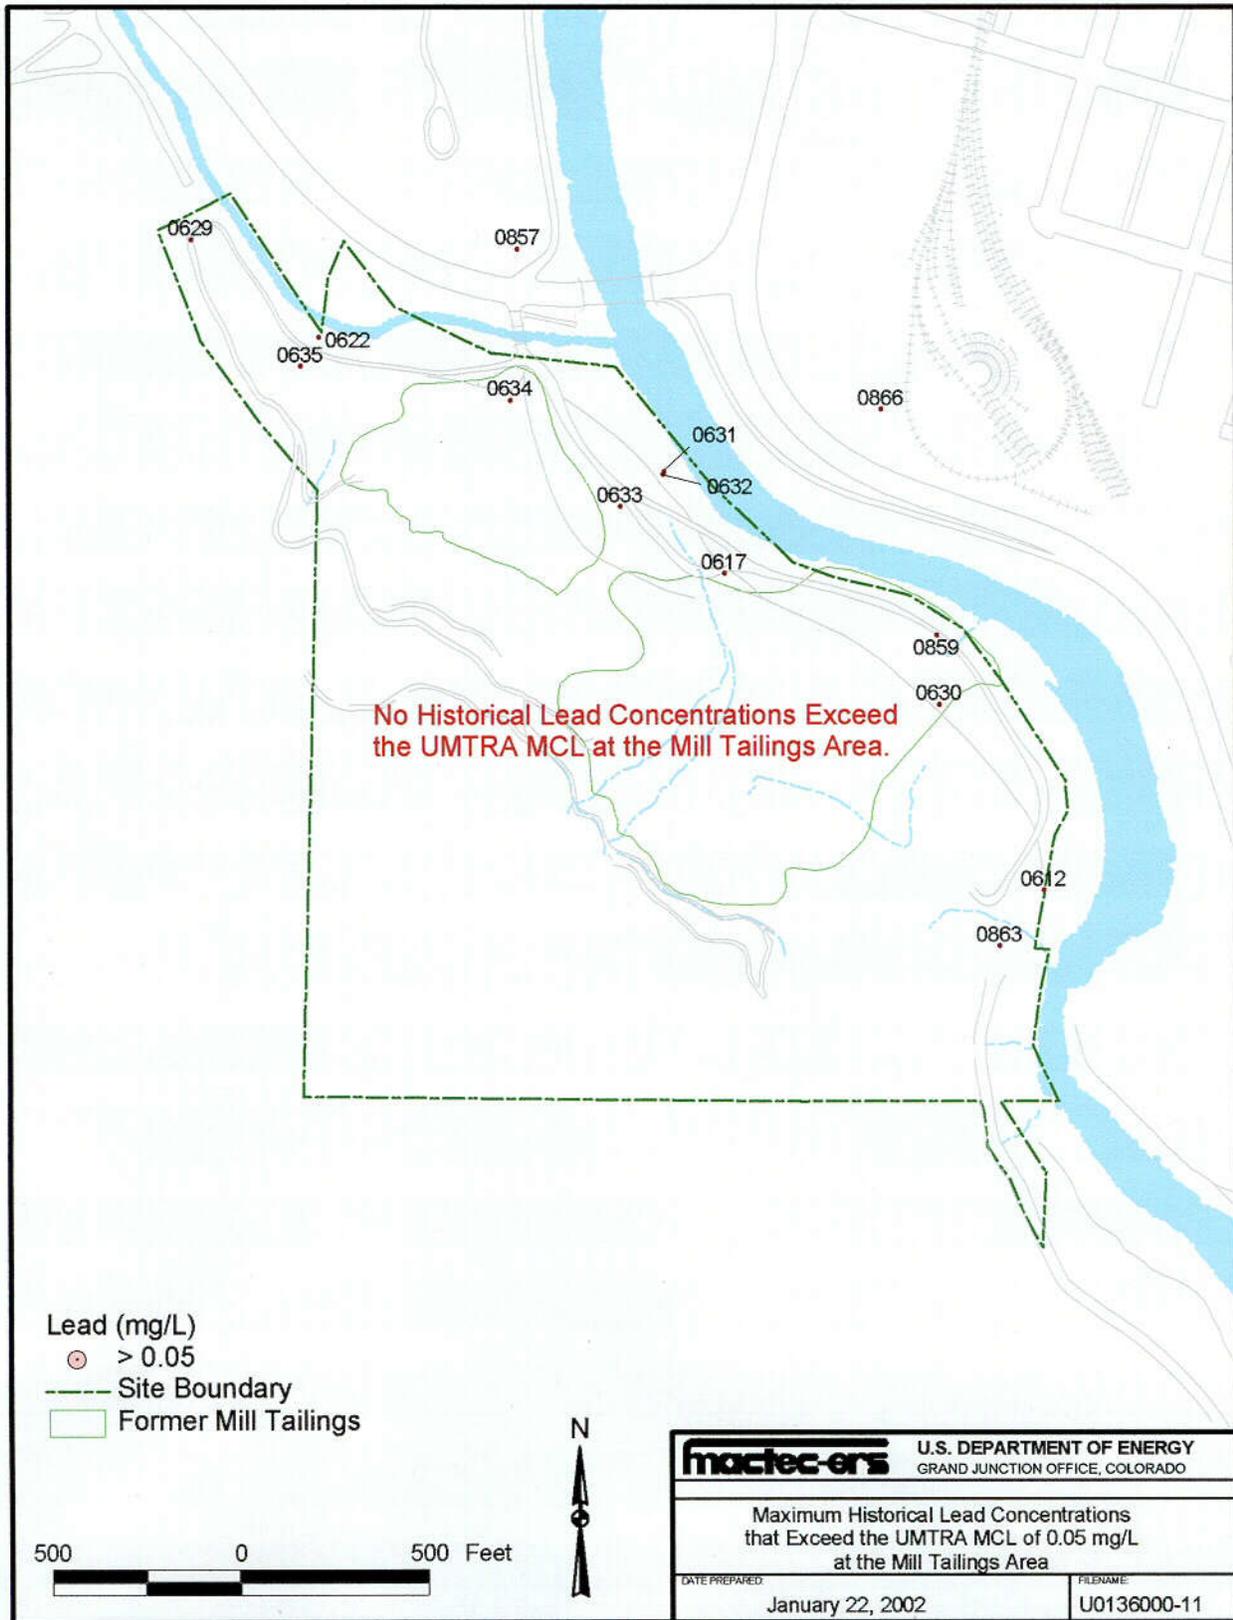
Figure 5-10. Maximum Historical Concentrations of Lead at the Mill Tailings Area

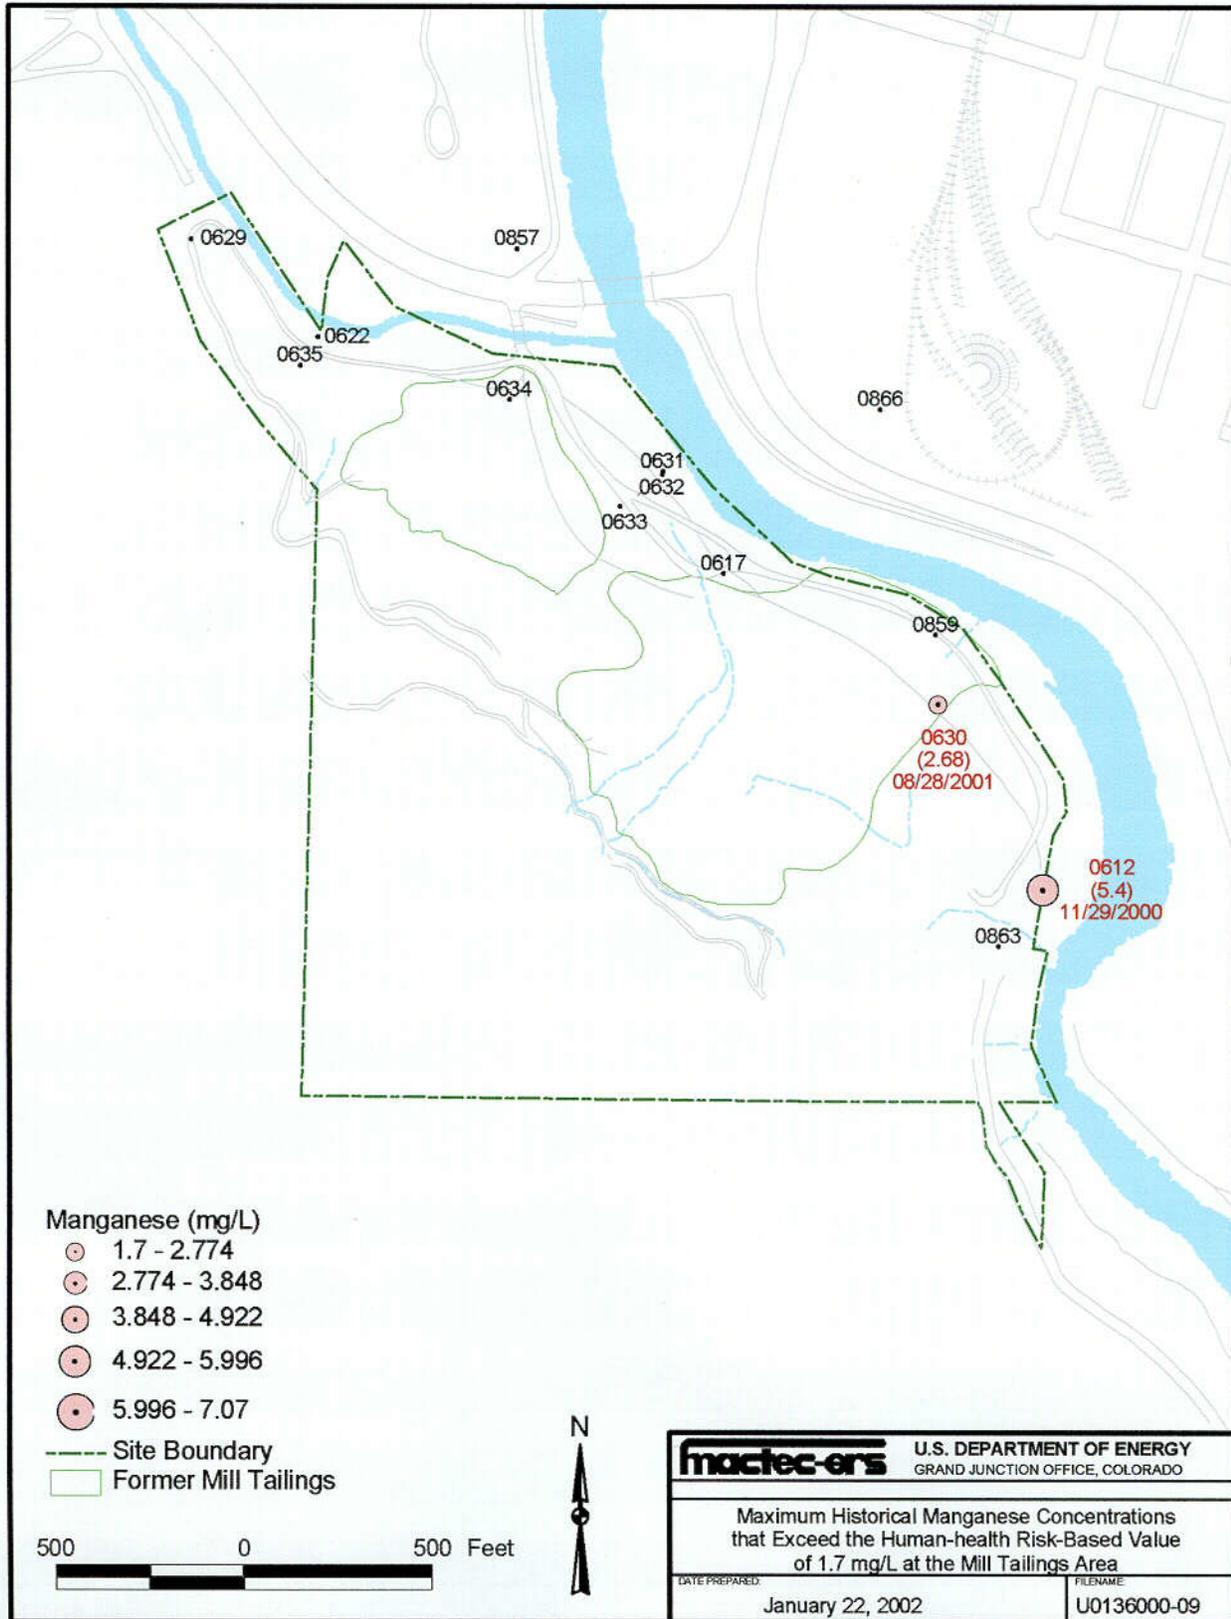
Figure 5-11. Maximum Historical Concentrations of Manganese at the Mill Tailings Area
