Site Observational Work Plan for the Durango, Colorado, UMTRA Project Site

January 2002

Prepared by the
U.S. Department of Energy
Grand Junction Office

Project Number UGW-511-0006-10-000
Document Number U0143200

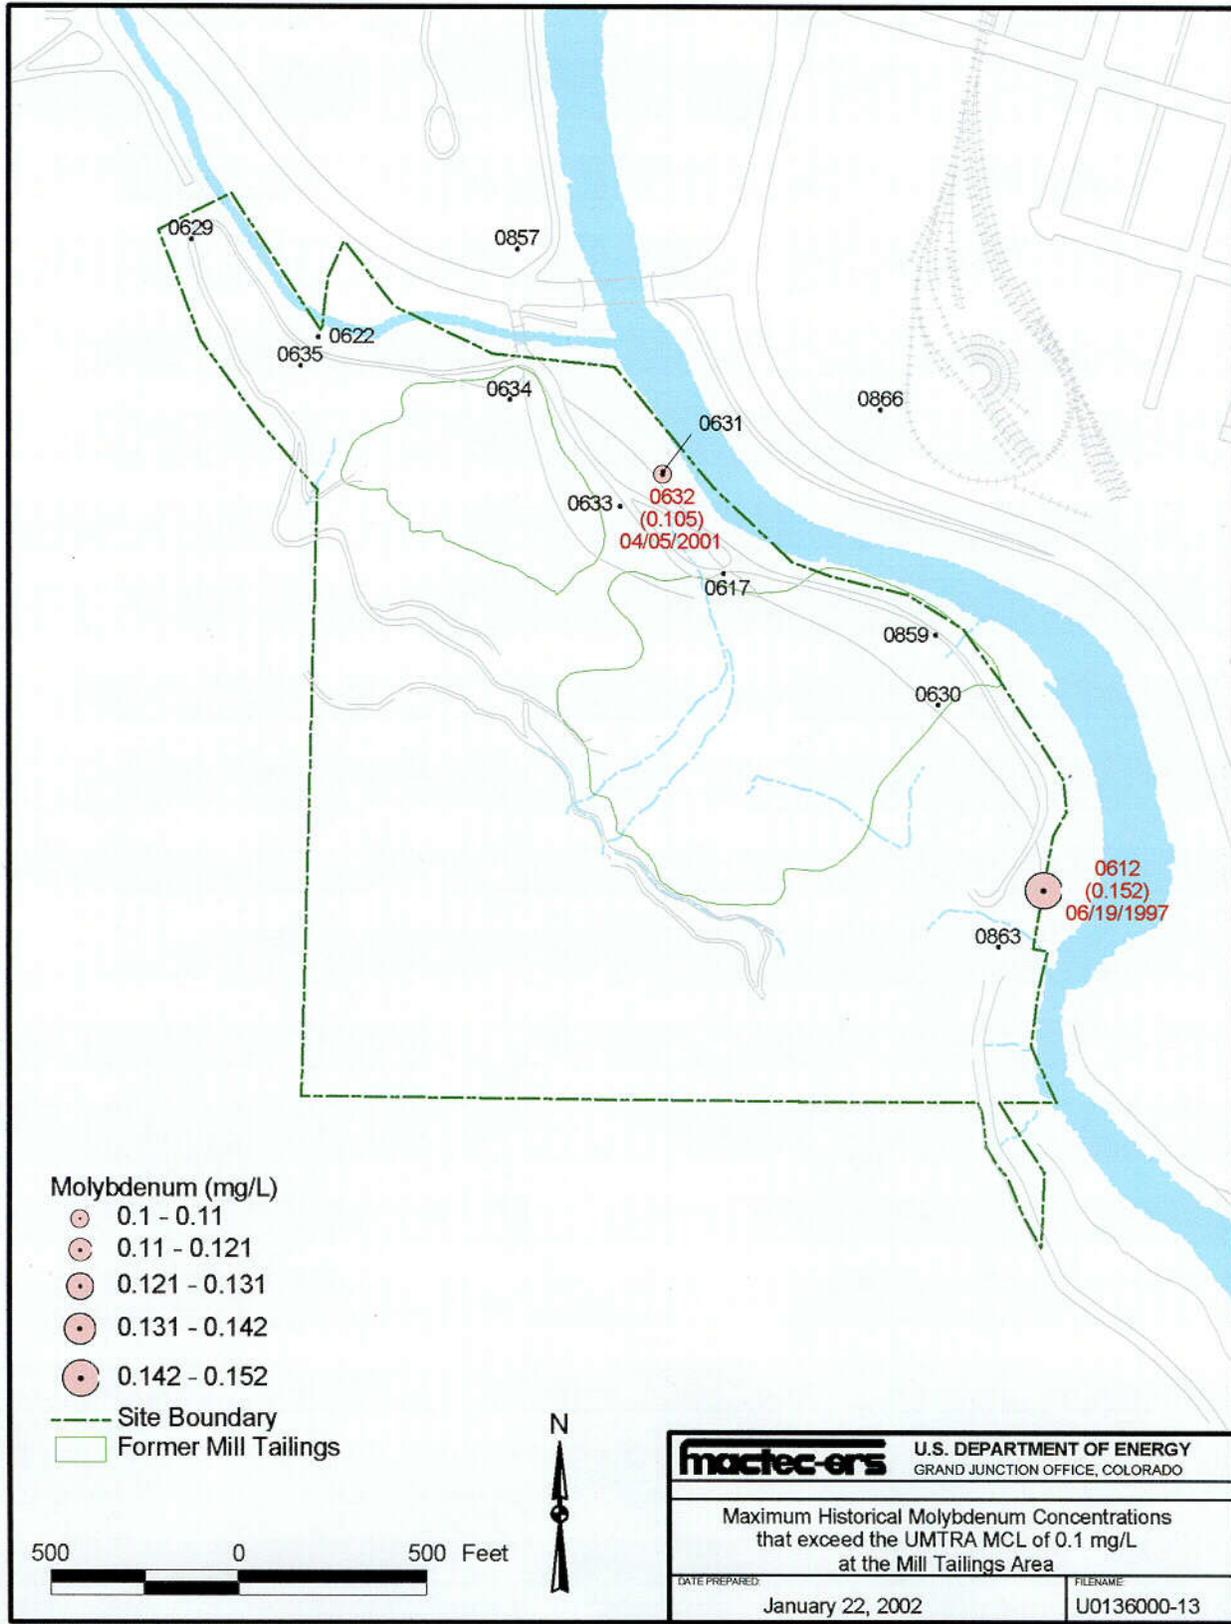
Figure 5-12. Maximum Historical Concentrations of Molybdenum at the Mill Tailings Area

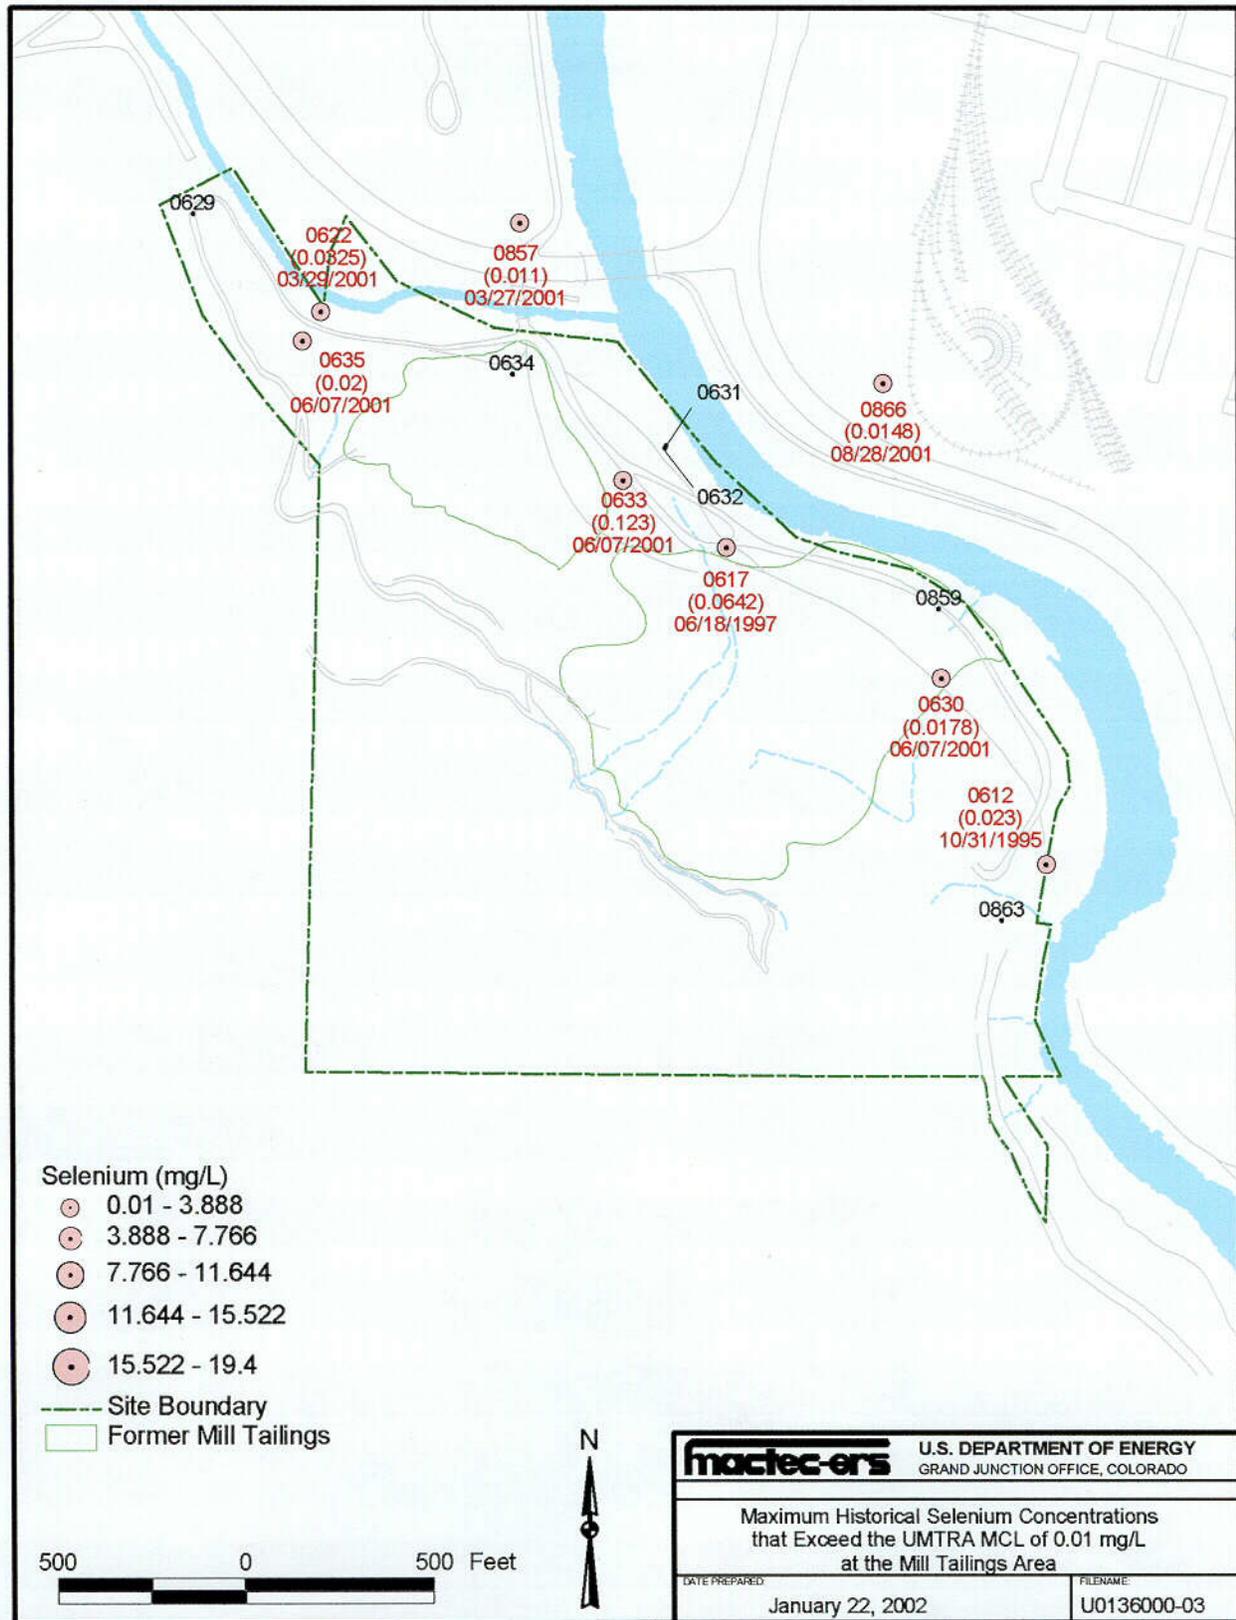
Figure 5-13. Maximum Historical Concentrations of Selenium at the Mill Tailings Area

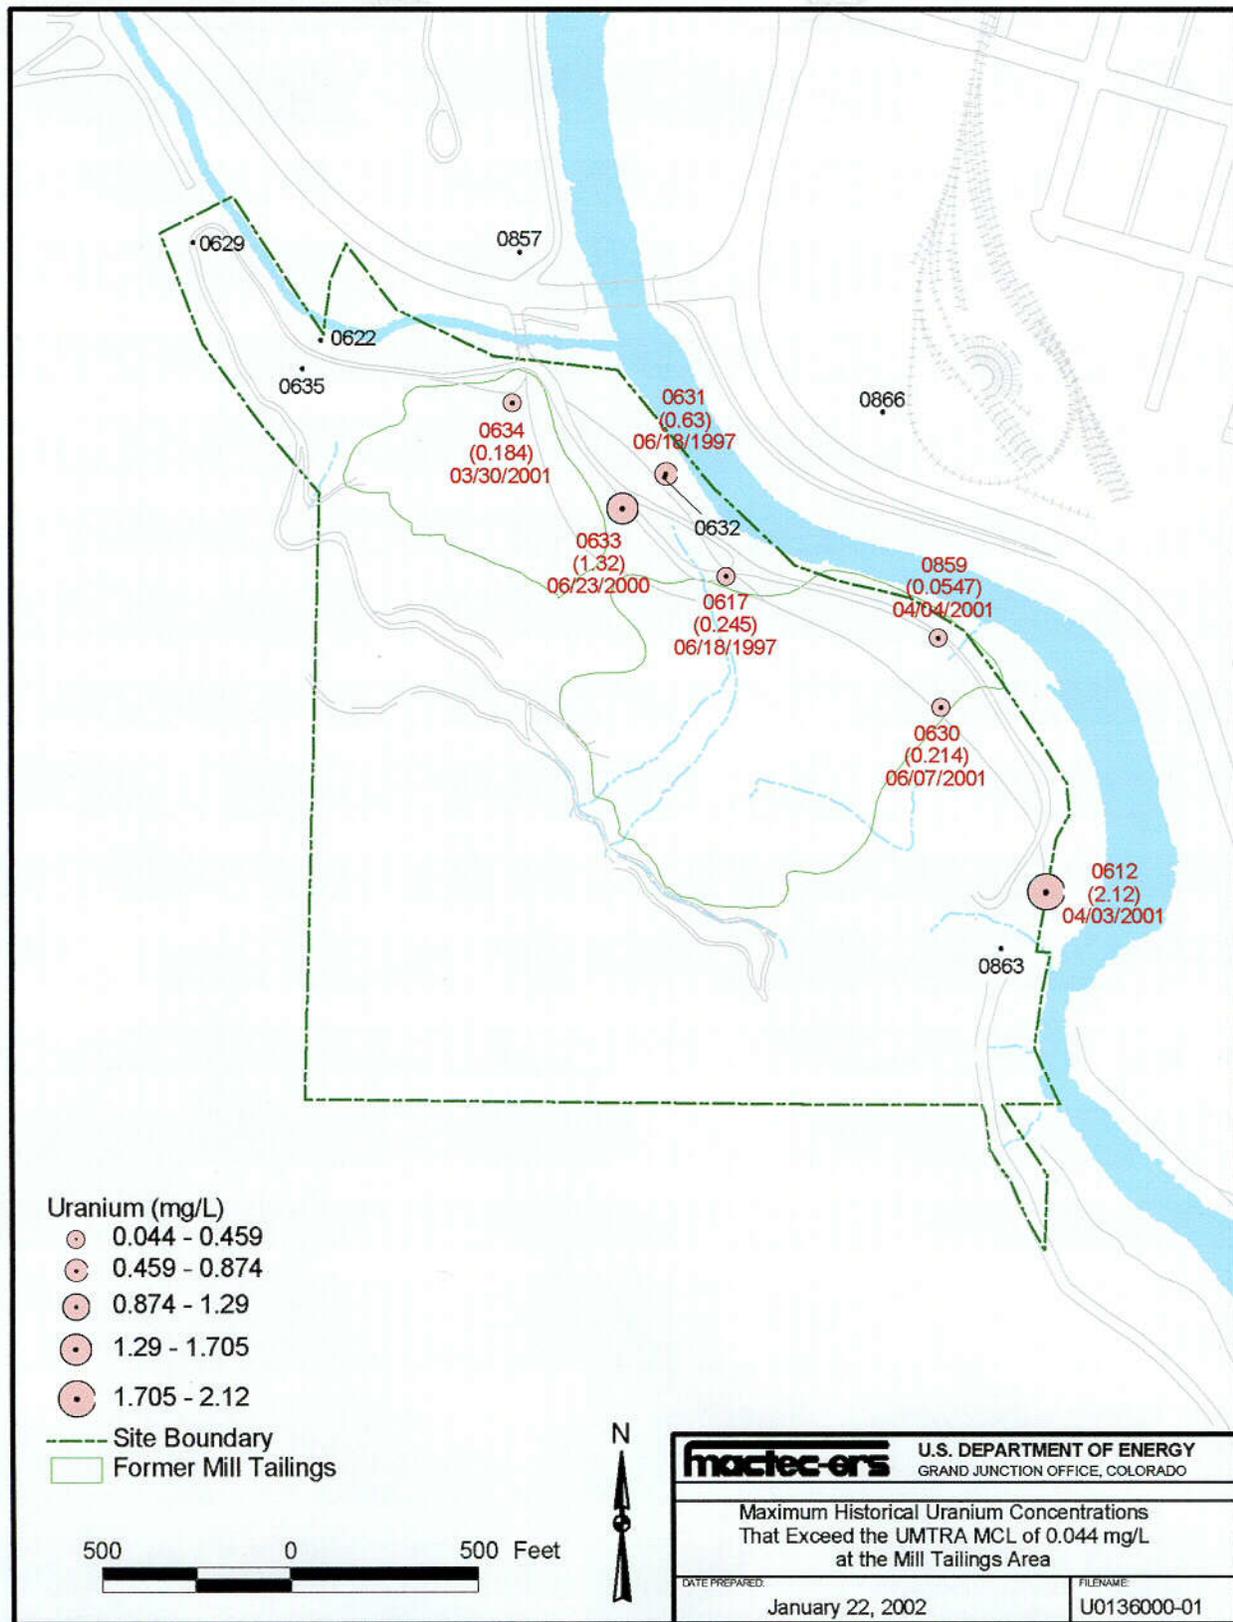
Figure 5-14. Maximum Historical Concentrations of Uranium at the Mill Tailings Area

Cadmium concentrations in well 0612 exceeded the 0.01 mg/L MCL; the highest value was in the November 2000 sample (Figure 5–9). From 1999 through August 2000 concentrations ranged from 0.0258 to 0.0435 mg/L. The only other location where cadmium concentration has exceeded the MCL is at well 0630, where the concentration of 0.0167 mg/L, was detected in a sample from the November 2000 sampling. The lead concentrations in all samples from June 1999 through August 2001 were below the 0.05 mg/L MCL and were below the detection limit (Figure 5–10). Concentrations of manganese have exceeded the human health risk-based level of 1.7 mg/L seven times at 0612 and two times at location 0630 from June 1999 through August 2001 (Figure 5–11). The 0.1 mg/L MCL for molybdenum was exceeded five times at well location 0612 (Figure 5–12). Molybdenum concentrations ranged from 0.116 to 0.150 mg/L. Selenium concentrations exceeded the MCL at well locations 0612, 0617, 0622, 0630, 0633, 0635, 0857, and 0866, which is the background well (Figure 5–13). Uranium concentrations exceed the MCL of 0.044 mg/L at seven locations: 0612, 0617, 0630, 0631, 0633, 0634, and 0859 (Figure 5–14).

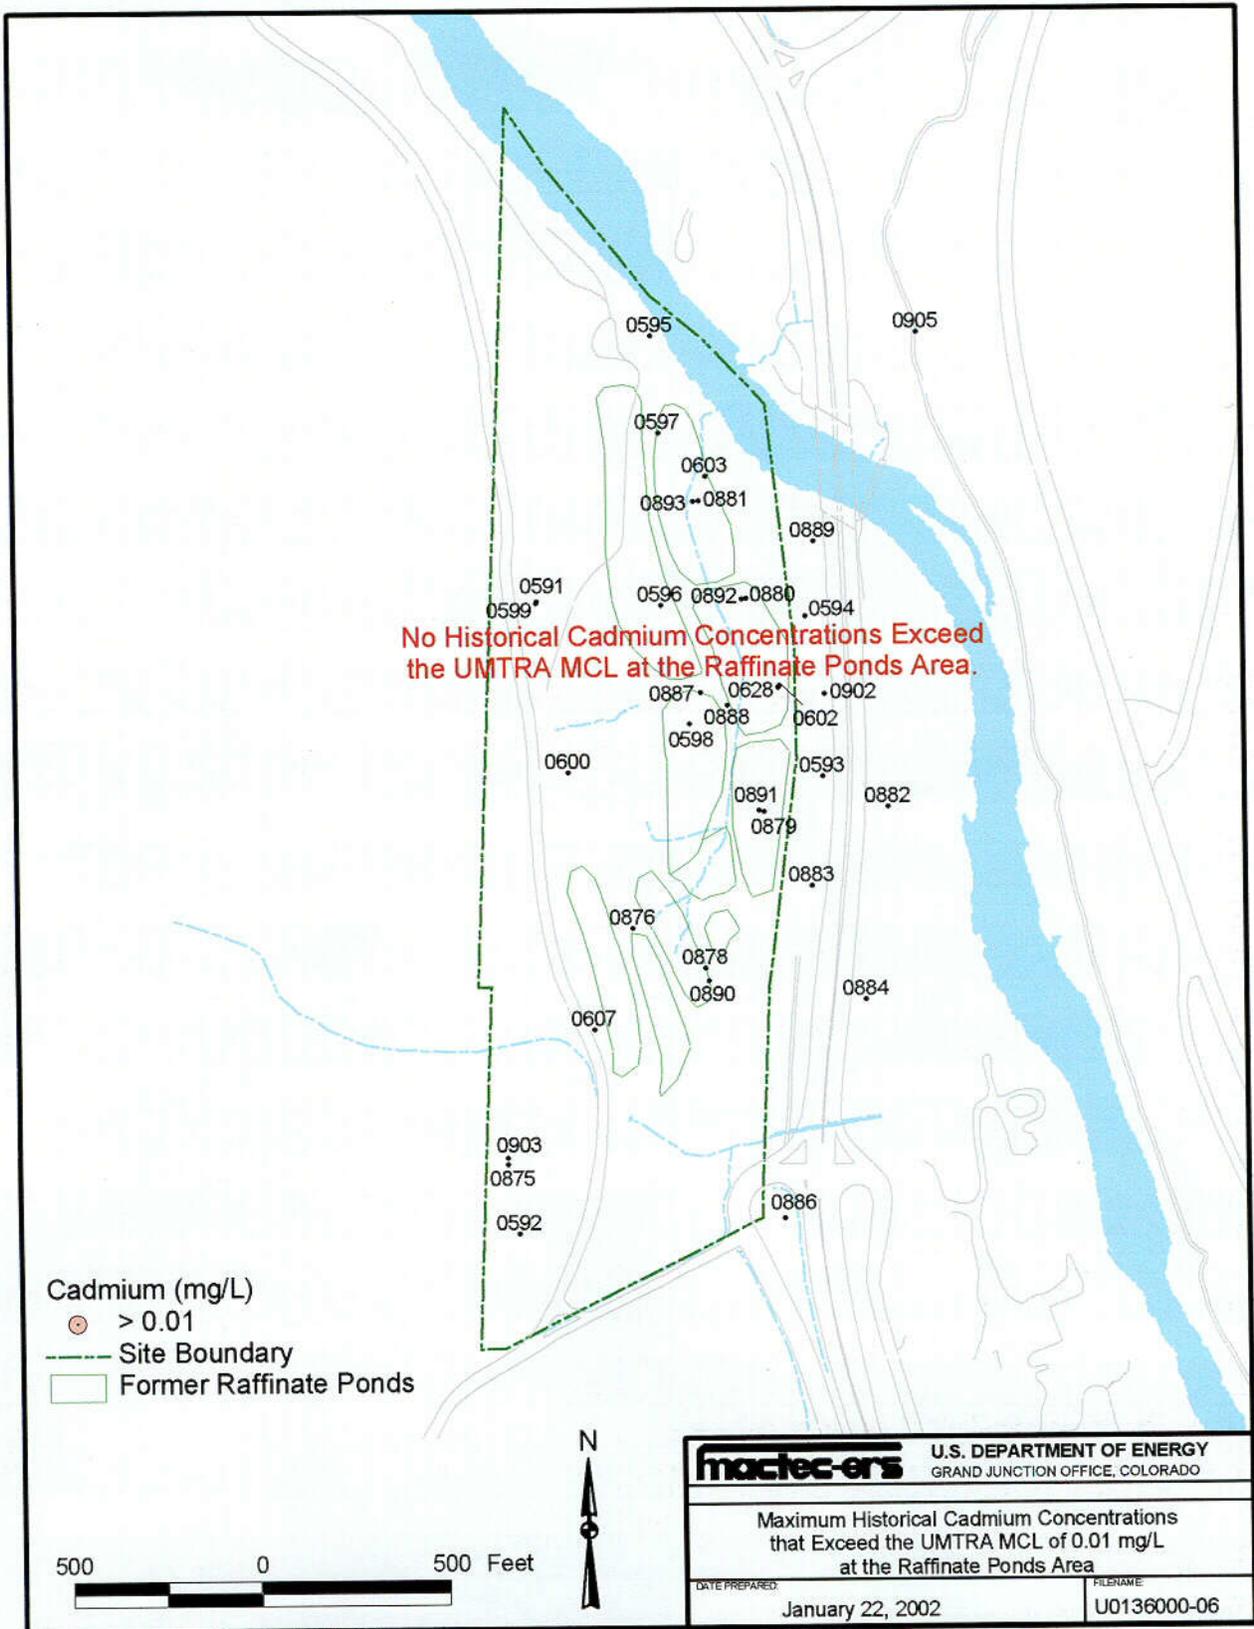
Figure 5-15. Maximum Historical Concentrations of Cadmium at the Raffinate Ponds Area

No sample from any well has exceeded the MCL for cadmium (Figure 5-15) or lead (Figure 5-16). Manganese concentrations have exceeded the human health risk-based levels at six wells: 0593, 0598, 0628, 0879, 0880, and 0882 (Figure 5-17). The molybdenum MCL was exceeded in December 2000 at well 0905 (Figure 5-18). Selenium concentrations exceeded the MCL at 10 wells in 2001: 0594, 0596, 0598, 0599, 0600, 0607, 0628, 0879, 0880, and 0884 (Figure 5-19). Uranium concentrations have exceeded the MCL at six wells: 0594, 0598, 0628, 0879, 0880, and 0884 (Figure 5-20).

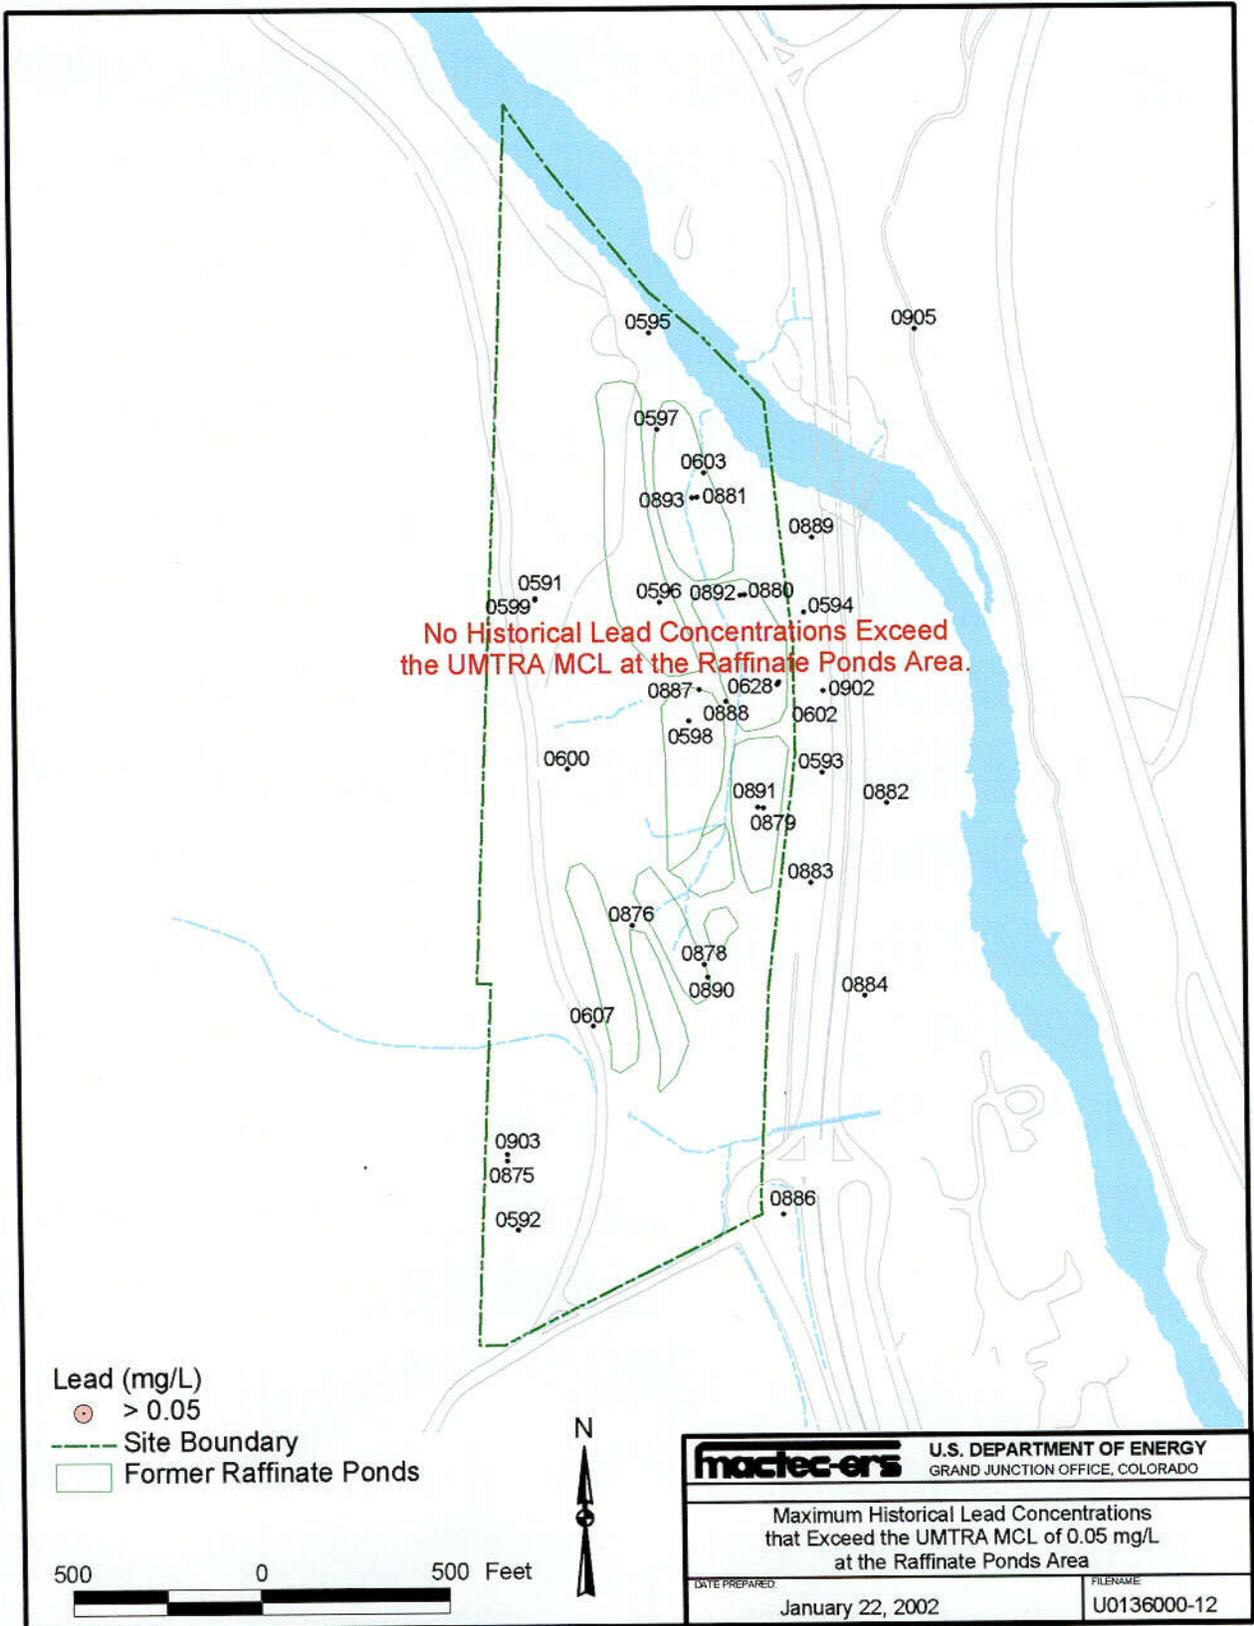
Figure 5-16. Maximum Historical Concentrations of Lead at the Raffinate Ponds Area

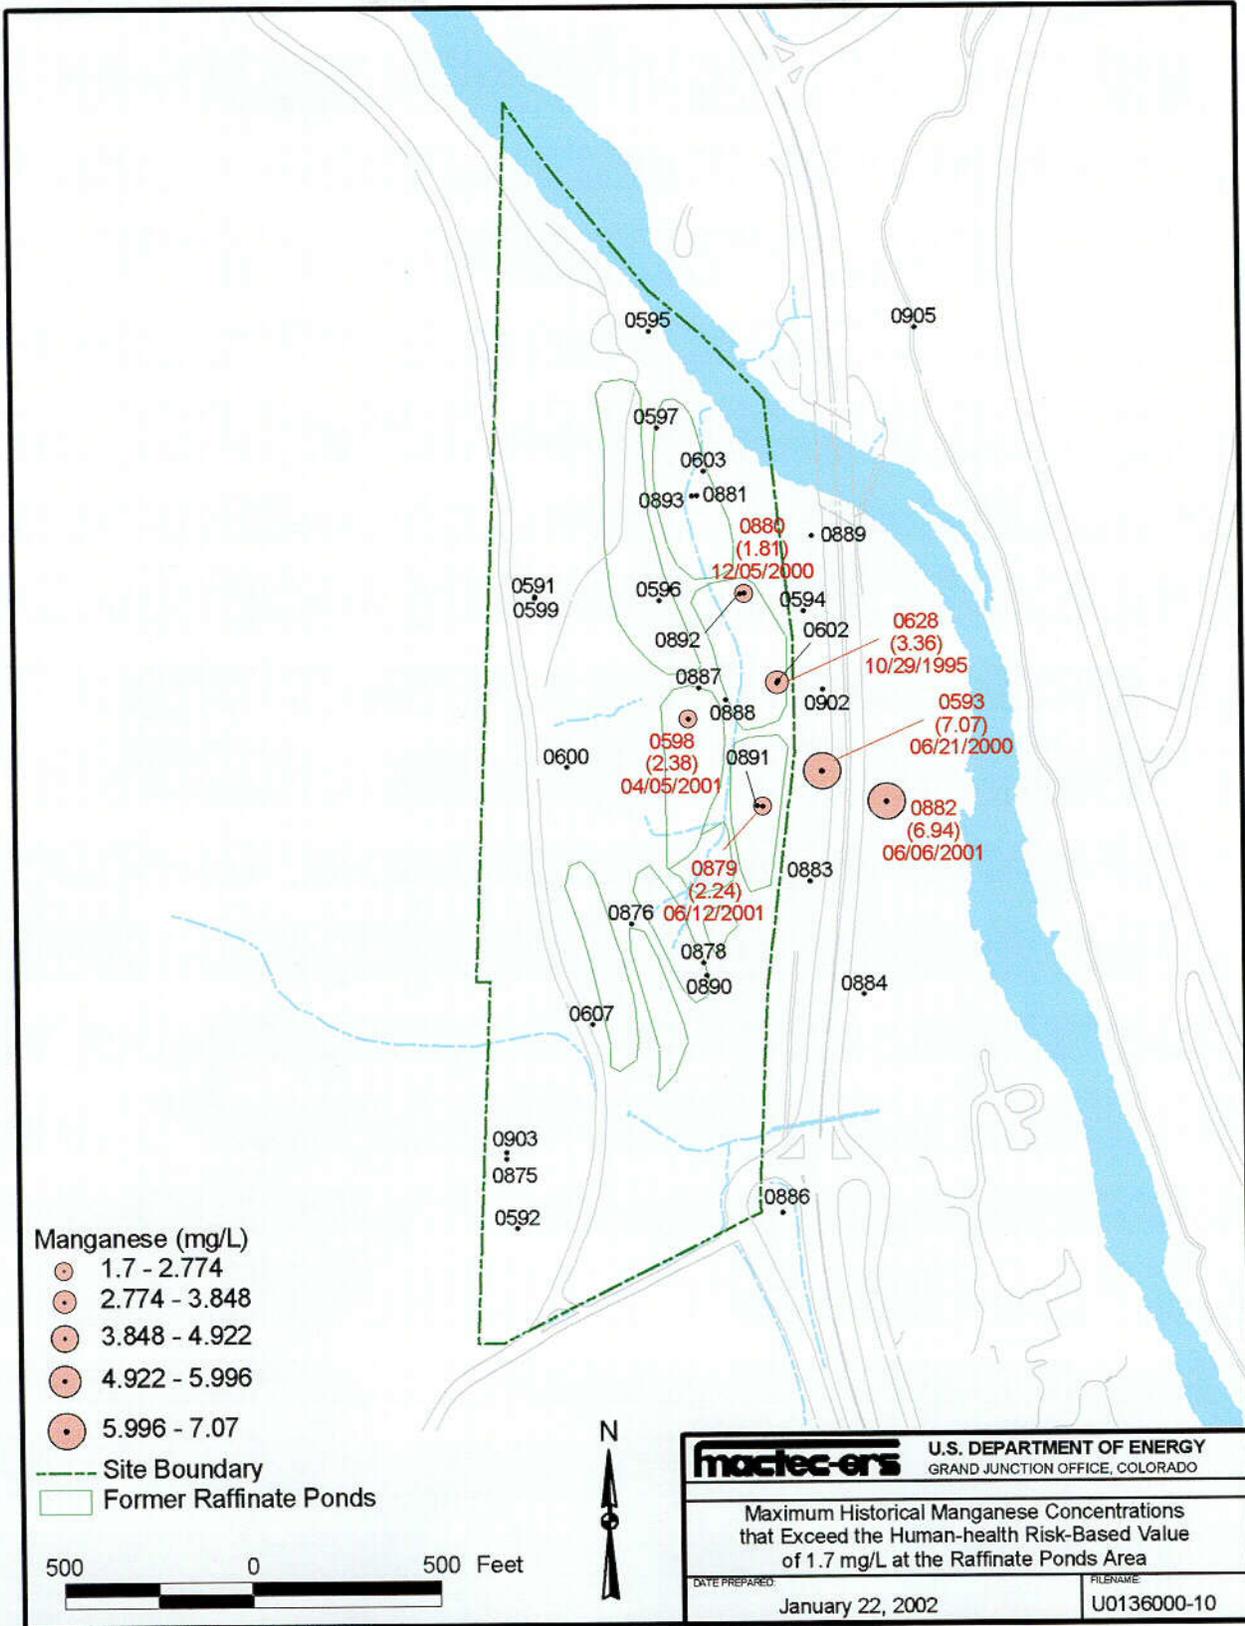
Figure 5-17. Maximum Historical Concentrations of Manganese at the Raffinate Ponds Area

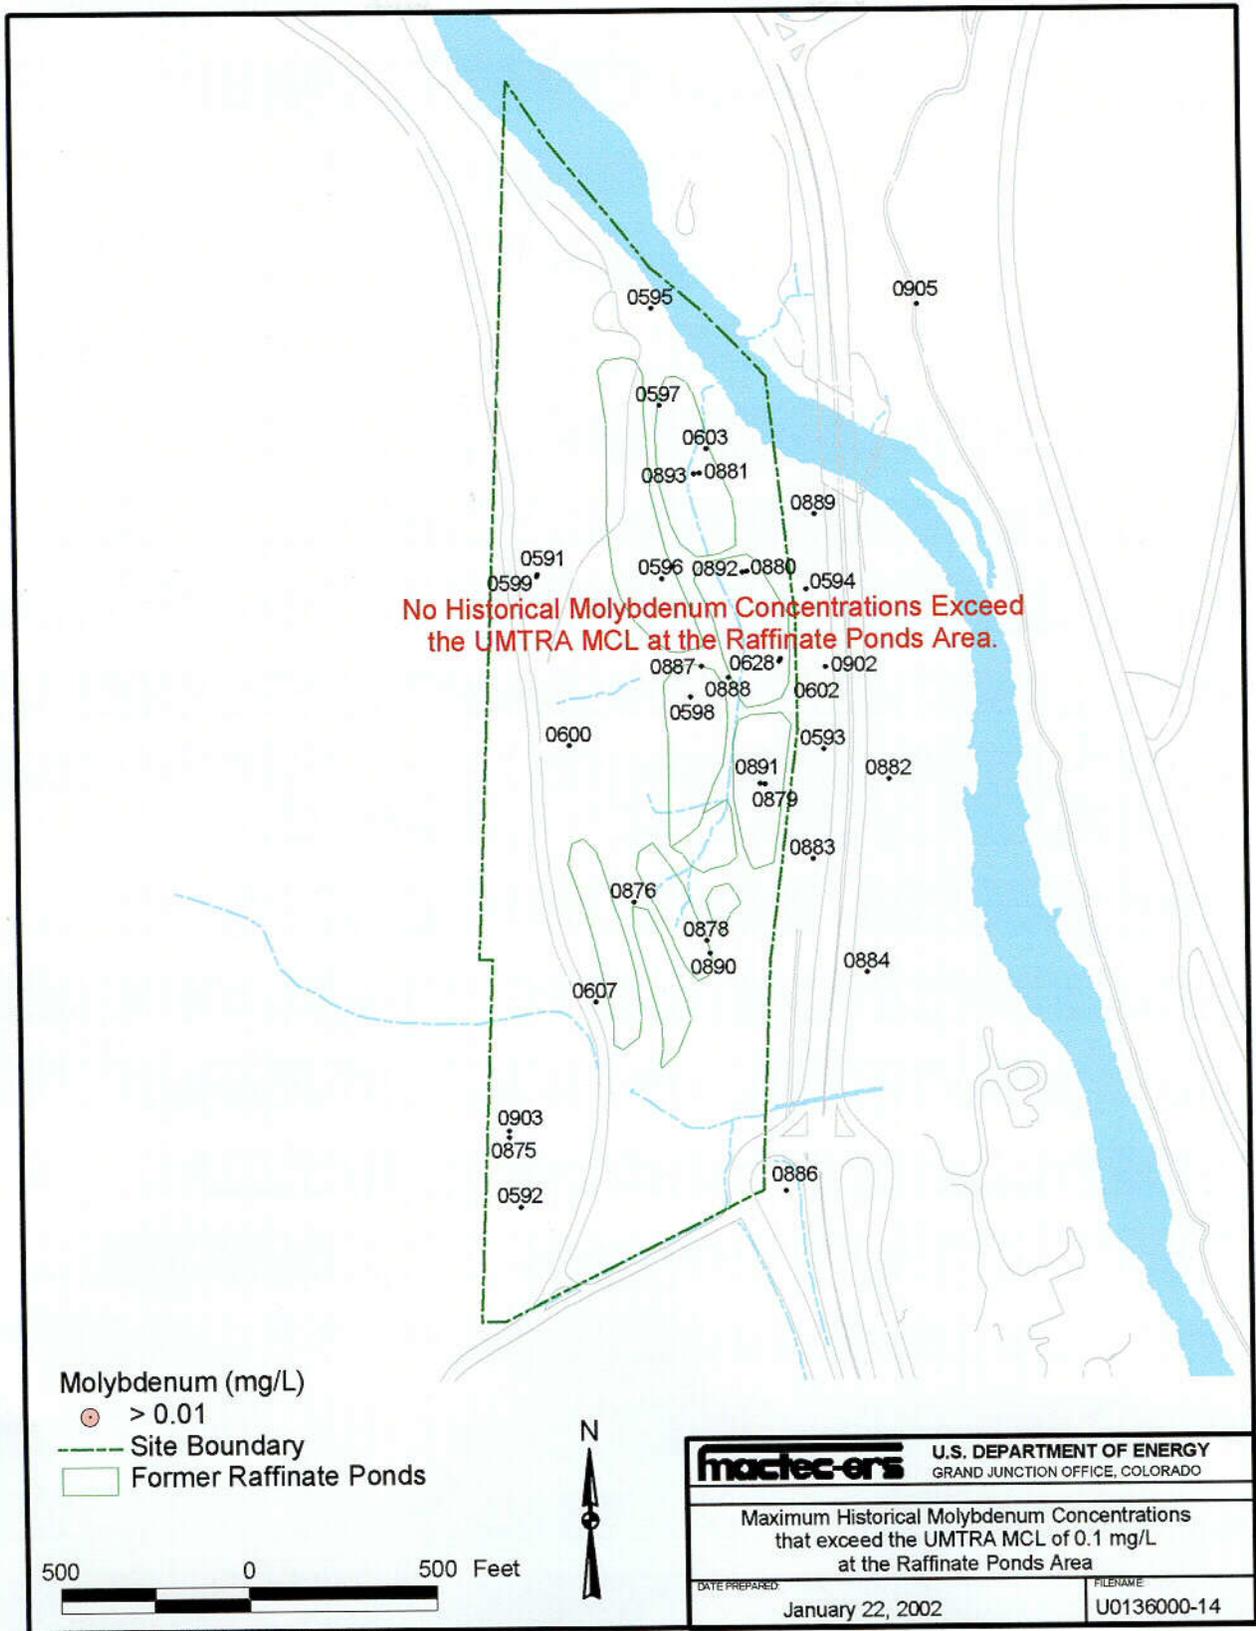
Figure 5-18. Maximum Historical Concentrations of Molybdenum at the Raffinate Ponds Area

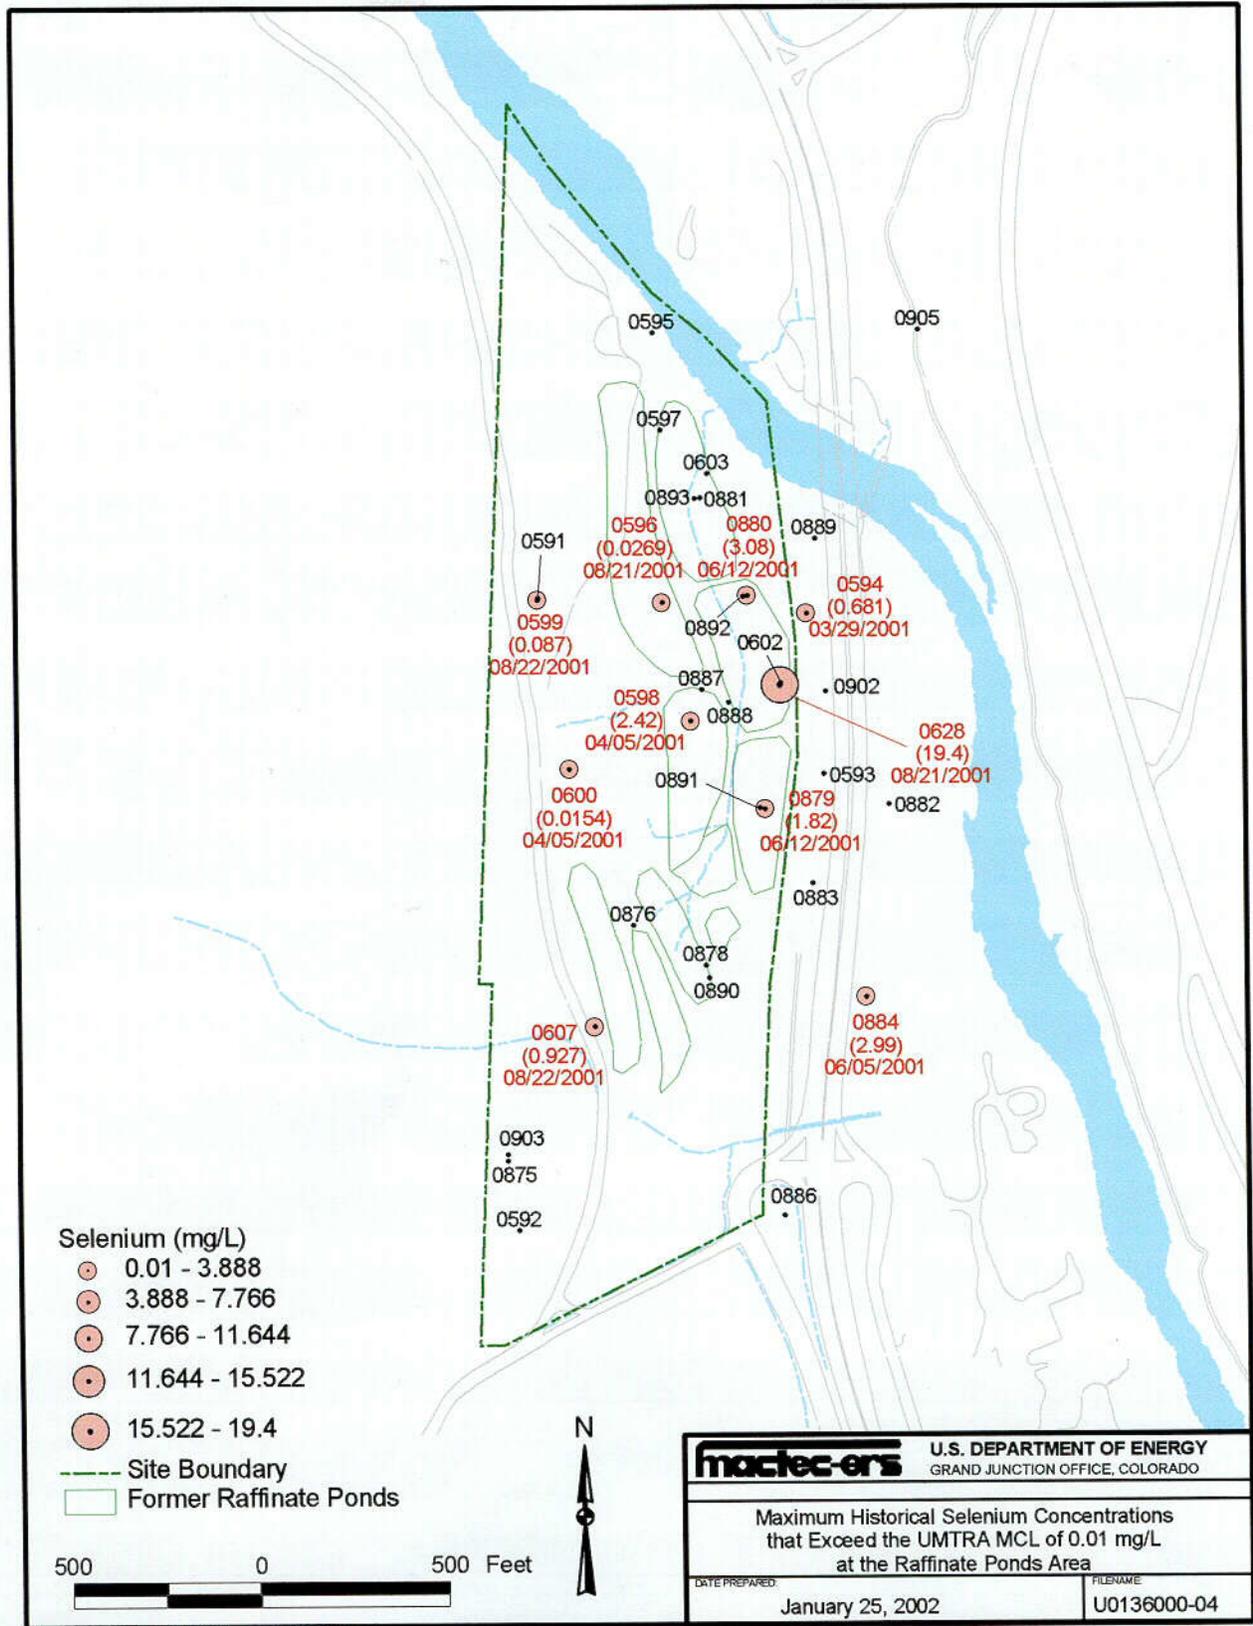
Figure 5-19. Maximum Historical Concentrations of Selenium at the Raffinate Ponds Area

Constituents that exceeded their MCL or human health risk-based standard (manganese), at the raffinate ponds area are displayed in Figure 5-15 through Figure 5-20. The concentrations shown are the maximum historical values for each well location from June 1999 through August 2001; where no historical value has exceeded an MCL or the human health risk-based standard, the constituent concentrations are not listed.

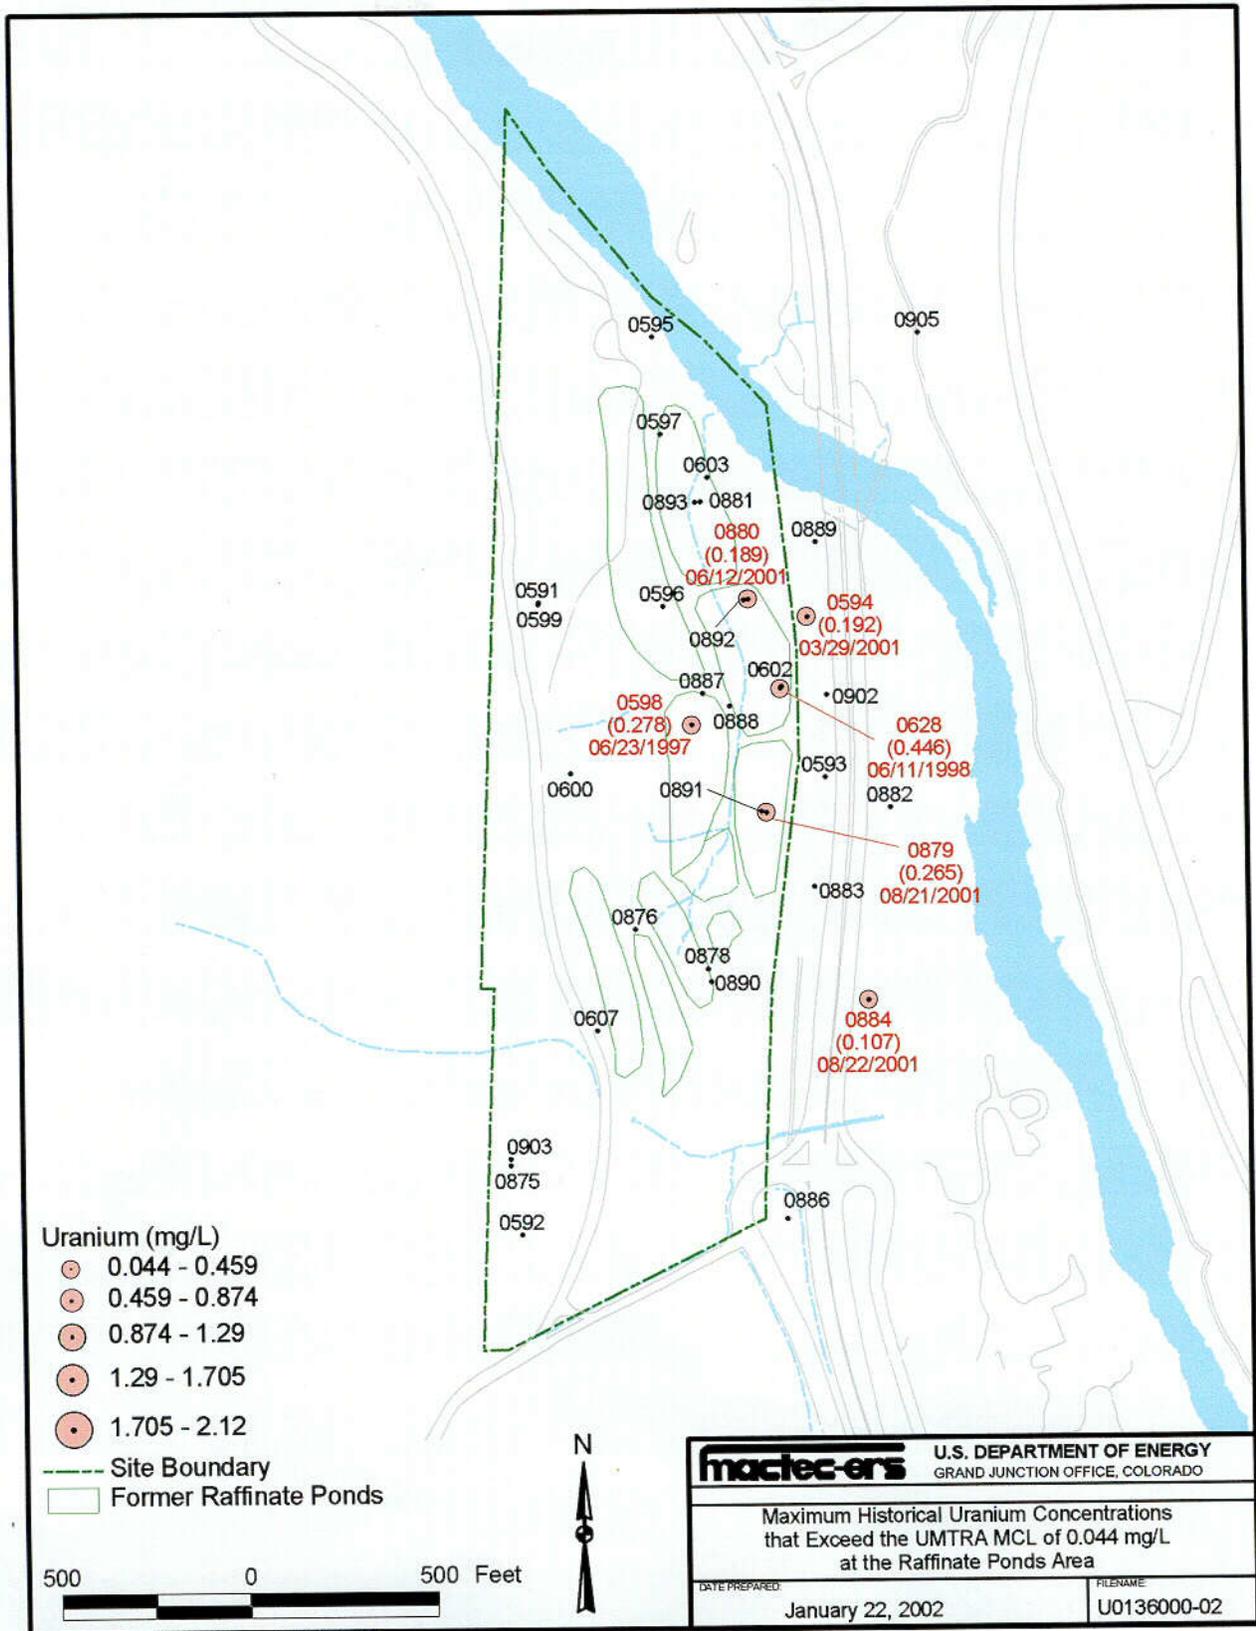
Figure 5-20. Maximum Historical Concentrations of Uranium at the Raffinate Ponds Area

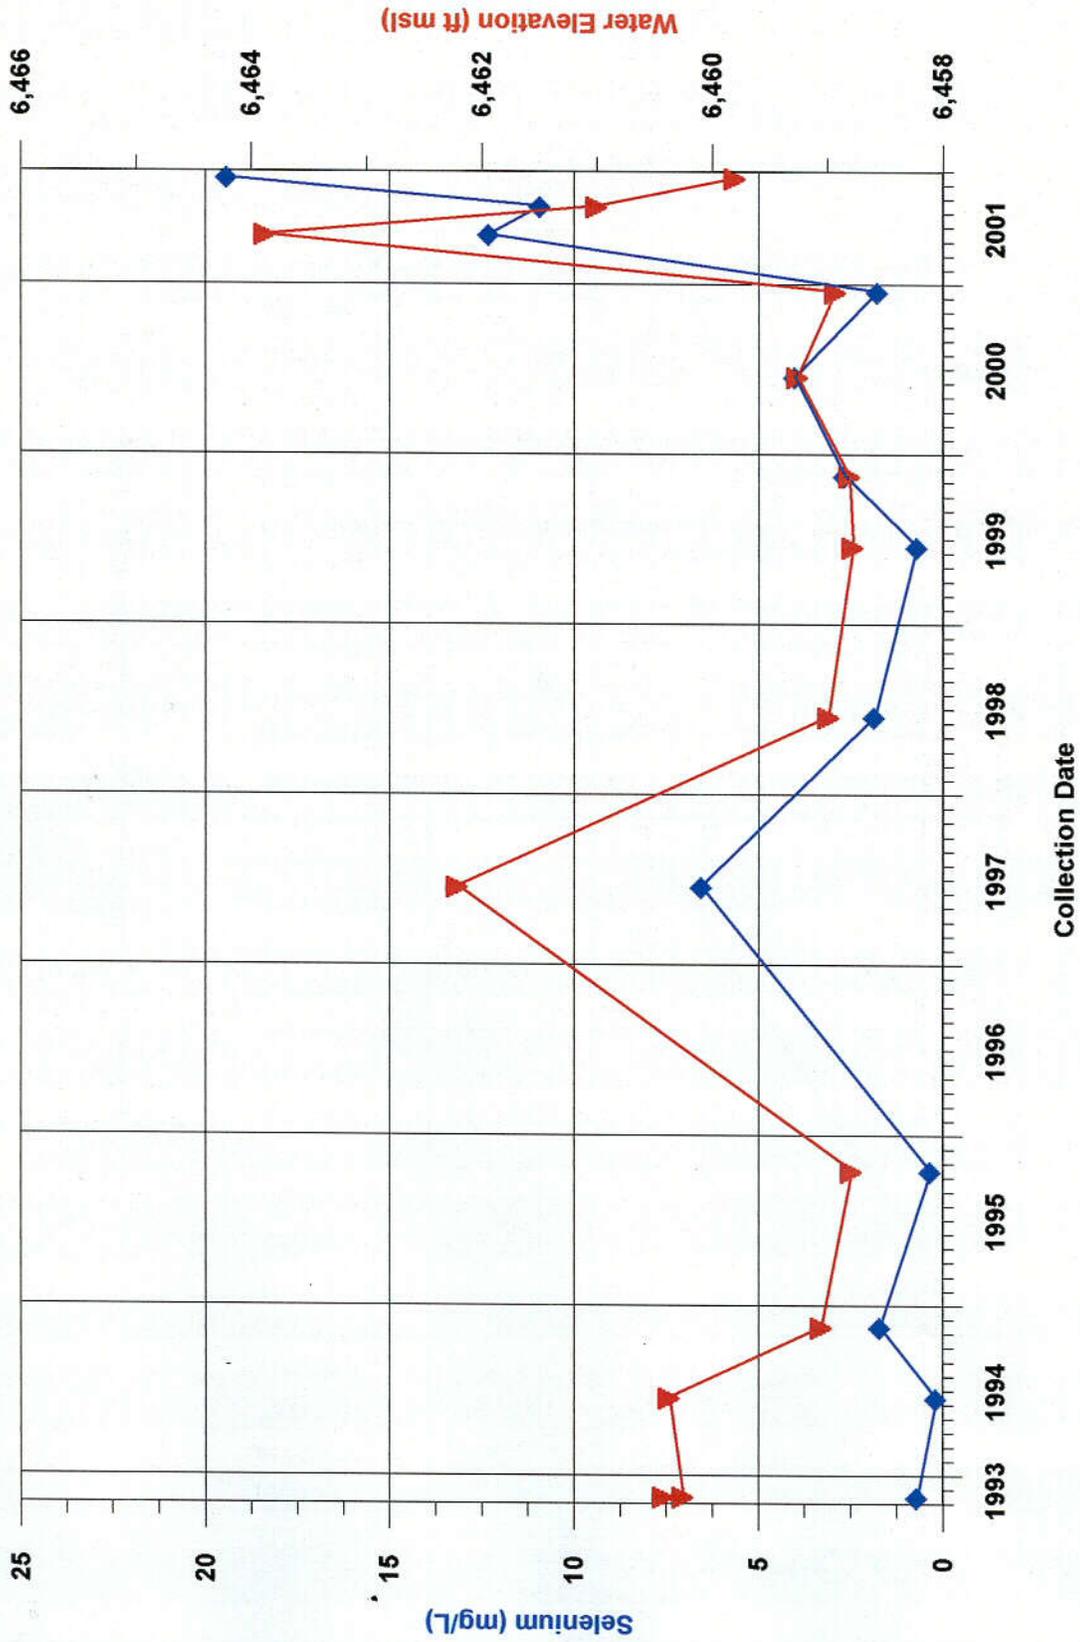
◆ Selenium
 ▼ Water Elevation
 Figure 5-21. Selenium Concentrations and Ground Water Elevations at Well 0628

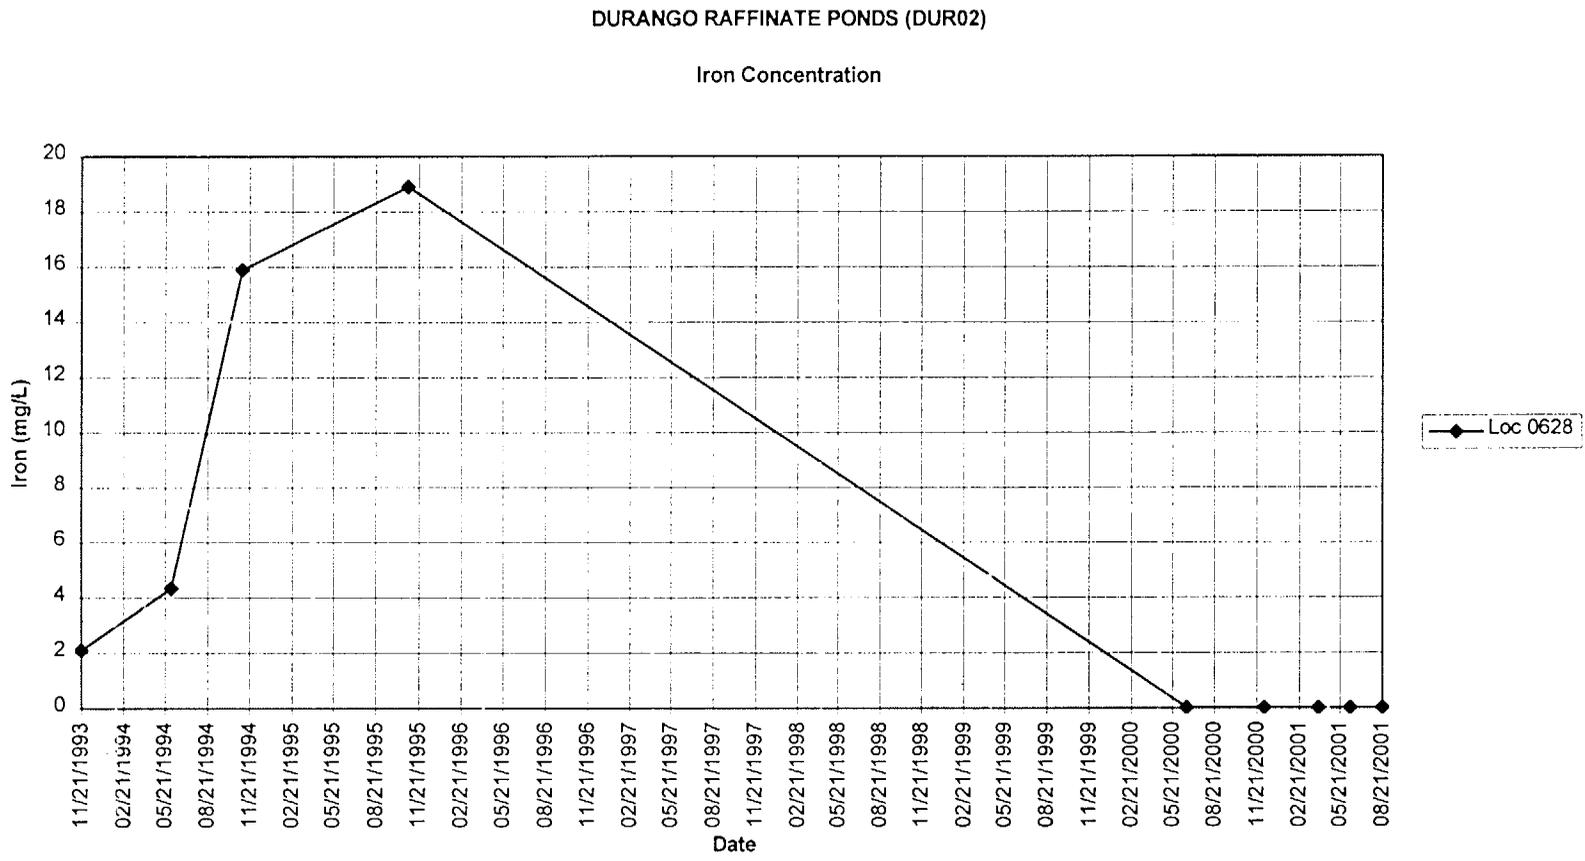
Figure 5-22. Time-Concentration Plot of Iron in Well 0628

The values for iron in well 0628 have also decreased dramatically since 1995 (Figure 5-22), indicating the ORP has likely increased, which enhances the mobilization of naturally occurring selenium.
