Site Observational Work Plan for the Durango, Colorado, UMTRA Project Site

January 2002

Prepared by the
U.S. Department of Energy
Grand Junction Office

Project Number UGW-511-0006-10-000
Document Number U0143200

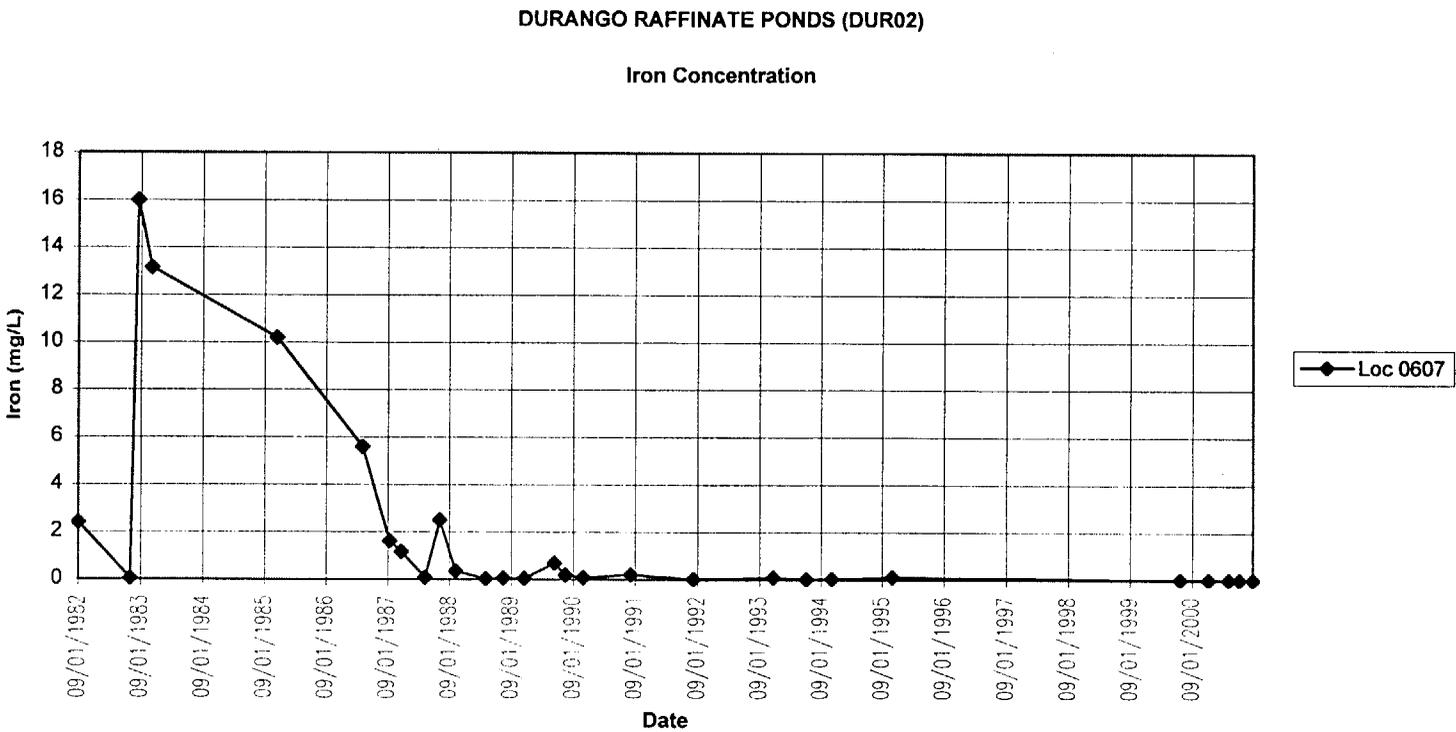
Figure 5-23. Time-Concentration Plot of Iron in Well 0607

Figure 5-23 shows all historical iron concentrations for well 0607, and Figure 5-24 shows more recent concentrations in detail. The results are notable because of the time frame when redox conditions began to change. As shown in the figures, the increase of ORP and the resulting decrease in iron concentrations began in 1983, approximately 4 years before surface remediation began. This indicates surface remediation activities were not a factor in changing the oxidizing conditions at this location.

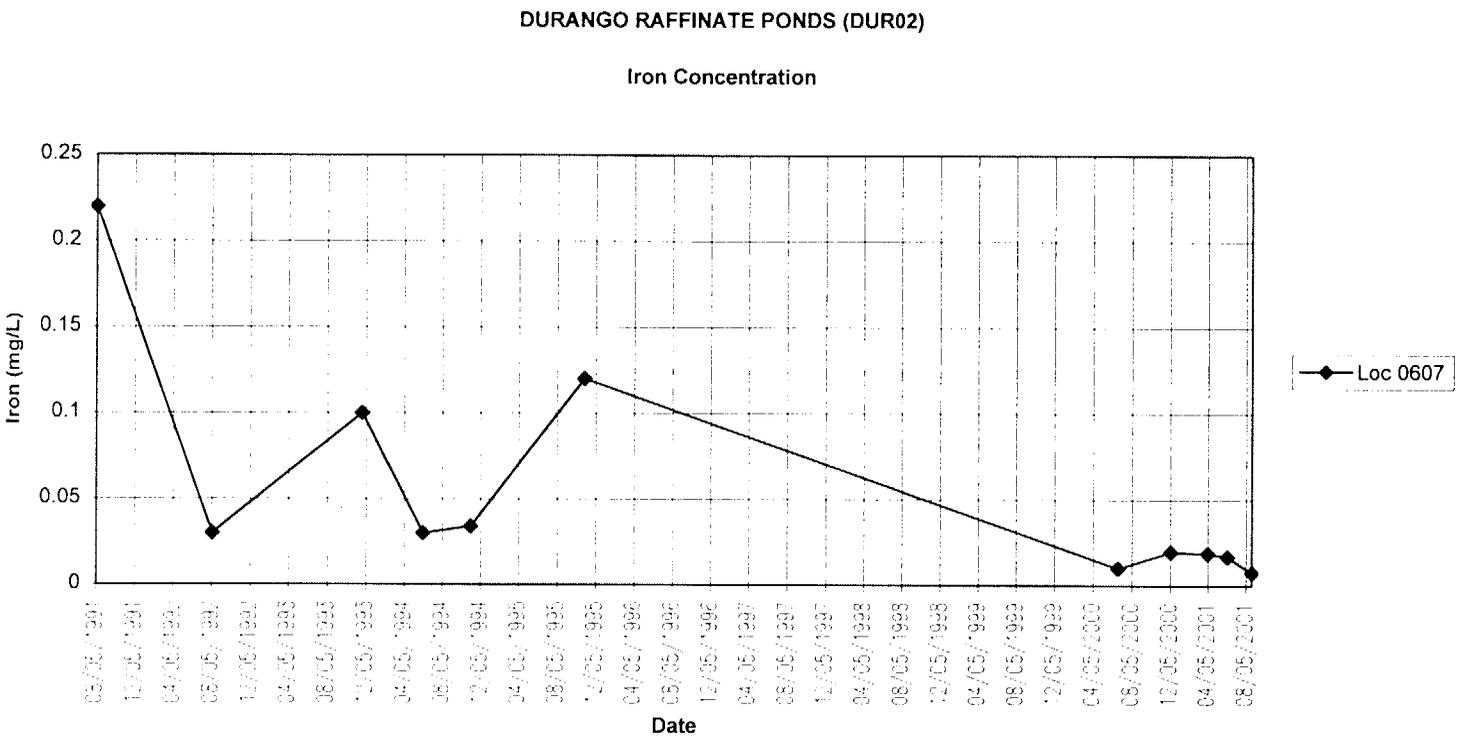
Figure 5-24. Time-Concentration Plot Detail of Iron in Well 0607

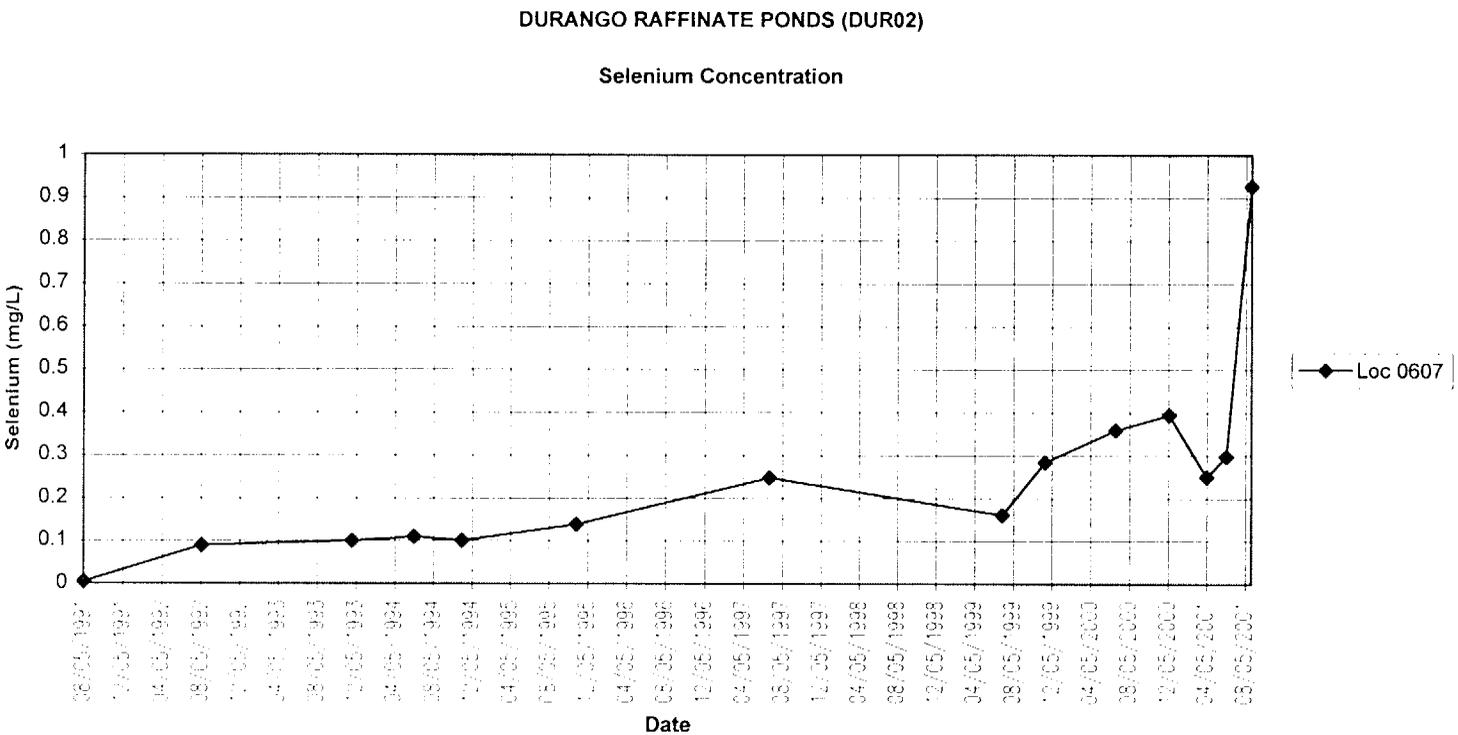
Figure 5-26. Time-Concentration Plot of Selenium in Well 0607

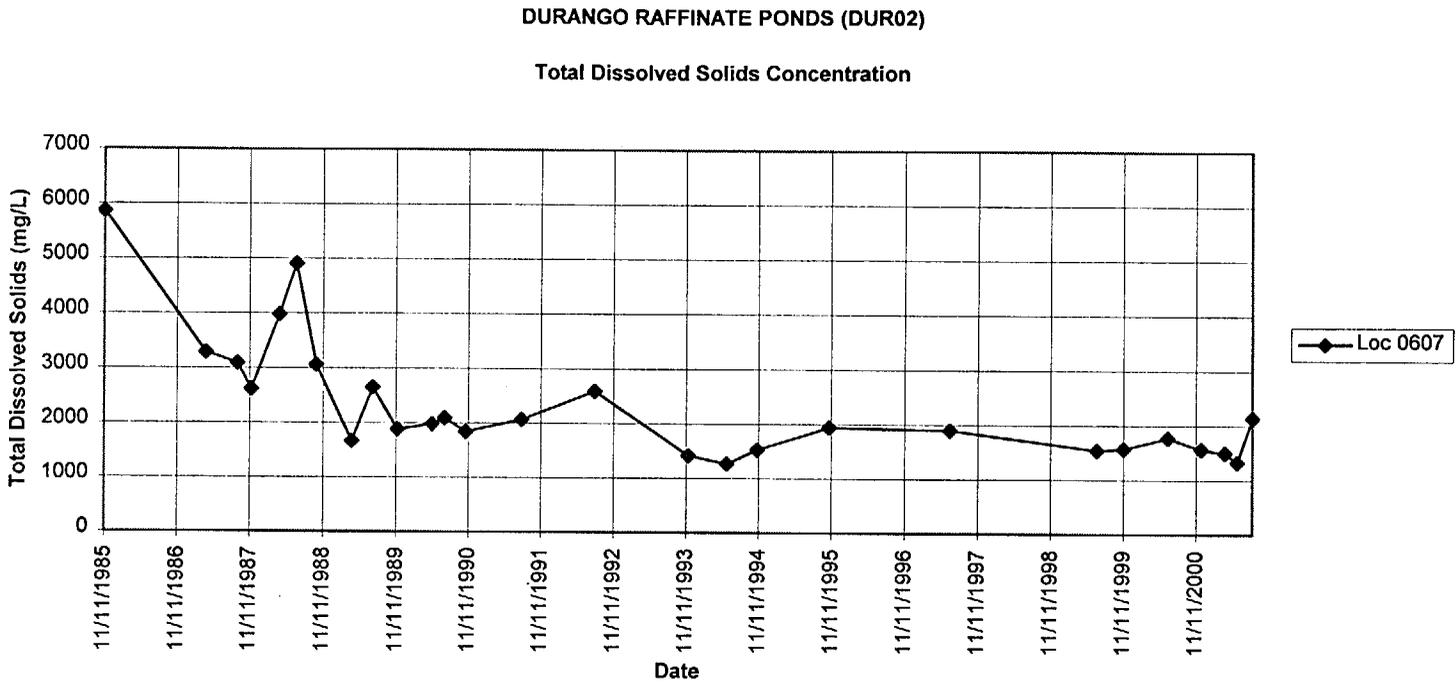
Figure 5-27. Time-Concentration Plot of TDS in Well 0607

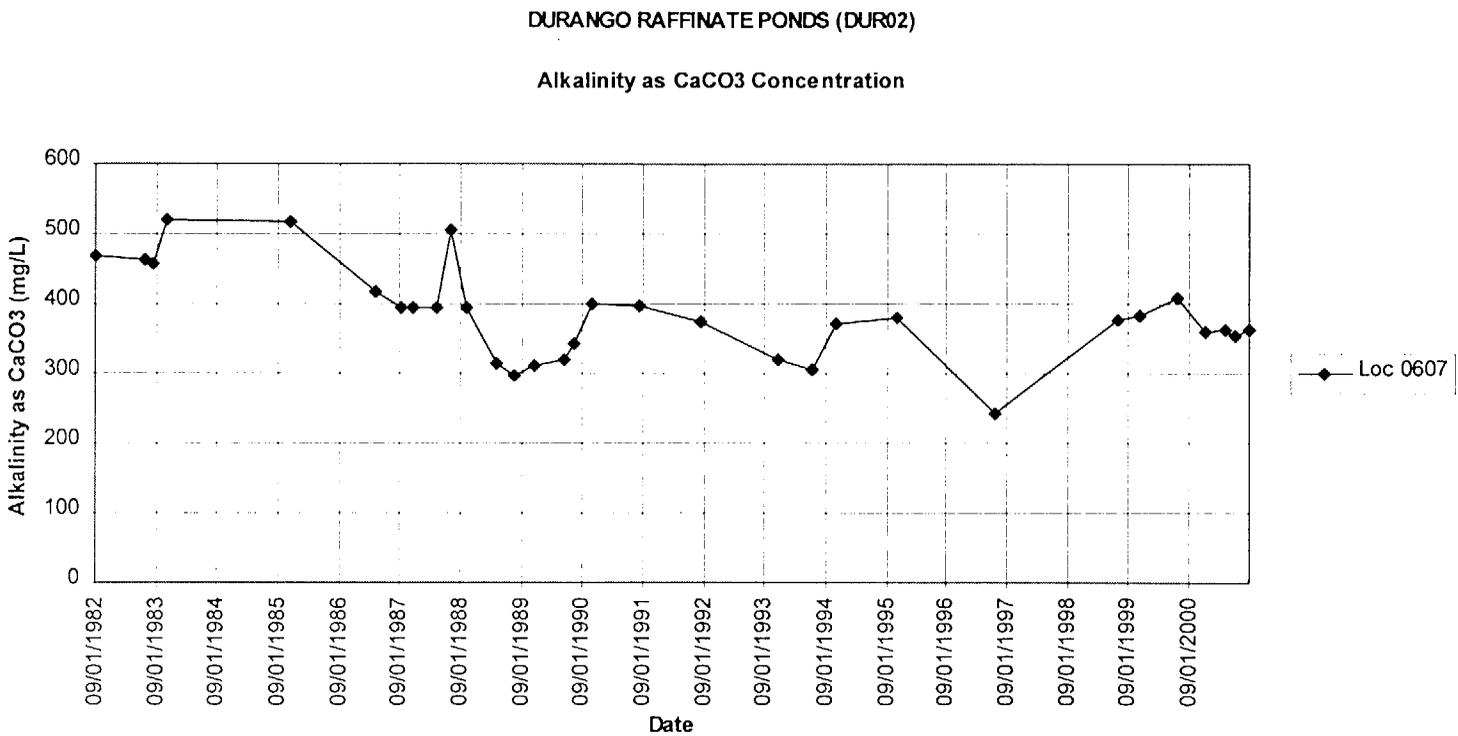
Figure 5-28. Time-Concentration Plot of Alkalinity as CaCO₃ in Well 0607

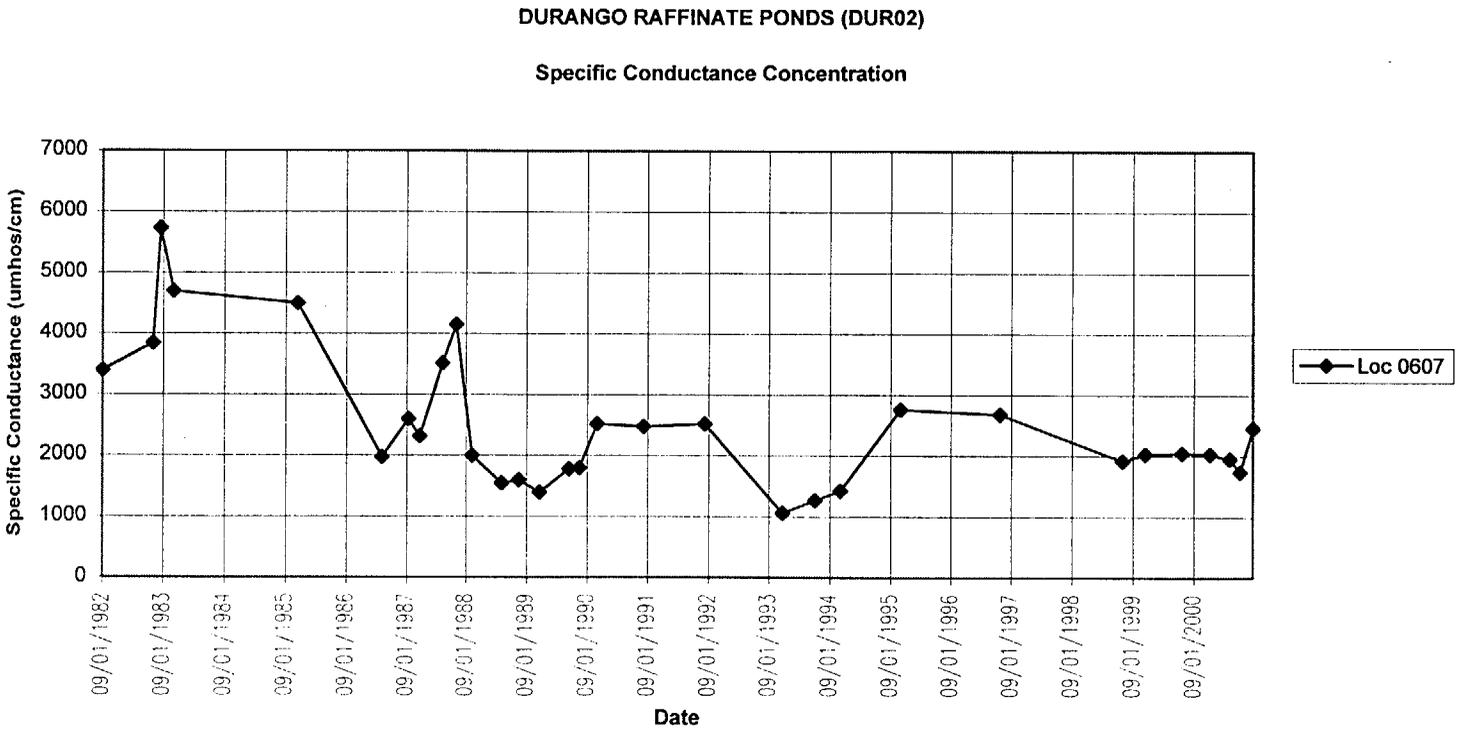
Figure 5-29. Specific Conductance in Well 0607

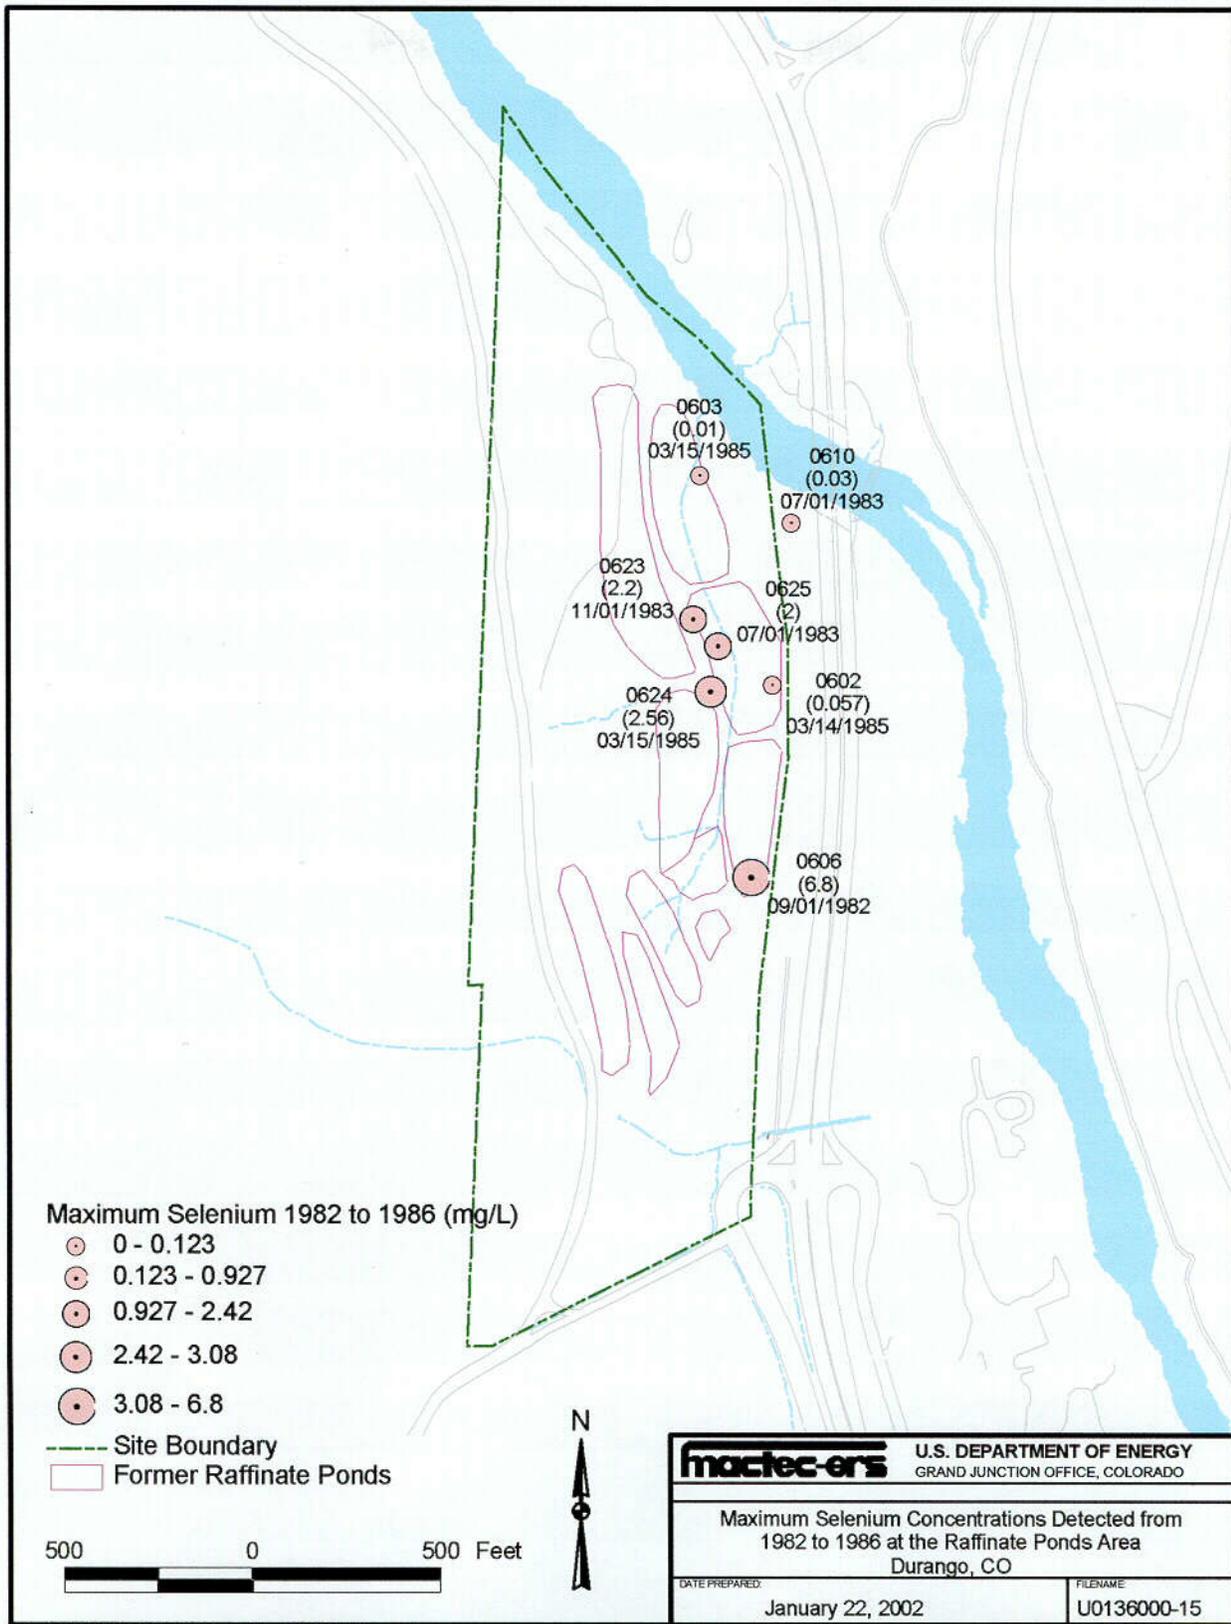
Figure 5-30. Maximum Selenium Concentrations Detected from 1982 to 1986 at the Raffinate Ponds Area

bedrock units. Prior to the start of surface remediation in 1987, selenium concentrations exceeded the MCL in seven raffinate ponds area wells, all of which were subsequently abandoned during remediation. Figure 5-30 shows the maximum selenium concentrations in wells sampled from 1982 to 1986 (prior to remediation) where the MCL was exceeded. Tables 5-14 through 5-16 show pre-remediation selenium and uranium concentrations at these locations.
