**Entergy Nuclear Generation Co.**  
Pilgrim Nuclear Power Station  
600 Rocky Hill Road  
Plymouth, MA 02360

**SUBJECT:** Entergy Nuclear Generation Company  
Pilgrim Nuclear Power Station  
Docket No. 50-293

Recent Reactor Water Level Indication Issues

**LETTER NUMBER:** 2.02.026

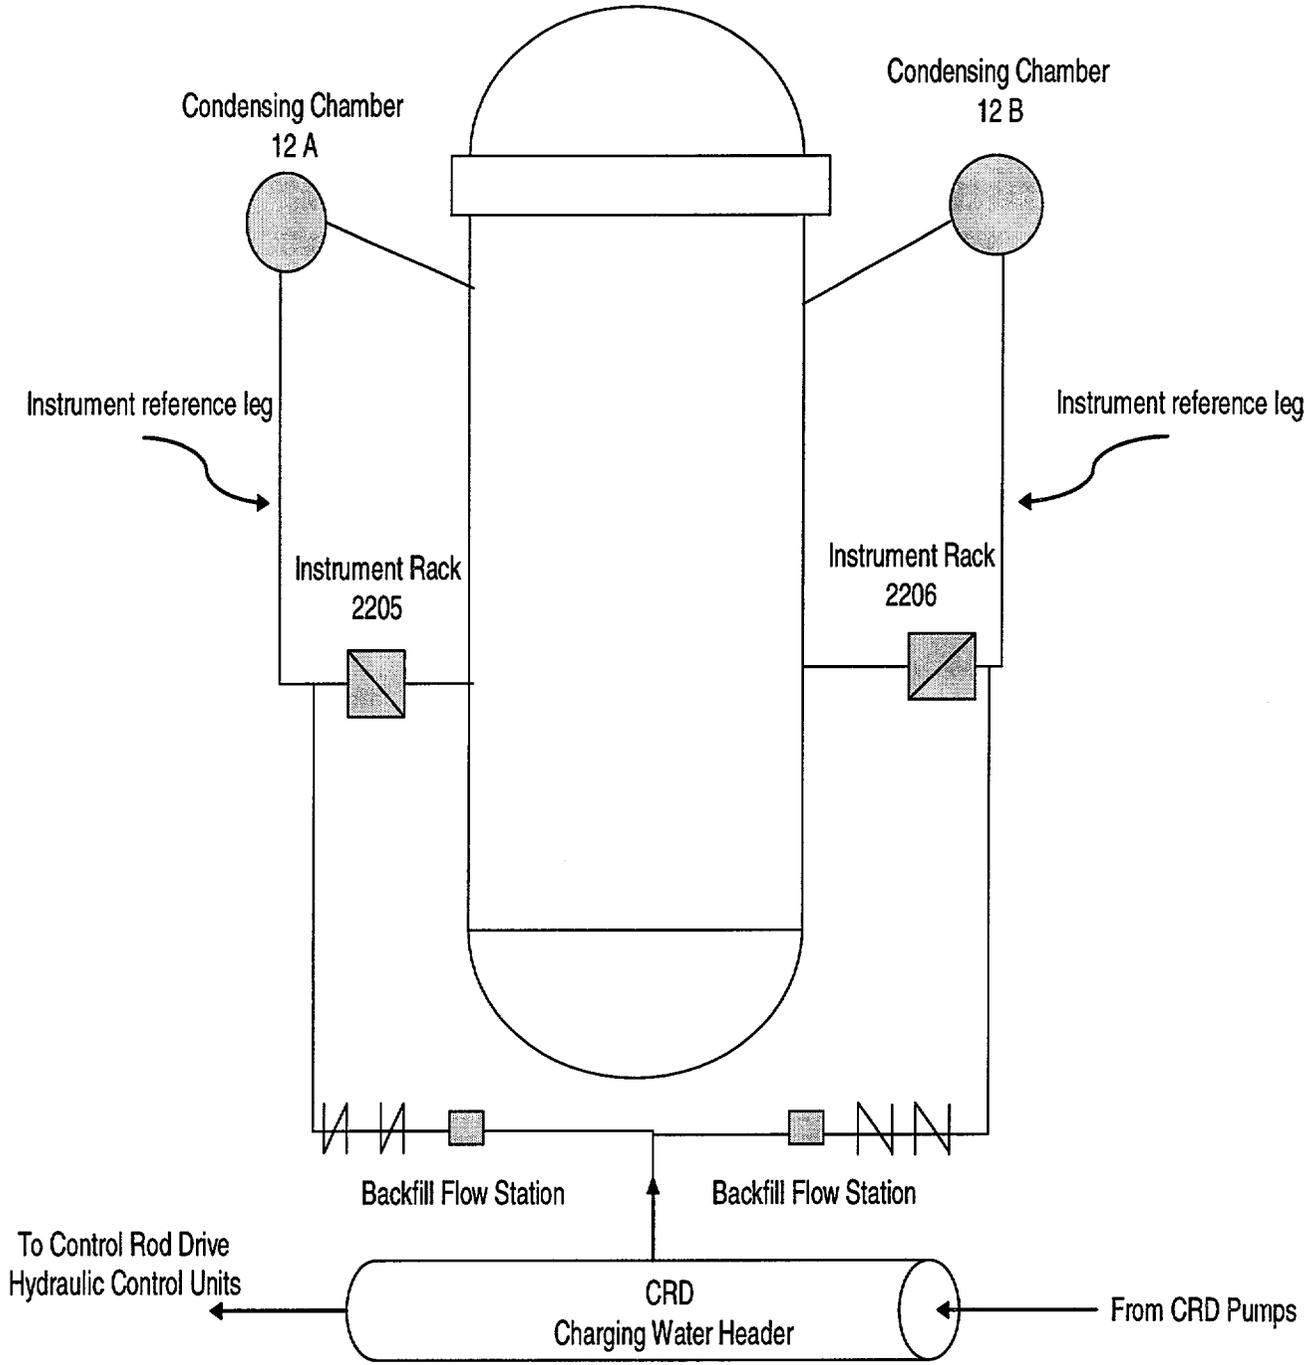
Figure 1

**Simplified Instrument Reference Leg Backfill System Arrangement**

The intent of the installed system, the Instrument Reference Leg Backfill System, was to prevent migration of non-condensable gases from the two condensing chambers to the reference legs of the ECCS and ATWS initiation instruments. This system was not installed on all of the reactor water level instrumentation reference legs (e.g., the feedwater level instrumentation reference leg). The system installed was to provide a continuous flow (.008 gpm) of water to the reference leg side of the instruments. The Instrument Reference Leg Backfill System takes its water supply from the Control Rod Drive (CRD) system charging water header between the CRD header isolation valve and the Control Rod Drive Hydraulic Control Units (HCUs). The system then feeds the two reference legs through independent flow control stations and two in-series check valves (See Figure 1). Following installation of this system Pilgrim did not experience "notching" due to non-condensable gases during reactor shutdowns on the modified reference legs until the December 2001 event.
