SUBJECT: MEETING WITH COLUMBIA GENERATING STATION

This refers to the public meeting conducted at the NRC Region IV offices, 611 Ryan Plaza Drive, Arlington, TX, on May 24, 2002. This meeting was conducted to discuss plant fuel corrosion issues and engineering initiatives. The meeting attendance list and licensee presentation are enclosed with this summary.

Columbia Generating Station Fuel Corrosion Investigation Status Report

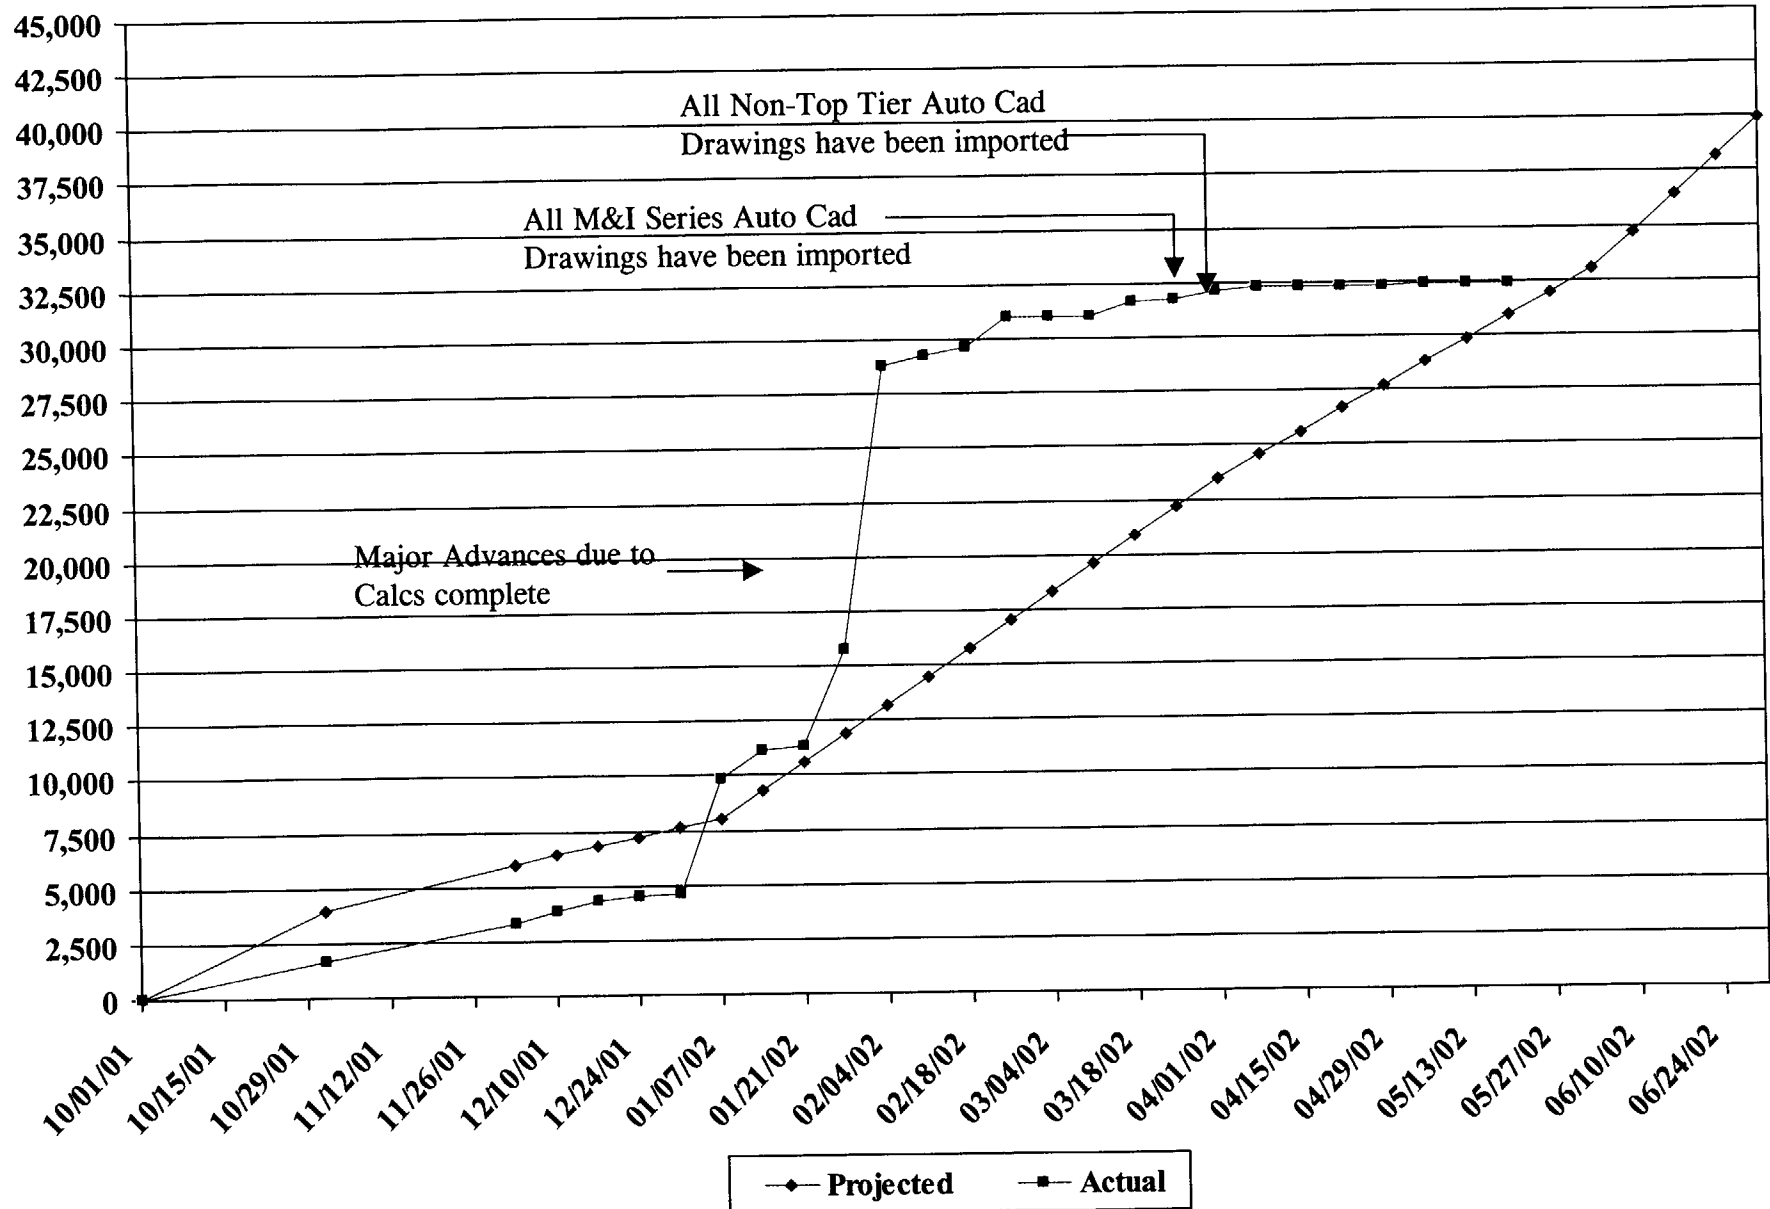
123,312 DOCUMENTS QA IMPORTED (26% Complete)
(Starting 1/1/02 - Goal is ~ 5,167 Images a Month)
(Starting 6/1/02 - Goal is ~ 6,947 Images a Month)
10/1/01 - 7/1/03
