SUBJECT: DAVIS-BESSE INSPECTION REPORT 50-346/99009(DRP)

Enclosure: Inspection Report 50-346/99009(DRP)

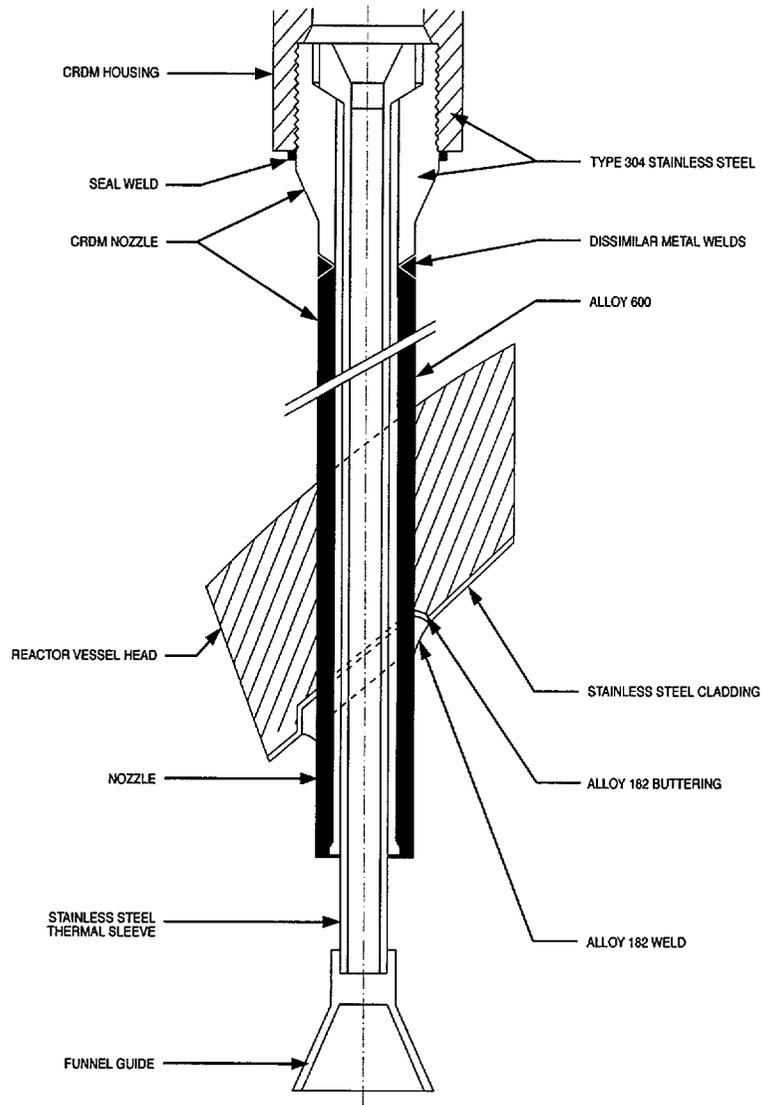
1. Figure 1. Typical Control Rod Drive Mechanism Nozzle

Figure 1. Typical control rod drive mechanism nozzle.
 Copyright the Minerals, Metals & Materials Society; reprinted with permission.

Most PWRs have Alloy 600 CRDM nozzle and other vessel head closure penetrations (VHPs) that extend above the reactor pressure vessel head. The stainless steel housing of the CRDM is screwed and seal-welded onto the top of the nozzle penetration, as shown in Figure 1. (Figure 1 is for illustrative purposes only and is not intended to be indicative of every nuclear steam supply system (NSSS) vendor's CRDM design.) The weld between the nozzle top and bottom pieces is a dissimilar metal weld, which is also called a bimetallic weld. The nozzles protrude below the vessel head, thus exposing the inside surface of the nozzles to reactor coolant. The CRDM nozzle and other VHPs are basically the same for all PWRs worldwide, which use a U.S. design (except in Germany and Russia). The areas of interest for potential cracking are the weld between the nozzle and reactor vessel head, and the portion of the nozzle inside the reactor vessel head above the nozzle-to-vessel weld.
