Union of Concerned Scientists

SUBJECT: QUESTIONS FOR DAVIS-BESSE MANUAL CHAPTER 0350 PANEL

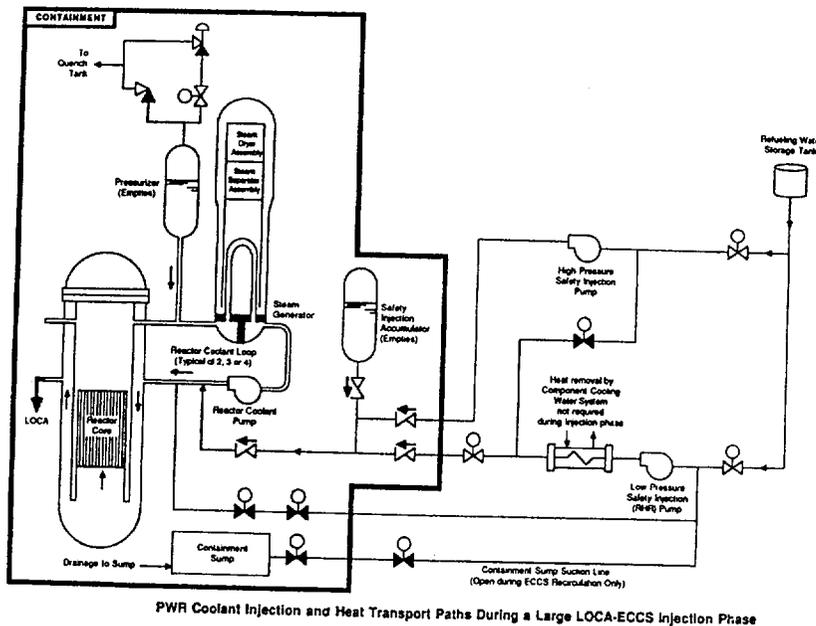
The schematic illustrates the systems involved following a loss-of-coolant accident. The LOCA is represented by the opening on the left side of the reactor vessel allowing cooling water to pour out into the containment building where it drains to the containment sump.

The high pressure safety injection pumps and the low pressure safety injection pumps (one each shown on the right portion of the schematic) initially supply water from the refueling water storage tank to the reactor vessel to compensate for the lost inventory. Thirty minutes to an hour into the accident, the refueling water storage tank empties. Operators close valve (shown as the white bow-ties on the schematic) and open other valves (the black bow-ties) to allow the pumps to take water from the containment sump and deliver it to the reactor vessel.

Sump failure is a very serious problem. It means the low pressure safety injection pumps are no longer able to take water from the containment sump and recycle it to the reactor vessel. Operators might be able to re-fill the refueling water storage tank or align the pumps to other external sources of water, but that doesn't completely save the day. Continued reliance on make-up water from outside the containment means that the flood level of water inside the containment rises and rises. Important safety equipment, like motors, could be submerged and disabled.
