**sensor**  
**SERVICES, Inc.** \_\_\_\_\_ Radiological & Maintenance Services for Industrial Nuclear Gauging Systems \_\_\_\_\_  
2757 Camden Pointe Drive, Sherrills Ford, NC 28673 (828) 478-2980 FAX (828) 478-2844

**SUBJECT:** Am-241 sealed source leakage.

EXPLODED DIAGRAMS OF INTERNAL ARRANGEMENT FOR GR100

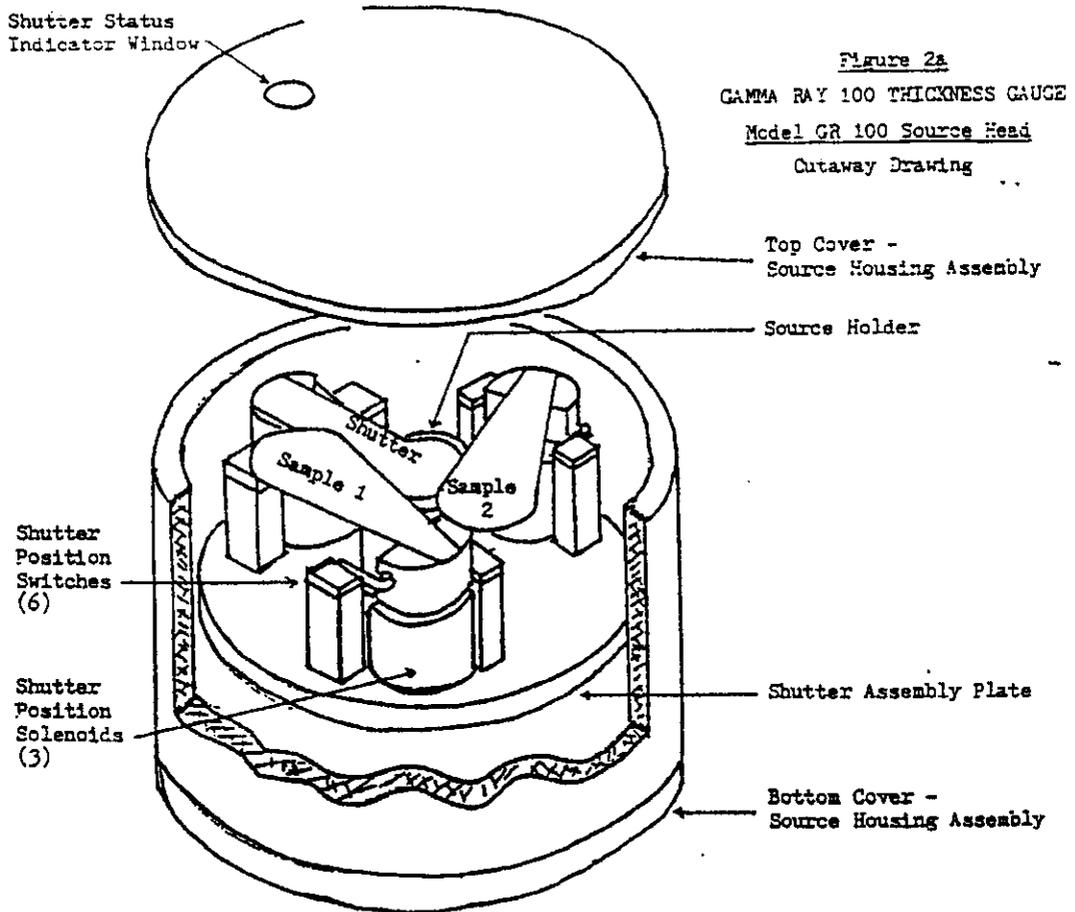
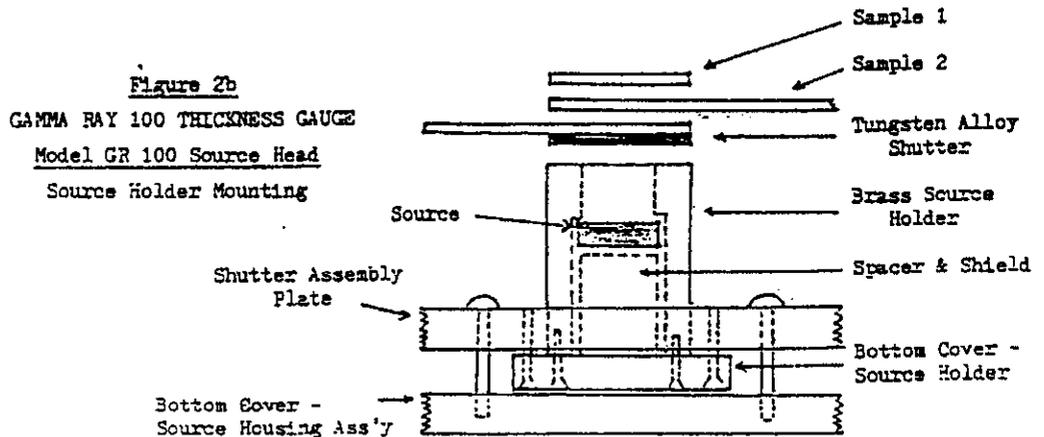
DEVICE TYPE: Gamma Gauge

- E. Pushed aside the shutter bar and inspected the surface of the source capsule with an inspection mirror. This was done at about a 12 inch distance. I observed the surface of the capsule which seemed to be intact with no dents or fissures. I did however, notice two small discolorations about the size the printed letter o and some discoloration at the rim of the capsule that appeared to me to be like rust. Having done this procedure many times, with this and other similar devices using the AMC.19 source, you normally would expect to see a shiny stainless steel cover at the bottom of the brass columniation cone. I have in the past, had to clean oil, grease, metal fragments and sometime damaged screws from the surface of similar devices using the AMC.19 source. The capsule always returned to being shiny and never have I had a positive leak test with those devices.

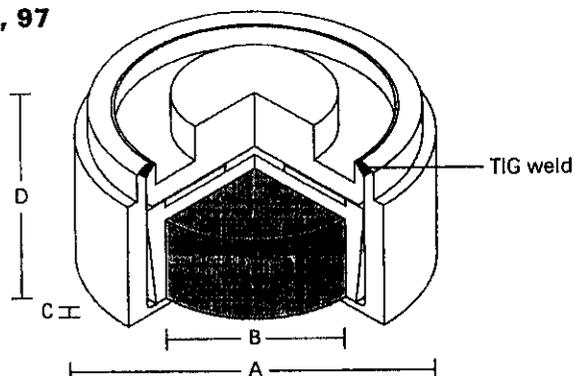
### X.91-95, 97

### Capsule dimensions and Safety performance testing

Capsule	Overall diam. 'A' mm	Active diam. 'B' mm	Window thickness 'C' mm	Overall thickness 'D' mm	Safety performance testing		
					ANSI/ISO classification	IAEA special form	Model number
X.91	10.8	7.5	0.2-0.25	6.0	C64444	GB/38/S-85	AMC.16
X.92	15.0	12.0	0.2-0.25	6.0	C64444	GB/39/S-85	AMC.17
X.93	30.0	25.0	0.2-0.25	6.0	C64444	GB/40/S-85	AMC.19
X.94	36.0	31.0	0.25-0.3	8.0	E64444	GB/107/S-85	AMC.30
X.95	45.0	40.0	0.25-0.3	8.0	E64444	GB/121/S-85	AMC.50
X.97	22.0	18.0	0.2 0.25	6.0	C64444	GB/41/S-85	AMC.18
