Subject: Confirmatory Action Letter Response – Management and Human Performance  
Root Cause Analysis Report on Failure to Identify Reactor Pressure Vessel  
Head Degradation

# Root Cause Analysis Report

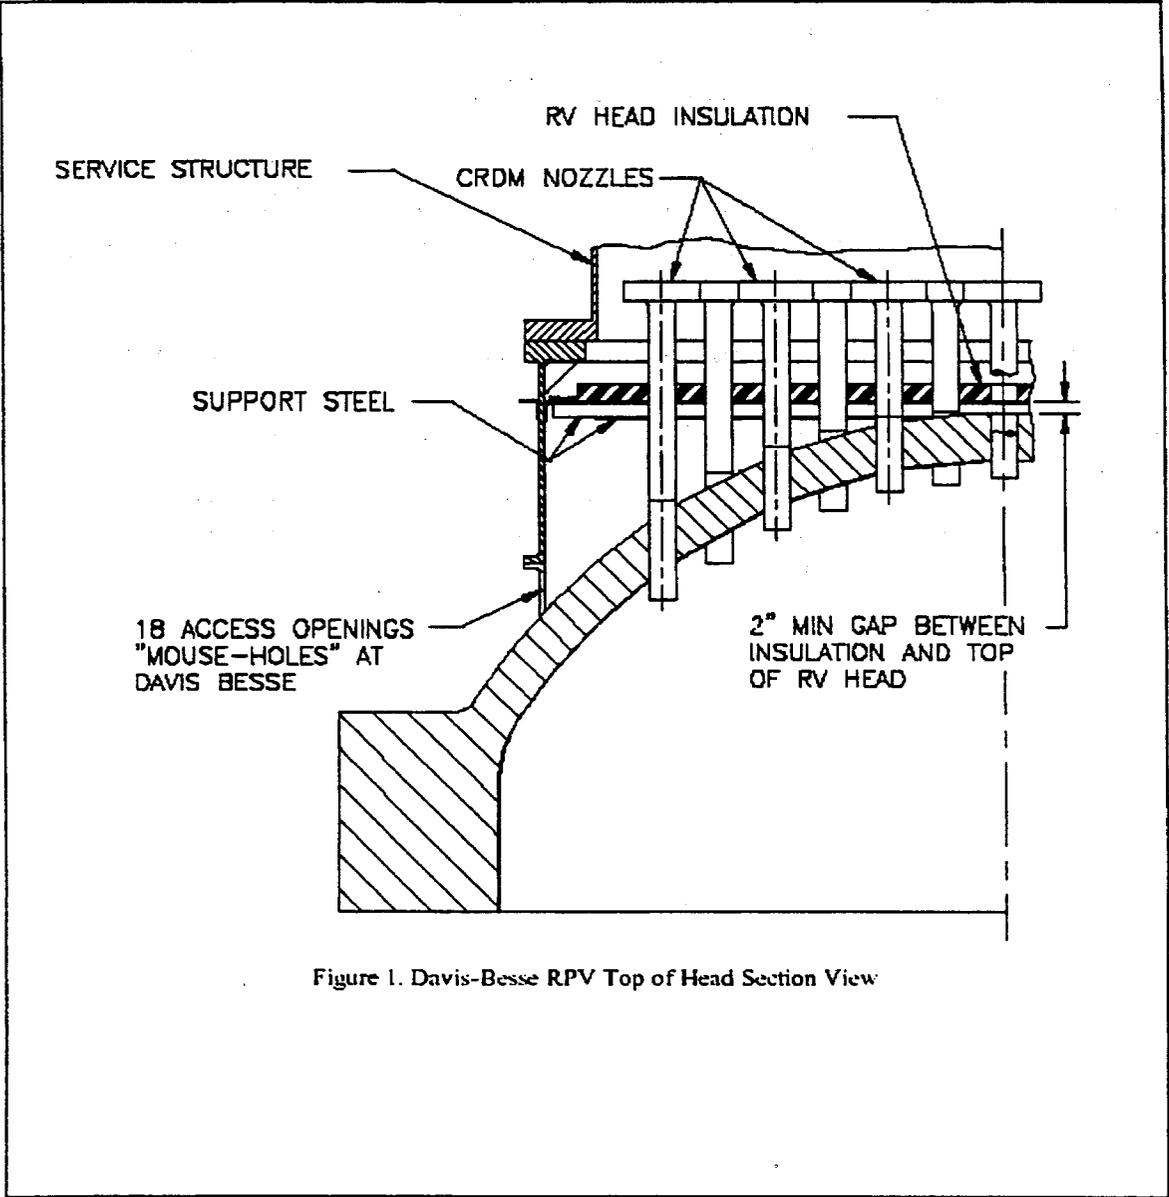
Figure 1. Davis-Besse RPV Top of Head Section View

The RPV head has 69 control rod drive mechanism (CRDM) nozzles welded to the RPV head. Of these, 61 are used for CRDMs, seven are spare, and one is used for the RPV head vent piping. Each CRDM nozzle is constructed of Alloy 600 and is attached to the RPV head by an Alloy 182 J-groove weld. The RPV head is constructed of low-alloy steel and is internally clad with stainless steel. Figures 1, 2 and 3 show the arrangement of the Davis-Besse RPV head. Figure 1 is a section view through the RPV centerline, Figure 2 is a plan view from the top of the RPV closure head, and Figure 3 shows how the CRDM nozzles are welded into the RPV head.
