Subject: Confirmatory Action Letter Response – Management and Human Performance  
Root Cause Analysis Report on Failure to Identify Reactor Pressure Vessel  
Head Degradation

# Root Cause Analysis Report

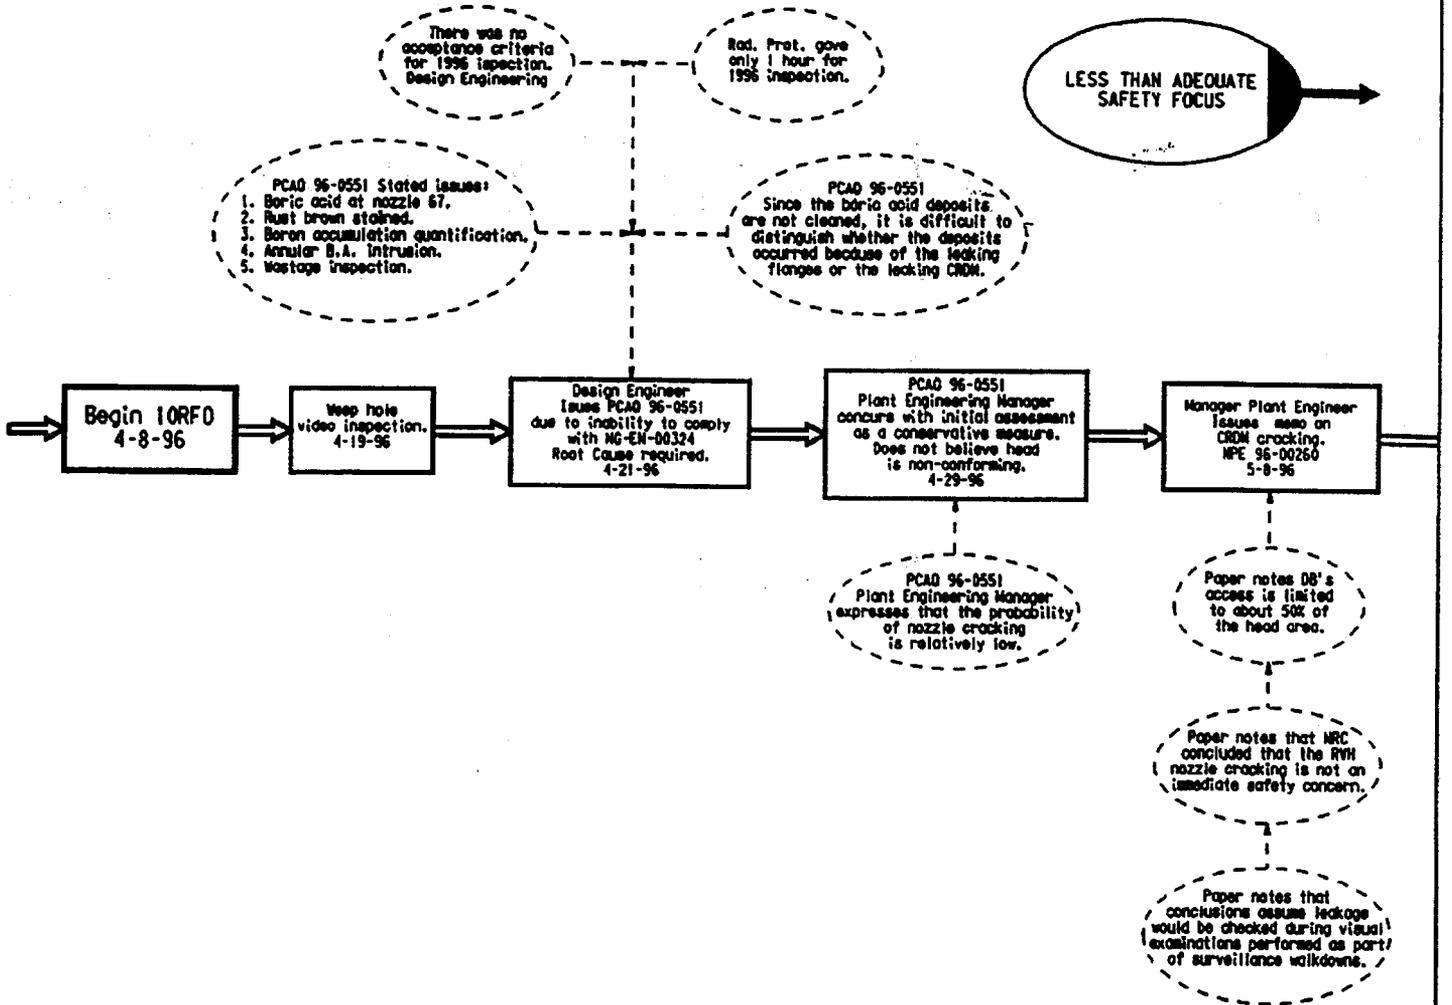
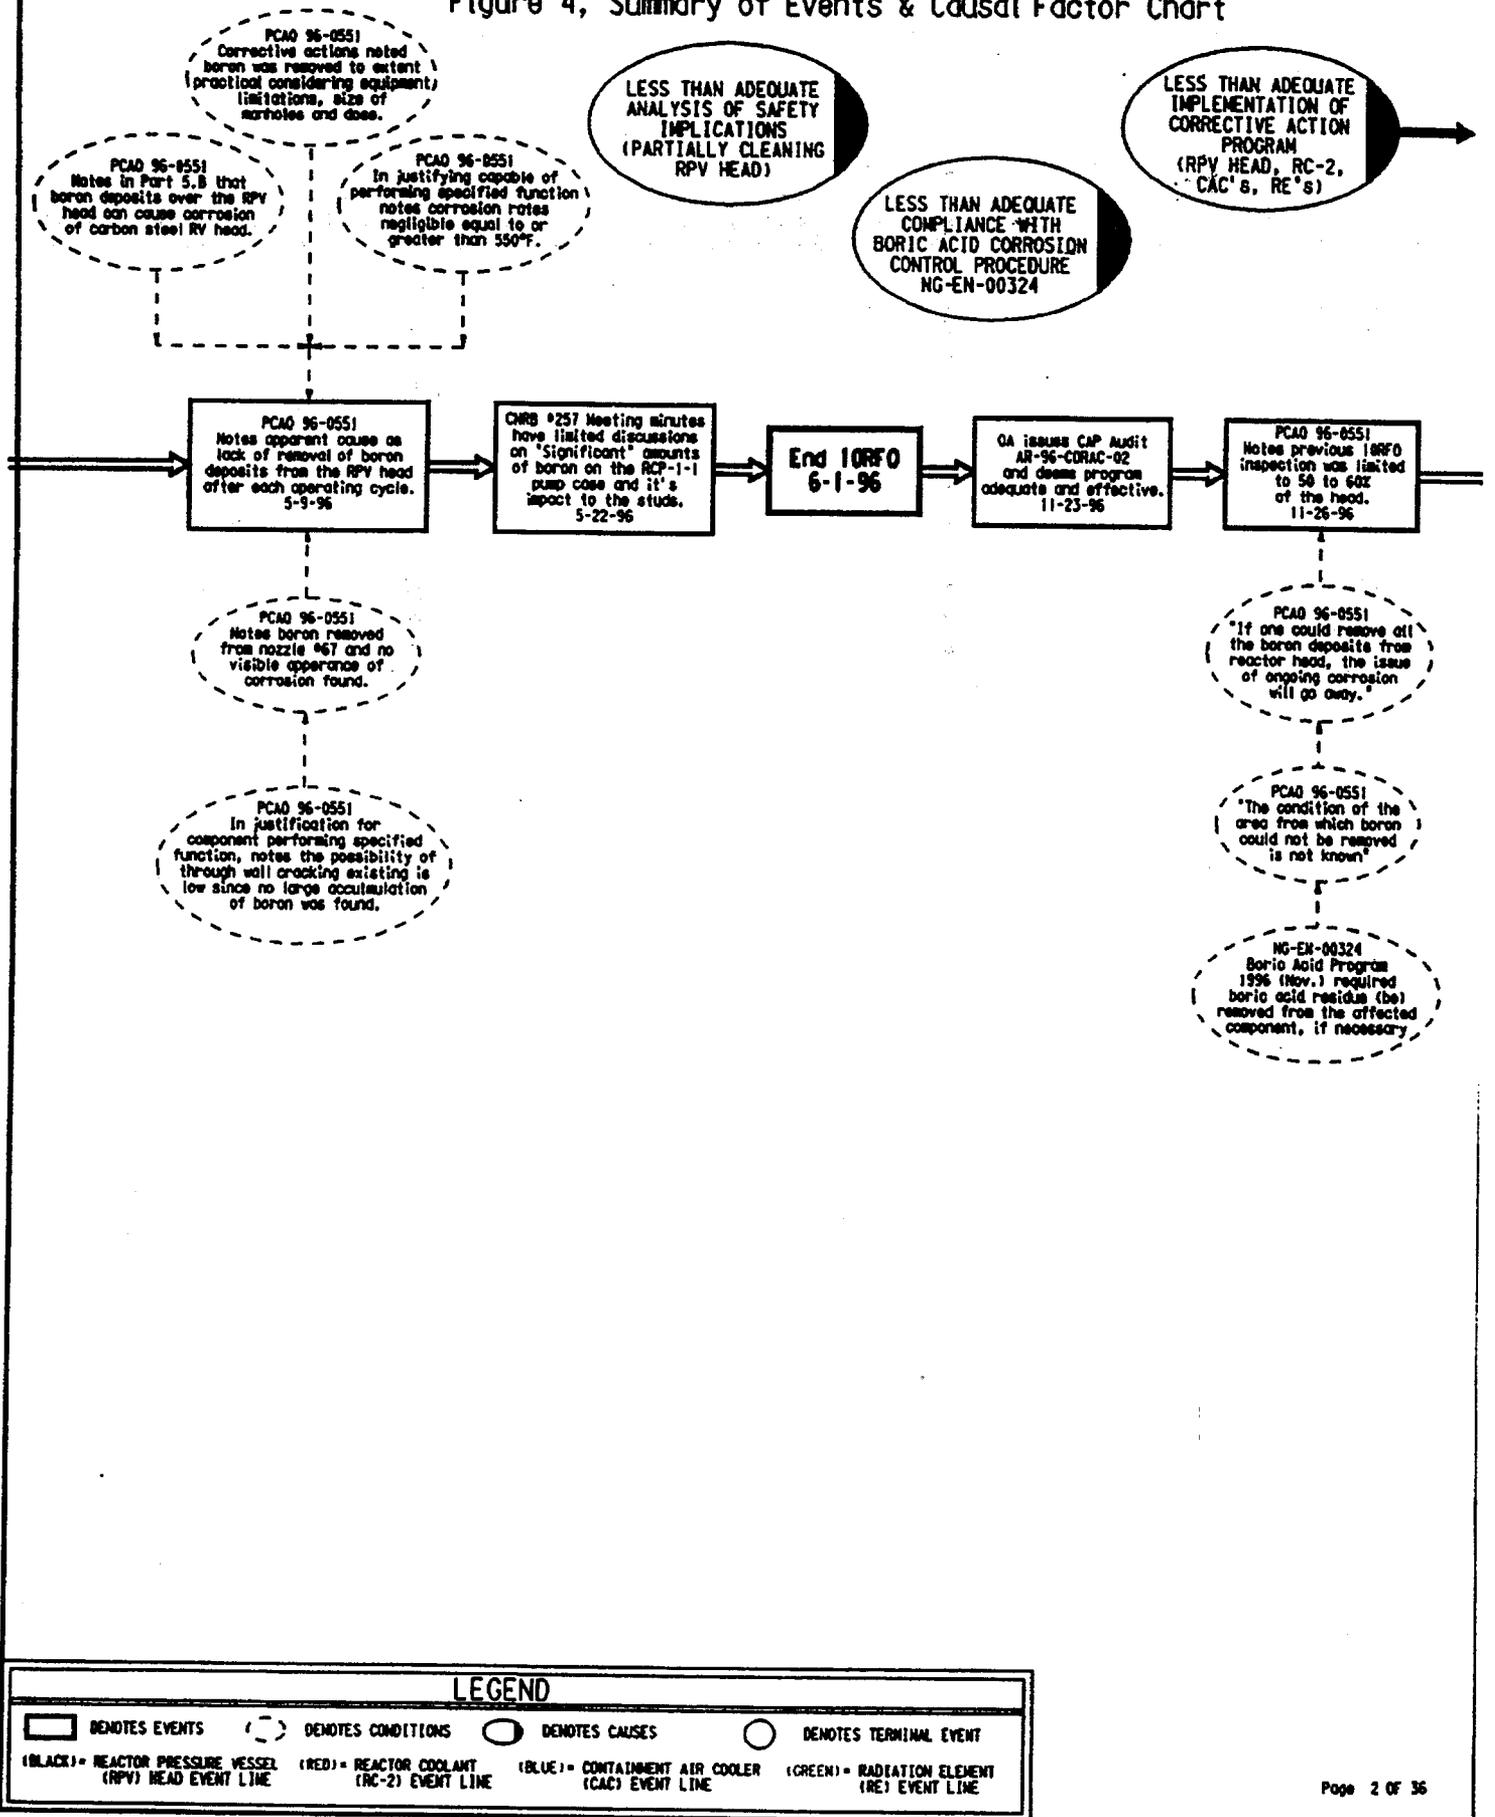
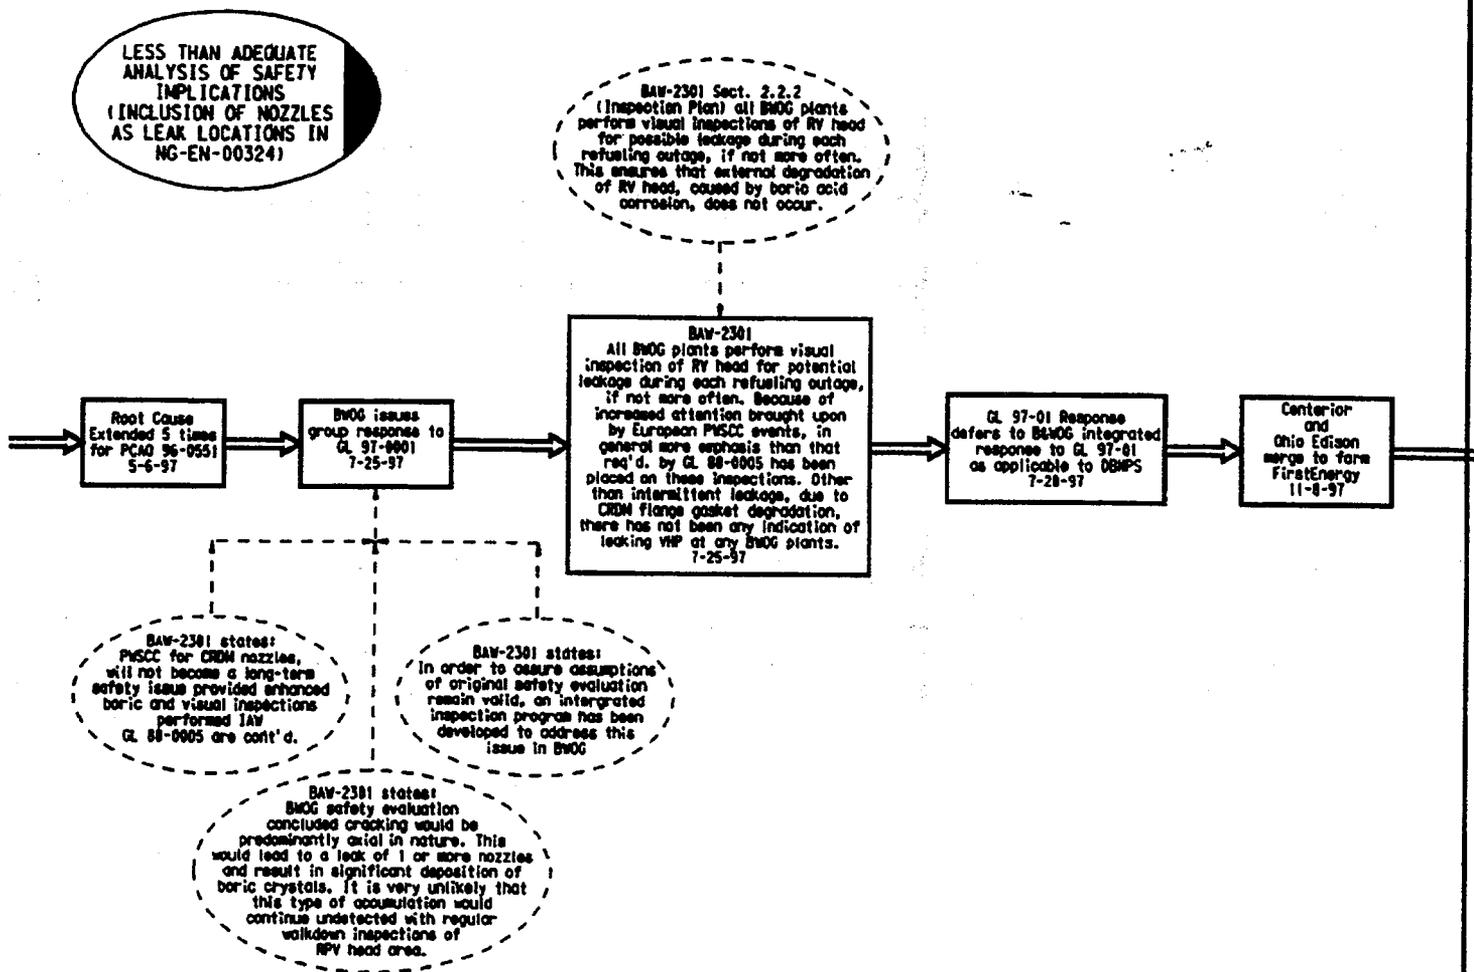
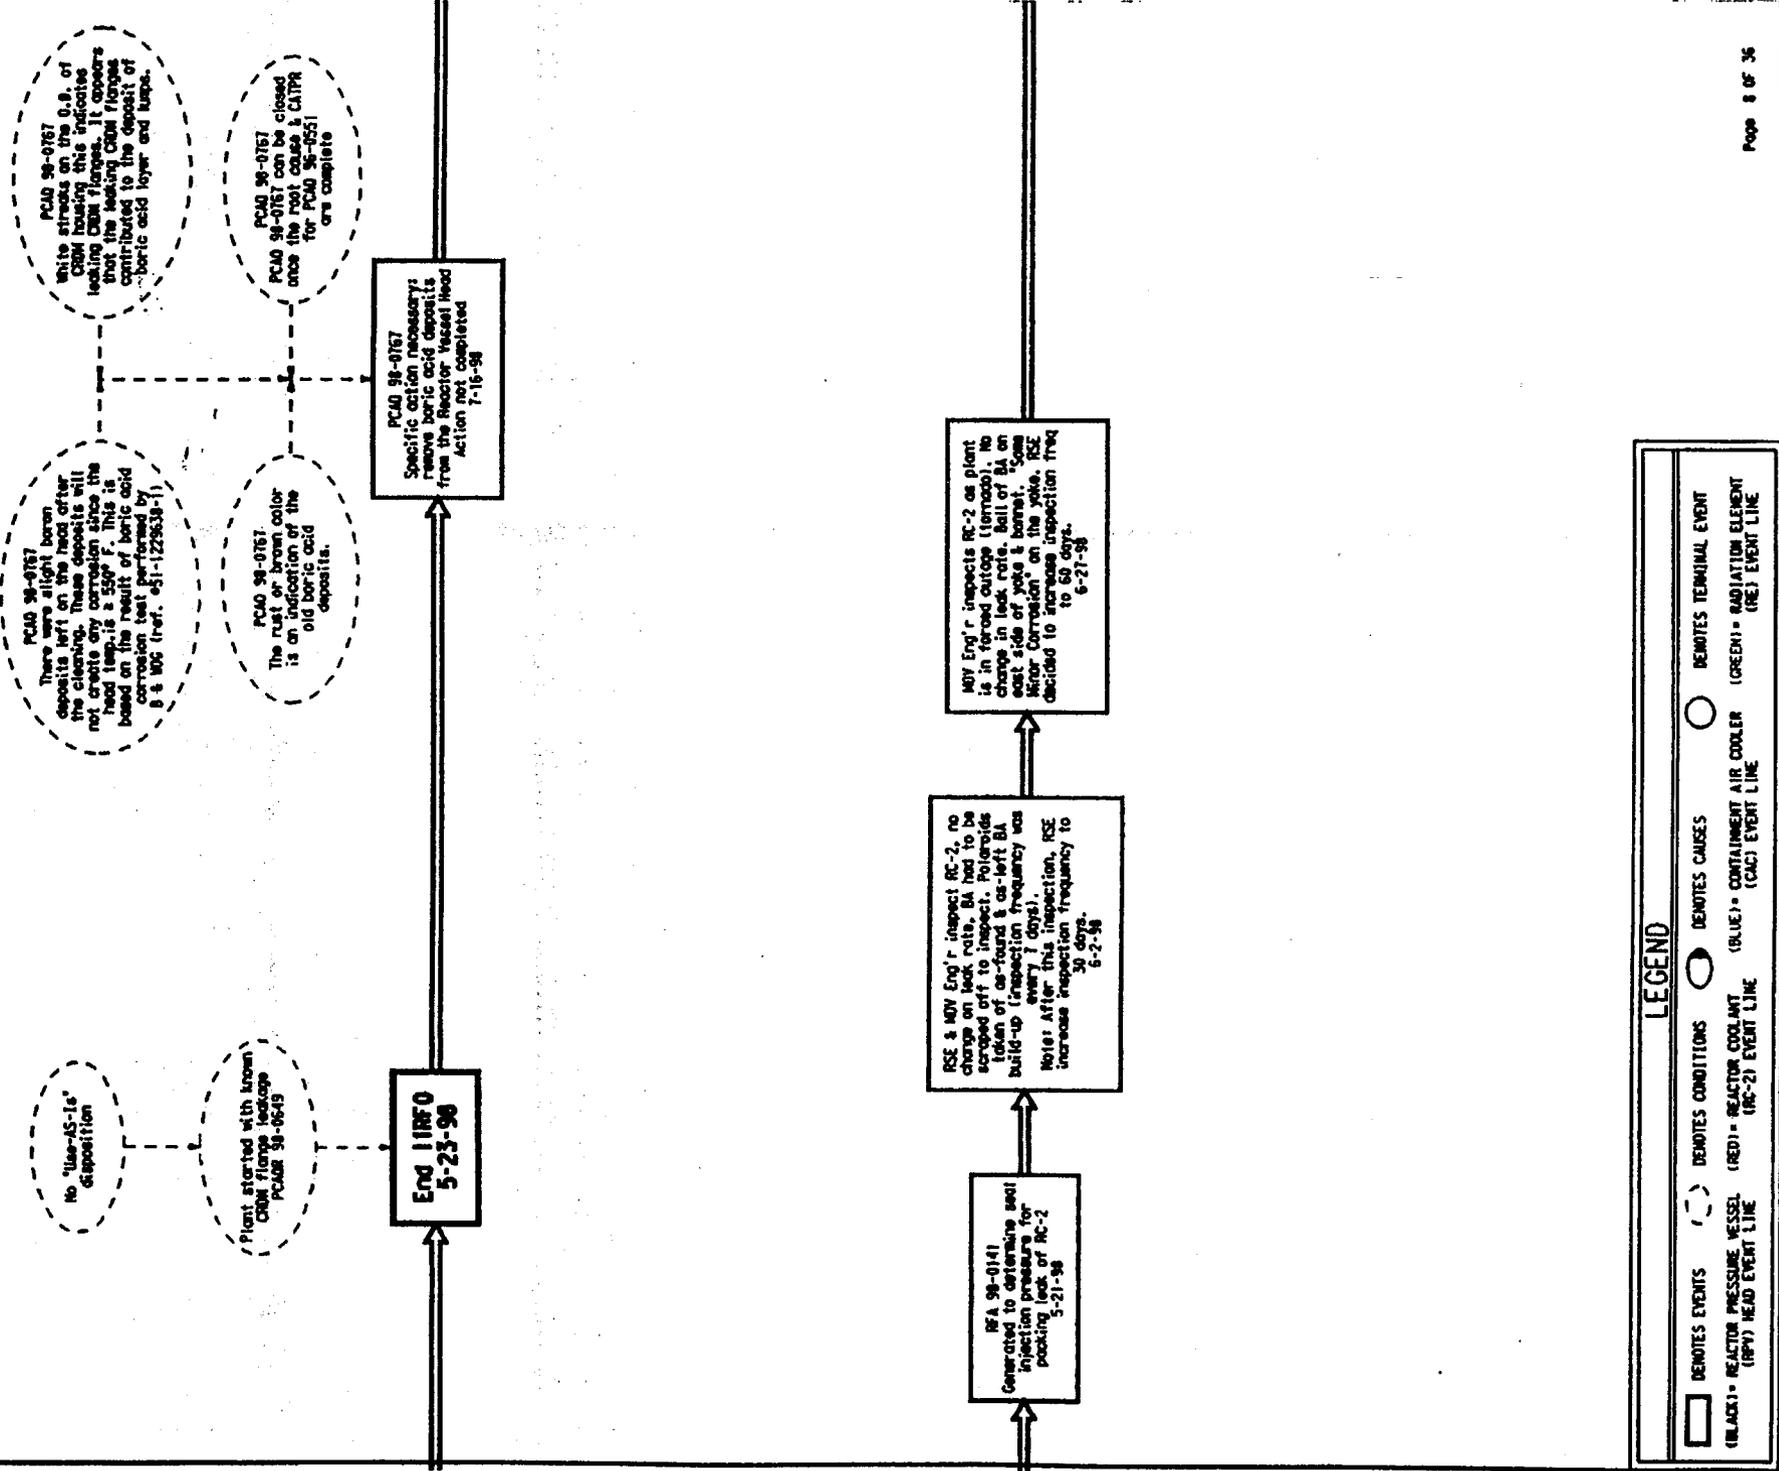
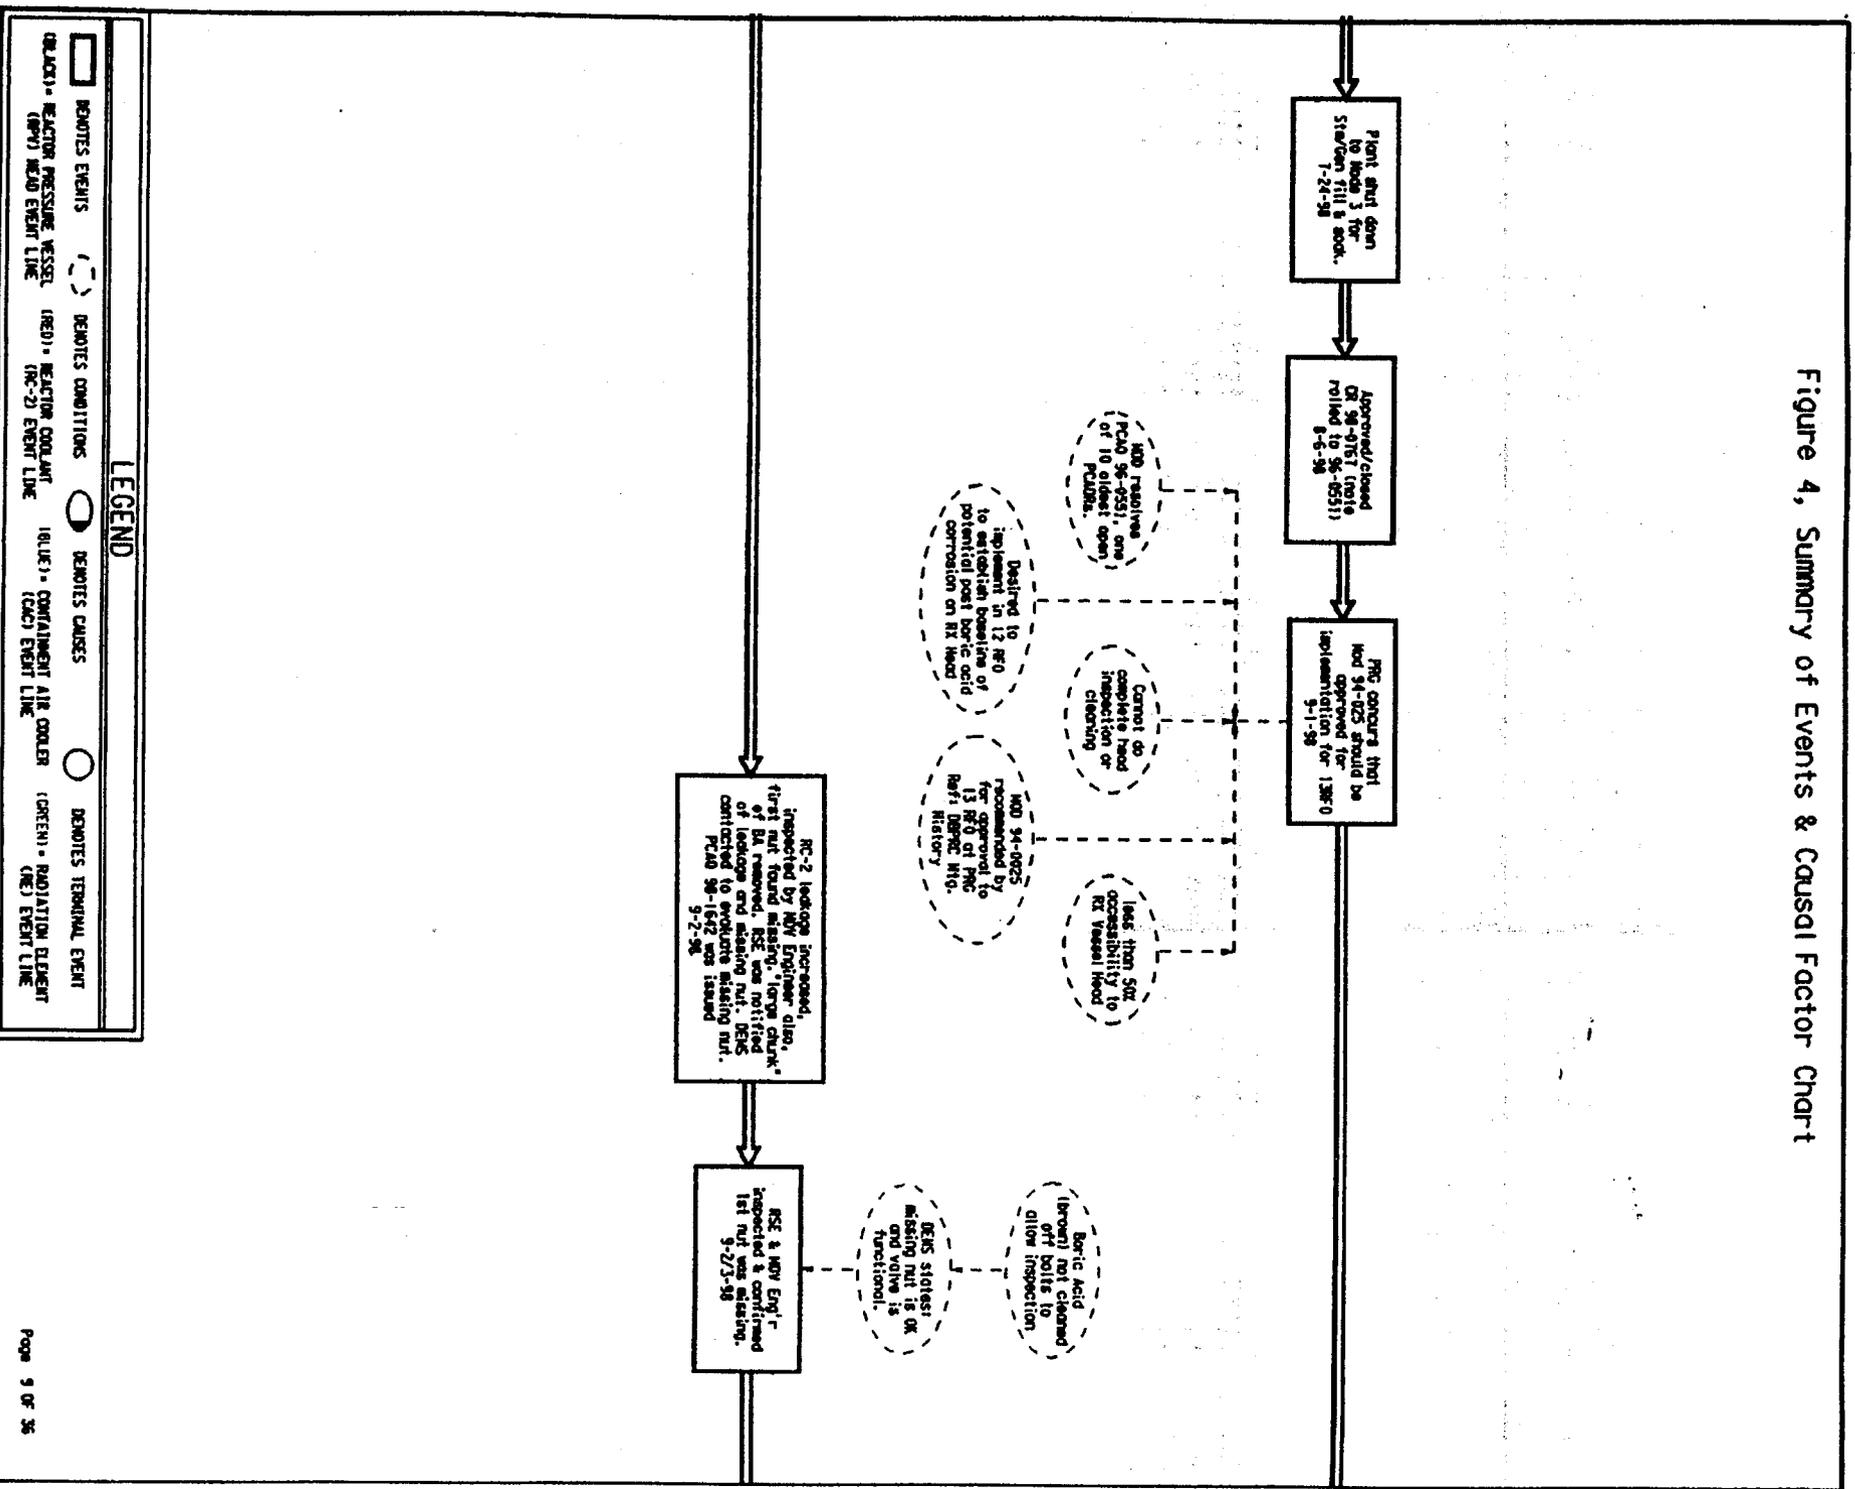
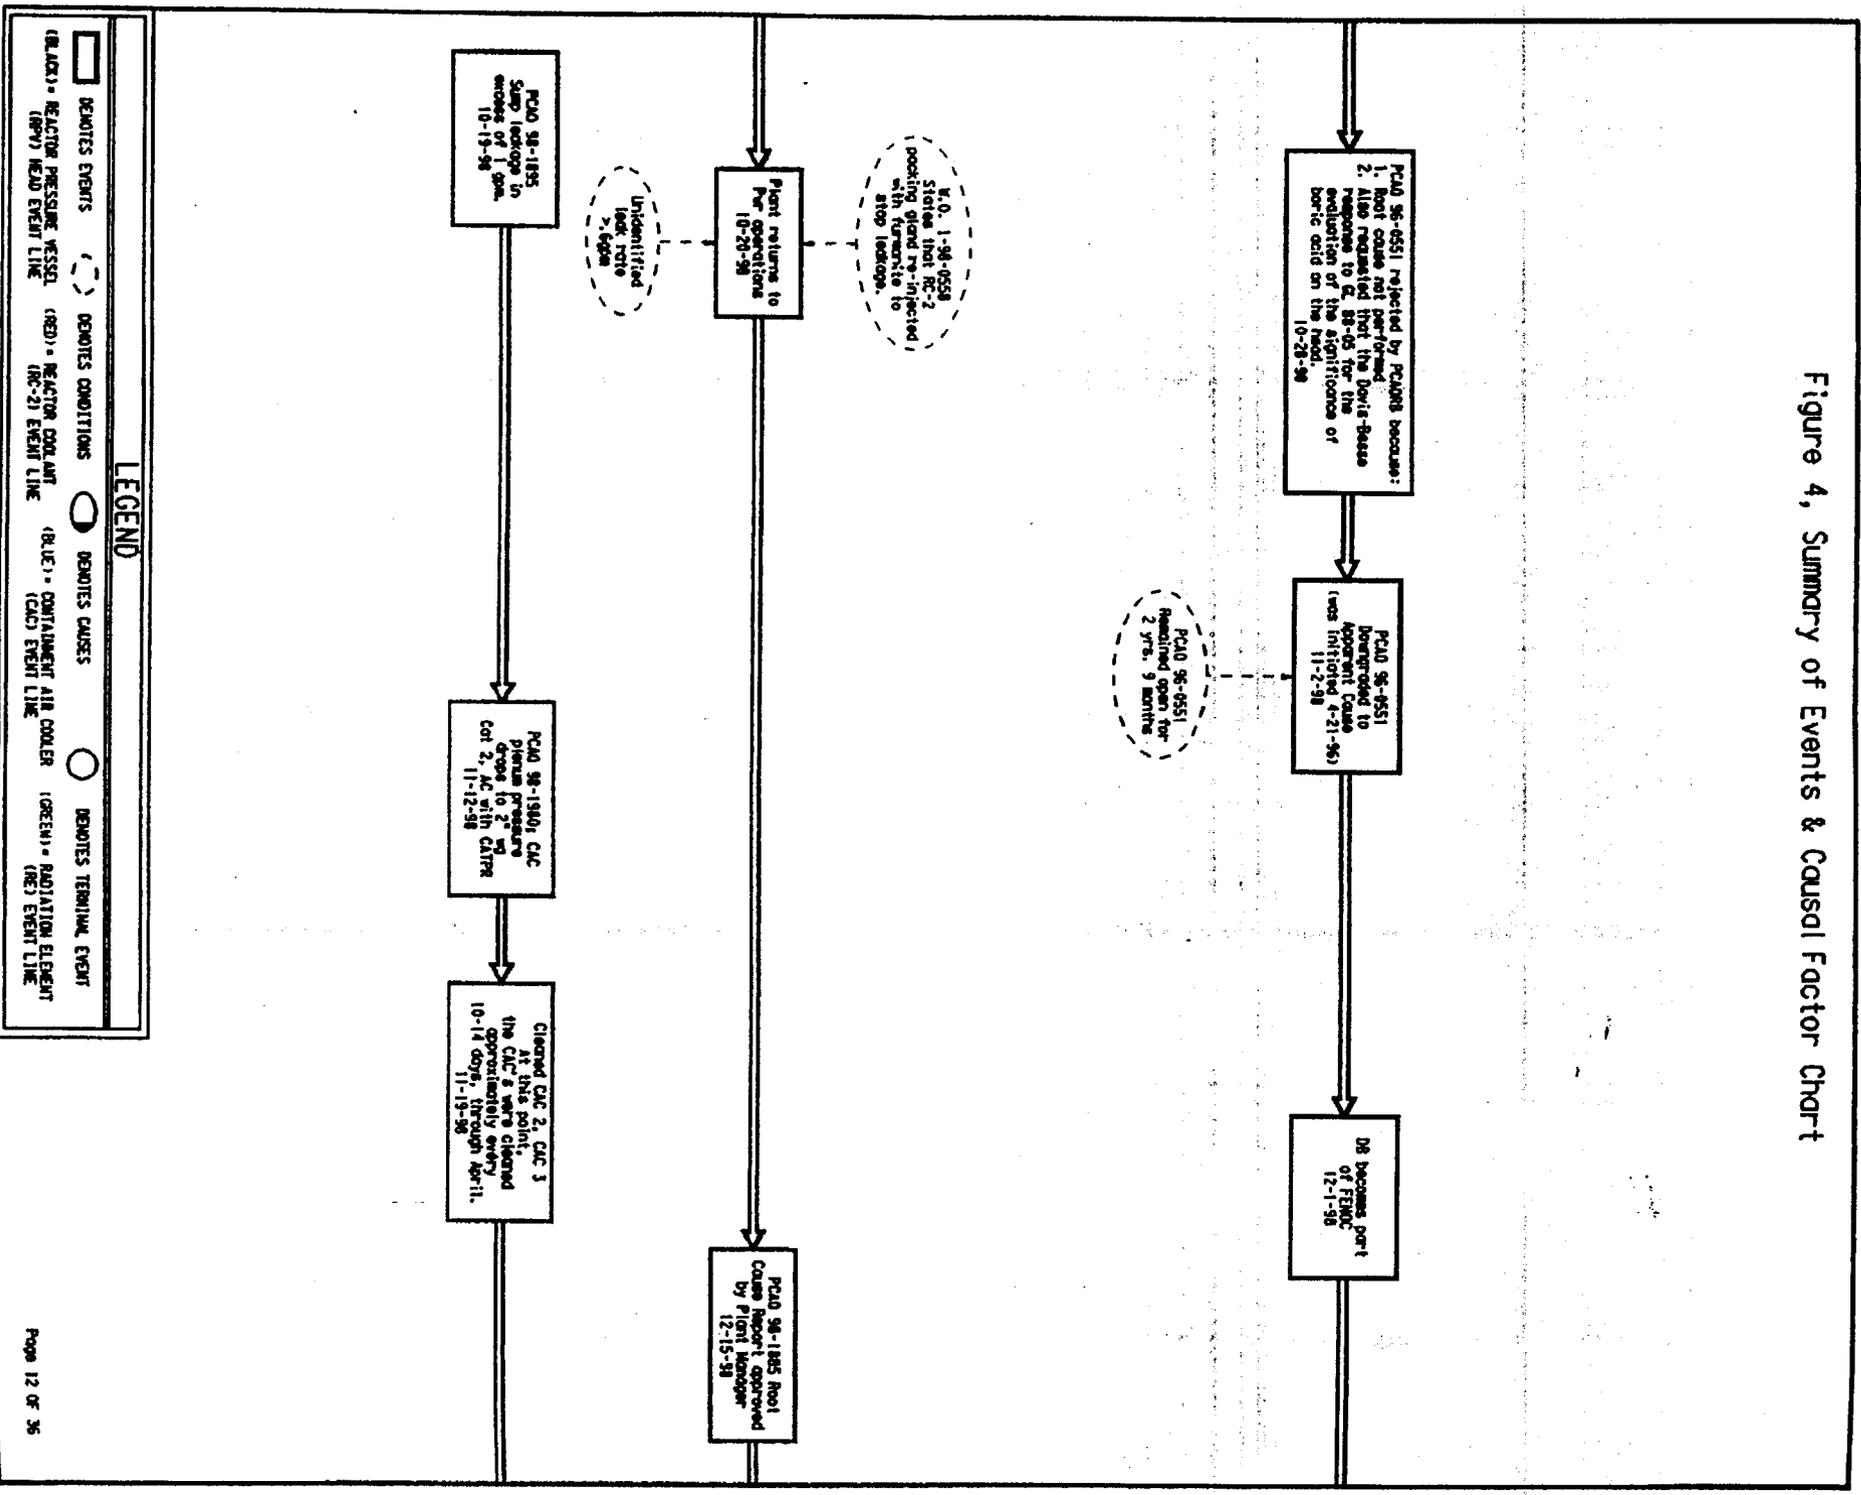
Figure 4, Summary of Events & Causal Factor Chart

- DENOTES EVENTS
  - DENOTES CONDITIONS
  - DENOTES CAUSES
  - DENOTES TERMINAL EVENT
- (BLACK) = REACTOR PRESSURE VESSEL (RPV) HEAD EVENT LINE   
 (RED) = REACTOR COOLANT (RC-2) EVENT LINE   
 (BLUE) = CONTAINMENT AIR COOLER (CAC) EVENT LINE   
 (GREEN) = RADIATION ELEMENT (RE) EVENT LINE
