CORPORATION
Crystal River Unit 3
Docket No. 80-302
Operating License No. DPR-72

Subject: Biological Assessment for Crystal River Unit 3 (TAC No. MA1706)

Biological Assessment of Impact to Sea Turtles at Florida Power Corporation's Crystal River Energy Complex

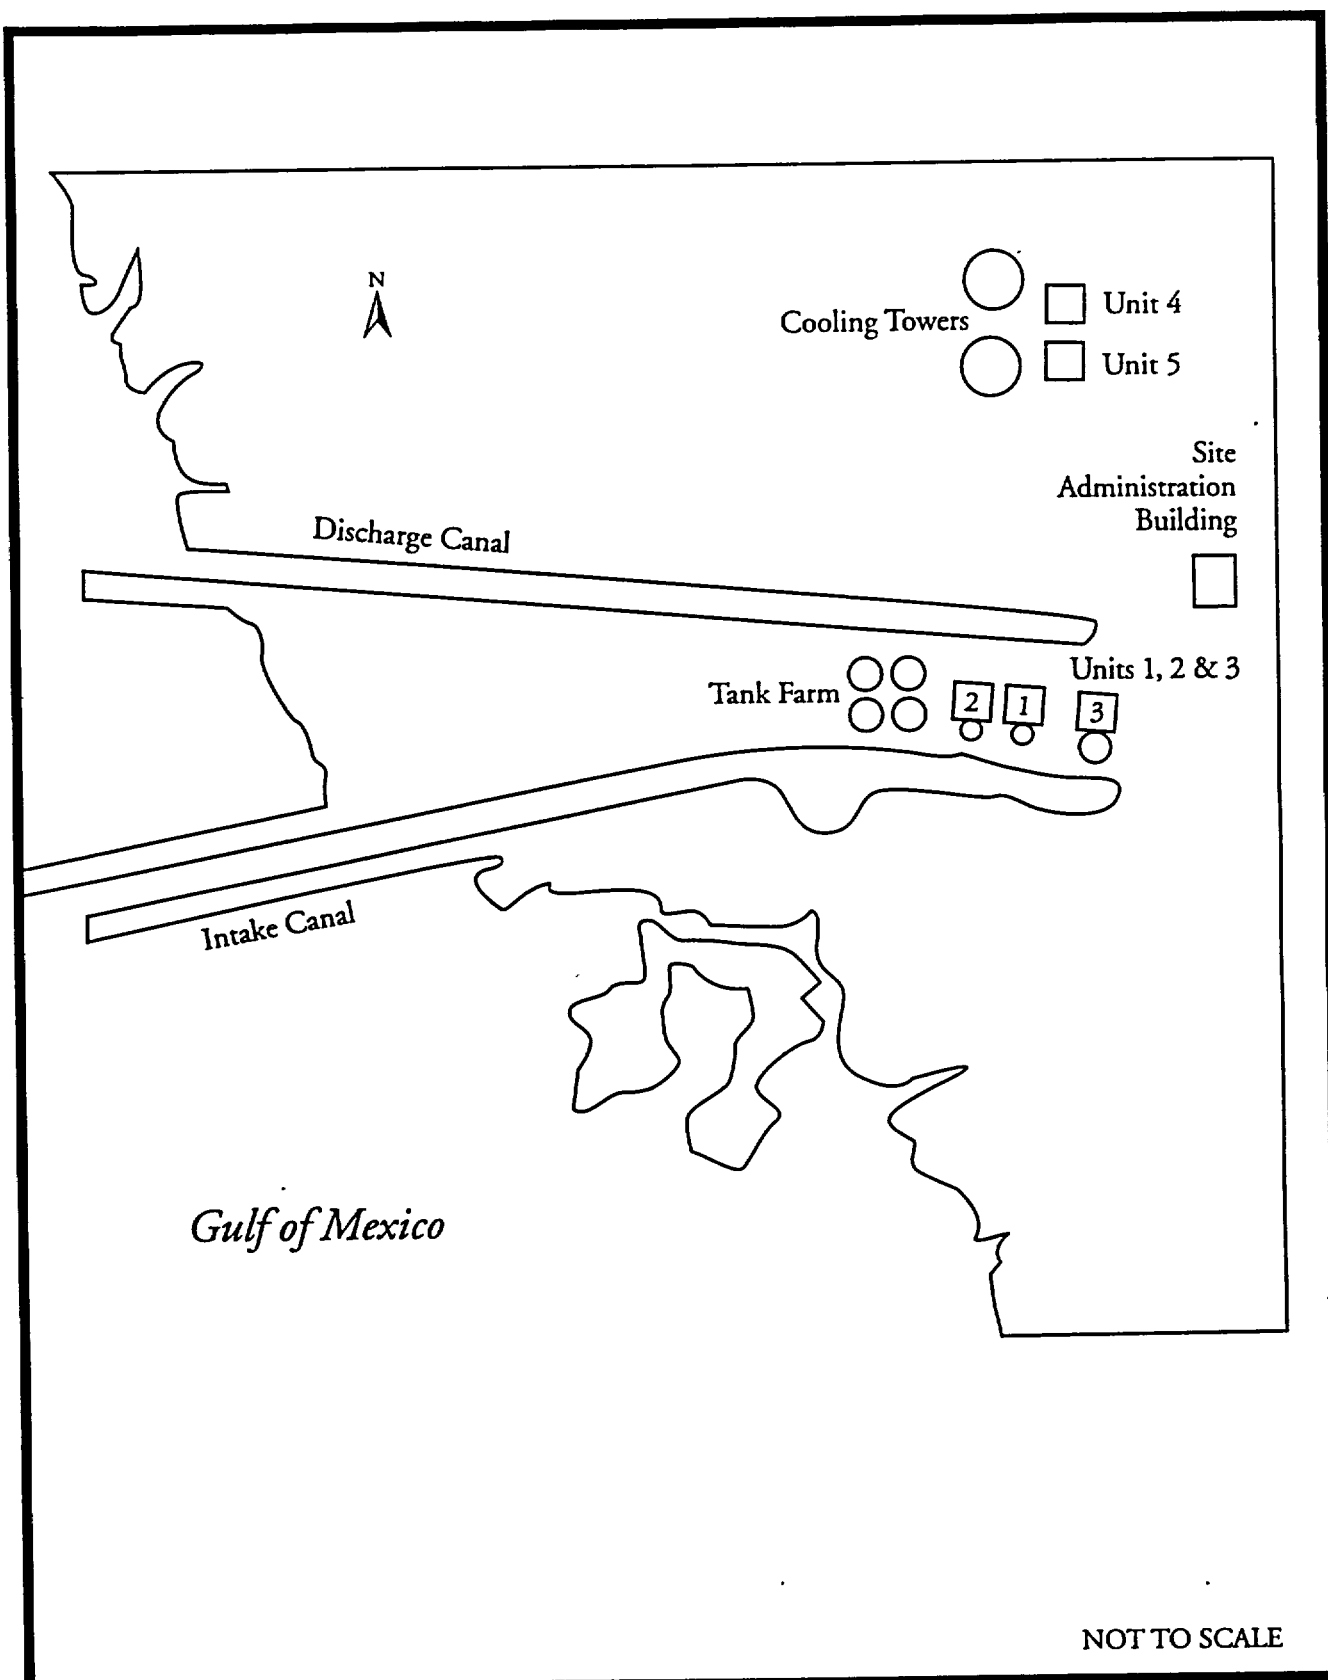
FIGURE 2

Site layout of the Crystal River Energy Complex.

The Crystal River Energy Complex contains five separate power plants (Figure 2). Unit 1 is an approximately 400 MW electric (MWe) coal-fueled plant, which began commercial operation in October 1966. Unit 2 is an approximately 500 MWe coal-fueled plant, which began commercial operation in November 1969. Unit 3 is an approximately 890 MWe pressurized water, nuclear-fueled plant, which began commercial operation in March 1977. Units 4 and 5 are two coal-fueled plants at approximately 640 MWe each. Units 4 and 5 began commercial operation in December 1982 and December 1984, respectively.

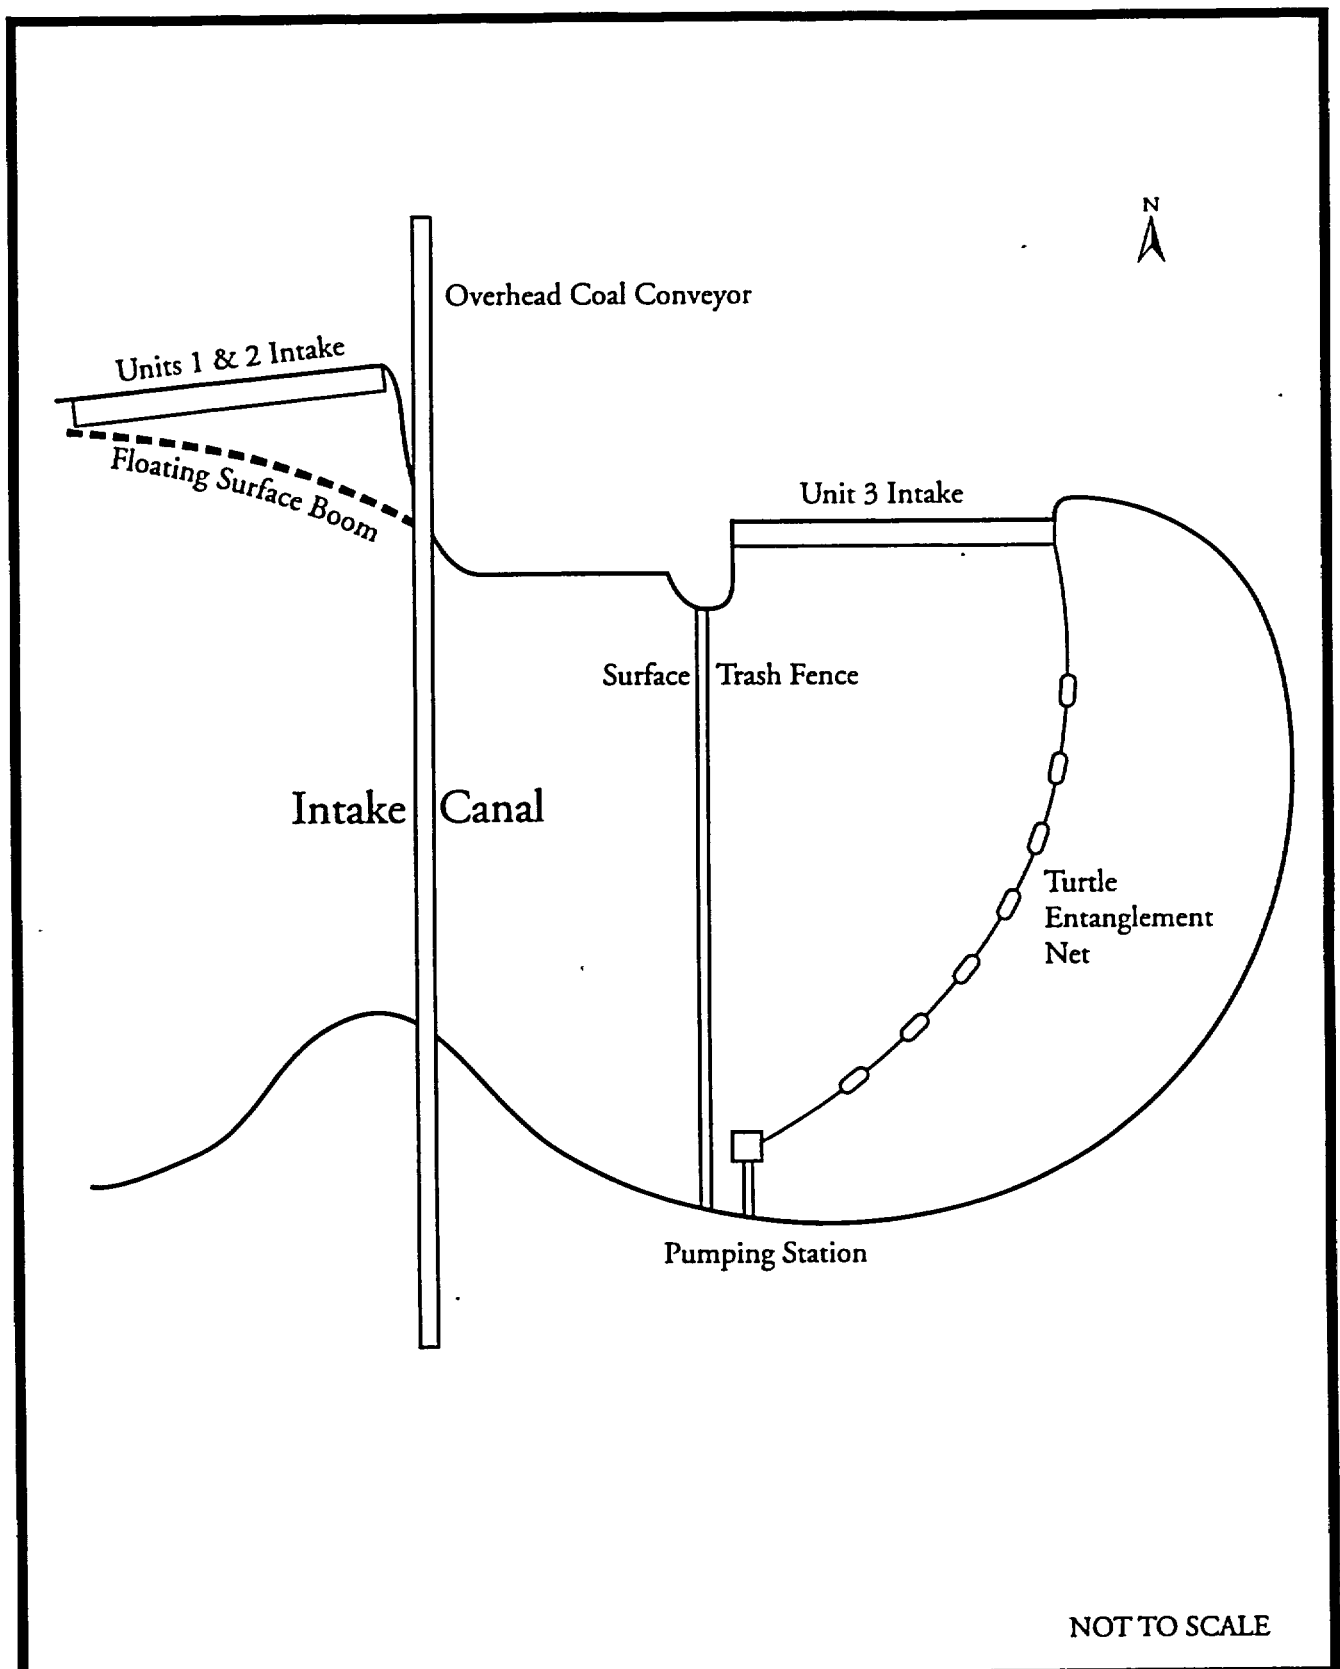
FIGURE 3

Orientation of turtle entanglement net deployed in the intake canal.

The consultant deployed a 45 m long, 6 m deep net in front of the Unit 3 intake structure (Figure 3). The net was deployed during daylight hours and fished for a total of 16 hours over three days. The net was constantly monitored from a johnboat while being fished. No turtles were captured during the netting effort, although turtles were observed in the intake canal. FPC has pursued improved netting techniques to increase the likelihood of turtle capture success should subsequent netting attempts be considered.

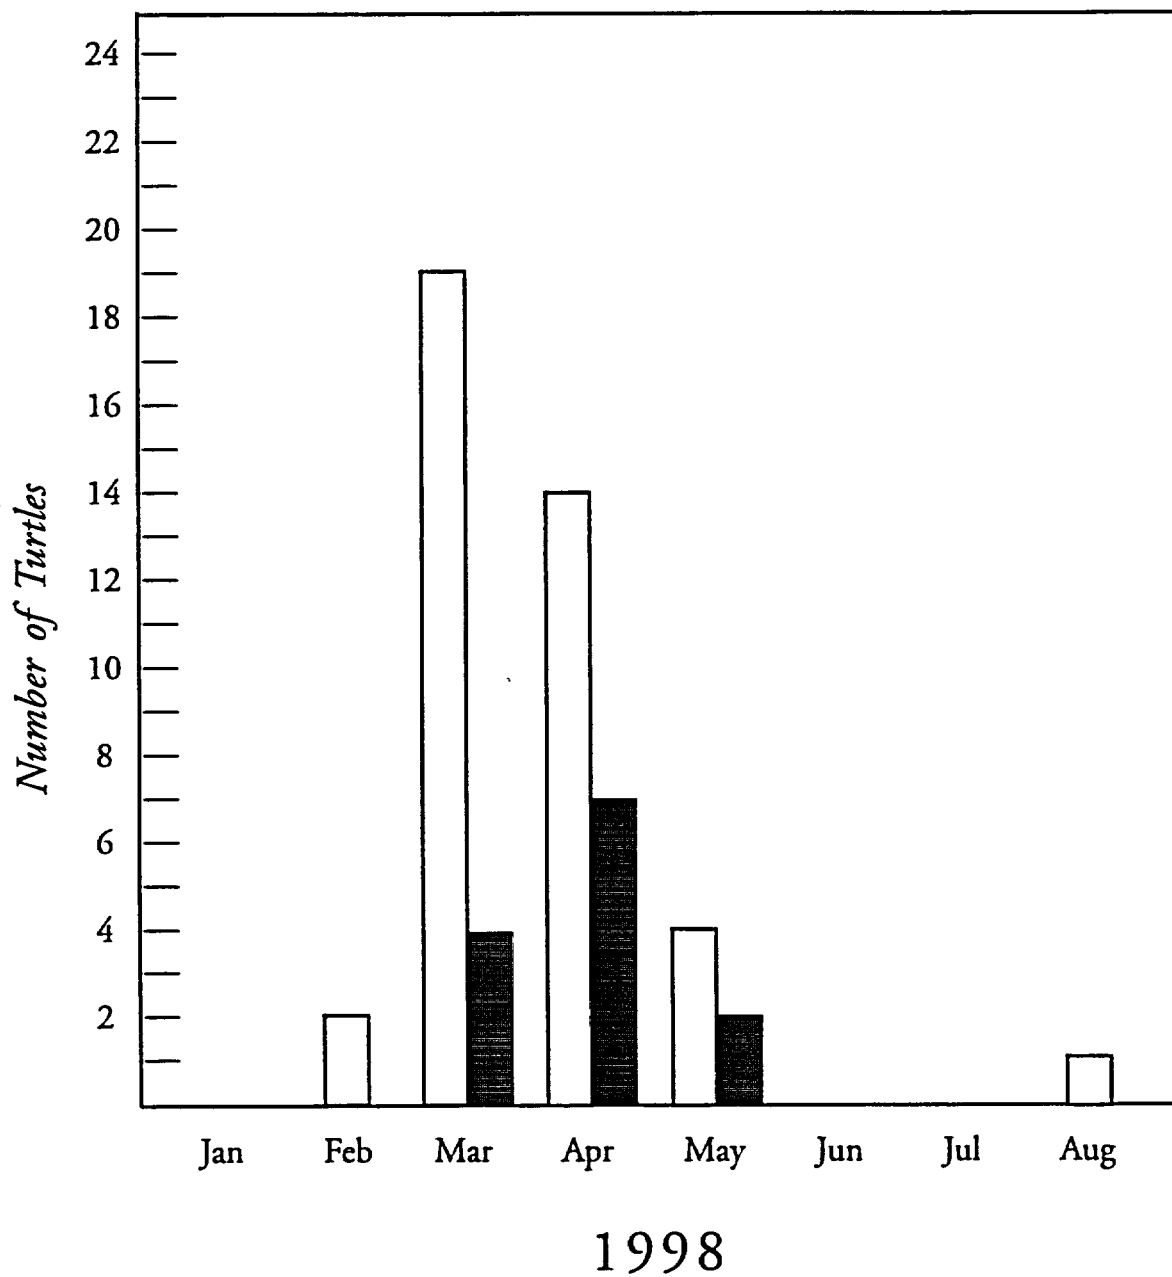
FIGURE 4

Rescued Live Strandings

Mortalities – All Causes

Total number of live and dead sea turtles recovered at the Crystal River Energy Complex from January through August, 1998.

From February 6, 1998, through May 24, 1998, a total of 38 sea turtles (Figure 4) were rescued live and released or relocated to a rehabilitation facility. Of those, 37 were Kemp's ridley. In addition, on August 12, 1998, a green sea turtle was rescued which was severely debilitated by fibropapillomatosis. All of these turtles were sub-adults, ranging from a straight carapace length of approximately 21 cm to 55 cm. A total of 13 sea turtle mortalities have been recorded. Eight mortalities can be attributed to factors other than the operation of the power plants. These were floating carcasses drawn into the intake canal by the water current. These carcasses eventually become stranded on the intake bar racks or debris screens.
