RS-02-205

Subject: Response to Request for Additional Information Supporting a License Amendment Request Revising the Technical Specifications Surveillance Requirements for Containment Spray Nozzles

**Response to Request for Additional Information Supporting a License Amendment
Request Revising the Technical Specifications Surveillance Requirements for
Containment Spray Nozzles**

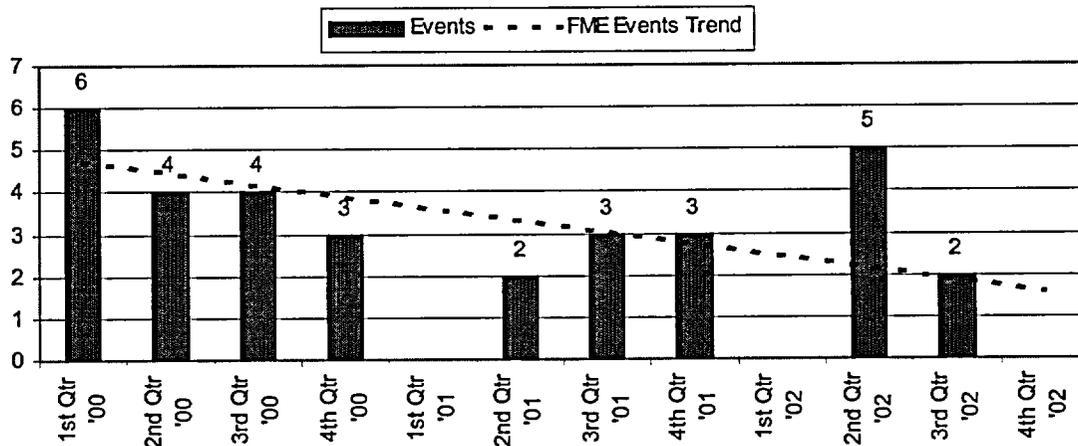
Loss of Foreign Material Integrity Events

The above information clearly shows that there have been FME issues at Braidwood Station in the past; however, none of the FME events involved the CS system. The FME issues/problems have been well documented and entered into the station's corrective action program. Based on the above discussion, there remains high confidence that the CS System is free of foreign material.

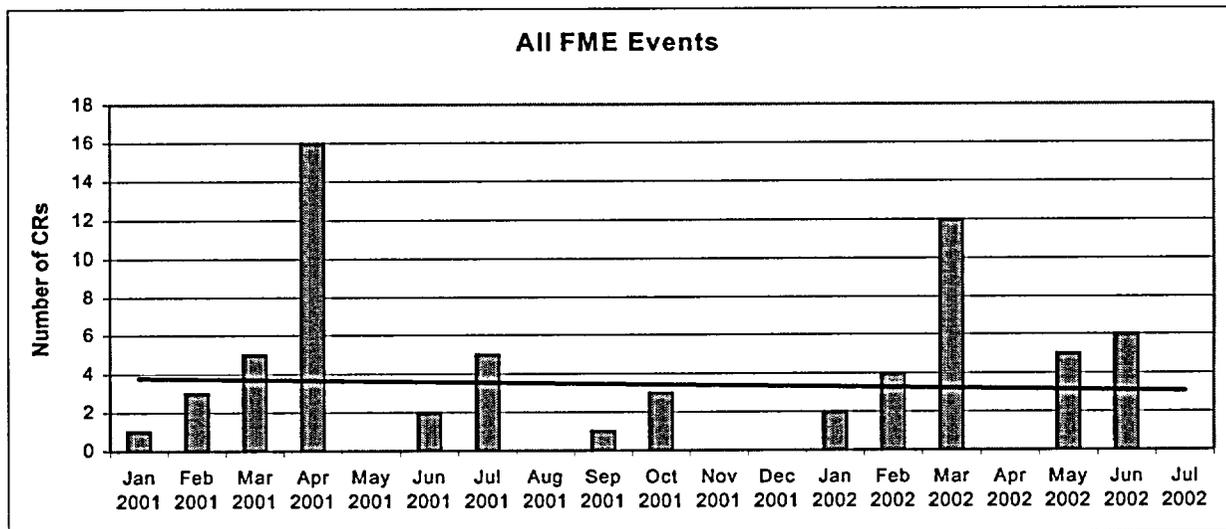
None of the 65 FME events involved the CS system.

As depicted on the below graph, the overall FME event trend has been on a slightly improving trend over the duration of the analysis (i.e., January 2001 through July 2002).
