Entergy

Subject: Arkansas Nuclear One - Units 1 and 2
Docket No. 50-313; 50-368
License No. DPR-51; NPF-6
Inspection Report 50-313; 368/01-06
Significance Determination Process Technical Information

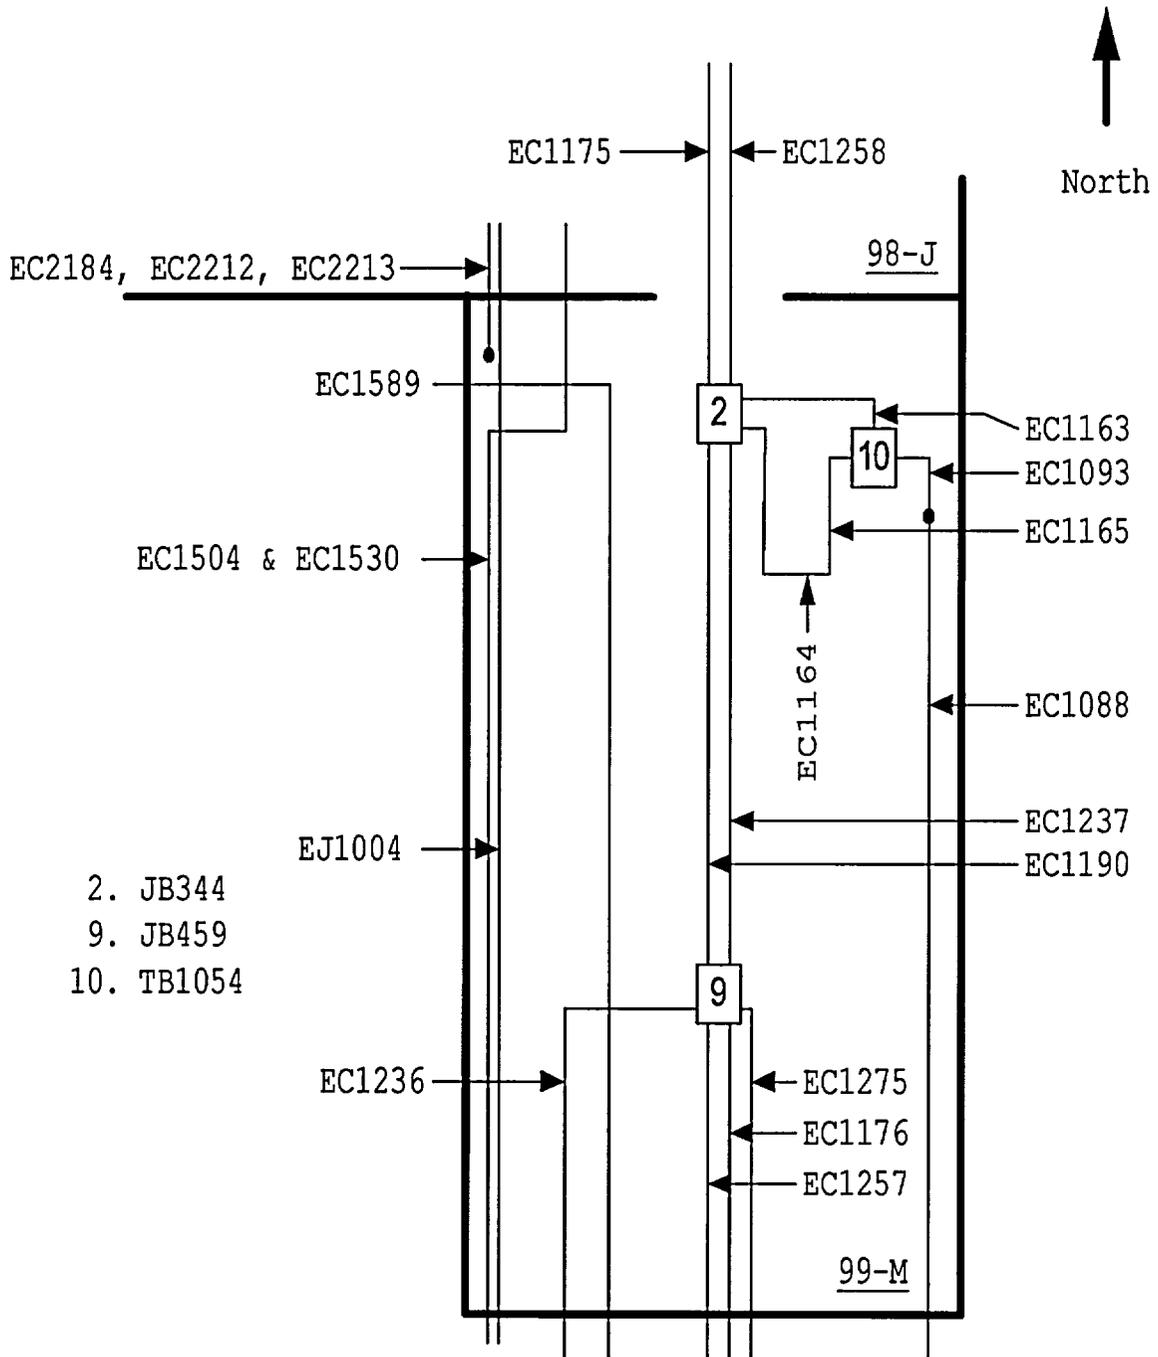
Raceways Located in Zone 99-M

3) Raceway Layout – This following sketch identifies the location of the raceways of interest in Zone 99-M.
