CAP029952 identified that a potential existed for a common mode failure where all AFW pump recirculation lines could have restricted flow rates (due to orifice plugging) resulting in eventual pump failure. The purpose of this investigation is to determine the root and contributing causes of why that potential existed and why the condition was not identified previously.

Low AFW line recirculation flow was identified during performance of IT 10 following maintenance on AFW pump P-38A. During troubleshooting, the restricting orifice (RO) from the AFW recirculation line was removed and inspected. Corrosion product debris was found in almost half of the holes in the outer cylinder of the orifice. Additional discussions identified a concern that the limiting dimensions of the orifice were smaller than the service water strainers and a potential existed for the orifices to become plugged when AFW was aligned to its safety-related source (service water) during accident response. The AFW ROs had been installed as modifications between November 2000 and September 2002.

- *DBD-01 describes a safety-related function of the orifice to provide sufficient flow to prevent low-flow instabilities

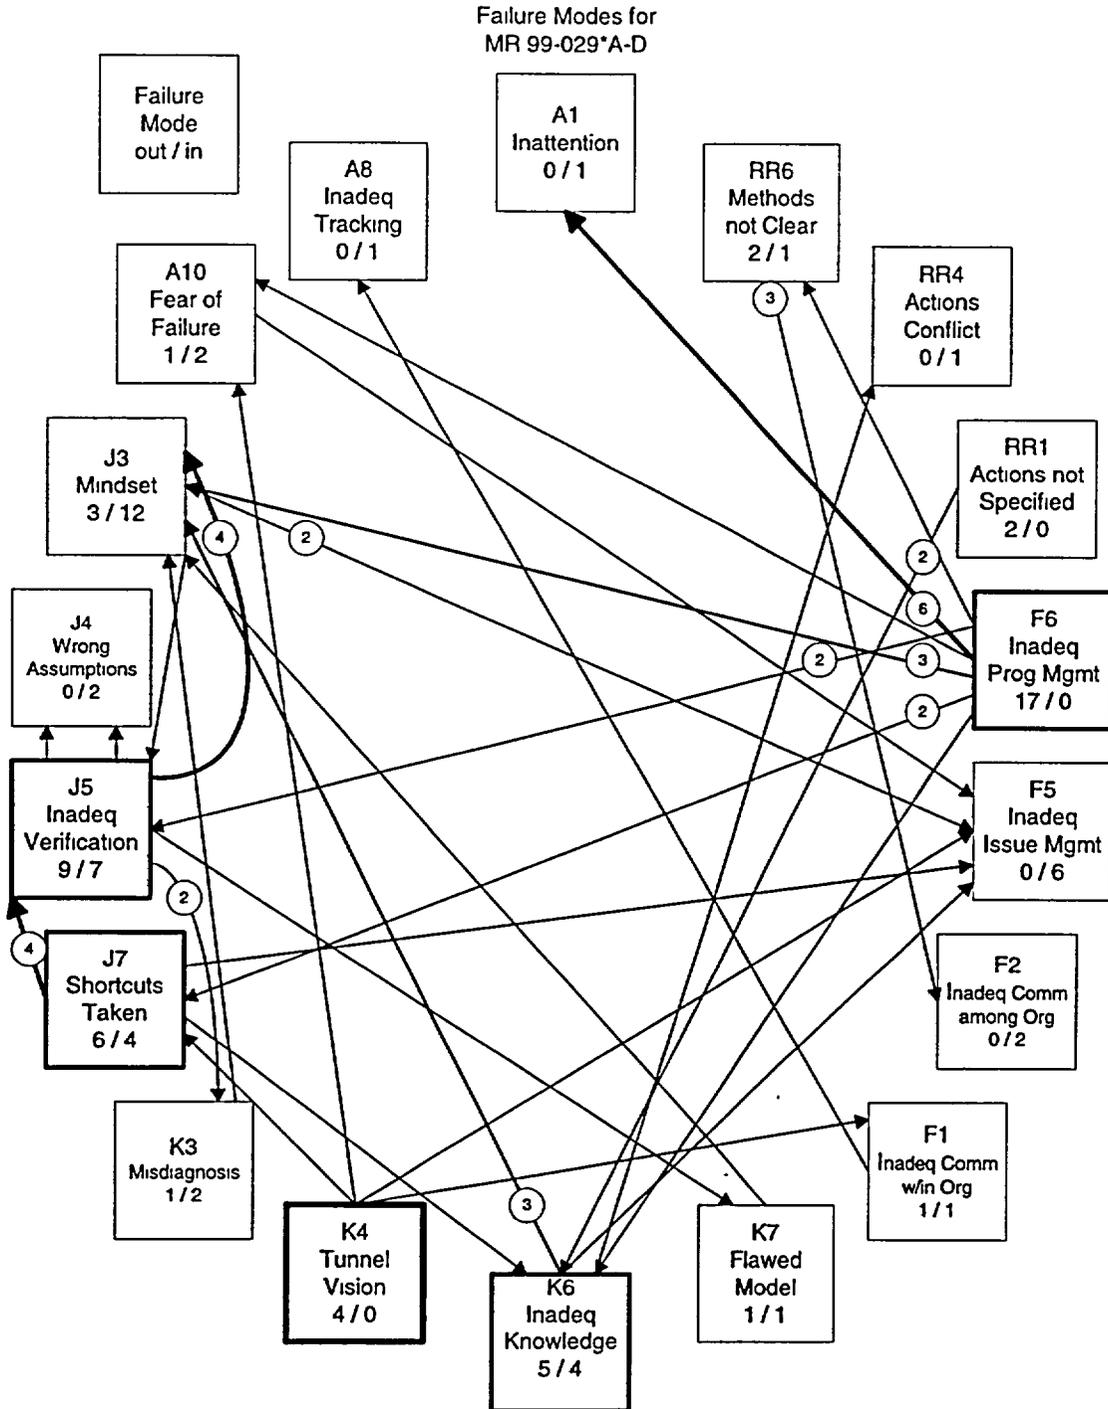
Attachment C – Stream Analysis

Failure modes with a high number of arrows out of their box are the drivers of the event.
