2. Calculation Title
Waste Package Misload Probability

3. Document Identifier (including Revision Number)
CAL-WHS-MD-000001 REV 00

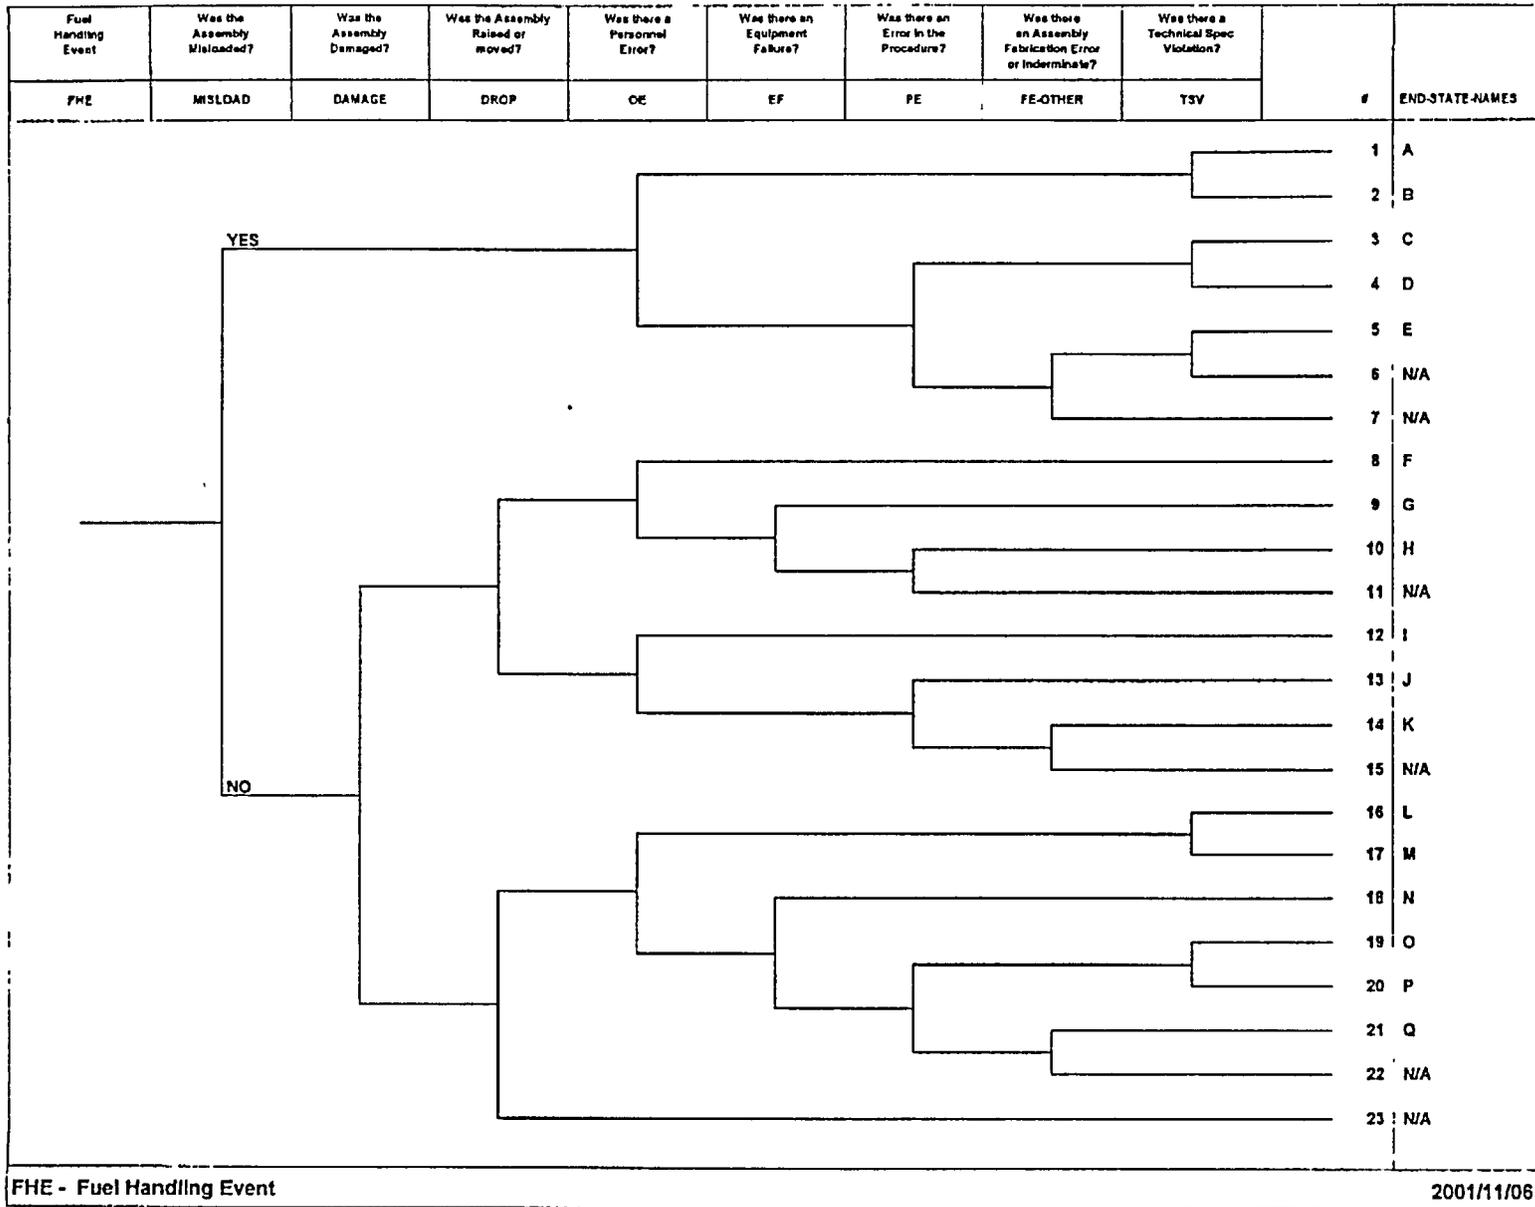
Using the top events listed above, the event tree shown in Figure 1 was created in SAPHIRE V6.69 (STN: 10325-6.69-00). SAPHIRE V6.69 is a state-of-the-art computer code for performing probabilistic risk analysis (PRA) evaluations. The top events of the event tree are queried from left to right. The branching below the top events are used to determine the specific path through the event tree. The branching under each top event follows standard event tree convention that requires "success" or "YES" answers to branch up and "failure" or "NO" answers to branch down. After correctly defining the branching under each top event, a total of seventeen fuel-handling end state categories were identified. The various end state categories are listed below along with a brief description as to the type of fuel-handling event they represent.

- A – FA misload caused by human error resulting in a technical specification violation
- B – FA misload caused by human error but no technical specification violation

- C – FA misload caused by procedure error resulting in a technical specification violation
- D – FA misload caused by procedure error but no technical specification violation

- E – FA misload caused by fabrication/indeterminate error resulting in a technical specification violation
- F – FA damage caused by human error
- G – FA damage caused by equipment failure or equipment design

- H – FA damage caused by fuel-handling procedure error or deficiency
- I – No FA movement, but the FA was damaged due to human error
- J – No FA movement, but the FA was damaged due to procedure error or deficiency

- K – No FA movement, but the FA was damaged due to fuel fabrication/indeterminate error
- L – No FA damage, but human error during an FA movement caused a technical specification violation

FHE - Fuel Handling Event

- M – No FA damage, but human error occurred during an FA movement, though not leading to technical specification violation
- N – No FA damage, but equipment failure or design during an FA movement caused the event
- O – No FA damage, but fuel-handling procedure error or deficiency during an FA movement caused a technical specification violation
- P – No FA damage, but fuel-handling procedure error or deficiency during an FA movement resulted in the event, though no technical specification violation occurred
- Q – No FA damage, but fuel fabrication or indeterminate error during an FA movement caused the event

Given the information about the fuel-handling event and the top event definitions provided in Section 5.1, the event tree will be used to categorize this event. The first top event questions whether the event was a MISLOAD. The answer to this top event is "YES." The FA was placed in the wrong location of the SFP. The next top event that is questioned along this path is OE. This top event questions whether the event was caused by human error. Based on the information, plant personnel specified the wrong SFP location. Therefore, the answer to this top event is "YES." The next and last top event to be questioned on this branch path is TSV. This top event questions if a plant technical specification was violated. The answer to this top event is "YES." This specific branch path leads to the end state A. This event is categorized into end
