Re: St. Lucie Unit 2
Docket No. 50-389
Order (EA-03-009) Relaxation Requests 1 and 2
Examination Coverage of Reactor Pressure
Vessel Head Penetration Nozzles – Supplemental Data

**ST. LUCIE UNIT 2 RELAXATION REQUEST NO. 1
FROM US NRC Order EA-03-009**

**ST. LUCIE UNIT 2 RELAXATION REQUEST NO. 2
FROM US NRC Order EA-03-009**

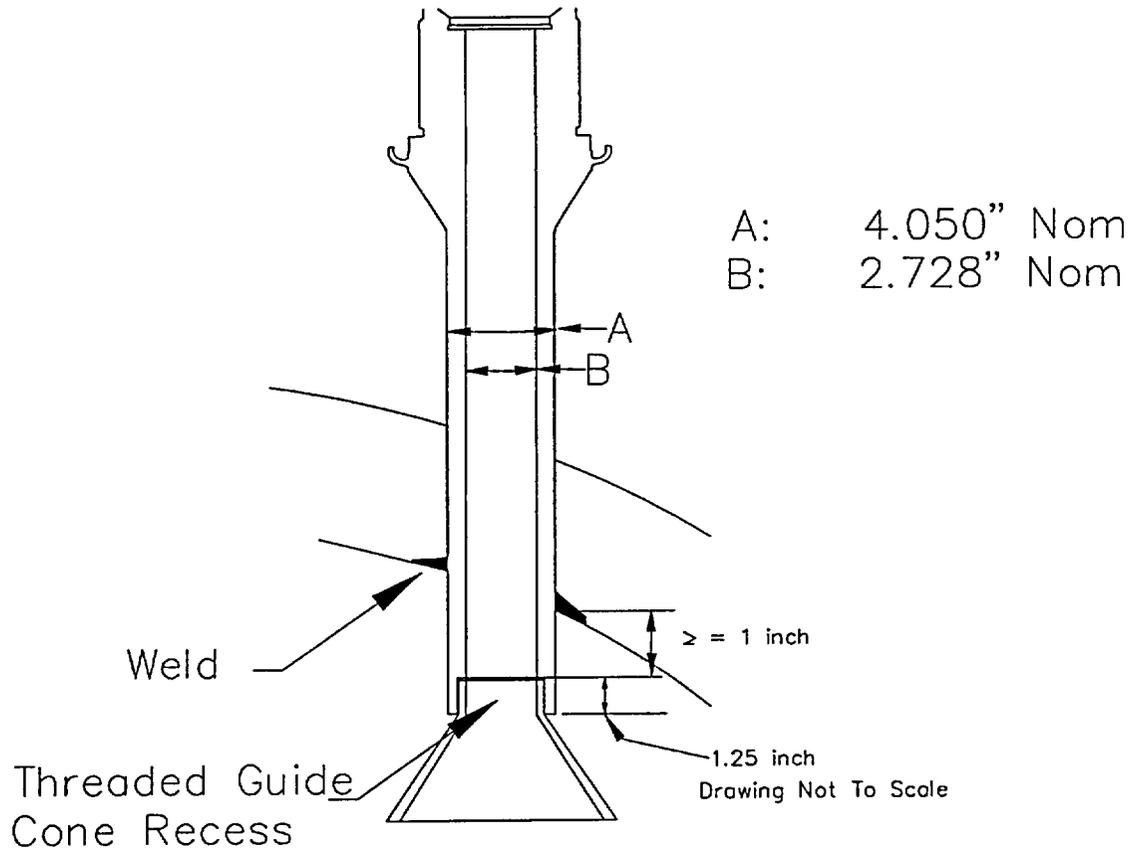
Figure 1: Typical RPV Nozzle with Threaded Guide Funnel

Pursuant to Order Section IV.F.(2) "Compliance with the Order for specific nozzles would result in hardship or unusual difficulty, without a compensating increase in the level of quality and safety", FPL is requesting this relaxation for St. Lucie Unit 2. The 91 CEDM nozzles contain areas that will have less coverage than required by the NRC Order. The Order requires examination from two inches above the J-groove weld to the bottom of the RPV head penetration nozzle. The reduced coverage is caused by the nozzle configuration, and the limitations of probe design used for the Ultrasonic (UT) examination. Specifically, actual coverage below the weld, in the non-pressure boundary portion of the nozzle, is precluded by the threaded area used for attachment of the guide cone as shown in Figure 1.

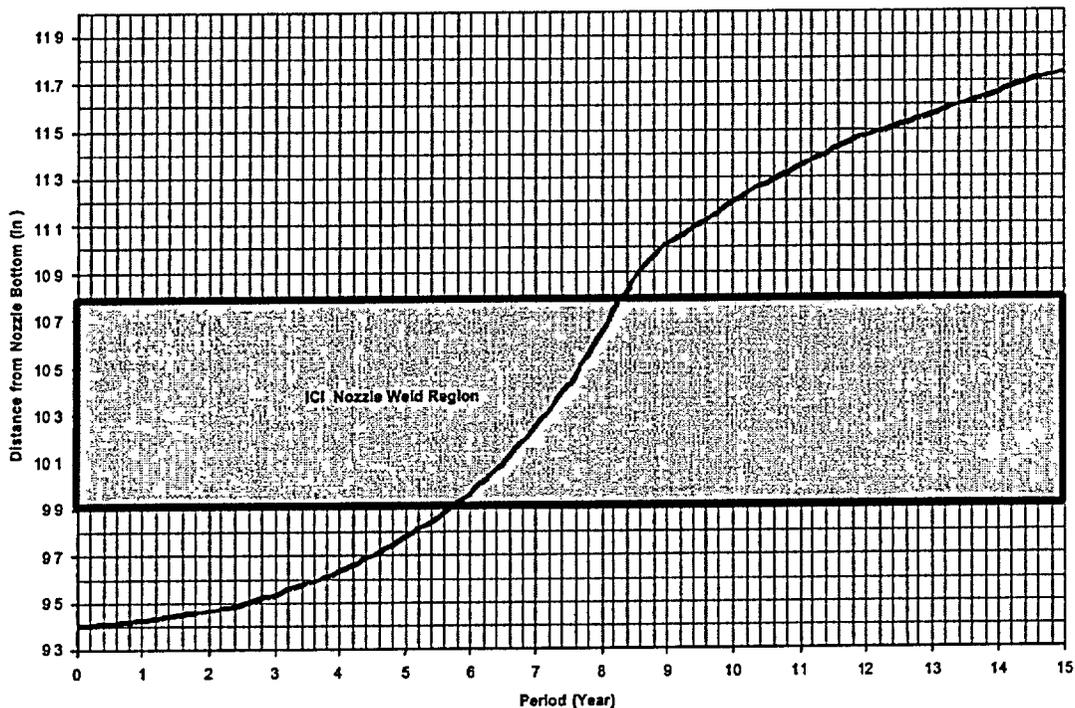
Figure 2: Through-Wall Axial Flaws Located in the 55.3 Degrees Row of Penetrations, Uphill Side - Crack Growth Predictions (From Figure 6-19, WCAP-16038-P)

flaw to grow from the bottom of the weld through the pressure boundary. Figure 2 provides a graphical presentation of the above flaw evaluation discussion for the outer most penetration location.

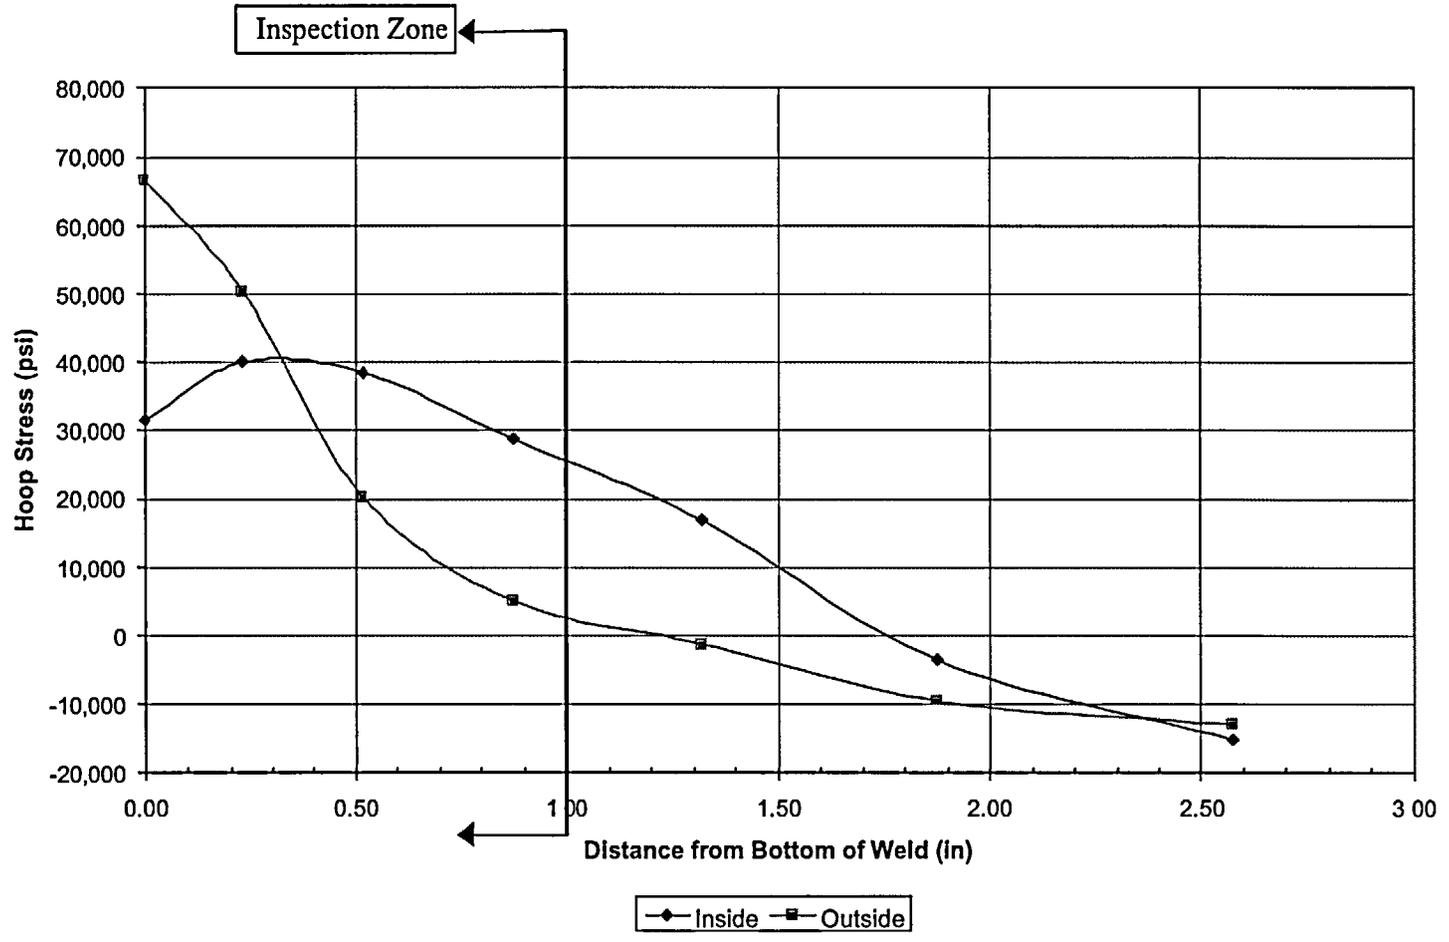
Figure 3: Hoop Stress Vs Distance from Bottom of Weld Plot for the Center CEDM Penetration

Figures 3 to 9 provided below (Appendix E, Figures E-1 through E-7 of WCAP-16038-P), show the hoop stress distribution as a function of distance from the bottom of the weld. These are the same nozzles whose stress distribution is shown in Figures 5-4 through 5-7 of WCAP-16038-P. These figures provide assurance that the stress levels below one inch are quite low, thereby reducing the potential for cracking.

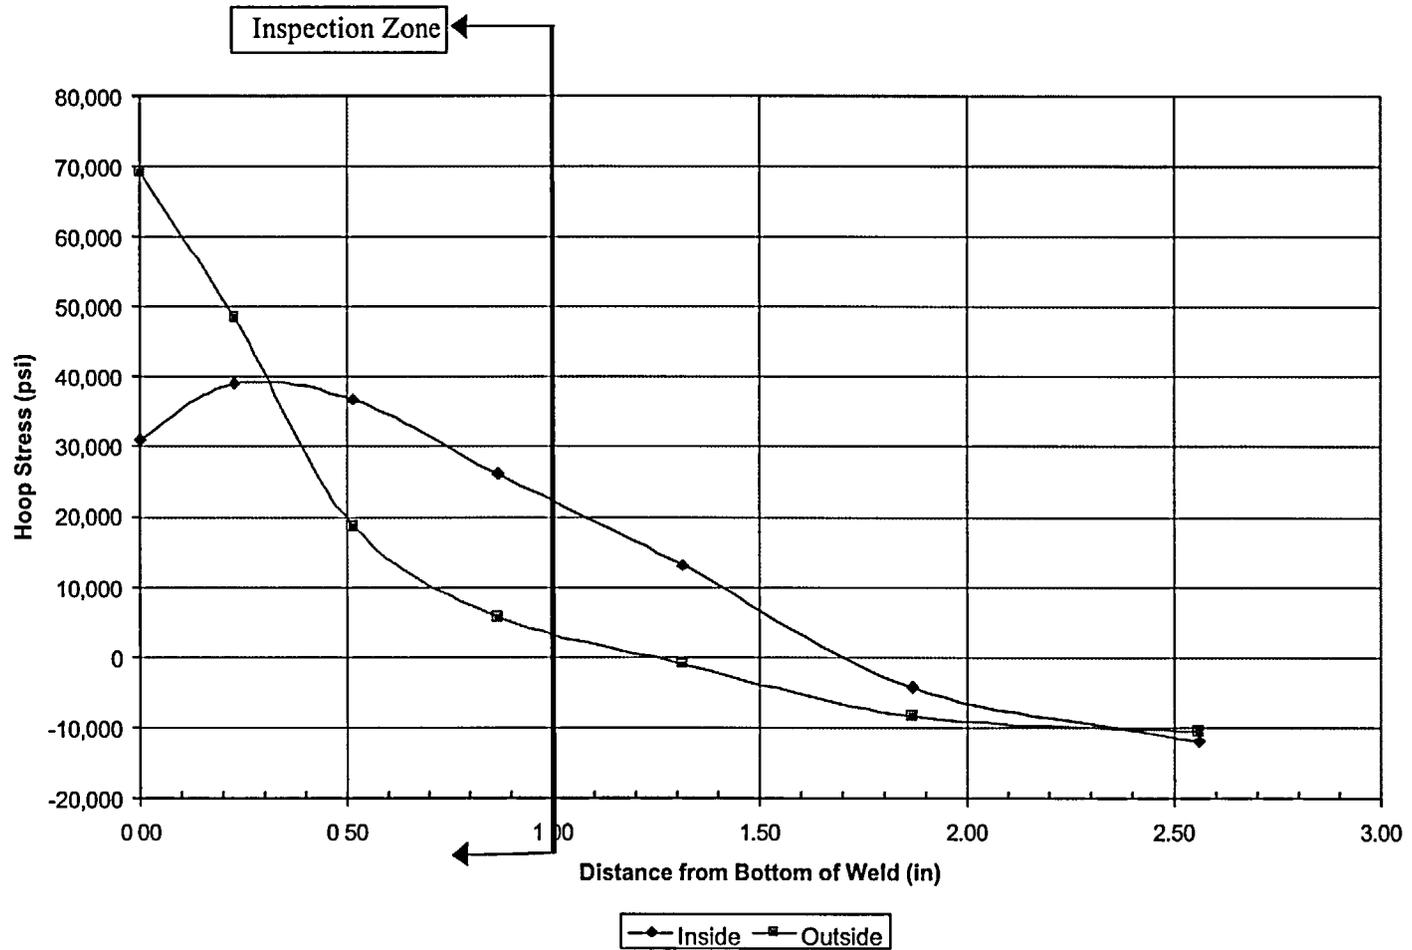
Figure 4: Hoop Stress Vs Distance from Bottom of Weld Plot for the 7.8 Degrees Row of Penetration, Downhill Side

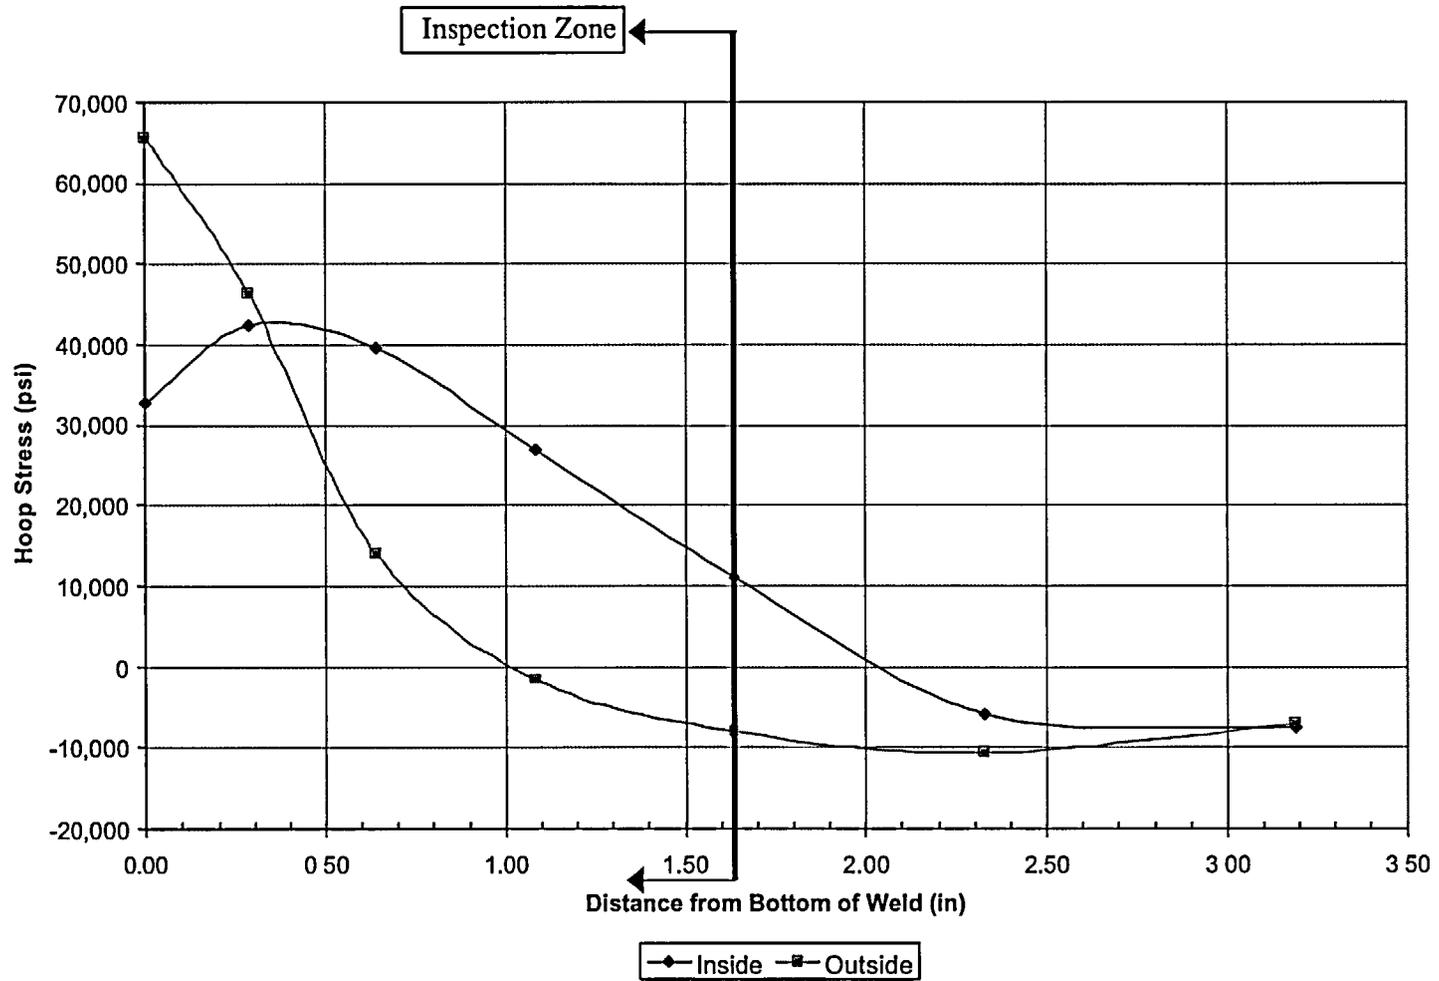
Figure 5: Hoop Stress Vs Distance from Bottom of Weld Plot for the 7.8 Degrees Row of Penetration, Uphill Side

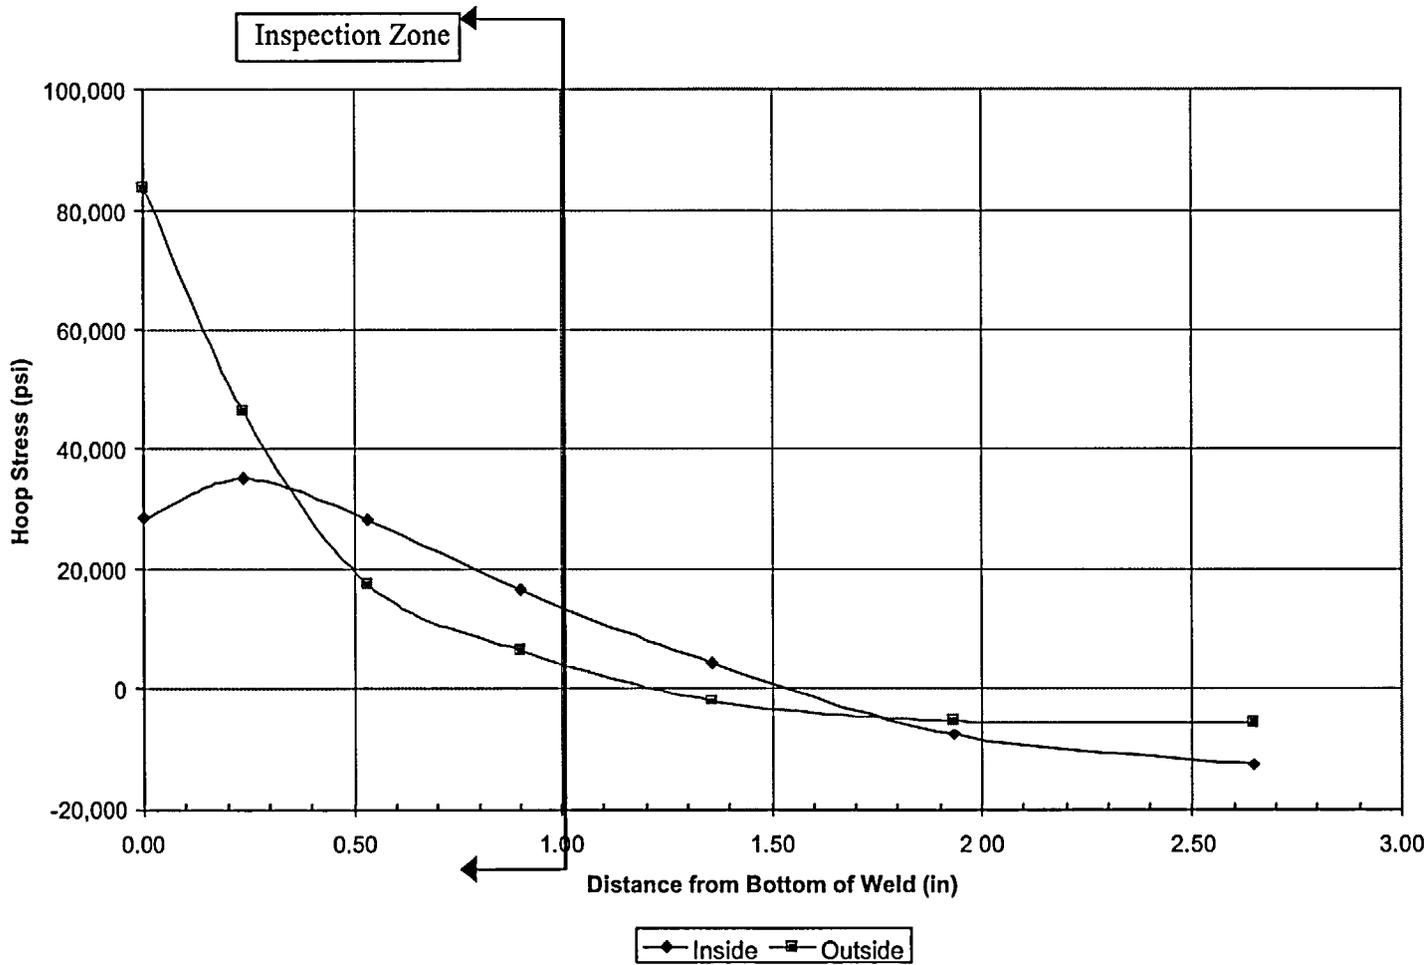
Figure 6: Hoop Stress Vs Distance from Bottom of Weld Plot for the 29.1 Degrees Row of Penetration, Downhill Side

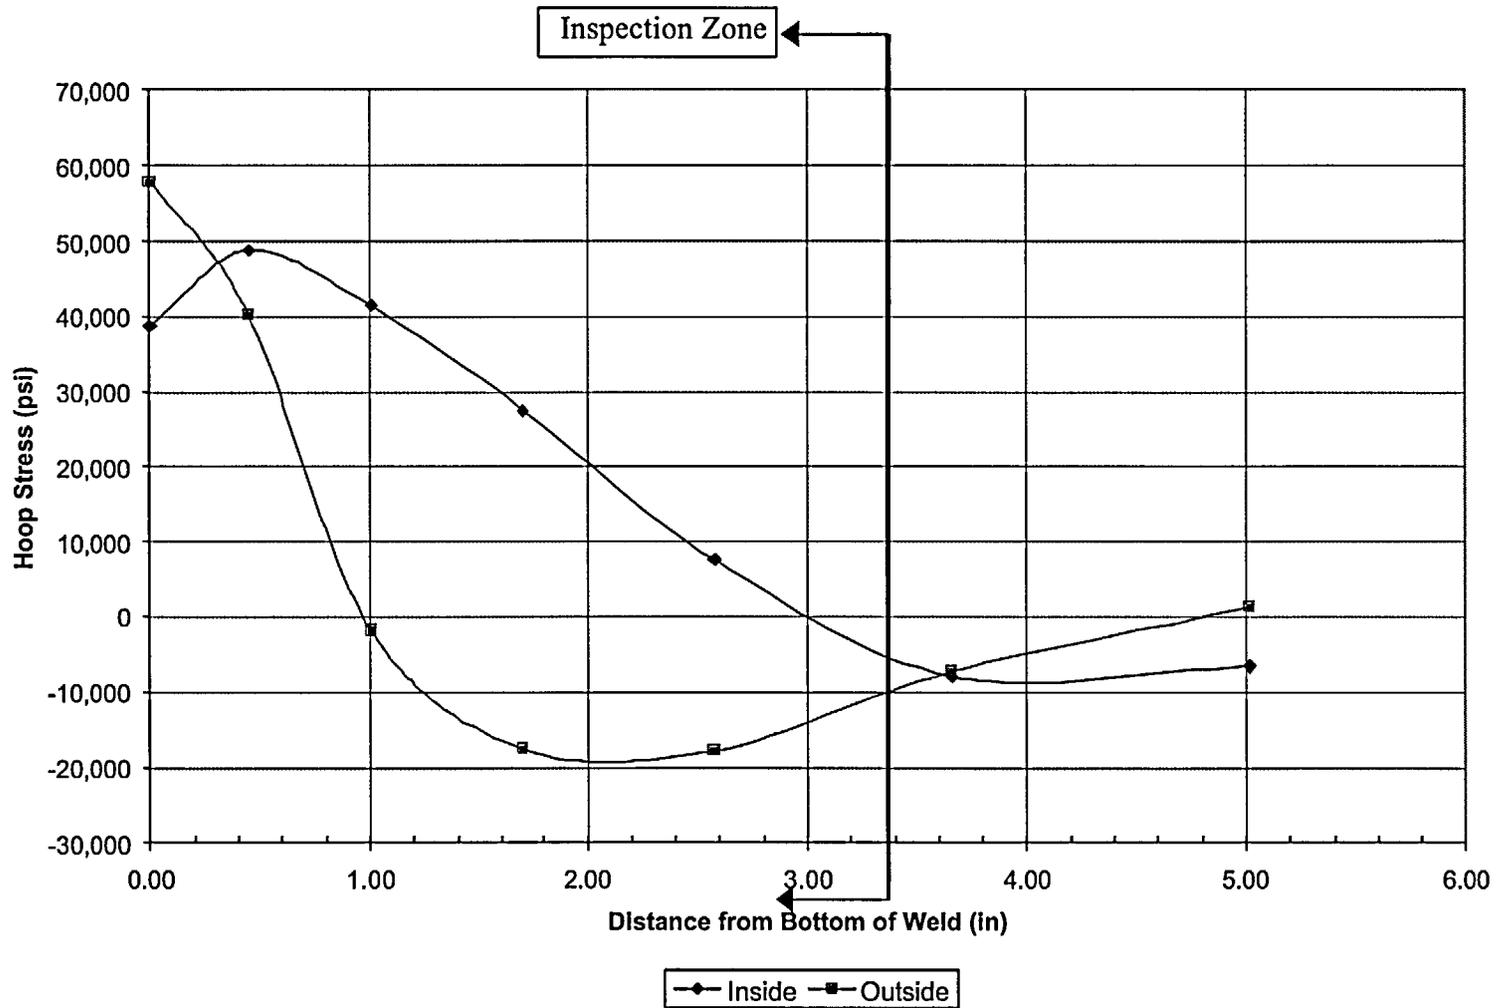
Figure 7: Hoop Stress Vs Distance from Bottom of Weld Plot for the 29.1 Degrees Row of Penetration, Uphill Side

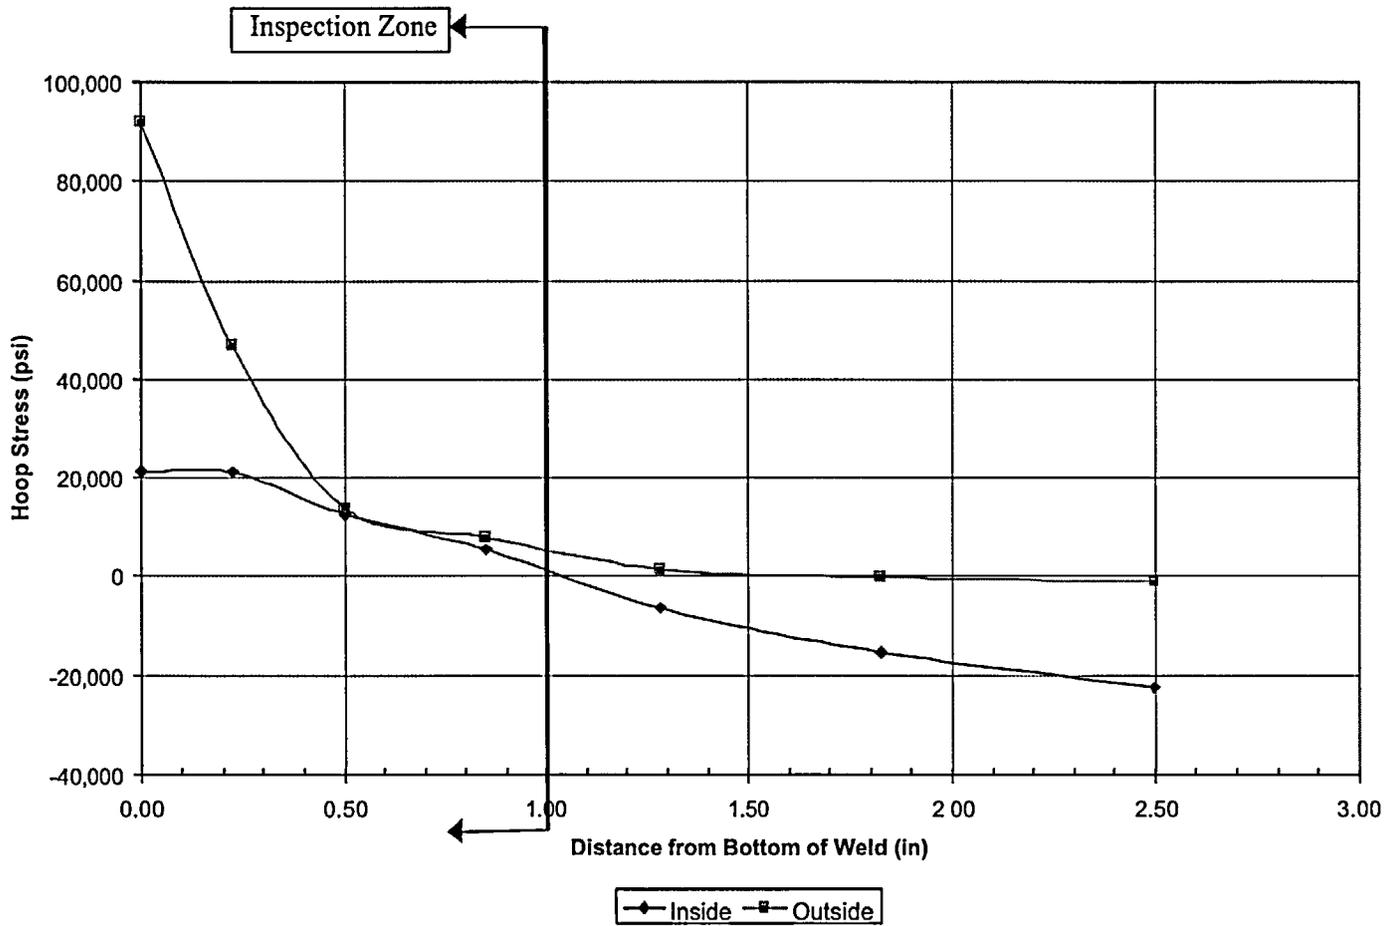
Figure 8: Hoop Stress Vs Distance from Bottom of Weld Plot for the 49.7 Degrees Row of Penetration, Downhill Side

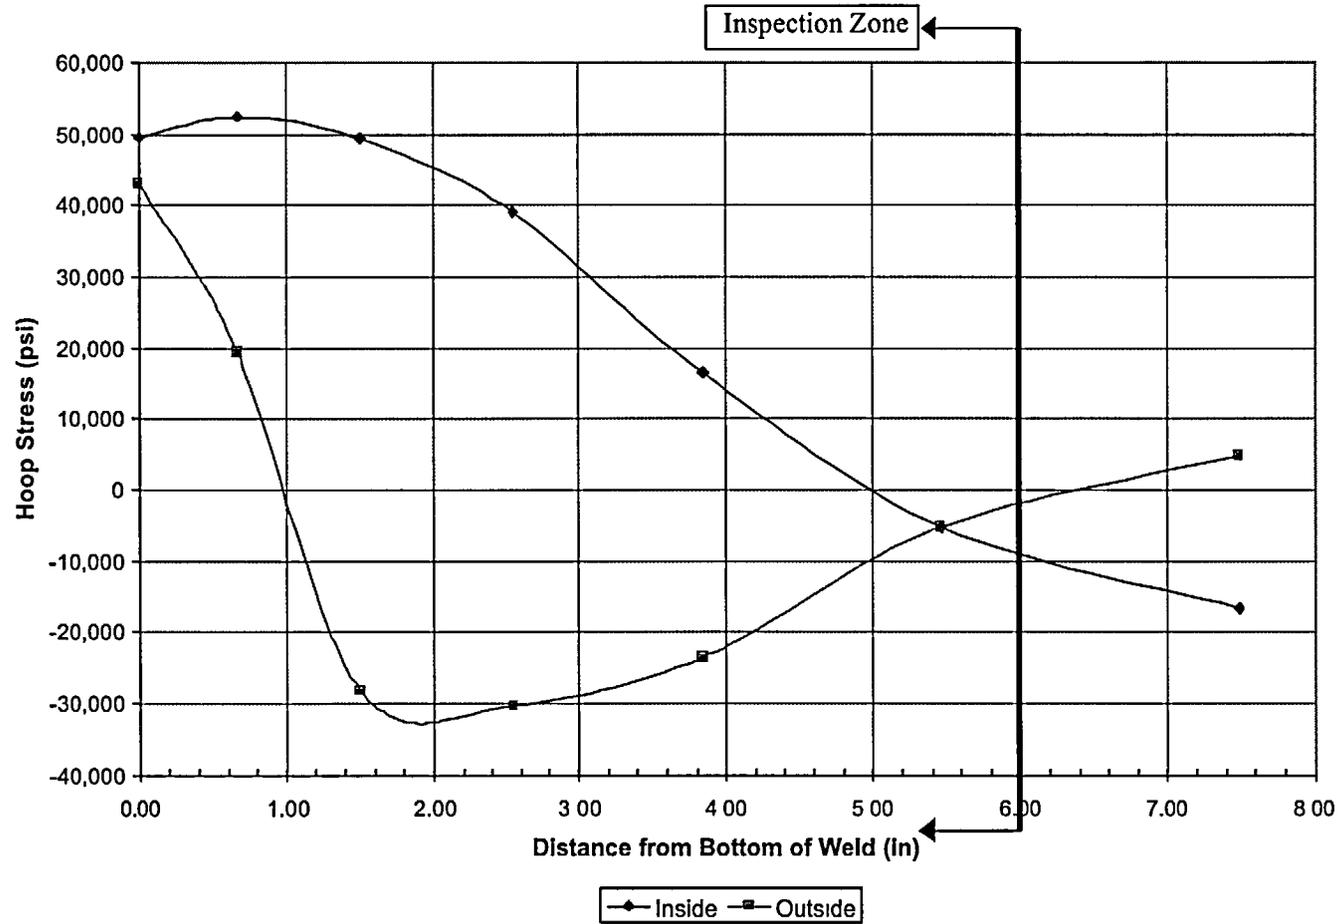
Figure 9: Hoop Stress Vs Distance from Bottom of Weld Plot for the 49.7 Degrees Row of Penetration, Uphill Side

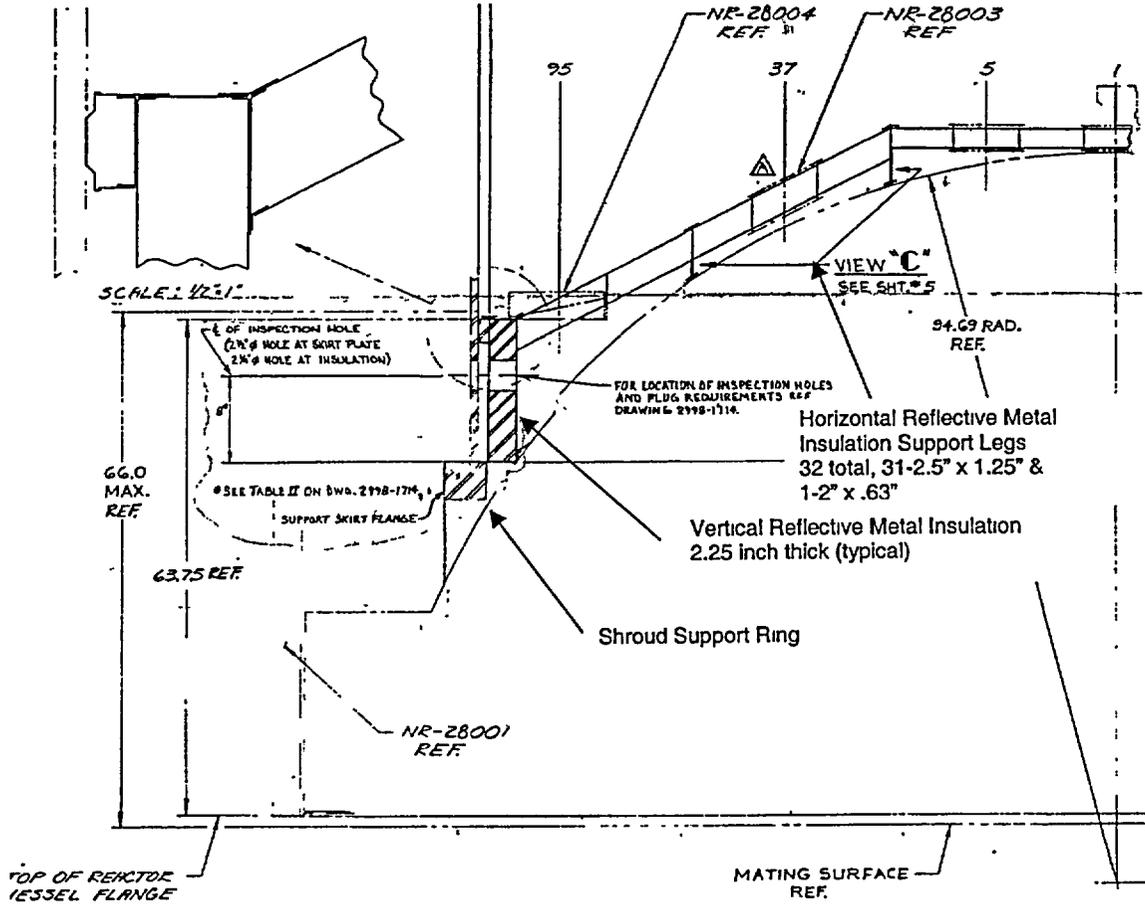
Figure 2: RPV Head Side View showing Insulation Panel Location

Pursuant to Order Section IV.F "all Licensees shall notify the Commission if: (1) they are unable to comply with any of the requirements of Section IV, or (2) compliance with any of the requirements of Section IV is unnecessary." FPL is requesting this relaxation for St. Lucie Unit 2. FPL is unable to comply with the requirement for 100% visual examination coverage due to lack of access and proposes that the requirement is unnecessary in that the inaccessibility of a small percentage of the head surface due to the vertical RMI panels, horizontal panel support legs, and shroud ring do not preclude performance of an effective bare metal visual examination of the RPV head to identify evidence of wastage. A side view of the RPV head showing the shroud ring location and RMI is shown in Figure 1 and Figure 2.
