U.S. Operating Experience With Thermally Treated Alloy 600 Steam Generator Tubes

U.S. Nuclear Regulatory Commission
Office of Nuclear Reactor Regulation
Washington, DC 20555-0001

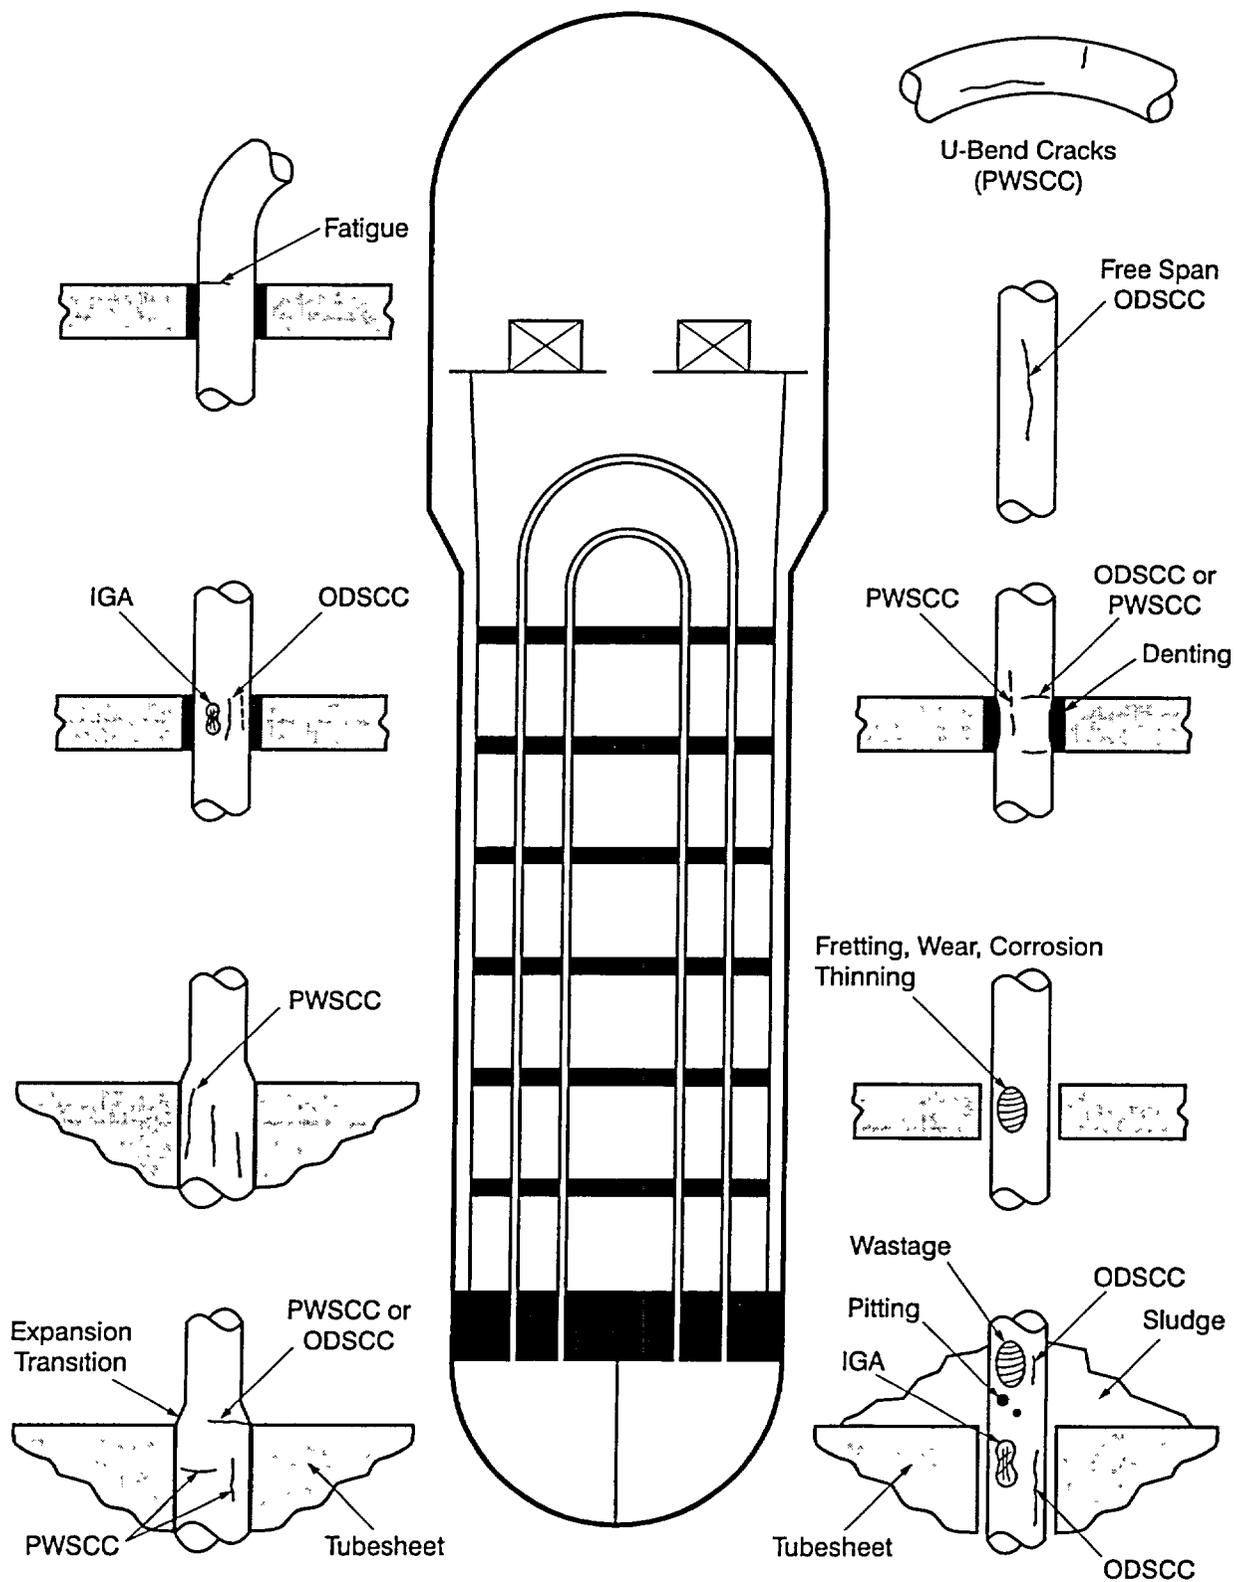
Figure 1-1. Mill Annealed Alloy 600 Steam Generator Tube Degradation

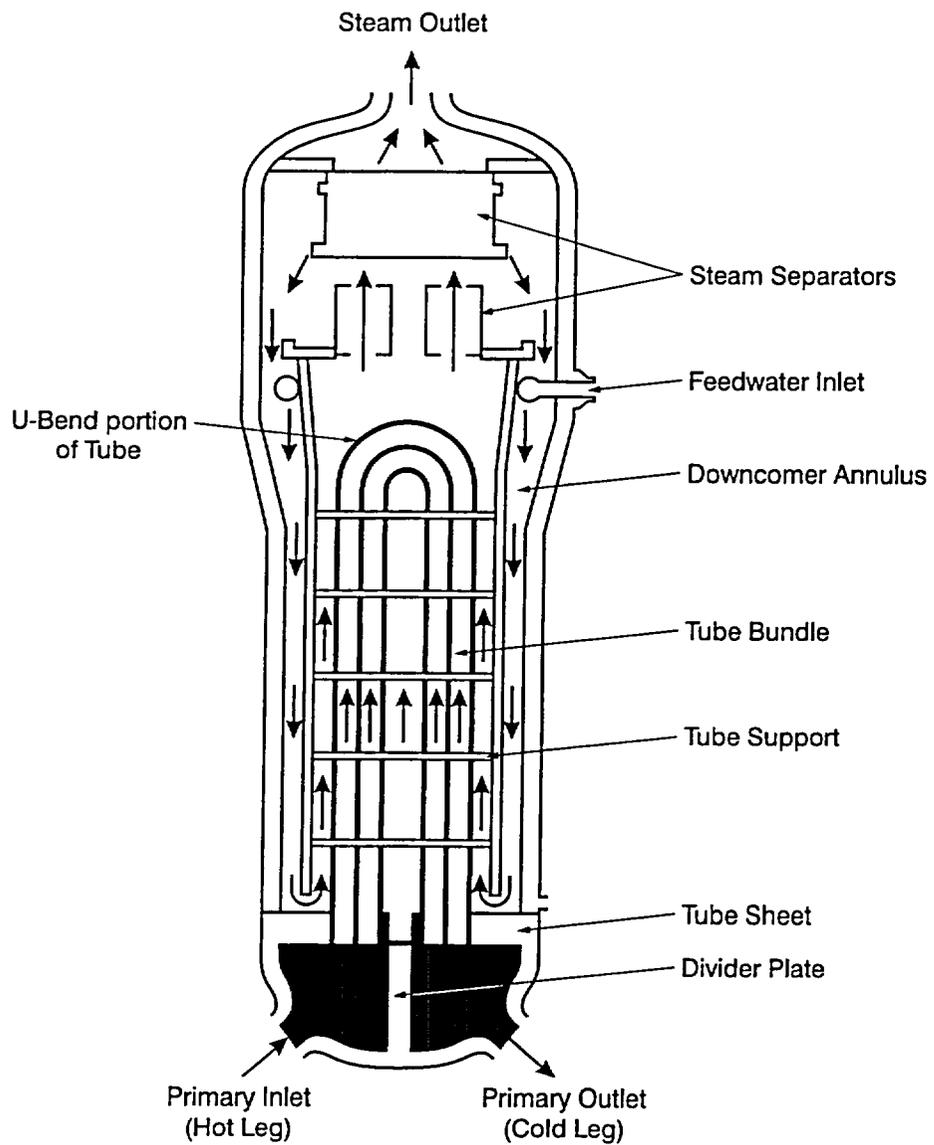
Figure 2-1. Typical PWR Recirculating Steam Generator Without a Preheater

The steam generators are designed with an evaporator section and a steam drum section. The steam drum section is the upper part containing the moisture separators. The evaporator section, sometimes called the "tube bundle", is an inverted U-tube heat exchanger containing the tubes. Typical features of a U-tube are shown in Figure 2-3. The evaporator section may have a preheater region depending on the model. The preheater enhances heat transfer to the incoming feedwater and is a series of baffle plates around a portion of the cold-leg side of the steam generator. Figure 2-1 depicts a typical PWR recirculating steam generator without a preheater, and Figure 2-2 depicts one with a preheater.

Unlike the model D5 steam generator, the model F steam generator does not have a preheater region. In the model F steam generator, the secondary-system water (feedwater) is fed through a feedwater nozzle to a feeding into the downcomer where it mixes with recirculating water draining from the moisture separators. This downcomer water flows to the bottom of the steam generator, across the top of the tubesheet, and then up through the tube bundle, where steam is generated (refer to Figure 2-1).

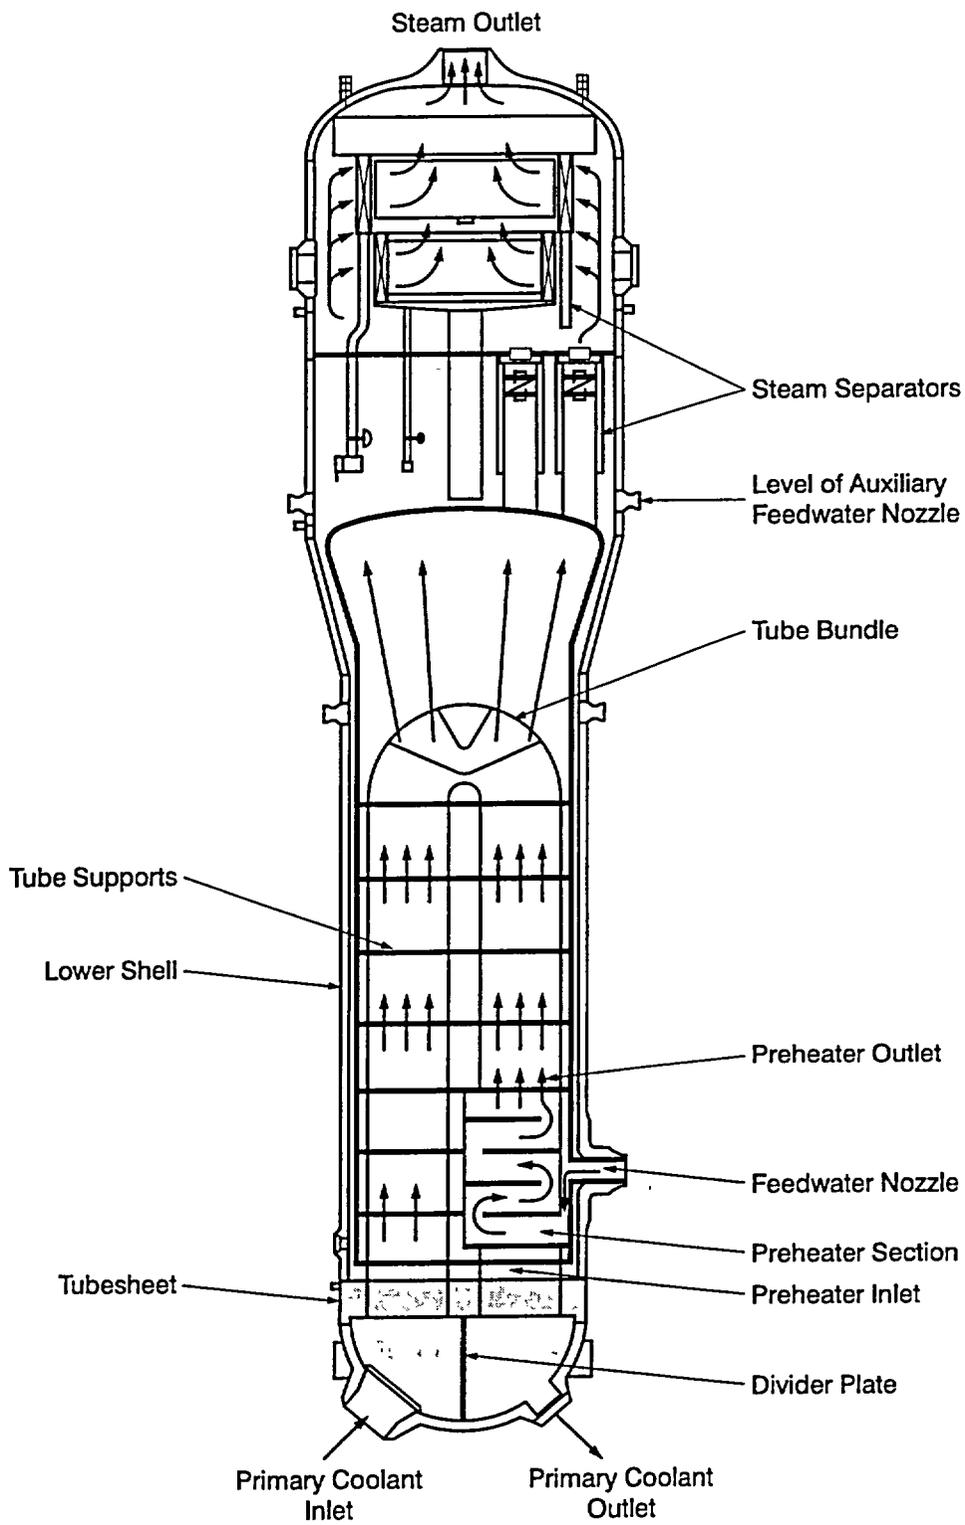
Figure 2-2. Typical PWR Recirculating Steam Generator With a Preheater

The preheater region (near the feedwater inlet) and its relation to the tube bundle are shown in Figure 2-2. The preheater region is located on the cold-leg side of the tube bundle and faces the feedwater inlet. A more detailed view of the preheater region is given in Figure 2-7. As can be inferred from Figure 2-7, the first five rows of tubes in the periphery of the tube bundle are not supported at baffle plates E and H. These tubes are sometimes called "window tubes."

The root cause of the tube wear and design modifications to mitigate its occurrence are discussed in NUREG-0966, "Safety Evaluation Report Related to the D2/D3 Steam Generator Design Modification," and NUREG-1014, "Safety Evaluation Report Related to the D4/D5/E Steam Generator Design Modification." The design modifications for plants with D5 steam generators involved expanding selected tubes (approximately 124 tubes) at baffle plates B and D to make the tubes stiffer and splitting feedwater flow by diverting a fraction of the main feedwater flow through an auxiliary feedwater nozzle to reduce the flow velocities and the potential for tube vibration. For plants with four model D5 steam generators, approximately 10% of the main feedwater flow was diverted. The auxiliary nozzle is located in the upper portion of the steam generator as illustrated in Figure 2-2.

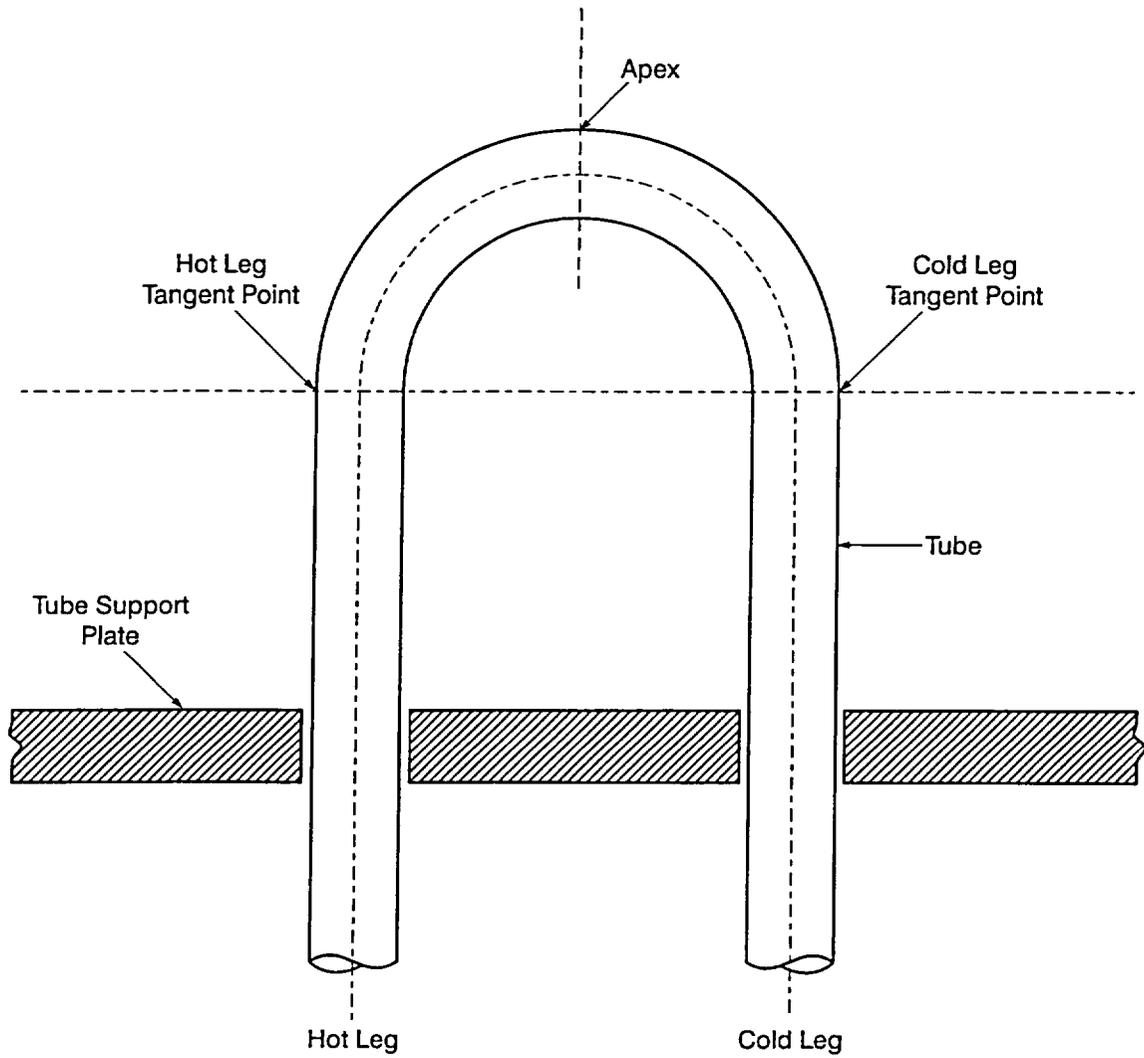
Figure 2-3. U-Bend Features

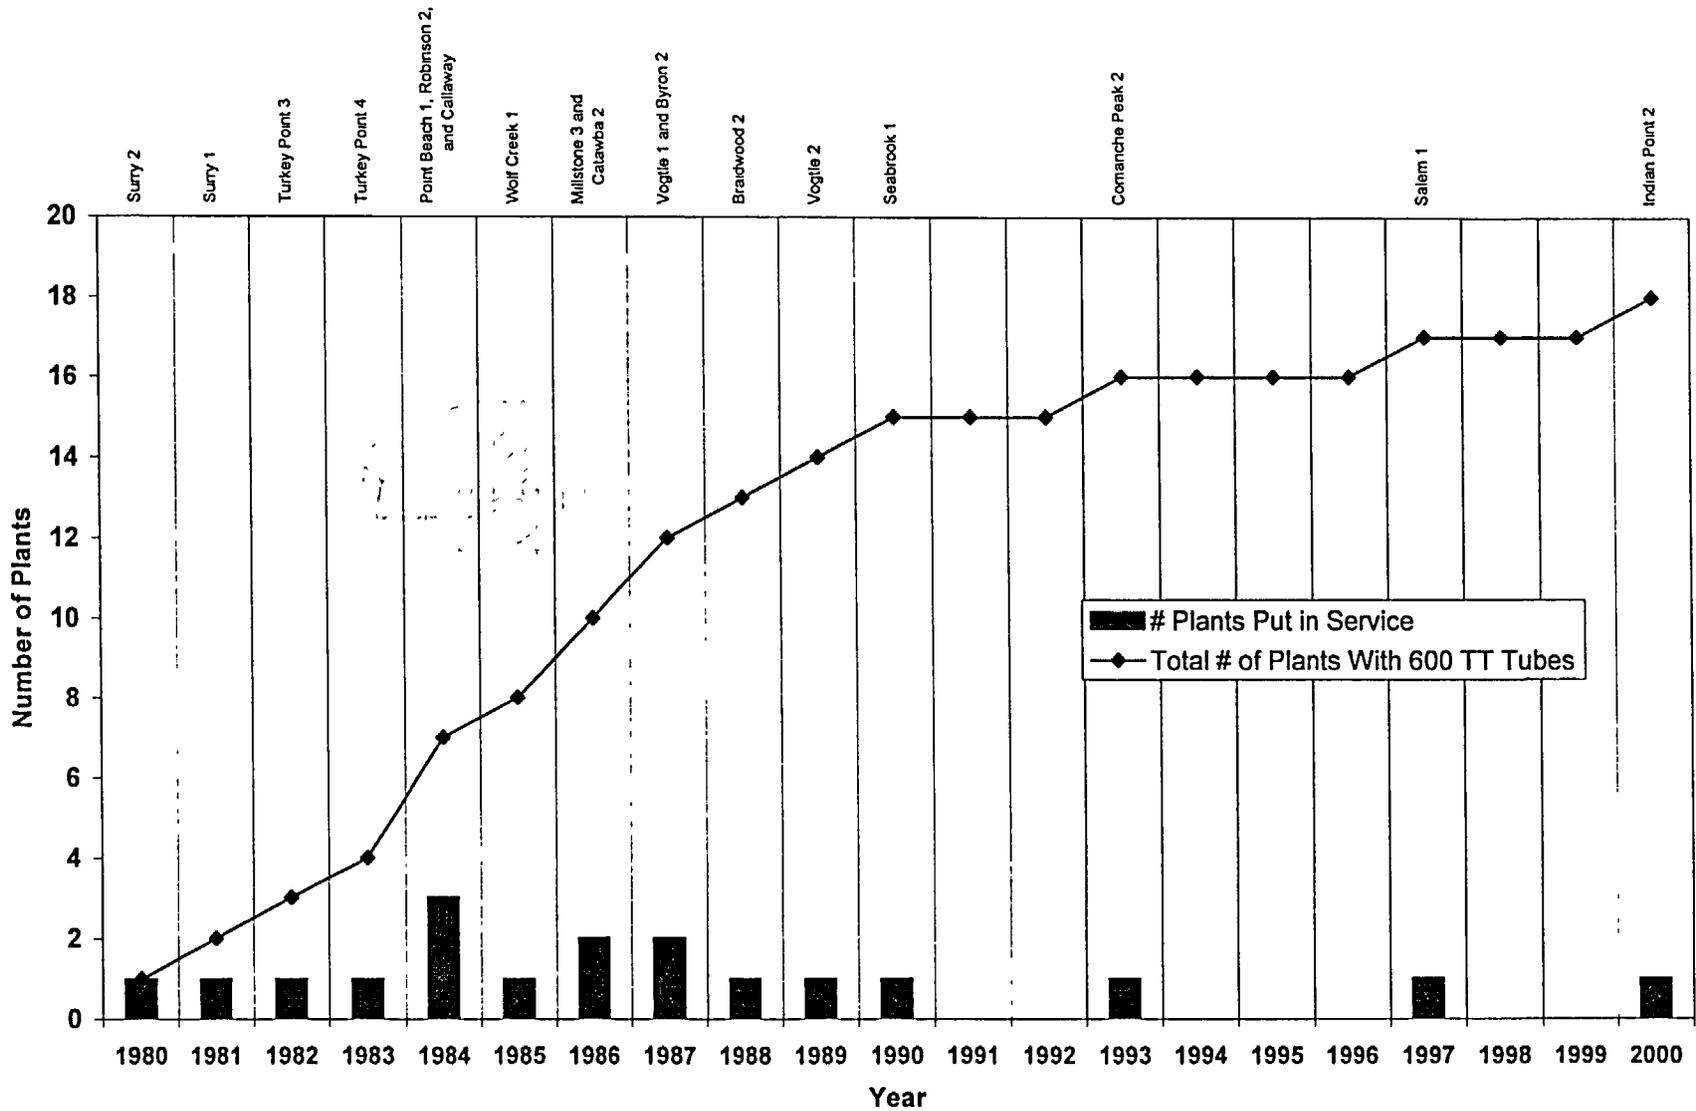
Figure 2-4: Number of Plants With Thermally Treated Alloy 600 Steam Generator Tubes as a Function of Year

As of December 2001, there were 69 operating PWRs, 18 of which had thermally treated Alloy 600 steam generator tubes

Steam generators with thermally treated Alloy 600 tubes were first placed in service in 1980. Figure 2-4 is a graph of the deployment of steam generators with thermally treated Alloy 600 tubes. Currently, 17 plants have steam generators with thermally treated Alloy 600 tubes. Another plant, Callaway, has steam generators in which only the first 10 rows have thermally treated Alloy 600 tubes; the remaining rows have mill-annealed Alloy 600 tubes. All plants with thermally treated Alloy 600 tubes are Westinghouse-designed plants.

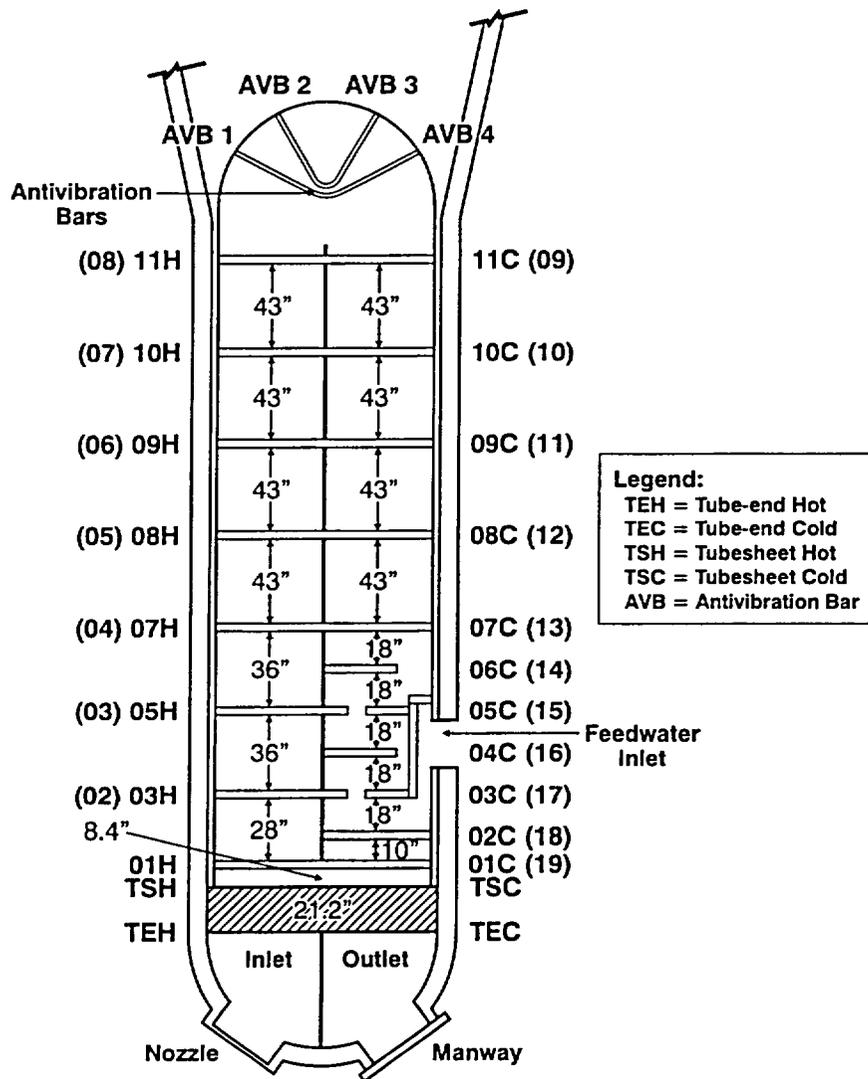
Figure 2-5. Westinghouse Model D5 Steam Generator
 Tube Support Locations
 (Alternate Naming Convention in Parentheses)

Westinghouse model D5 steam generators have 4,570 thermally treated Alloy 600 tubes with an outside diameter of 0.750-inch and a 0.043-inch nominal wall thickness. The tubes are hydraulically expanded for the full depth of the tubesheet at each end. The tubes are supported by stainless steel support plates with quatrefoil-shaped holes and V-shaped chrome plated Alloy 600 anti-vibration bars (AVBs). Figure 2-5 depicts the model D5 steam generator tube support configuration. As shown in this figure, several naming conventions are used for the tube support plates. Model D5 steam generator tubes have a square tube pitch as depicted in Figure 2-6 with a tube spacing of 1.063 inches.

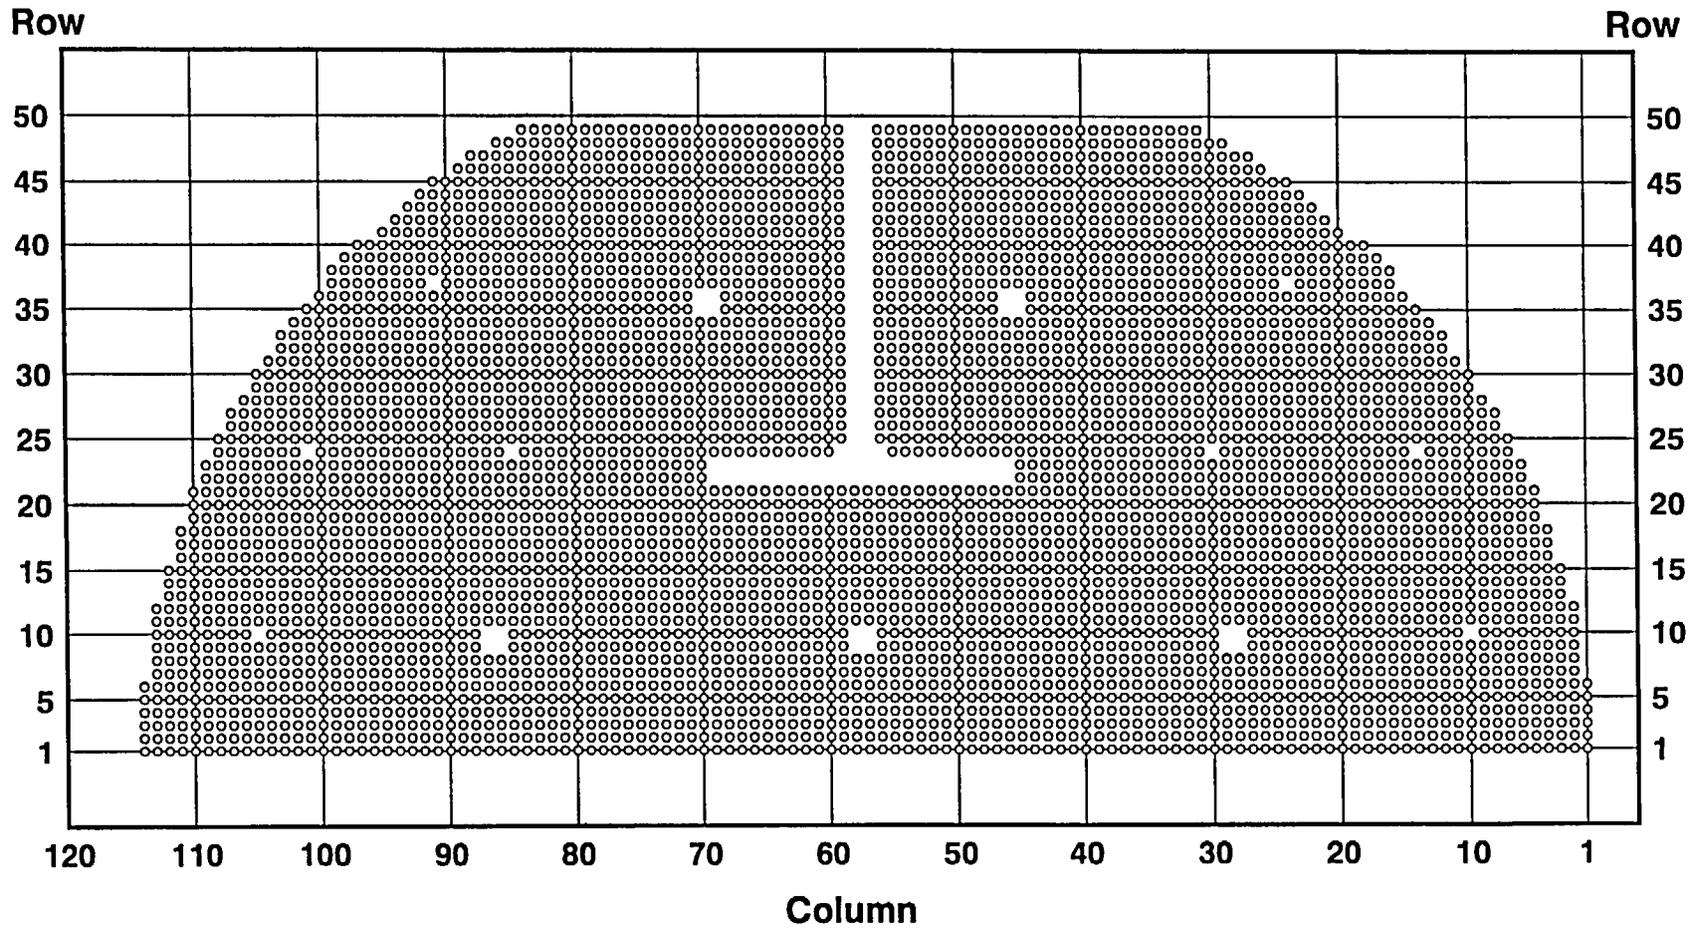
Figure 2-6. Westinghouse Model D5 Steam Generator Tubesheet Map

and a T-slot. The preheater is a region in the tube bundle which preheats the incoming feedwater (secondary coolant) prior to entering the main region of the tube bundle. The design and operation of the preheater are discussed further below. The T-slot is an untubed portion of the tube bundle. It has a T shape and is used in steam generator blowdown for sludge removal. The T-slot is depicted in Figure 2-6.

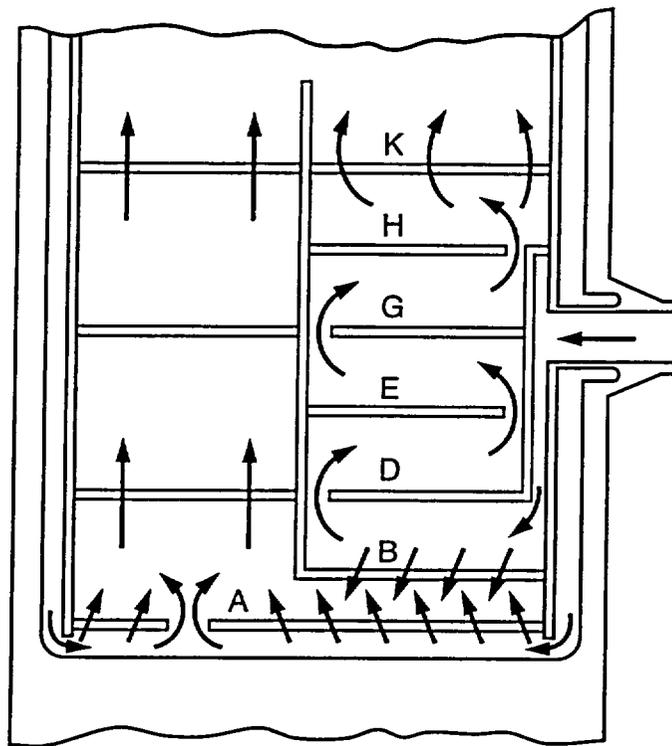
Figure 2-7. Preheater Region of Westinghouse Model D-5 Steam Generator

Feedwater flowing into the steam generator first passes through a venturi insert in the main feed nozzle. The insert serves as a backflow restrictor to limit the rate of blowdown from the steam generator in the event of a main feedwater line break. In the preheater section, as illustrated in Figure 2-7, the incoming feedwater enters the inlet waterbox and encounters the impingement plate, which directs the water outward to fill the waterbox volume and downward to the preheater inlet located between baffle plates B and D. In the lower section of the preheater, or first pass, the feedwater enters the tube bundle. The water then flows around the tubes and baffles until it enters the main region of the tube bundle. Because the water changes direction between the baffle plates of the preheater (i.e., right-to-left between B and D and then left-to-right between D and E), this type of preheater design is called a "counterflow preheater."

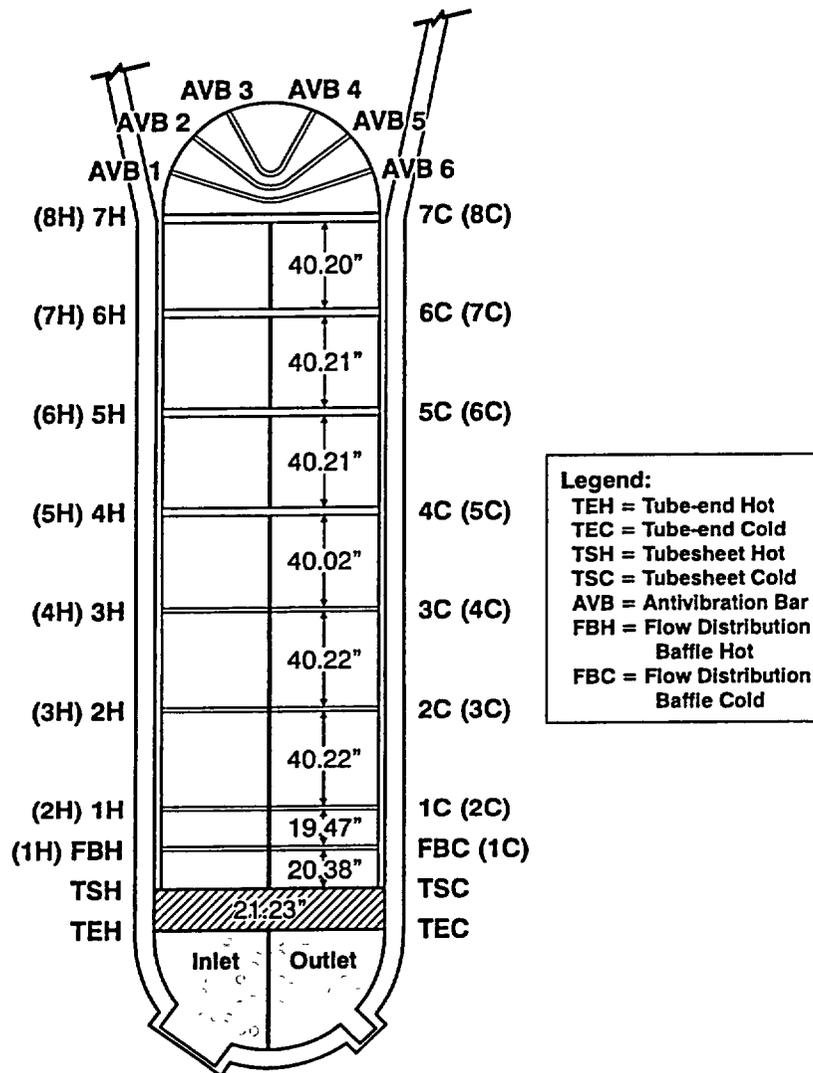
**Figure 2-8. Westinghouse Model F Steam Generator
 Tube Support Locations
 (Alternate Naming Convention in Parentheses)**

The model F steam generators were designed in the mid 1970s. Except for the model F steam generators at Callaway, all model F steam generators have 5,626 thermally treated Alloy 600 tubes. At Callaway, only the first 10 rows of tubes in each steam generator have thermally treated tubes (i.e., only 1,214 tubes per steam generator are thermally treated). The tubes have an outside diameter of 0.688-inch and a nominal wall thickness of 0.040 inch. The tubes are hydraulically expanded for the full depth of the tubesheet at each end. The tubes are supported by stainless steel support plates with quatrefoil-shaped holes and V-shaped chrome plated Alloy 600 AVBs. The first 10 rows of tubes were stress-relieved to improve corrosion resistance. Figure 2-8 depicts the model F steam generator tube support configuration. As shown in this figure, several naming conventions are used for the tube support plates. Model F steam generator tubes have a square tube pitch as depicted in Figure 2-9 with a tube spacing of 0.980 inch.

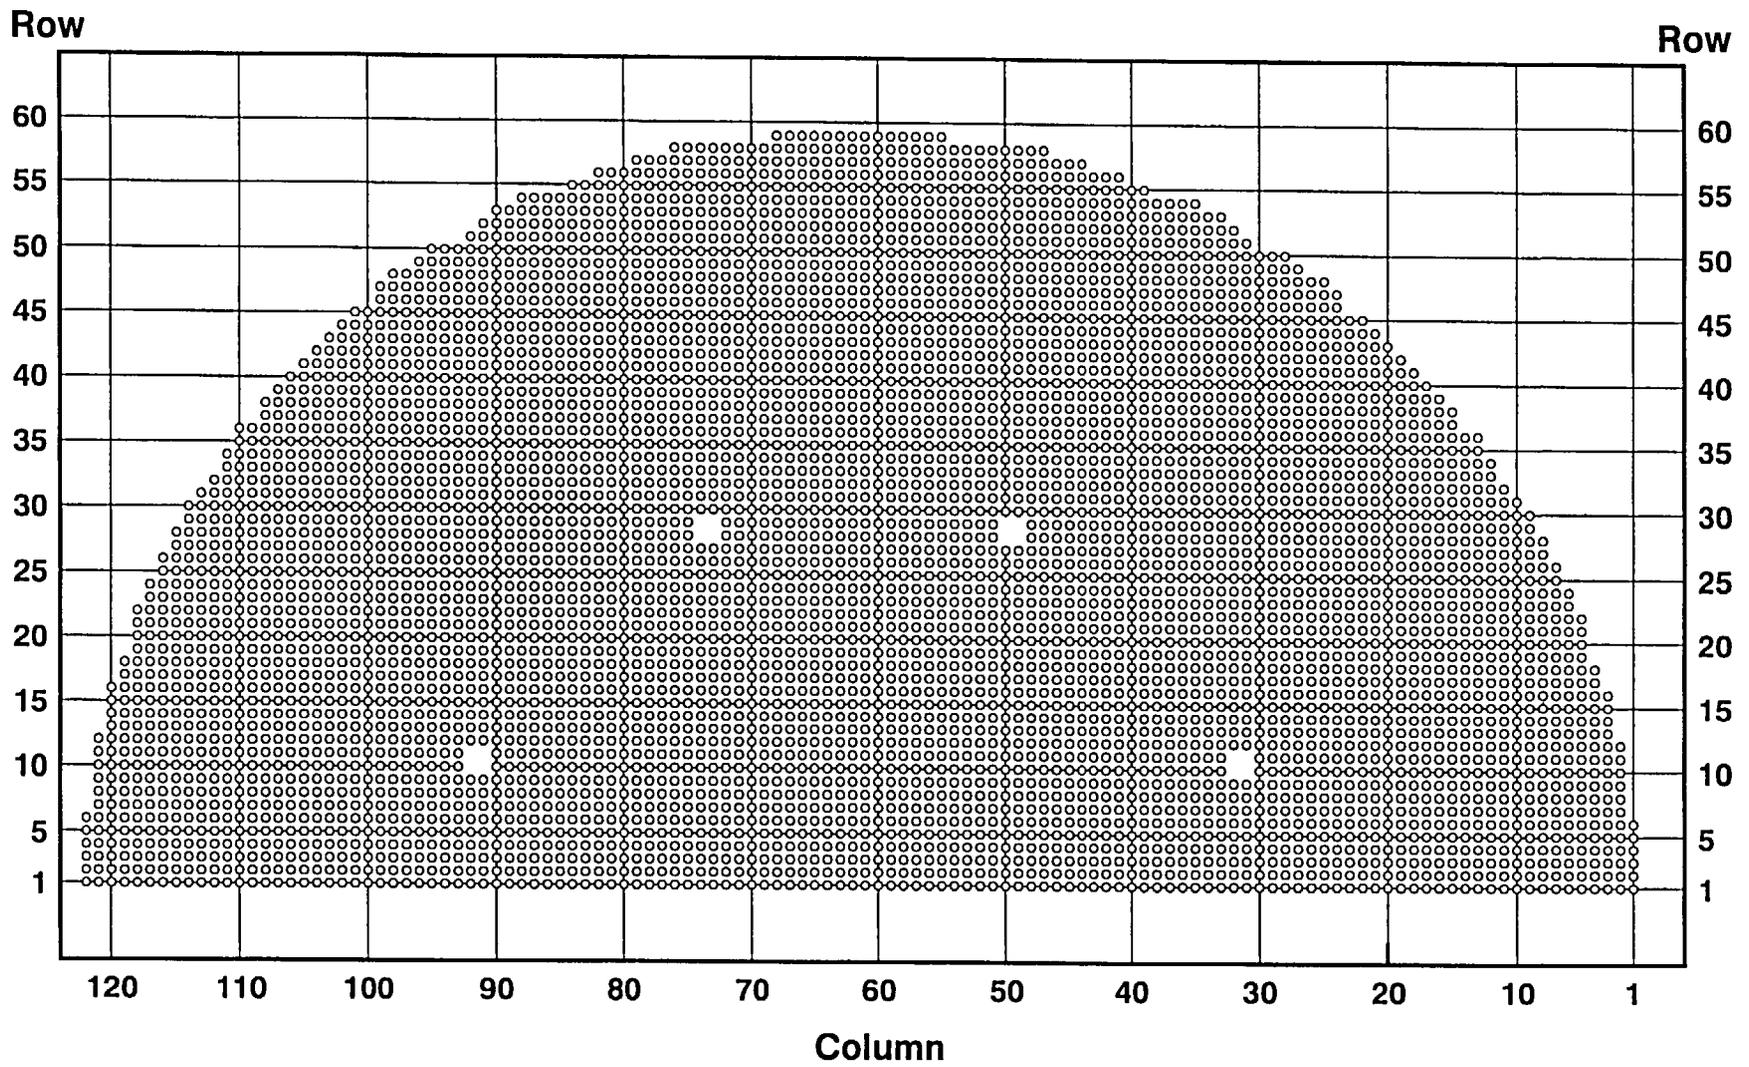
Figure 2-9. Westinghouse Model F Steam Generator Tubesheet Map

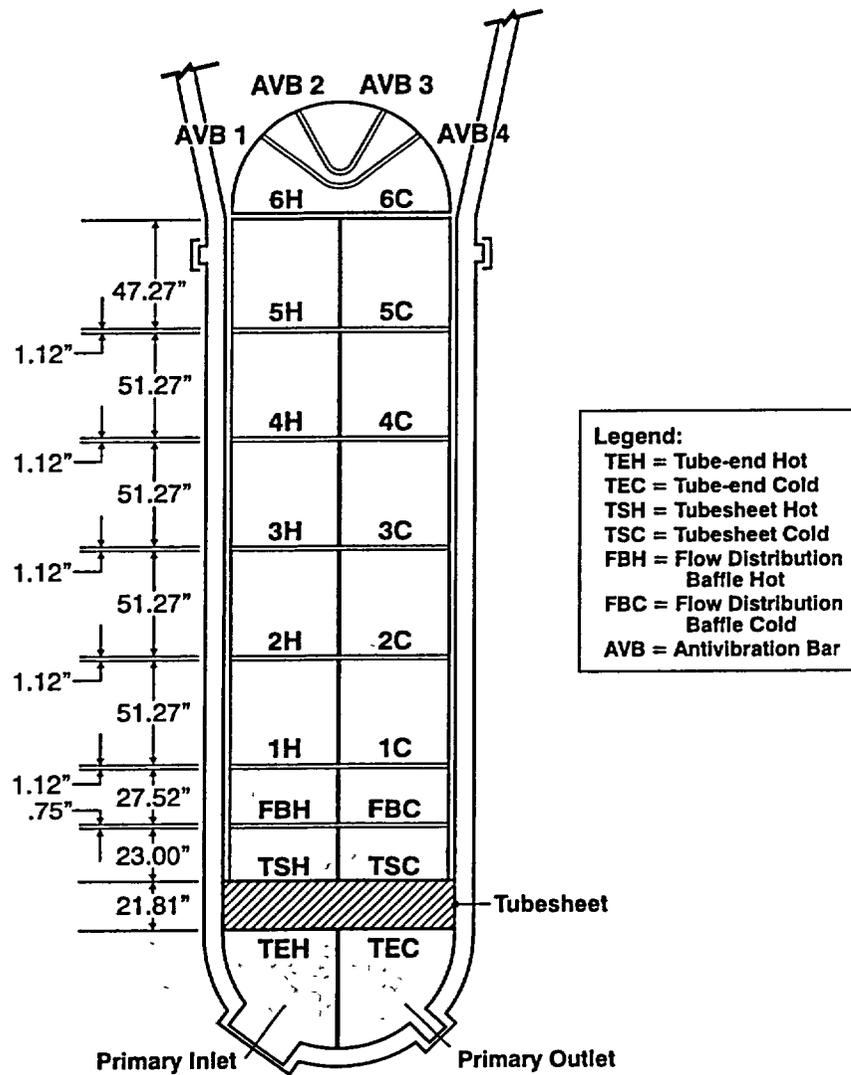
Figure 2-10. Westinghouse Model 44F Steam Generator Tube Support Locations

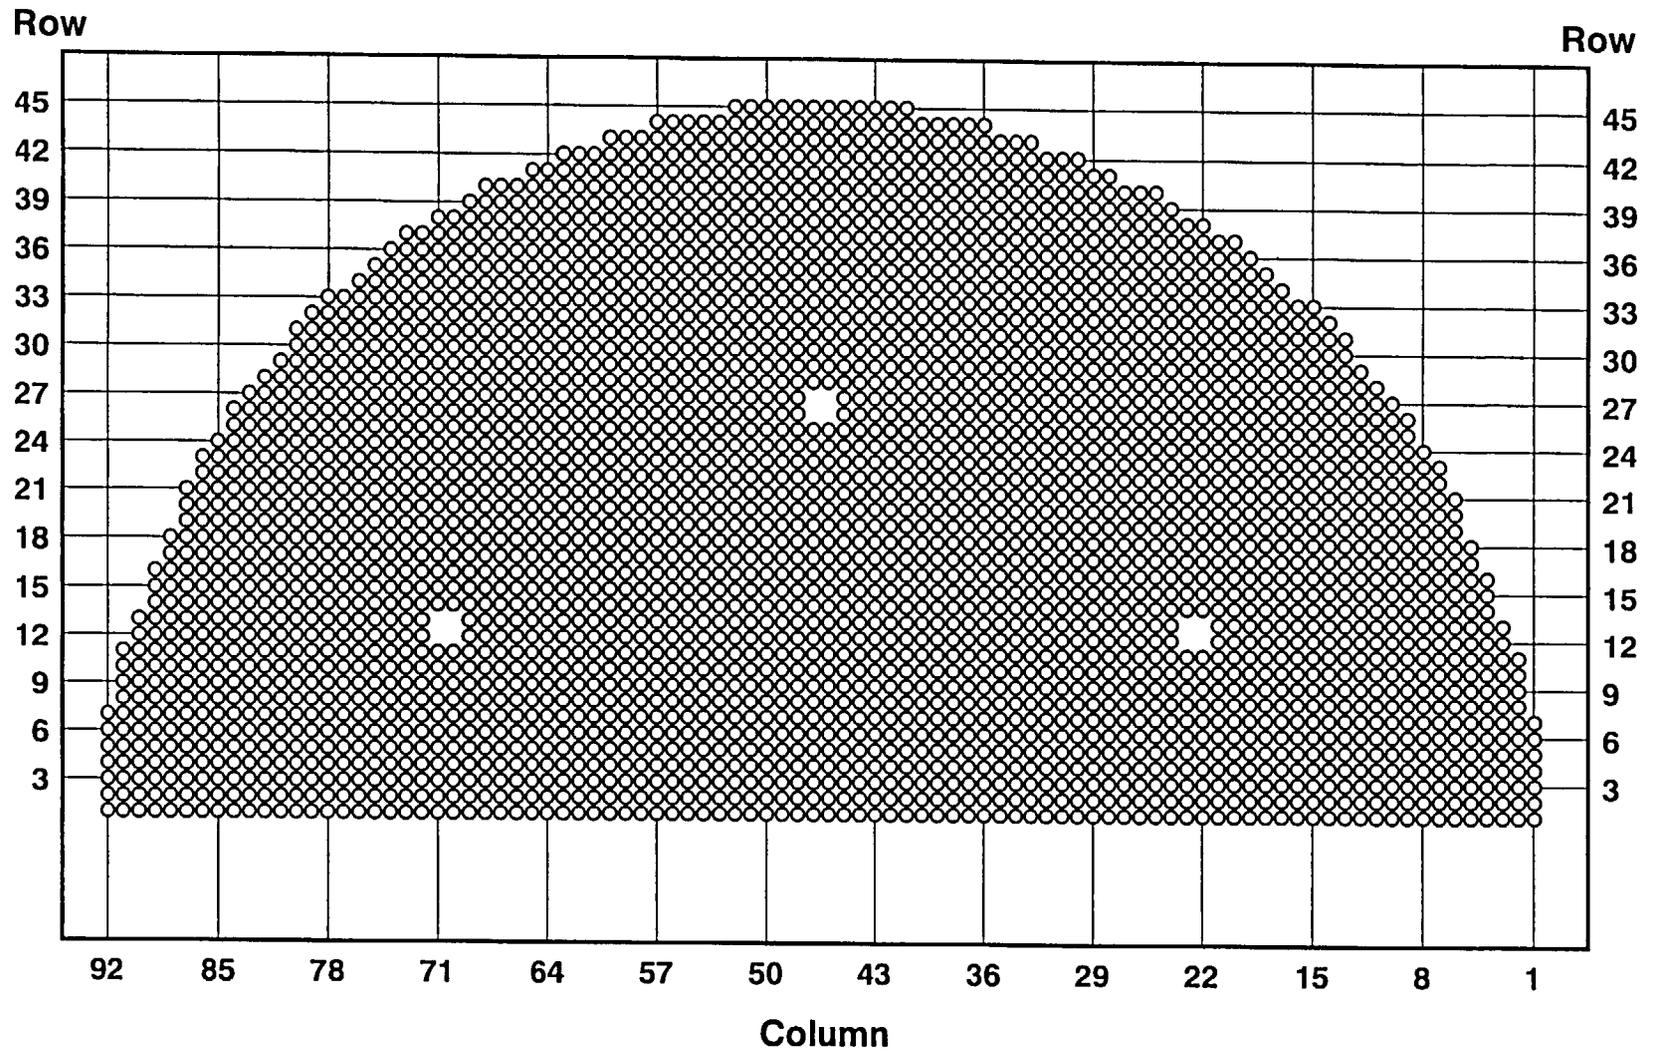
Figure 2-11. Westinghouse Model 44F Steam Generator Tubesheet Map

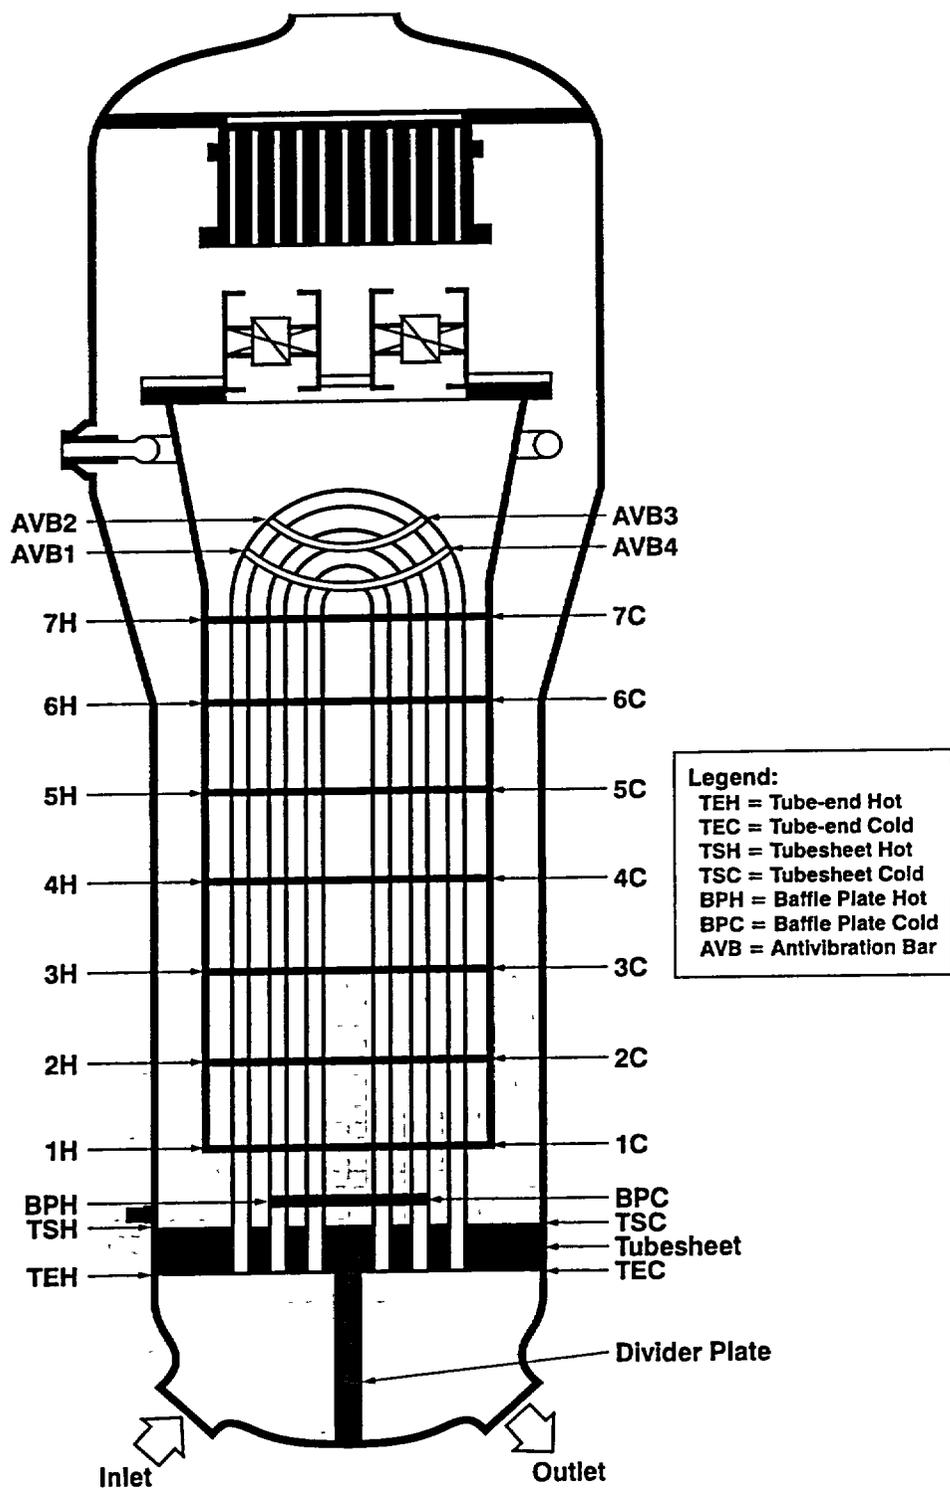
Figure 2-12. Westinghouse Model 51F Steam Generator Tube Support Locations

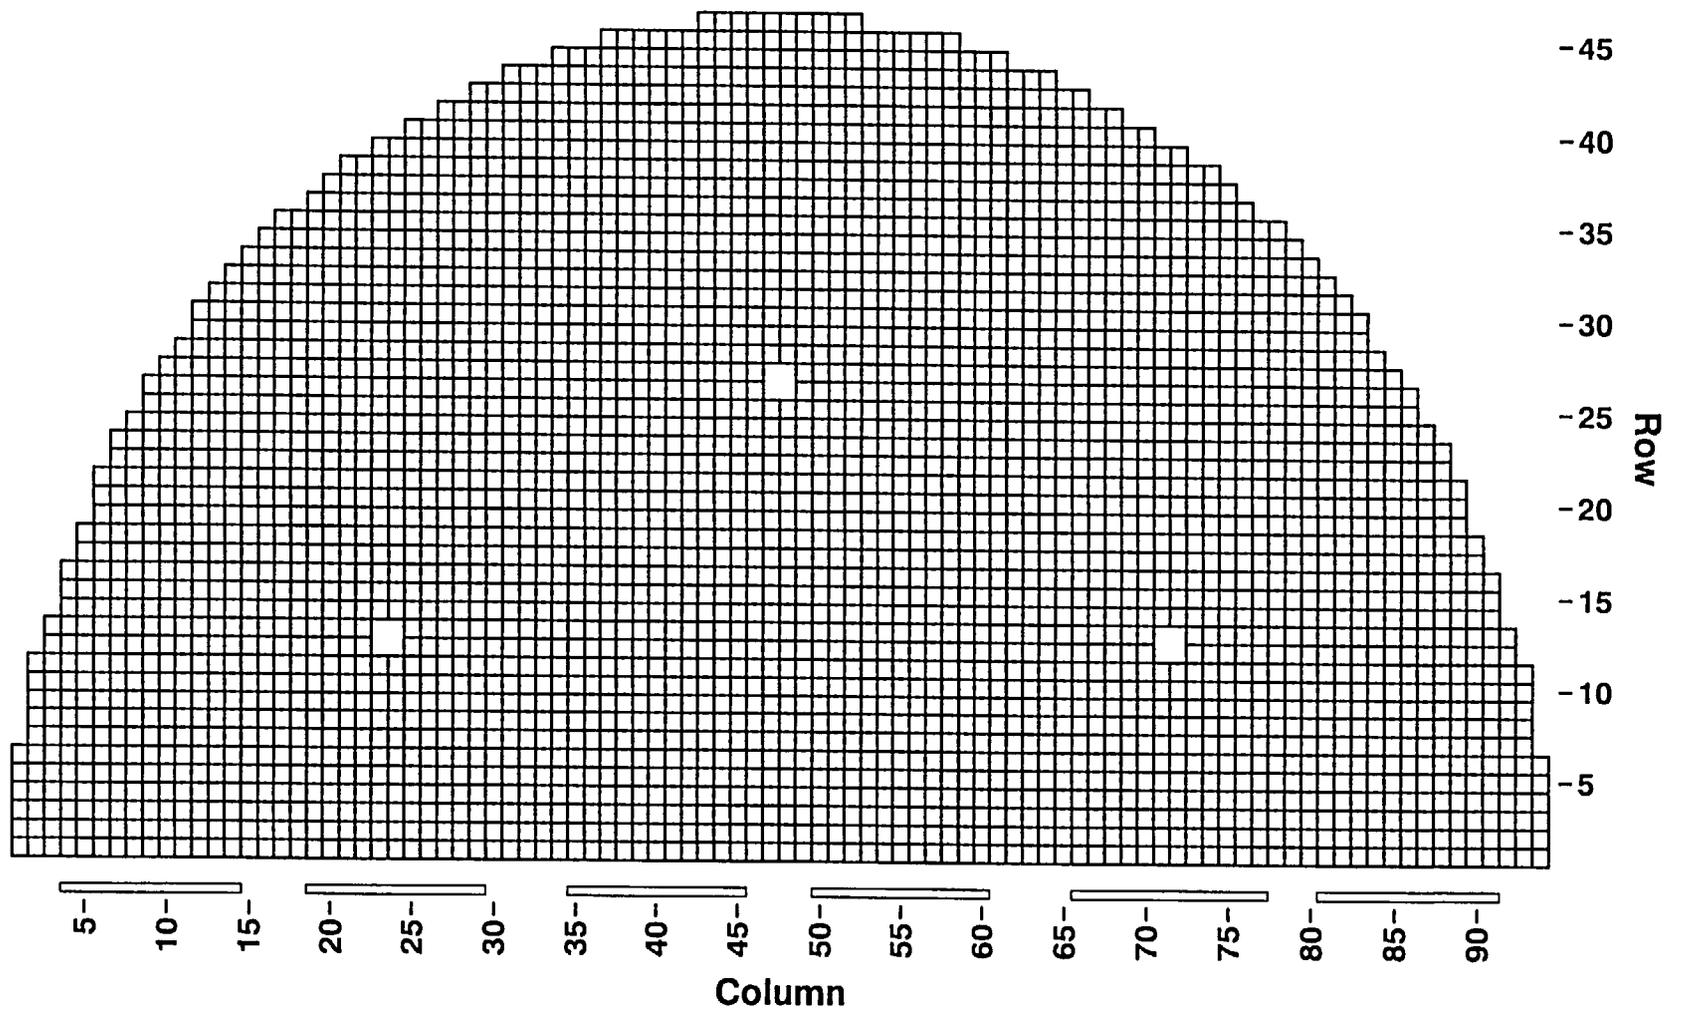
Figure 2-13. Westinghouse Model 51F Steam Generator Tubesheet Map
