### **RAI 4.6.3-1**

The FAC program in RNP includes prediction of the wall thinning for the components susceptible FAC. The wall thinning is predicted by the EPRI's CHECWORKS computer code. In order to allow the staff to evaluate the accuracy of these predictions, the applicant should provide a few examples of the components for which wall thinning is predicted by the code and at the same time measured by ultrasonic examination or any other measurement method employed in the RNP. This procedure will show the effectiveness of CHECWORKS in predicting the as-found condition.

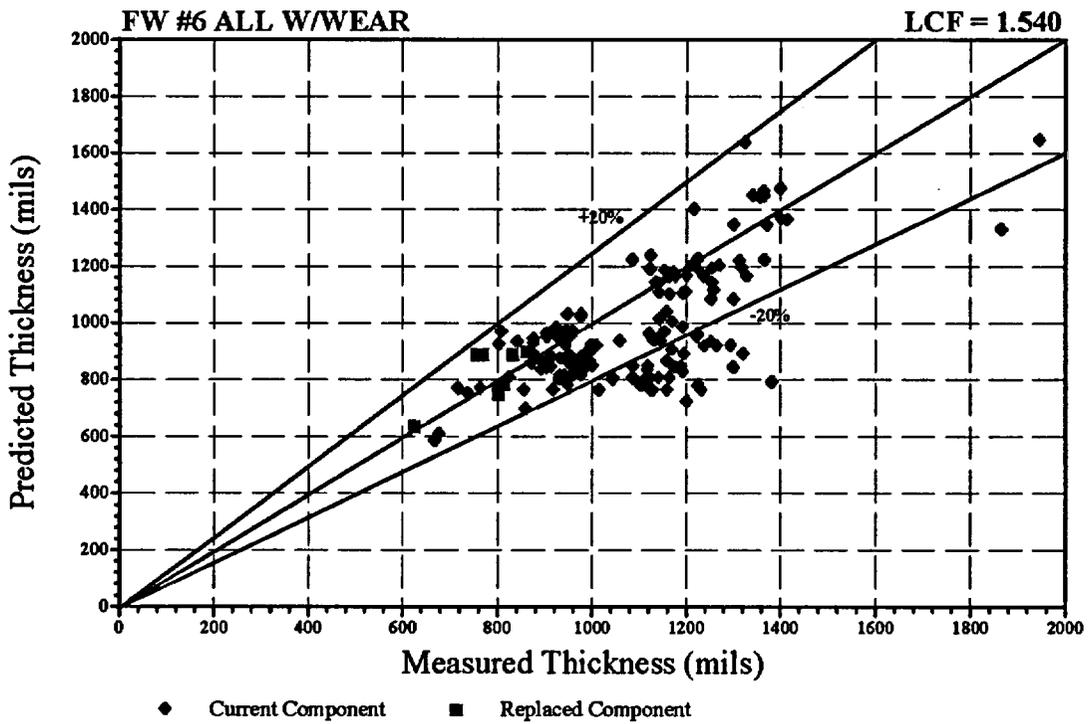
### Comparison of Thickness Predictions

Below is a chart that provides comparisons of predicted versus as-found thicknesses for RNP feedwater piping. The thickness prediction is based on initial thickness (nominal wall) minus the predicted wear over the life of the component. The predicted wear is calculated initially assuming no known wear. The wear is then adjusted based on actual measurements of many components within a line. The adjustment is a correction factor which is applied to the predicted wear in the components in the line. Normally, some components will wear less than predicted and some will wear more than predicted. The line correction factor (LCF) is derived by calculating an adjustment factor for each component, then taking the median value of these individual adjustments as the line correction factor. The actual thickness measurements vary from predictions due to variations in initial pipe wall thickness, e.g., some components are substantially thicker than nominal. The data points in the non-conservative direction are a result of higher than median wear, combined with initial thickness values close to nominal.

Also provided below are data sheets from several systems within the program scope. These data sheets contain data points (in inches) for measured thickness, predicted thickness, and minimum allowable thickness.
