## **APPENDIX A**

### **Grid Events**

## Appendix A Grid Events

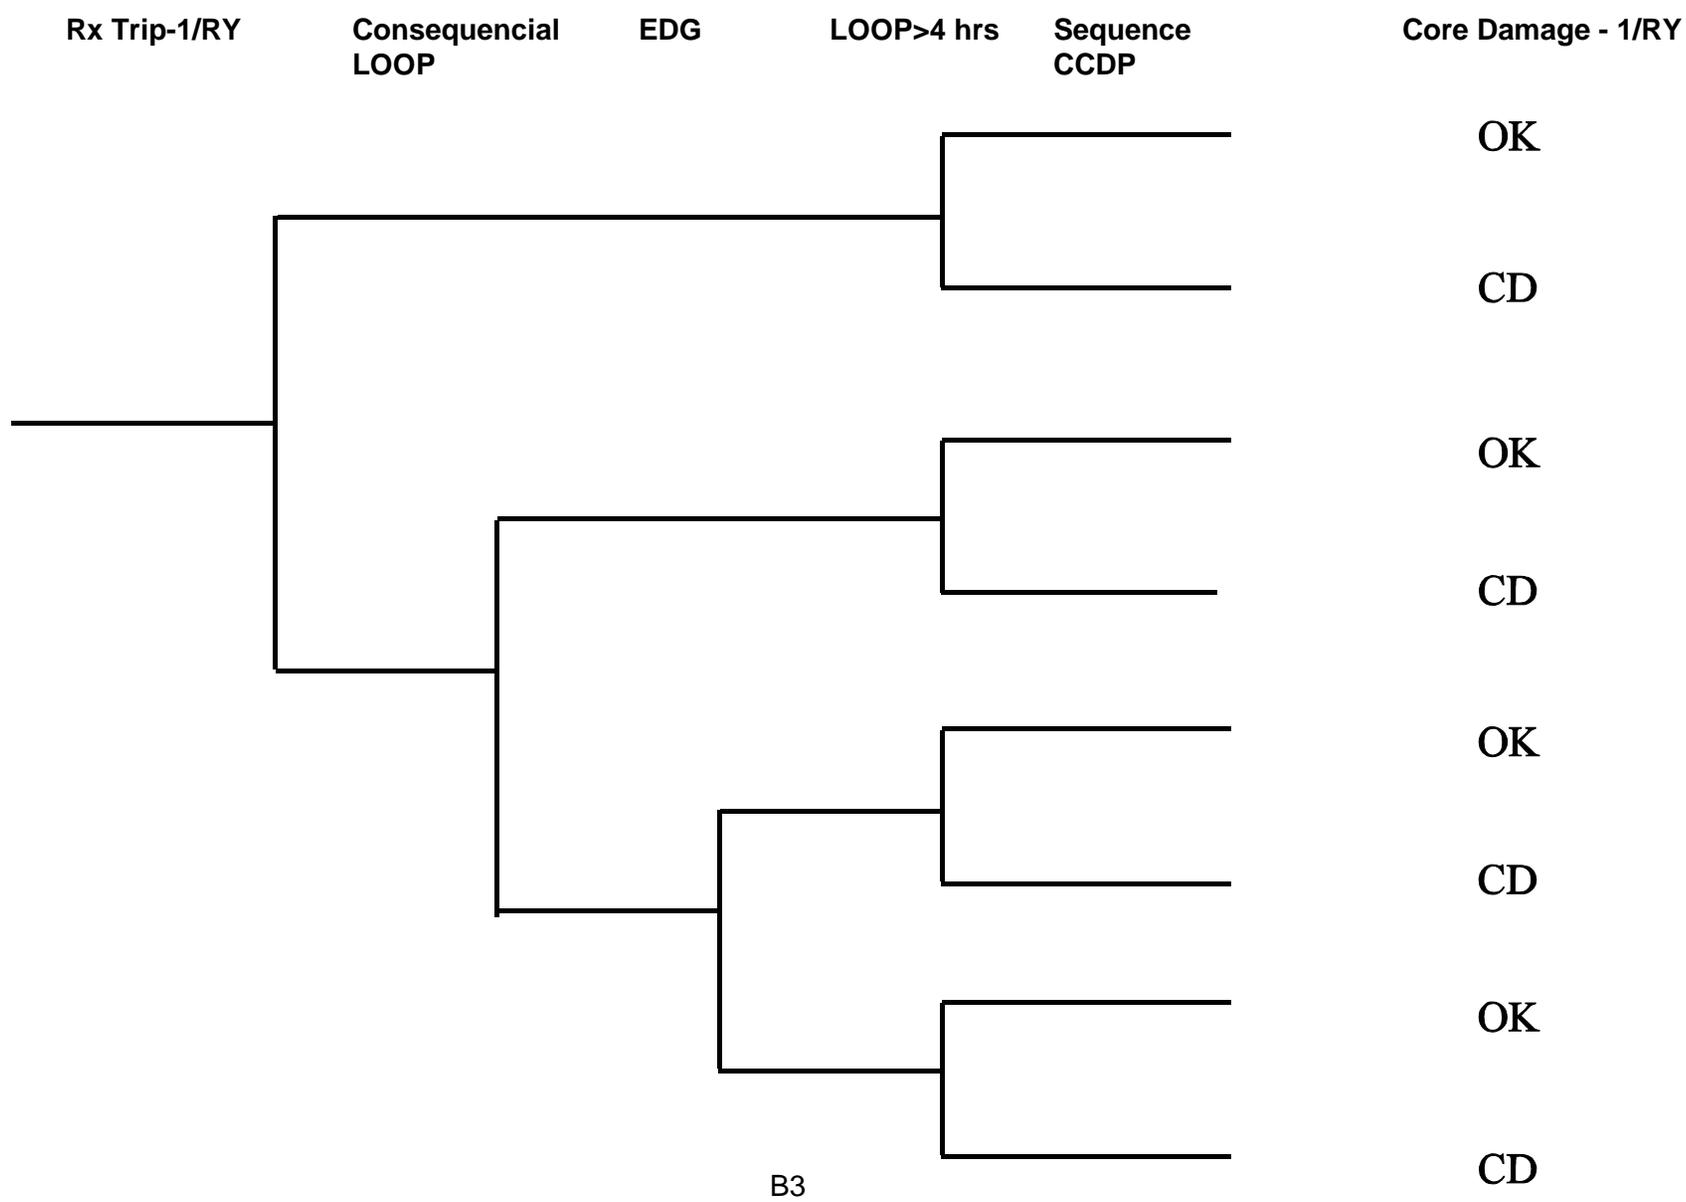
represents a LOOP induced reactor trip. The event trees end with an outcome in terms of “OK meaning recovery without core damage and “CD” meaning some core damage can be expected.

**Figure B-1  
Reactor Trip- Consequential LOOP Event Tree**

Figures B-1 and B-2 show the events progress from a LOOP to “EDG” to reflect whether the onsite emergency power supplies ( EDGs), started and loaded, or failed to start and load. The system failure rate for “EDG” was based on a two train EDG system and calculated from the square of the individual EDG rates (P) plus the product of the common mode ( $\alpha$ ) and EDG train failure rates (P squared + $\alpha$ P). A two train system is typical of the NPP onsite power system; of 103 operating reactors, approximately 75 percent have 2 or less EDGs per reactor unit. The same EDG data was used in the before and after analyses and based on actual demand performance data published by the NRC. Table B-1 shows the “EDG failure rate for a two train system” data.

A baseline average industry CDF from an SBO before deregulation was calculated as the sum of the CDFs leading to core damage in Figure B-1 and Figure B-2. The average industry CDF from an SBO for the after deregulation cases were calculated using the sum of the CDFs leading to core damage from Figure B-1 and Figure B-2 event trees. The data showed a need to analyze the risks in the summers (May to September); all of the LOOPS since 1997 occurred in the summer (May to September) in contrast to 23 of 54 LOOPS in the summers of 1985-1996.

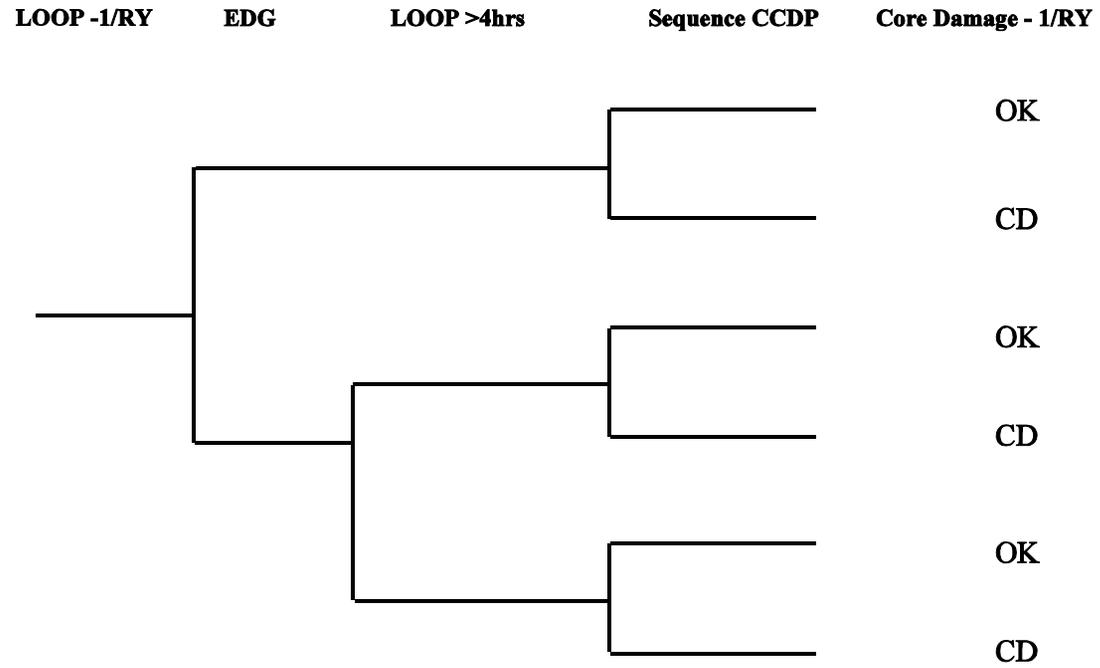
Figure B-2

# LOOP Event Tree

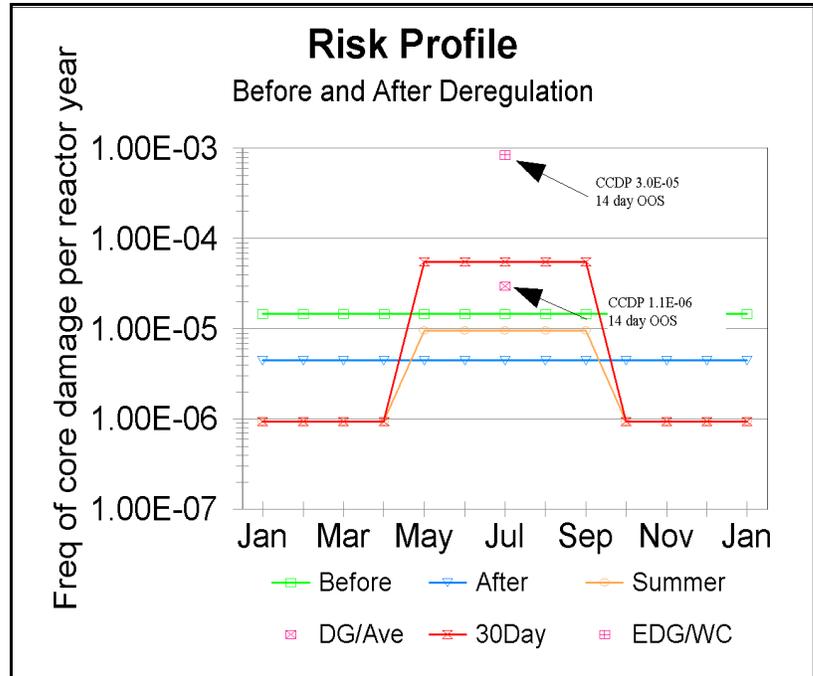
Figure B-3 -Risk Profile

The after deregulation cases were: (1) all LOOP data 1997-2001, (2) the summer months (May–September), and three summer sensitivities cases based on actual experience (3) the EDG out of service (OOS) for 14 days with a higher likelihood that grid will degrade, (4) increasing in the amount of time that the grid is degraded, and (5) the EDG OOS for 14 days while the grid is degraded. In each of the five cases, the risks after deregulation were subtracted from the risks before deregulation to obtain a “delta CDF” and the results displayed in Table B-2 and Figure B-3.

- The risks “AFTER” deregulation (1997-2001) have decreased just below the risk BEFORE deregulation. This indicates that deregulation has not eroded the risk reduction from SBO rule implementation. Comparison of the key factors in Table 2 before and after deregulation help to explain the decrease in the risk; i.e., the decreases in the risk from the decreases in the number reactor trips/Ry and number of LOOPS/Ry have offset the increases in the risk from the increases in percentage of LOOPS more than 4 hours and probability of a LOOP given a reactor trip. As a point of reference P(LOOP/RT) is 0.0045 (as compared to 0.002) and corresponds to the grid being in this condition approximately 40 hours per year.

- The risks after deregulation in the “SUMMER” - May to September, 1997–2001- have decreased slightly below that BEFORE deregulation; again deregulation has offset the risk reduction from SBO rule implementation. Comparison of the key factors in Table 2 before and after deregulation help to explain the decrease in the risk; i.e. the decreases in the risk from the decreases in the number reactor trips/Ry and number of LOOPS/Ry have offset the increases in the risk from the increases in the

percentage of LOOPS more than 4 hours and the probability of a LOOP given a reactor trip. As a point of reference P(LOOP/RT) is 0.01 and corresponds to the grid being in this condition approximately 88 hours per year, all during the summer months.

(3) As shown in Figure 1 and Table 2, the worse case increase in the risk above the before deregulation values is when the one EDGs is unavailable for 14 days with the reactor at power and the grid is in a condition such that a LOOP could result from a reactor trip. Figure 1 shows this as a spike, "EDG/WC." As previously discussed, TS typically allow one EDG to be unavailable for allowed outage times (AOTs) of up to 72 hours, and in some cases with compensatory measures, up to 14 days. As previously discussed the CCDPs used in the risk analysis reflect the use of compensatory measures.
