ADAMS ACCESSION NUMBER ML031220130

APPENDIX A

Grid Events

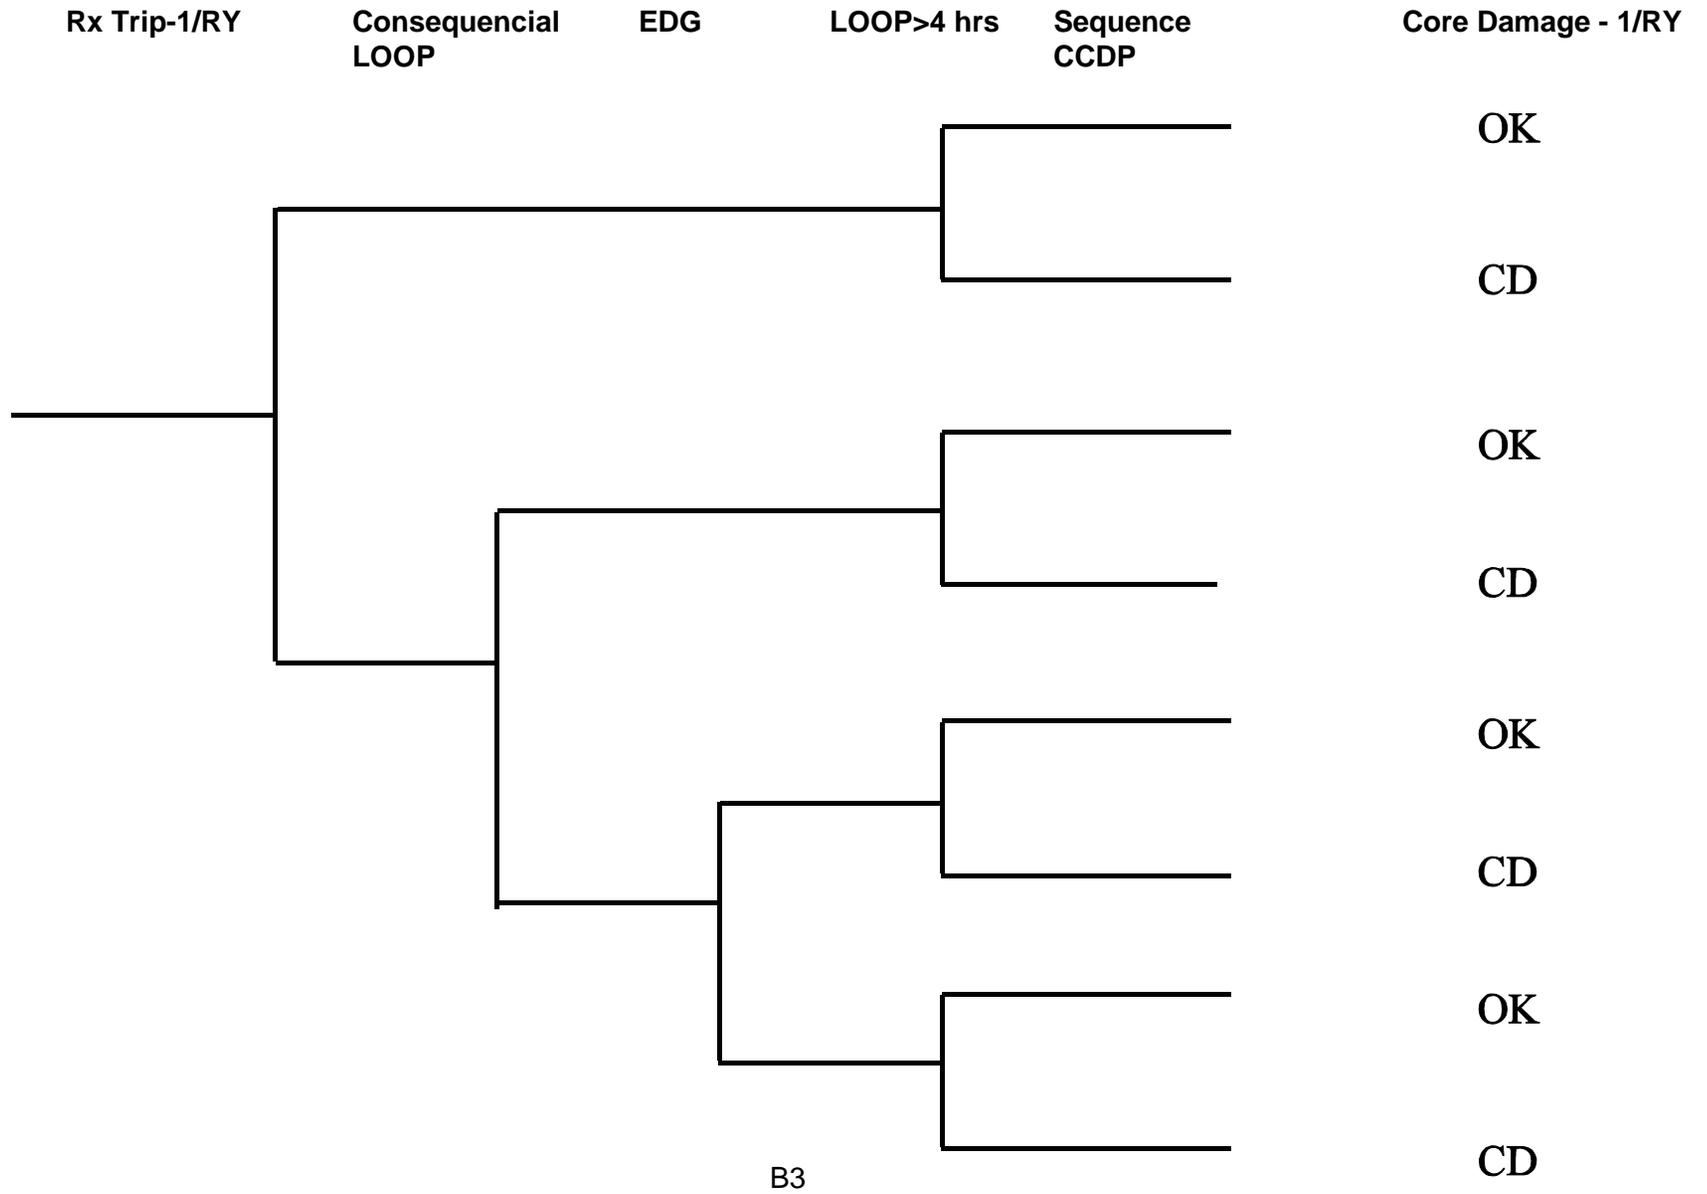
**Figure B-1
Reactor Trip- Consequential LOOP Event Tree**

represents a LOOP induced reactor trip. The event trees end with an outcome in terms of “OK meaning recovery without core damage and “CD” meaning some core damage can be expected.

Figures B-1 and B-2 show the events progress from a LOOP to “EDG” to reflect whether the onsite emergency power supplies (EDGs), started and loaded, or failed to start and load. The system failure rate for “EDG” was based on a two train EDG system and calculated from the square of the individual EDG rates (P) plus the product of the common mode (α) and EDG train failure rates (P squared + α P). A two train system is typical of the NPP onsite power system; of 103 operating reactors, approximately 75 percent have 2 or less EDGs per reactor unit. The same EDG data was used in the before and after analyses and based on actual demand performance data published by the NRC. Table B-1 shows the “EDG failure rate for a two train system” data.

A baseline average industry CDF from an SBO before deregulation was calculated as the sum of the CDFs leading to core damage in Figure B-1 and Figure B-2. The average industry CDF from an SBO for the after deregulation cases were calculated using the sum of the CDFs leading to core damage from Figure B-1 and Figure B-2 event trees. The data showed a need to analyze the risks in the summers (May to September); all of the LOOPS since 1997 occurred in the summer (May to September) in contrast to 23 of 54 LOOPS in the summers of 1985-1996.

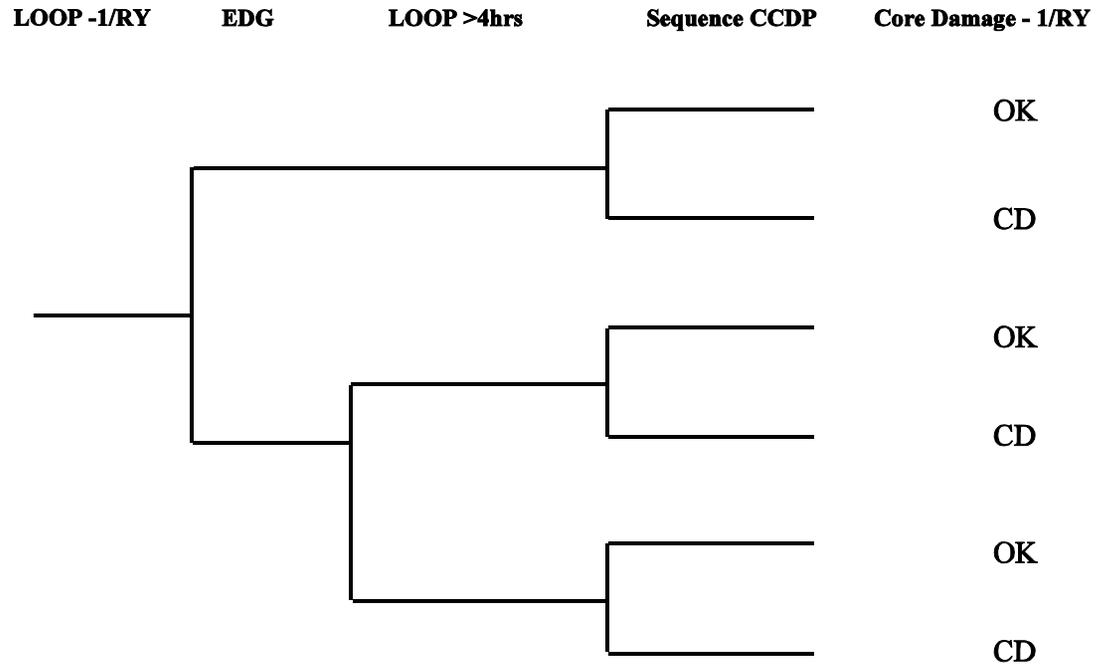
Figure B-2

LOOP Event Tree

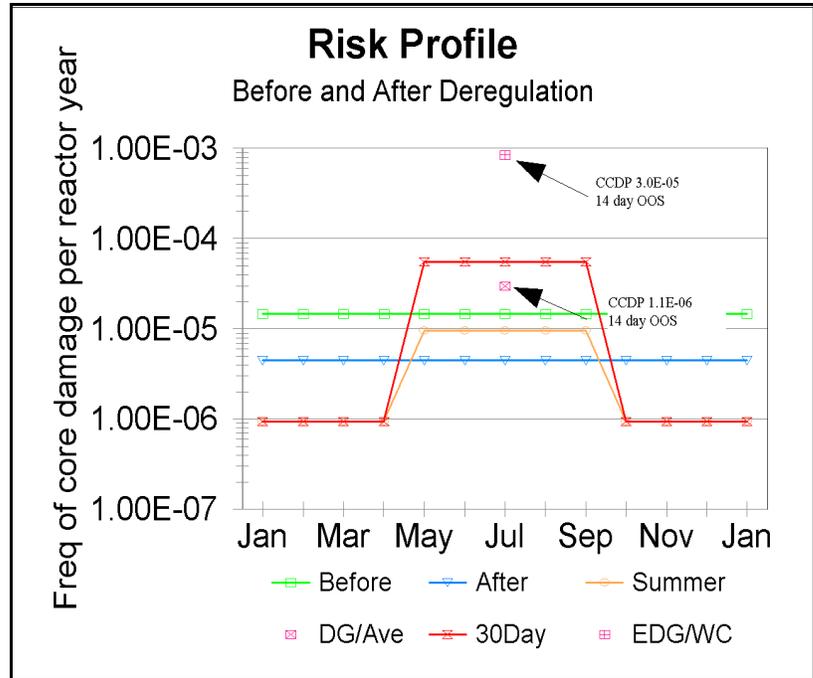
Figure B-3 -Risk Profile

The after deregulation cases were: (1) all LOOP data 1997-2001, (2) the summer months (May–September), and three summer sensitivities cases based on actual experience (3) the EDG out of service (OOS) for 14 days with a higher likelihood that grid will degrade, (4) increasing in the amount of time that the grid is degraded, and (5) the EDG OOS for 14 days while the grid is degraded. In each of the five cases, the risks after deregulation were subtracted from the risks before deregulation to obtain a “delta CDF” and the results displayed in Table B-2 and Figure B-3.

The BEFORE observations benchmark the risks, the risk reduction obtained from SBO rule implementation which are used to evaluate the significance of changes in risk after deregulation, and key data that are used to explain the delta CDF. The key data include the number of reactor trips per R Y; the number of LOOPS/R Y; the probability of a LOOP as a consequence of a reactor trip or and the percent LOOPS more than 4 hours. As a point of reference P(LOOP/RT) is 0.002 and corresponds to the grid being in this condition approximately 18 hours per year (8760 hours per year times 0.002). The results are compared graphically at the end of the discussion in Figure 1, “Risk Profile” in terms of the CDF/R Y. Figure 1 and Table 2 indicate the following:

- The risks “AFTER” deregulation (1997-2001) have decreased just below the risk BEFORE deregulation. This indicates that deregulation has not eroded the risk reduction from SBO rule implementation. Comparison of the key factors in Table 2 before and after deregulation help to explain the decrease in the risk; i.e., the decreases in the risk from the decreases in the number reactor trips/Ry and number of LOOPS/Ry have offset the increases in the risk from the increases in percentage of LOOPS more than 4 hours and probability of a LOOP given a reactor trip. As a point of reference P(LOOP/RT) is 0.0045 (as compared to 0.002) and corresponds to the grid being in this condition approximately 40 hours per year.

- The risks after deregulation in the “SUMMER” - May to September, 1997–2001- have decreased slightly below that BEFORE deregulation; again deregulation has offset the risk reduction from SBO rule implementation. Comparison of the key factors in Table 2 before and after deregulation help to explain the decrease in the risk; i.e. the decreases in the risk from the decreases in the number reactor trips/Ry and number of LOOPS/Ry have offset the increases in the risk from the increases in the percentage of LOOPS more than 4 hours and the probability of a LOOP given a reactor trip. As a point of reference P(LOOP/RT) is 0.01 and corresponds to the grid being in this condition approximately 88 hours per year, all during the summer months.
