Docket Number(s)	<u>50-368</u>
Plant/Facility Name	<u>Arkansas Nuclear One, Unit 2 (ANO-2)</u>
TAC Number(s) (if available)	<u>MB8927</u>
Reference Meeting Notice	<u>06/04/03 (ML031560682)</u>
Purpose of Meeting (copy from meeting notice)	<u>To discuss the licensee's May 8, 2003, request for</u> <u>relaxation from NRC's vessel head inspection Order.</u>

# **ANO-2 Bare Metal Visual Relaxation Request**

**Entergy Operations, Inc.**

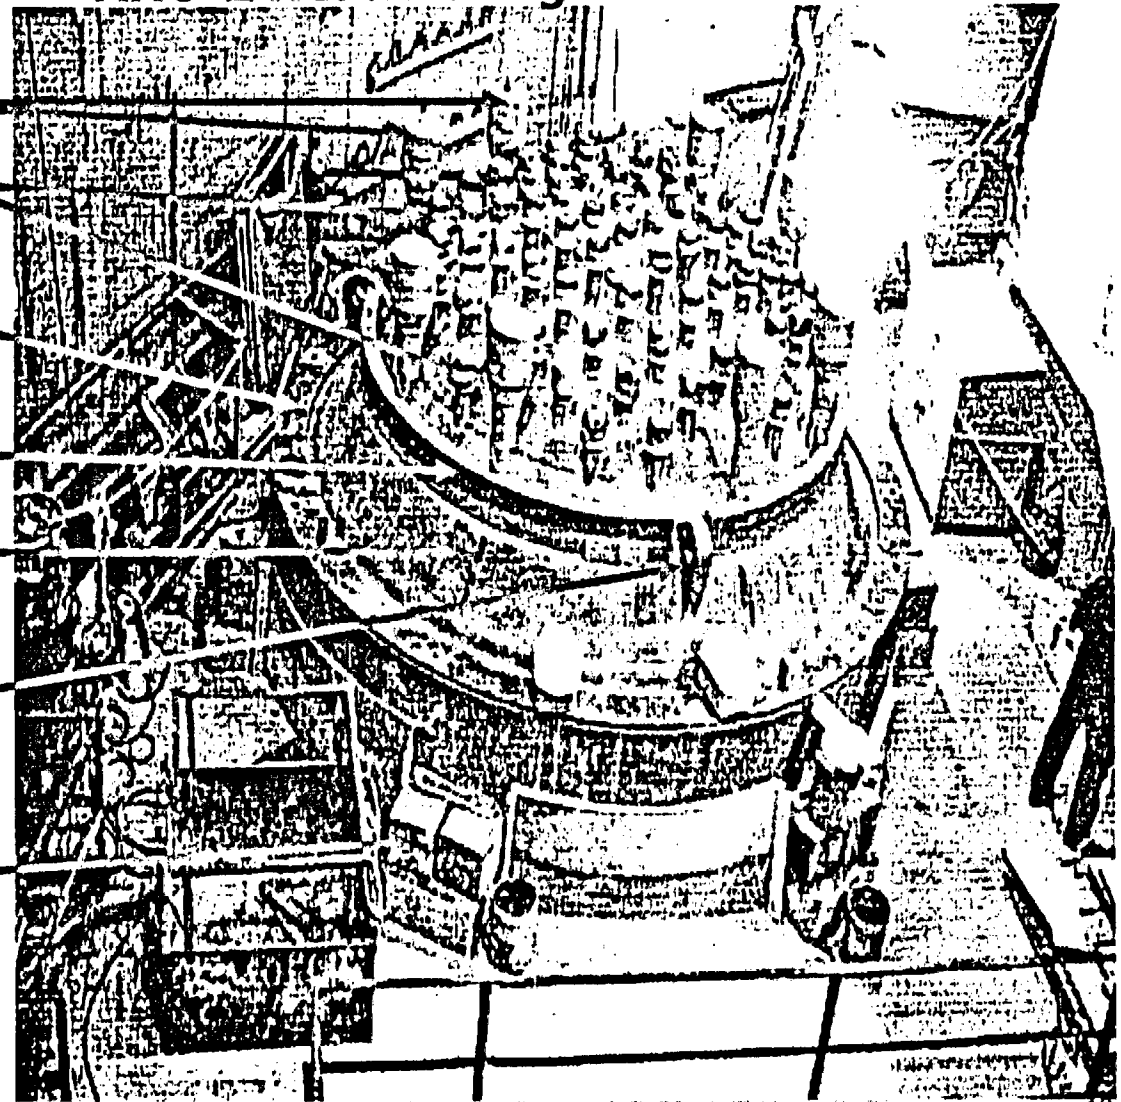
# Reactor Vessel Head Design

ANO-2 Head During Plant Construction

- ▶ ICI Nozzles (8)
- ▶ CEDM Nozzles (81)
- ▶ RVH Flange
- ▶ Insulation Retainer Ring
- ▶ Accessible Area for BMV
- ▶ Lifting Trunion
- ▶ Head Stand

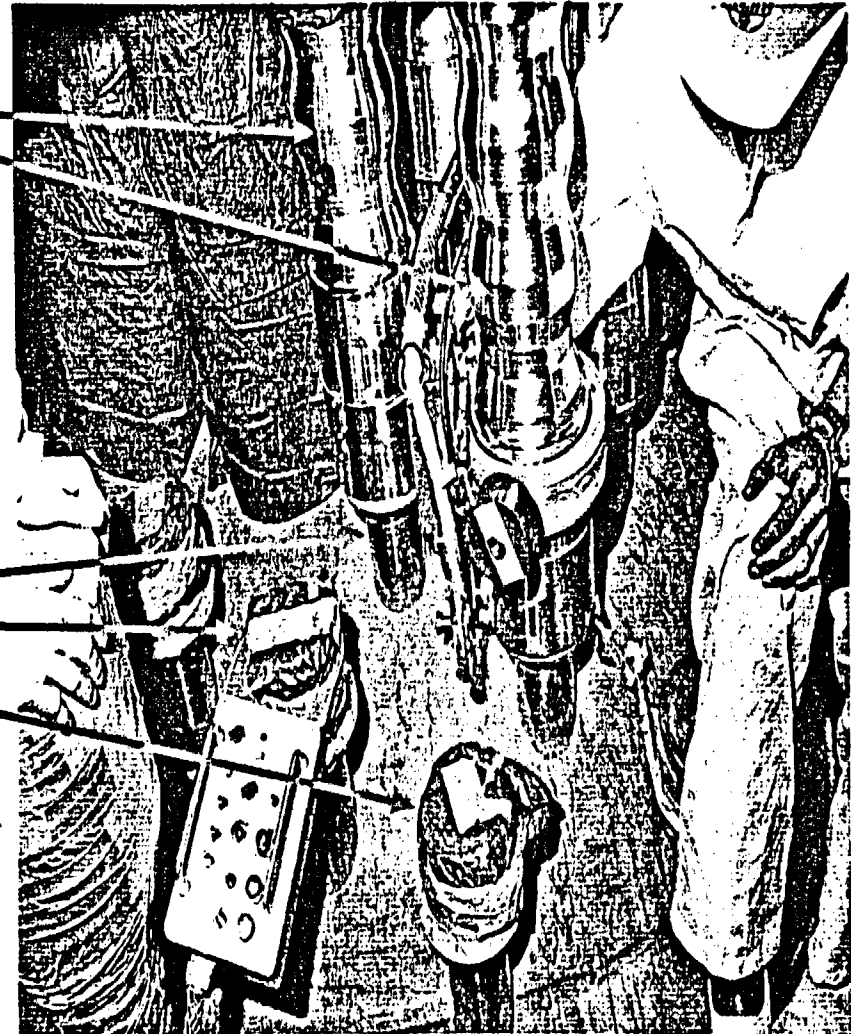
# Reactor Vessel Head Fabrication

## ANO-2 Head During Plant Construction

- ▶ CEDM Motor Housings
- ▶ Motor housing and insulation collars were installed from the center out due to the restricted access

- ▶ CEDM Nozzles
- ▶ ICI Nozzles

**Note: Nozzle to CEDM connection follow head contour**

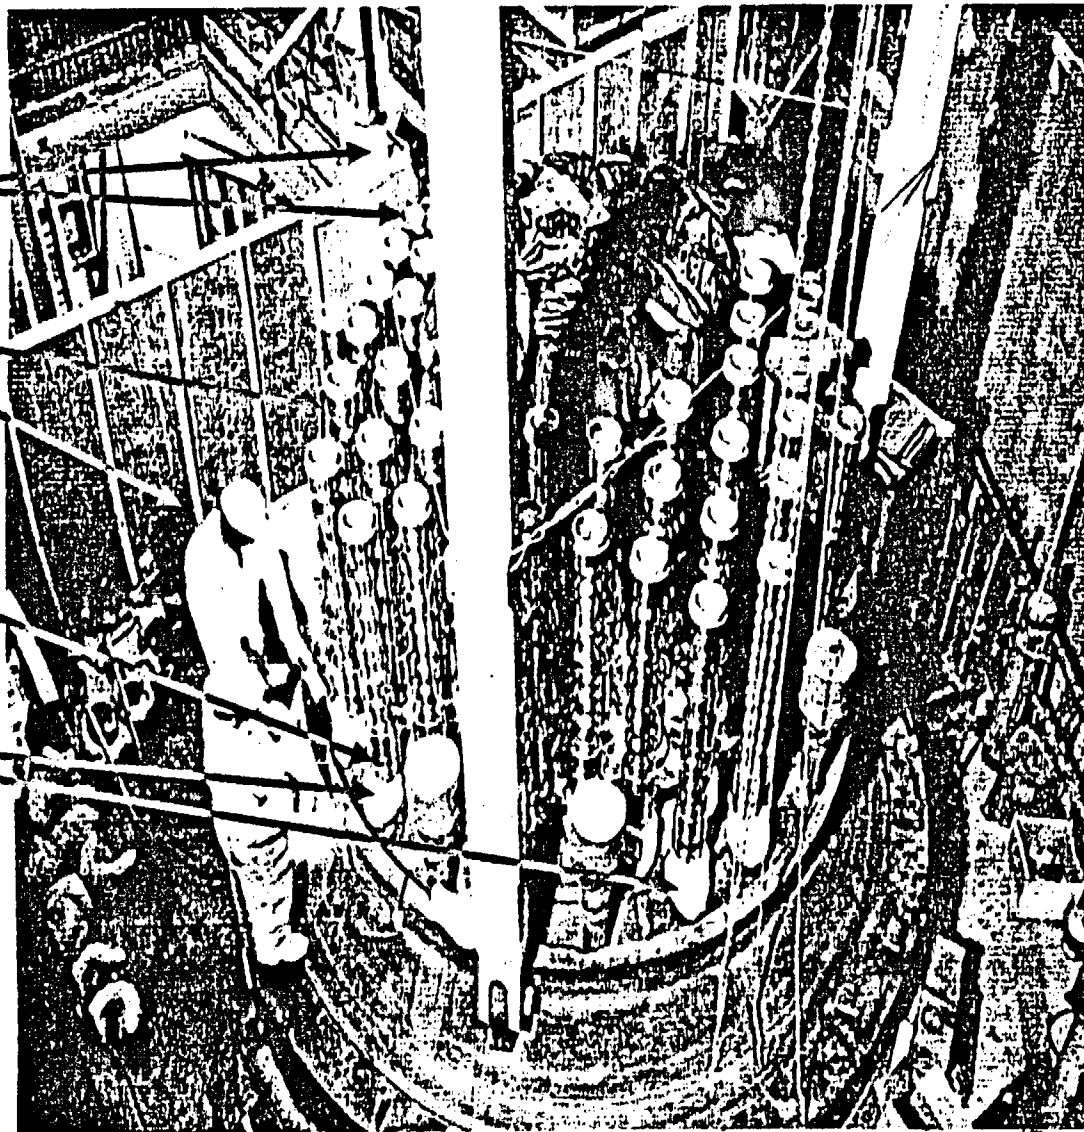
# Reactor Vessel Head Fabrication

- ▶ **Lift Rig Columns**
- ▶ **CEDM Motor Housings**
- ▶ **ICI Nozzles**
- ▶ **CEDM Insulation Collars**

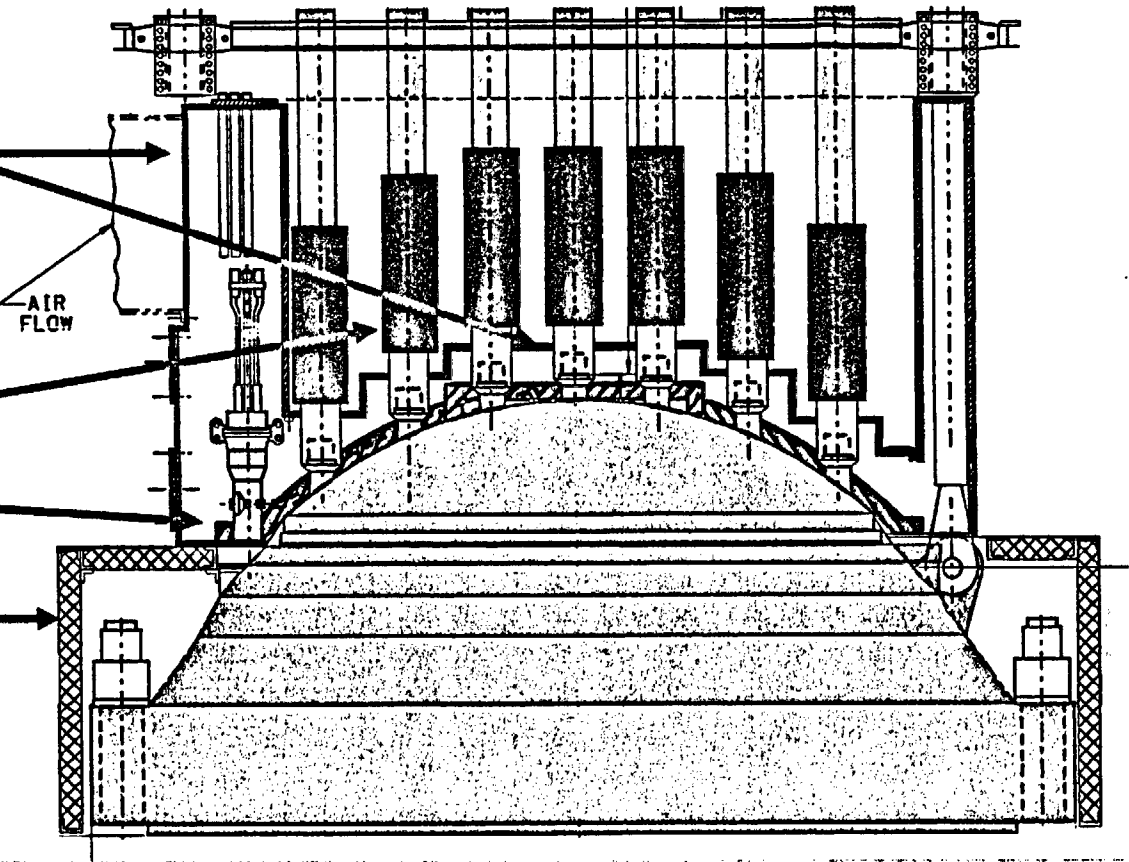
# RVH Cooling Shroud and Insulation

- ▶ **Cooling Shroud**
- ▶ **ICI Access Doors**
- ▶ **CEDM Coil Stacks**
- ▶ **Panel Insulation**
- ▶ **Removable Insulation**

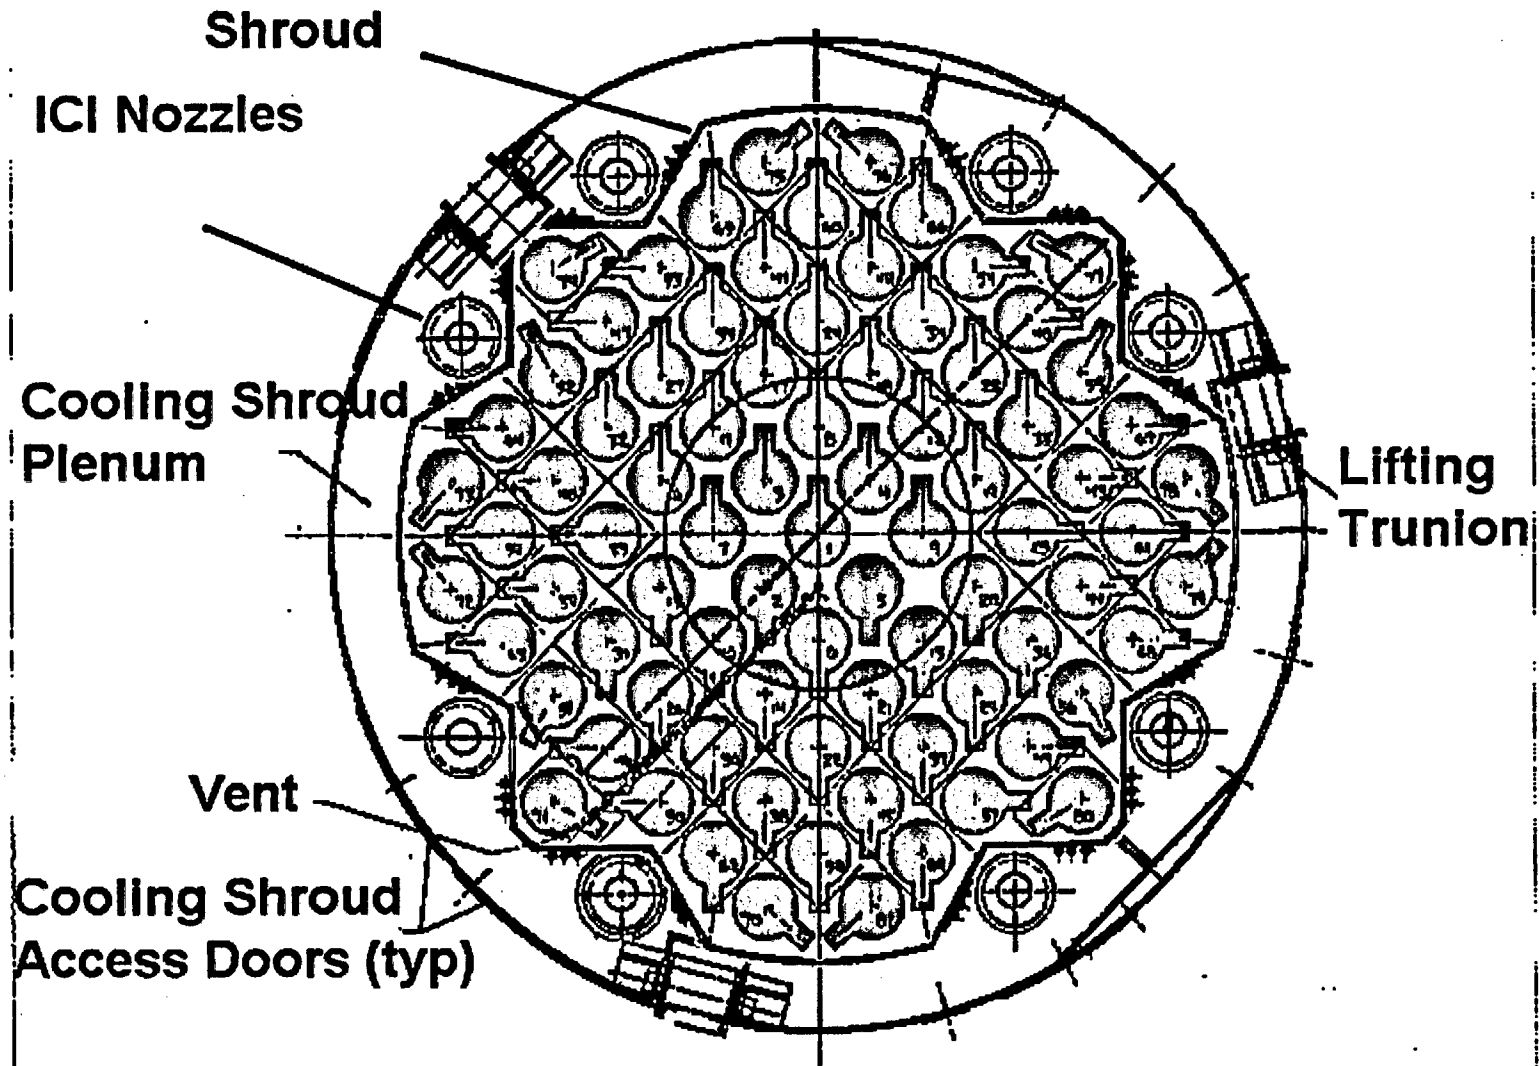
# RVH Cooling Shroud and ICI BMV

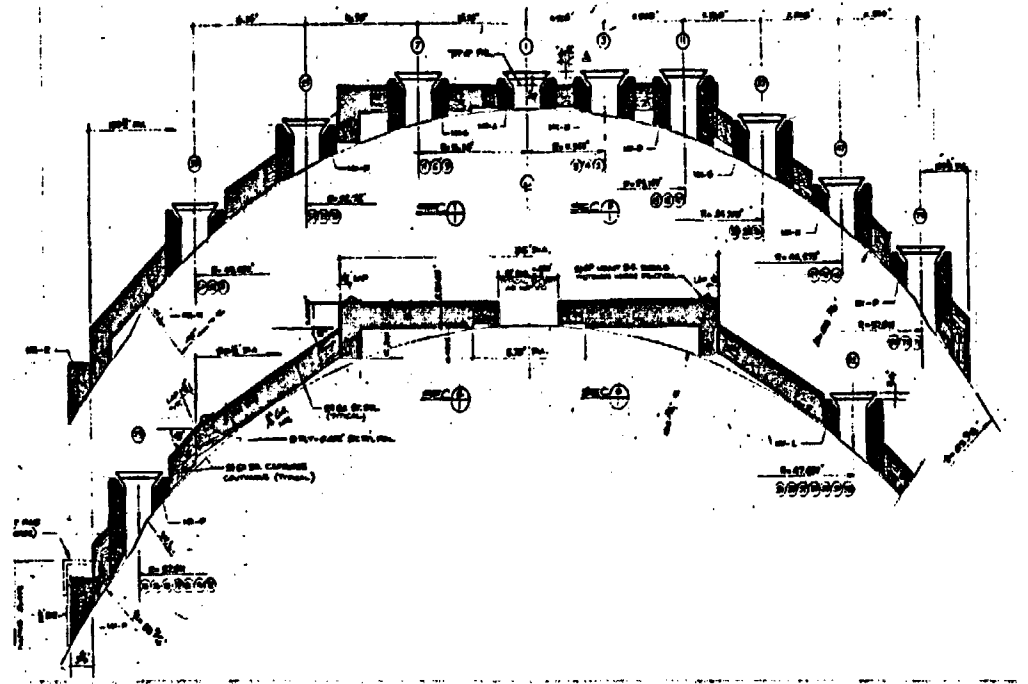
# Panel Insulation

- ▶ Collars are enclosed by prefabricated Stainless Steel reflective insulation panels
- ▶ Panels are sized to closely fit around the collars
- ▶ 56" diameter dome panel and 16 panels around the radius

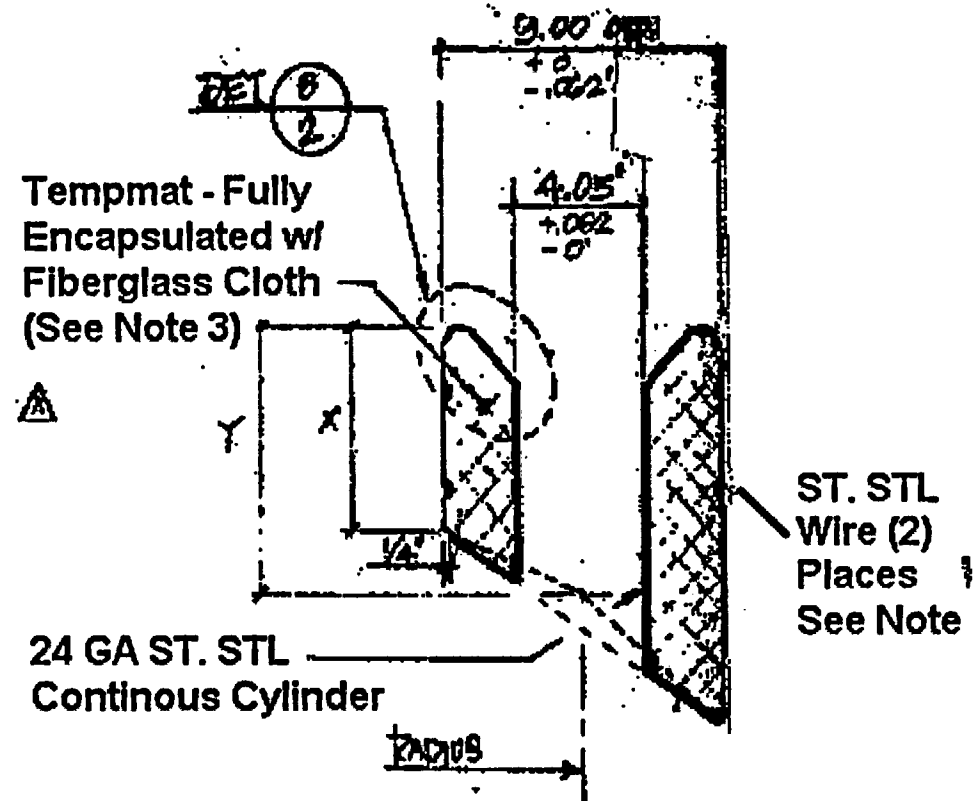
# Nozzle Insulation Collars

- ▶ 81 CEDM and 8 ICI collars
- ▶ Collars are custom fit to vessel contour
- ▶ Collars are Pittsburgh Corning TempMat insulation covered with fiberglass cloth lagging and held in place by stainless steel (SS) wire.
- ▶ Each collar contains a 24 GA SS Continuous Cylinder

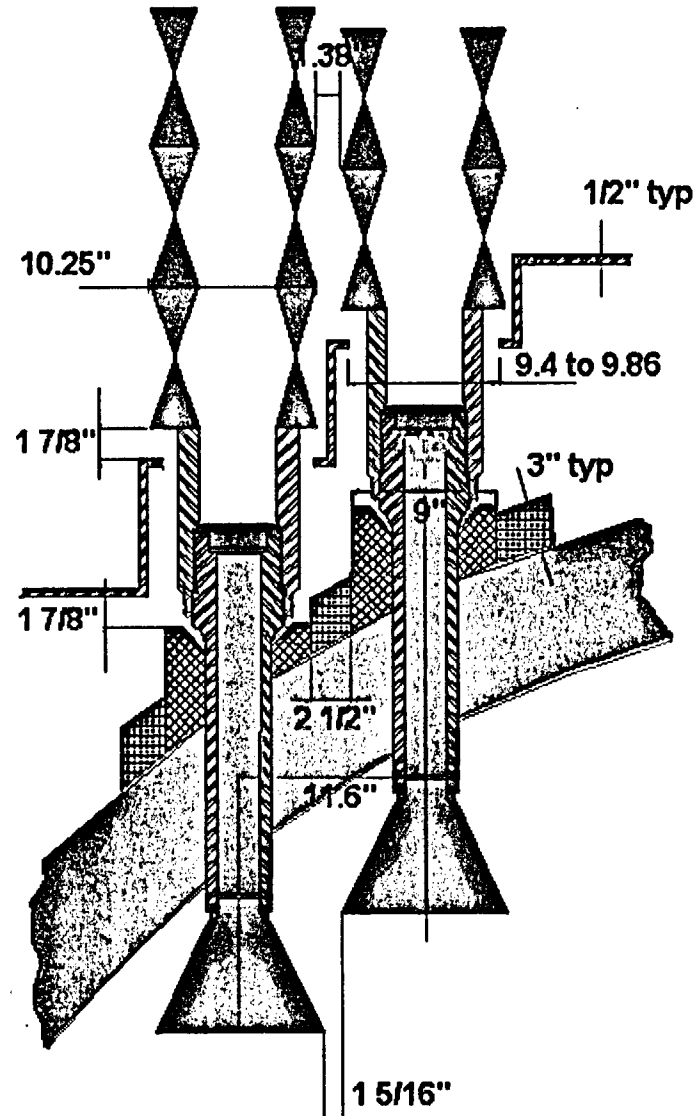
# Interferences to BMV

- ▶ CEDM collars cannot be removed with panels installed
- ▶ Cooling Shroud to Coil Stack Interference
- ▶ Openings in Cooling Shroud are part of the cooling system design
- ▶ Nozzle spacing limits access
- ▶ Limited access between cooling shroud and insulation

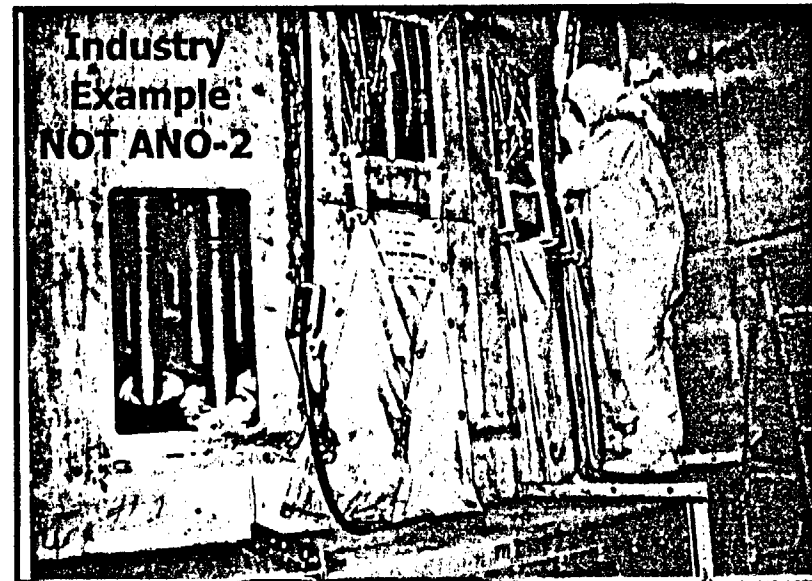
# What's Unique About ANO-2

- ▶ **CEDM Motor Housings follows the RVH contour**
- ▶ **Stepped shroud design severely limits access for BMV**
- ▶ **All Coil Stack/RSPTs must be removed to support a BMV**

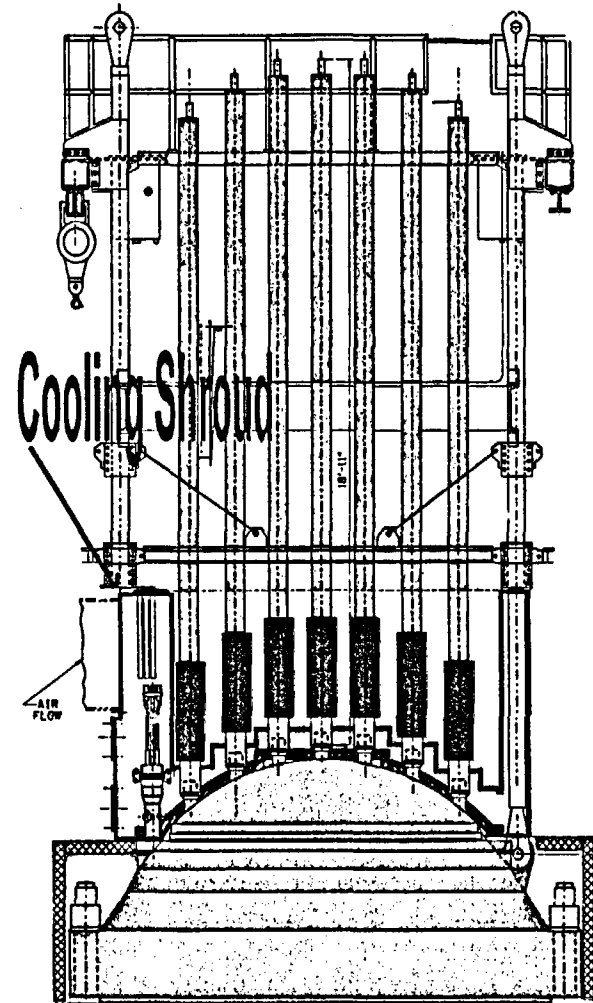
# Disassembly Sequence

- ▶ **Remove & Store 162 RSPTs**
- ▶ **Remove & Store 81 CEDM Coil Stacks**
- ▶ **Disconnect, Rig and Store Superstructure**
- ▶ **Remove 17 Insulation Panels**
- ▶ **Remove 81 CEDM Insulation Collars**

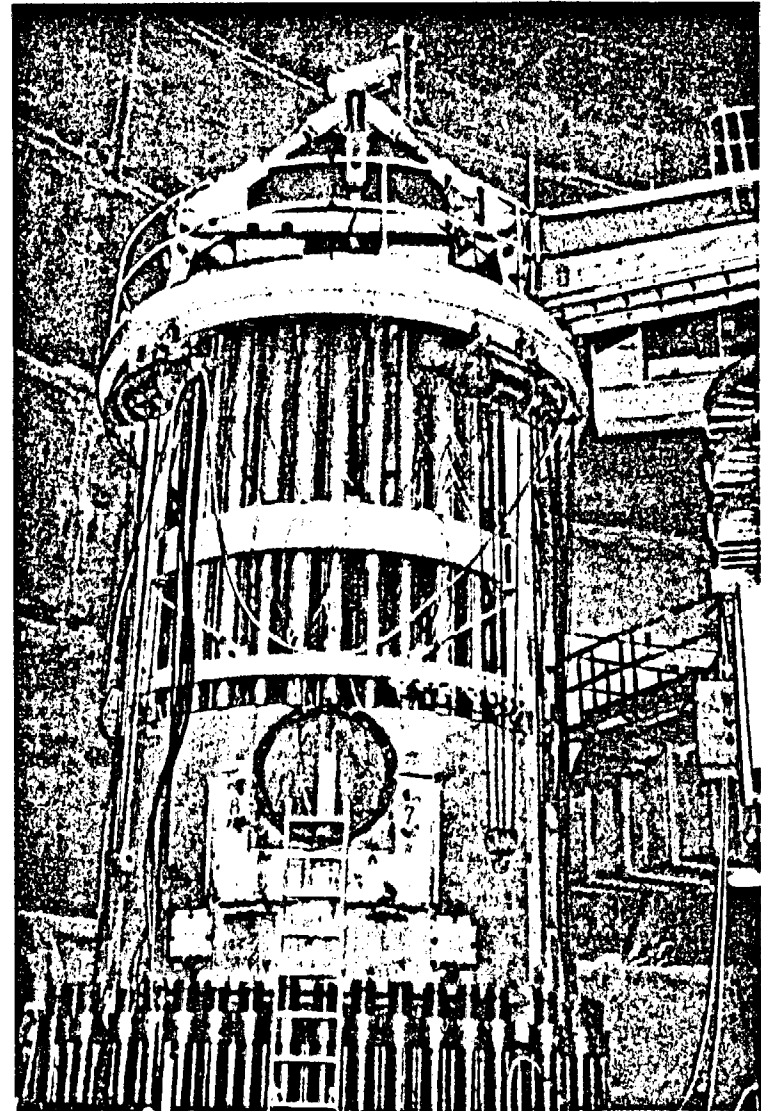
# Assembly Sequence

- ▶ **Install 81 re-designed Insulation Collars**
- ▶ **Re-install insulation Panels**
- ▶ **Re-install superstructure**
- ▶ **Re-install and test 81 CEDM coils stacks**
- ▶ **Re-install and test 162 RSPTs**

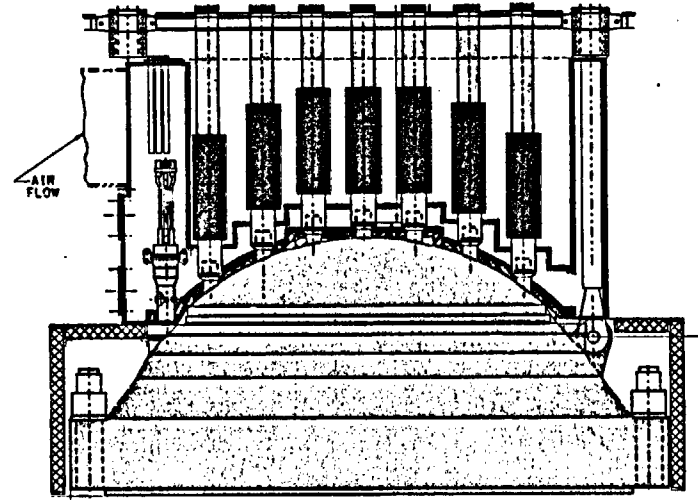
# 2R15 - Supplemental Visual Inspection Above Insulation

- ▶ Performed visual exam above shroud, around all ICI nozzles, and some outboard CEDM nozzles
- ▶ No boron found

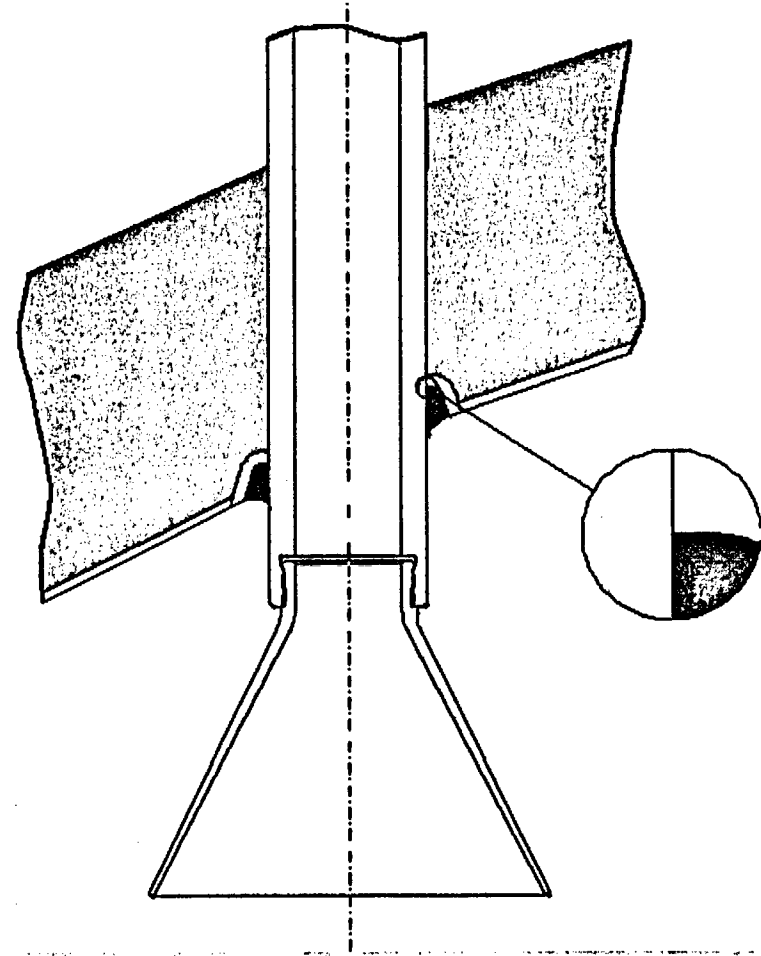
# Demonstration of Triple Point

## Energy Demonstration

- ▶ Demonstrated detection of flat-bottomed holes up to 0.200" in depth, on Energy/MRP Mock-up in 2002.
- ▶ Detected Circ Flaws extending to approximately 0.050" deep in Energy/MRP Mock-up in 2002.

## Phase 2 MRP Demonstration

- ▶ Detected a pure axial/radial squeezed notch that extended thru-weld to the Triple Point (0.060").

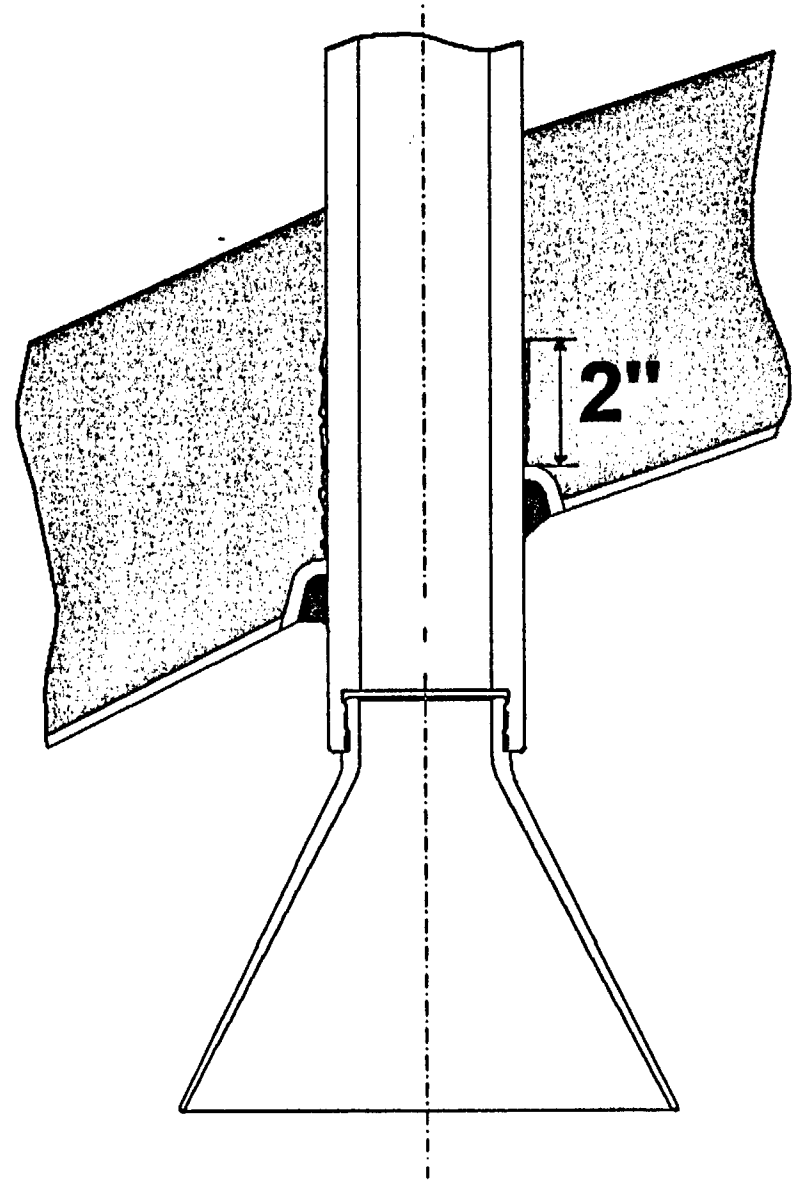
# Riverbed Exam

- ▶ Proceduralized process
- ▶ Performed with 2.25 MHz, 0 degree Transducer
- ▶ Highly sensitive to amplitude changes in tube backwall signal
- ▶ Effective for detection of leakage in annulus

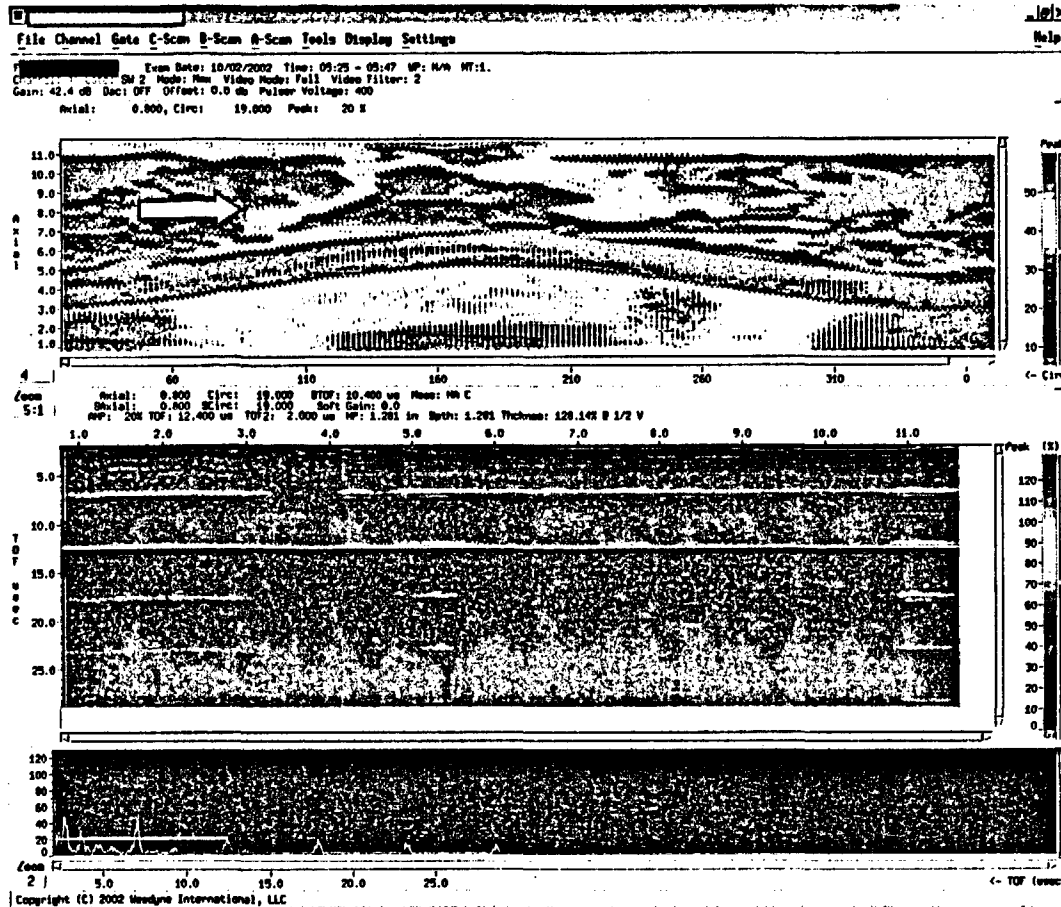
# Riverbed Identification

- ▶ Leak path identified with straight beam ultrasonics
- ▶ Leak path leads to loss of shrink fit integrity and a resulting increase in reflectivity

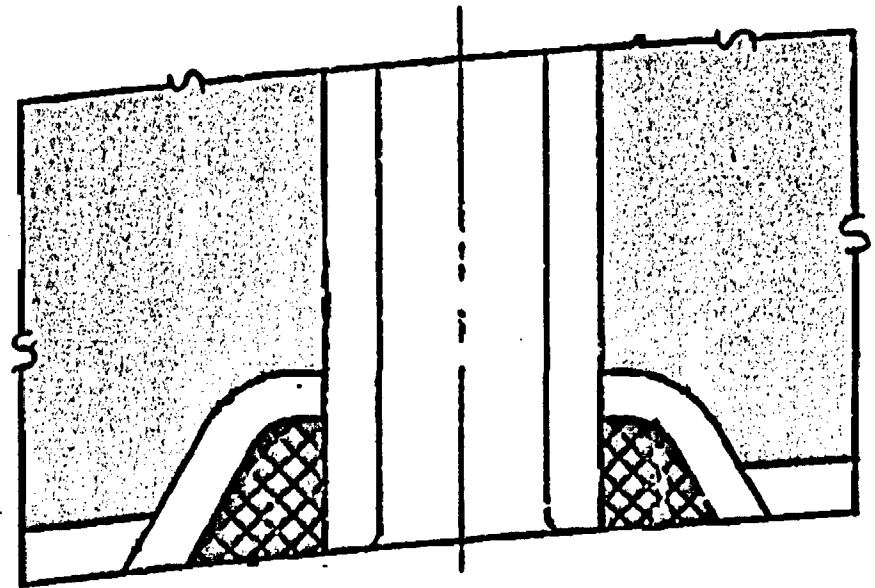
# Vent Line Wetted Surface Exam

- ▶ Complete wetted surfaces examination
  - ECT examination at tube ID surface
  - ECT array examination of J-weld surface

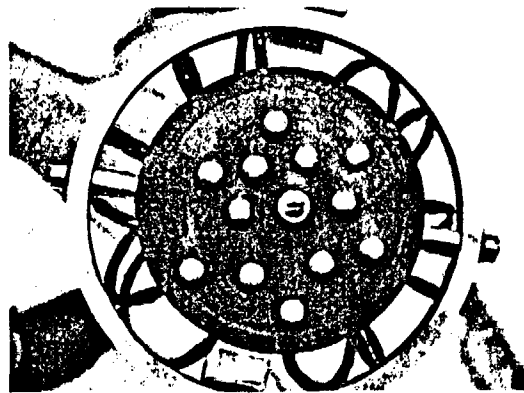
# Reactor Vessel Vent Line J-Groove Weld ECT Examination

- ▶ Manual delivery, low dose
- ▶ 12-coil array
  - 100, 250 and 600 kHz
- ▶ Coils offset to provide coverage in one rotation

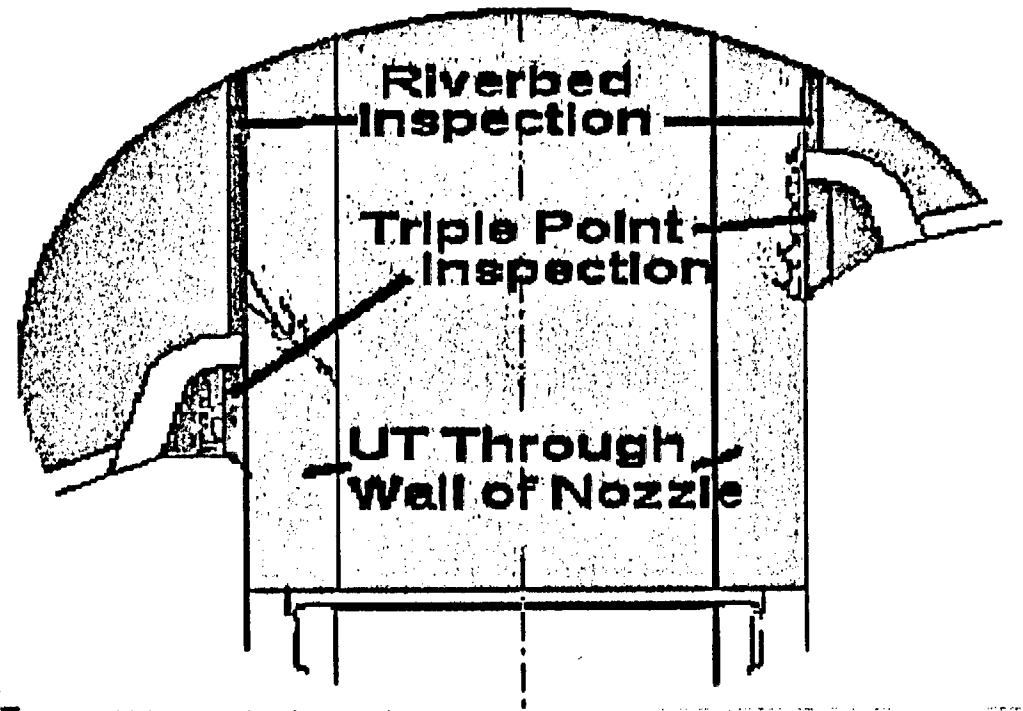
# CEDM/ICI Volumetric Summary

- ▶ Axial and Circ TOFD
- ▶ 0 degree UT
- ▶ Triple Point
- ▶ 0 degree "Riverbed" examination for leakage assessment

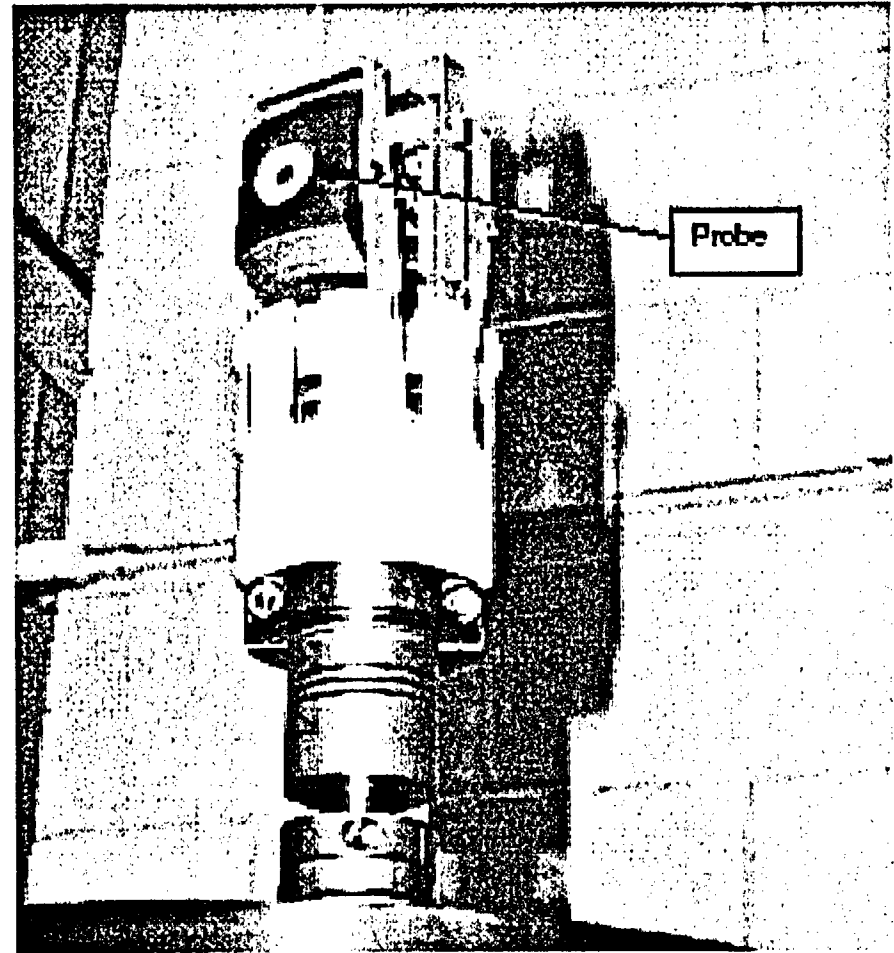
# Development of Low Frequency EC Vessel Leakage/Integrity Inspection

- ▶ Developed in Spring of 2002, as diagnostic tool
- ▶ Designed to detect leakage/degradation of carbon steel in head penetration annulus region
- ▶ Utilizes  $\frac{3}{4}$ " Driver/Pick-up probe, operating at 200 Hz

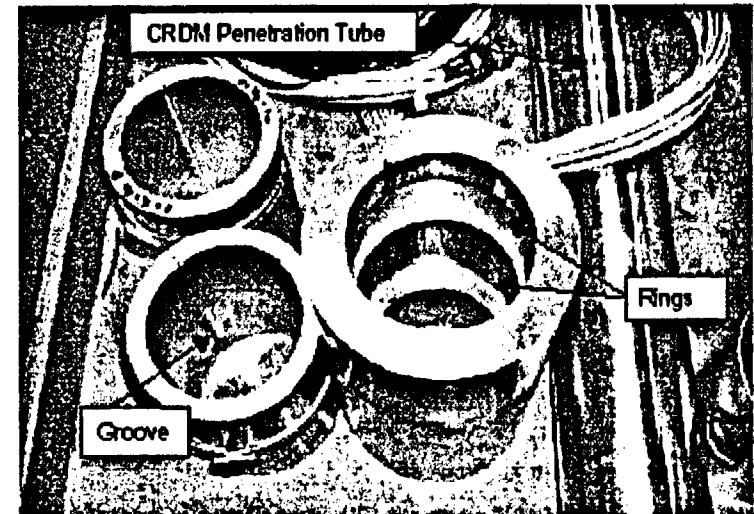
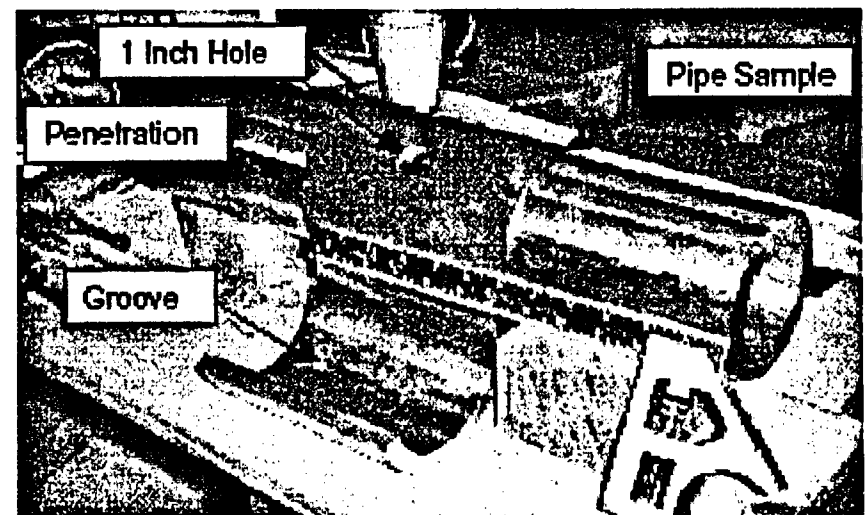
# Development of Low Frequency Vessel Leakage/Integrity Inspection

- ▶ Evaluated using machined samples, representing various degradation morphologies (rings, grooves, drilled holes)
- ▶ Tests performed both on a test stand, and on an actual reactor vessel head at the Waltz Mill facility

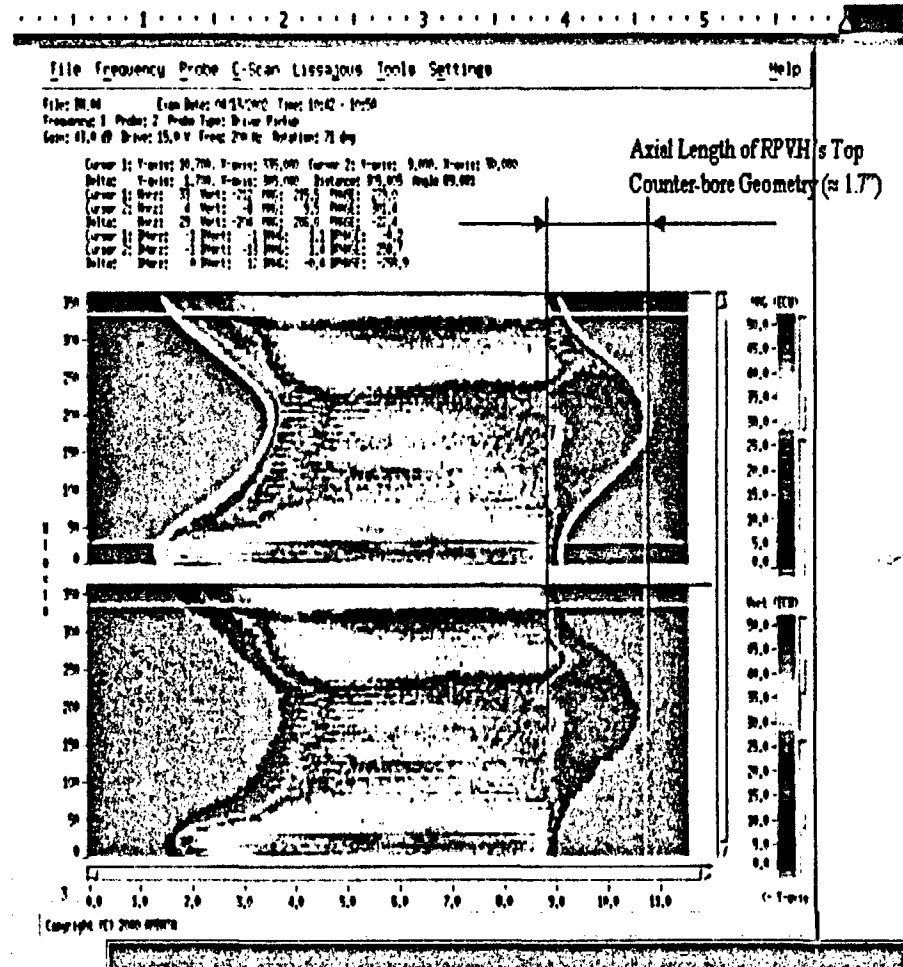
# Development of Low Frequency Vessel Leakage/Integrity Inspection

- ▶ Inspections were performed on six penetrations on the Jamesport reactor head
- ▶ Results showed this tool's ability to map the counter bore region near the OD of the head (0.015" change)

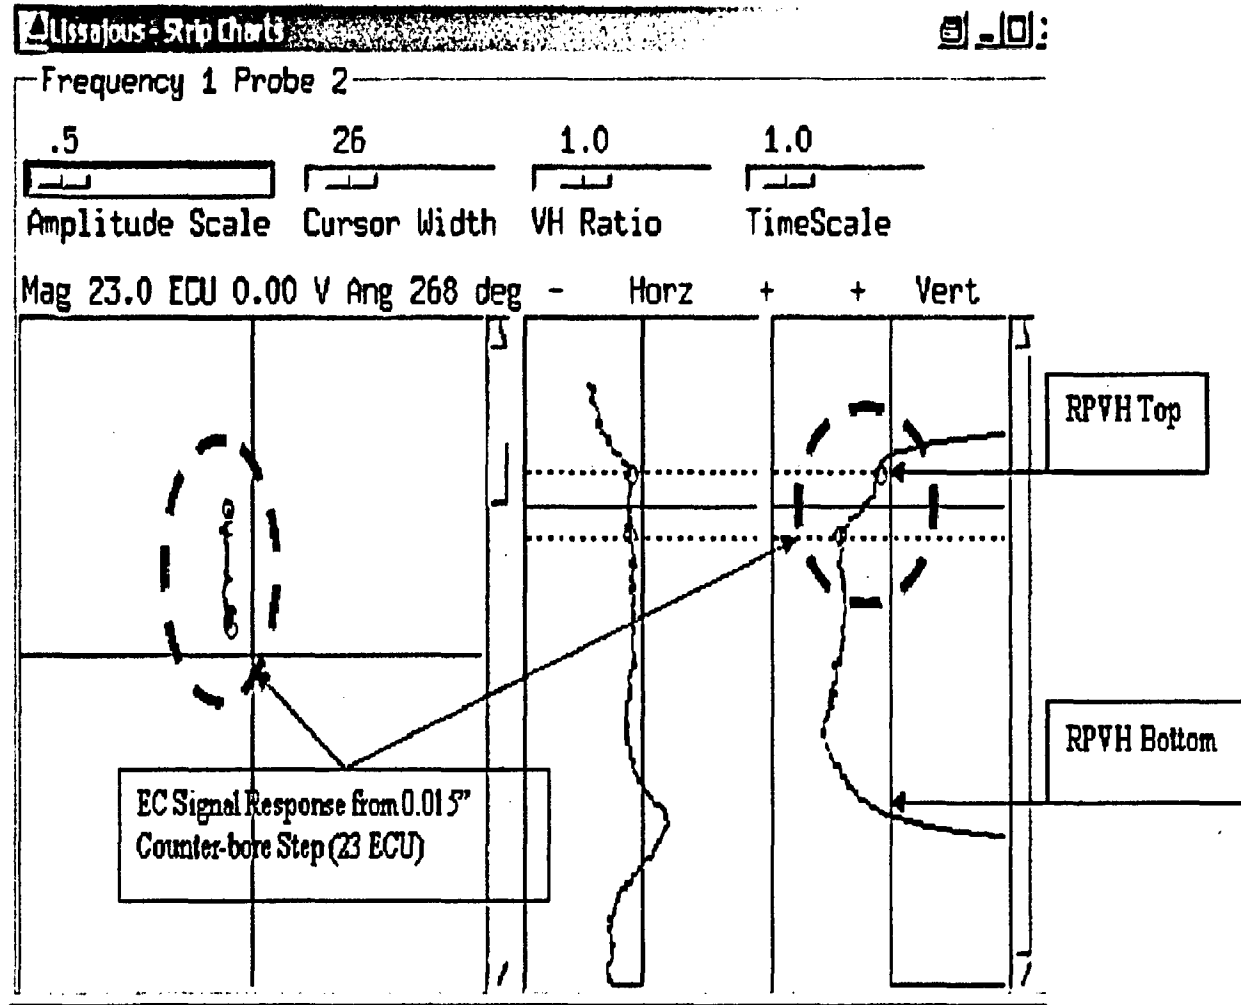
# Development of Low Frequency ECT Vessel Leakage/Integrity Inspection

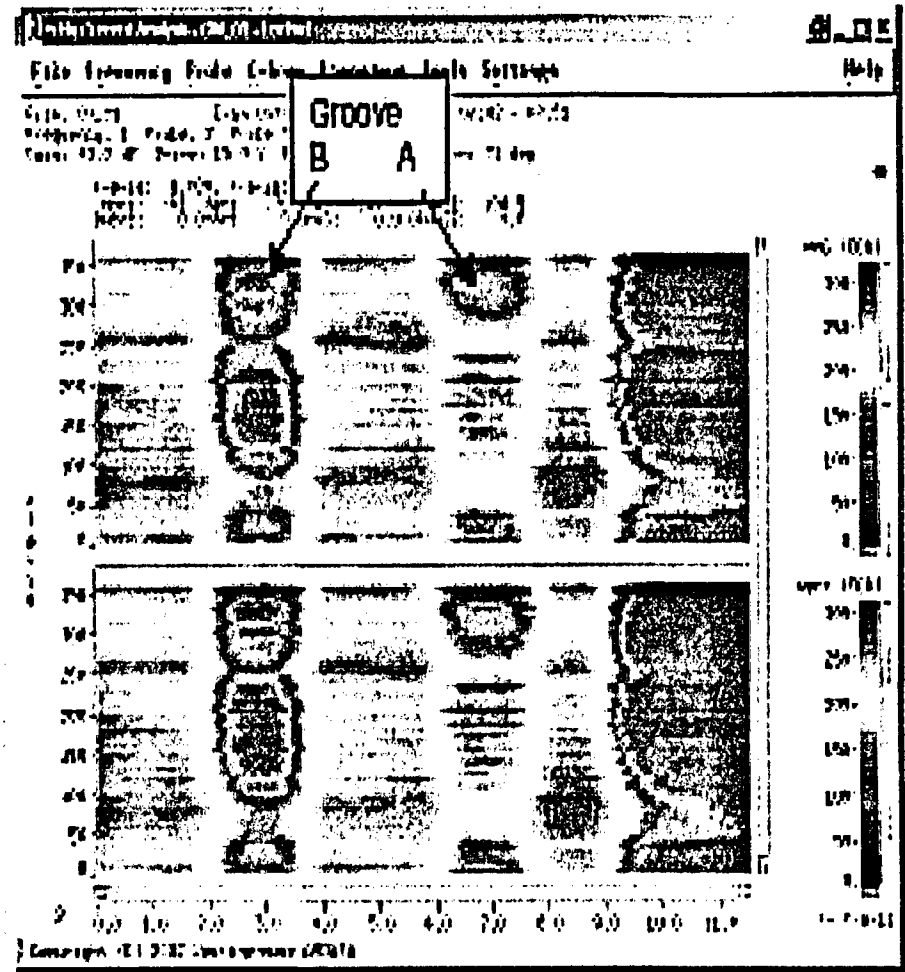
# Development of Low Frequency Vessel Leakage/Integrity Inspection

- ▶ Picture shows machined grooves of 0.250" depth (A) and 0.500" depth (B).
- ▶ Both grooves are 2" in axial length and 360 degrees around the sample.

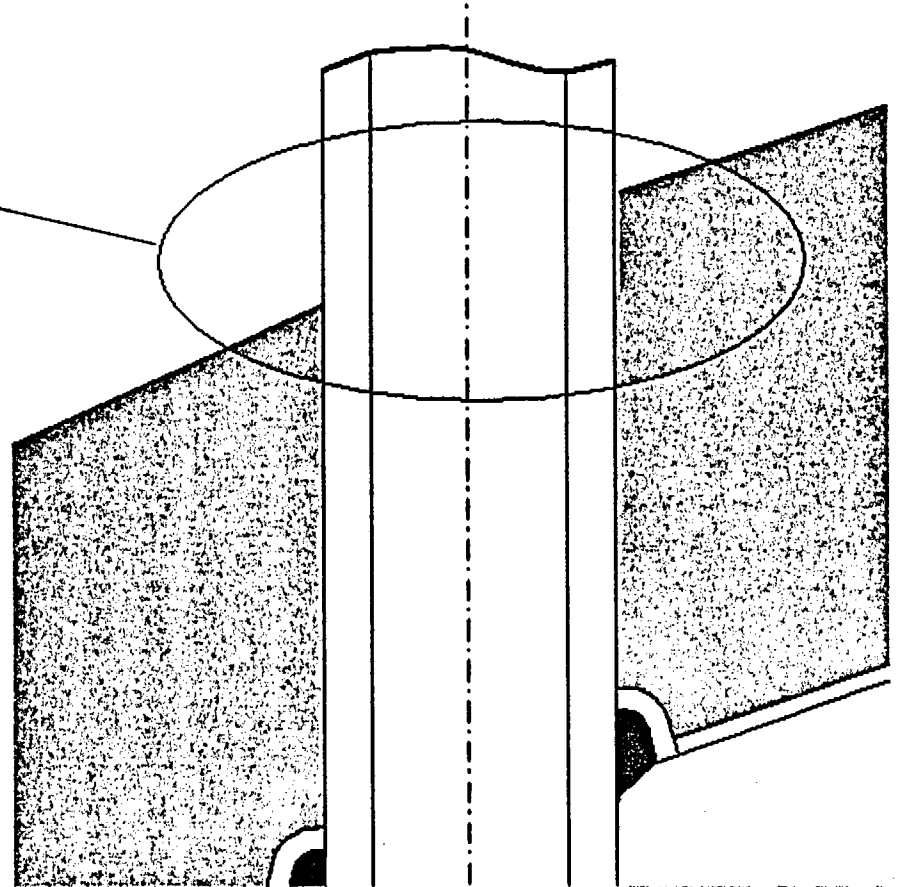
# Low Frequency Vessel Inspection

- ▶ OD of Vessel and counter bore inspection area
- ▶ Measures degradation
- ▶ Diverse and complementary to UT (triple point and riverbed)
- ▶ Assures integrity of OD of Vessel

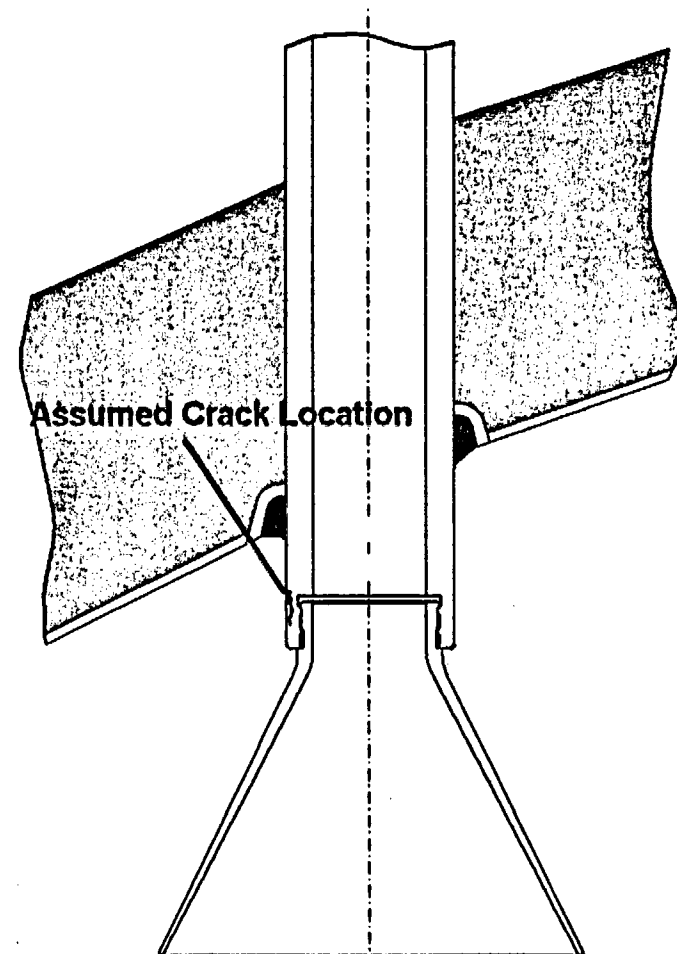
# ORDER Relaxation - Inspection of Threaded Nozzle Cone Area

- ▶ Threaded length 1.34" not inspected
- ▶ Dead Zone ~0.2 inches
- ▶ Crack Growth Analysis from dead zone area to J-weld interface
  - Finite element analysis for residual operating and weld stresses
  - Elastic/plastic fracture mechanics analysis
- ▶ All nozzles acceptable for greater than one cycle
