Docket Number(s)	<u>50-368</u>
Plant/Facility Name	<u>Arkansas Nuclear One, Unit 2 (ANO-2)</u>
TAC Number(s) (if available)	<u>MB8927</u>
Reference Meeting Notice	<u>06/04/03 (ML031560682)</u>
Purpose of Meeting (copy from meeting notice)	<u>To discuss the licensee's May 8, 2003, request for</u> <u>relaxation from NRC's vessel head inspection Order.</u>

# **ANO-2 Bare Metal Visual Relaxation Request**

**Entergy Operations, Inc.**

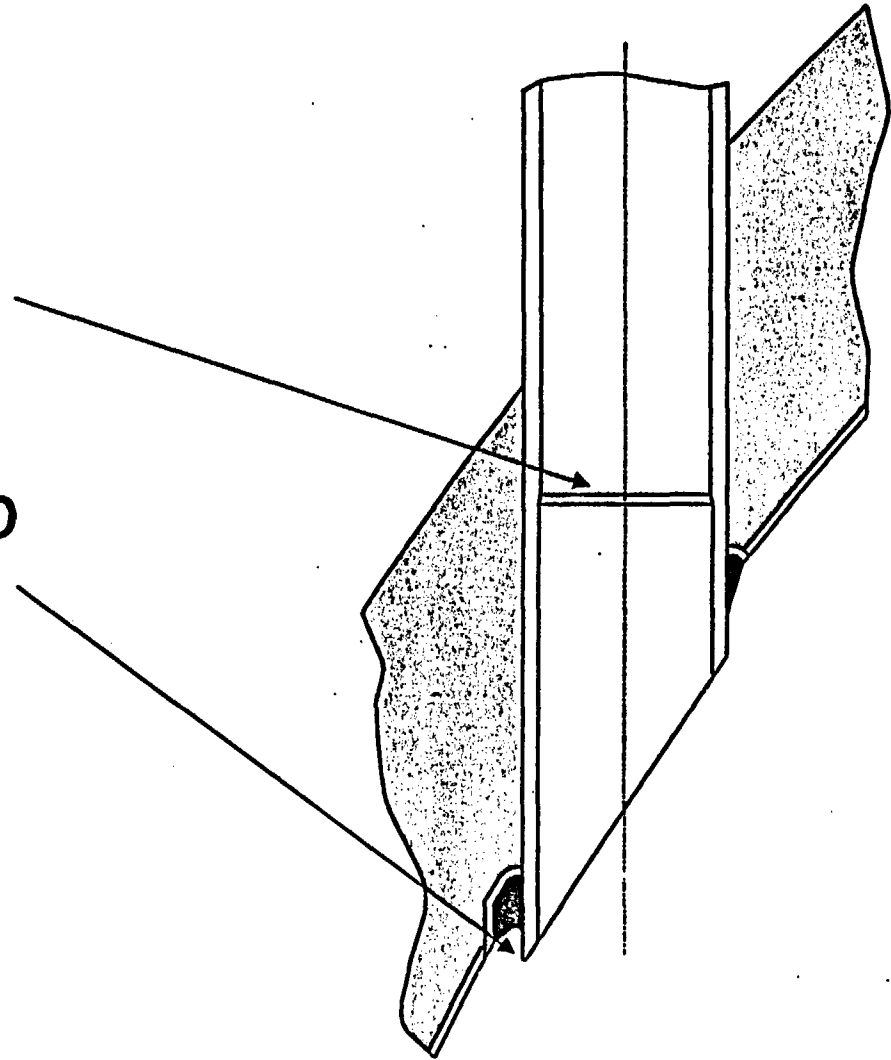
# ORDER Relaxation - Inspection of ICI Nozzle Ends

- ▶ Counter Bore affects the 2" criteria above the weld
- ▶ Cannot see to the tip of nozzle
