Enclosed please find the response to your request for additional documentation regarding the design and safety features of the Genesis irradiator that had been previously discussed with representatives from the NRC on former site visits to our facility and to the fabricator.

This is in reference to the problem of the hoist cables breaking. This was a concern to CHL during the design of the Pool, the Plenum, and the Hoist Assemblies. Design standards were followed in the design of the Hoist Assembly to insure that a cable never does break. In addition to the design of the hoist, an annual inspection of the hoist will be performed that will include an inspection of the cables to identify any cables with broken strands. Any cables that are found to have broken strands would be replaced before the hoist is returned to service. Tests were done on three different cable assemblies to prove out the swaging of the fittings and the ultimate break strength of the cable itself. The break strength test showed that the cable itself failed at 24,410 lbs. for a single cable. (See test results attached.) The maximum weight of the bell and cart with a full load of product is less than 8,000 lbs. Th

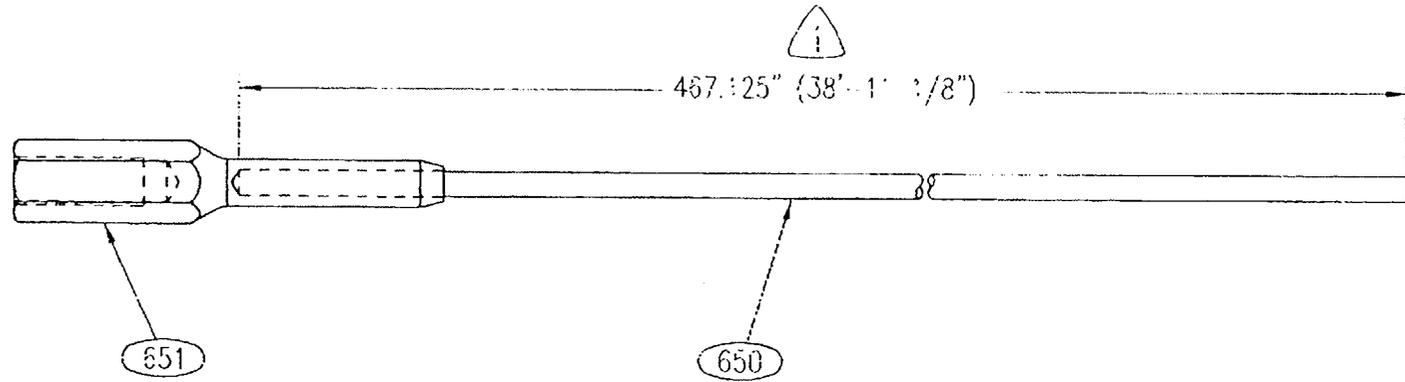
NOTES:
1. EACH ASSEMBLY TO BE LOAD TESTED TO 9,120 LBS.

651	33248-621-651
ITEM	DETAIL DWG

Drawn	C. Feiv	DATE	2/14/03
Engineer	A. Landis	DATE	2/18/03
Approved		Customer	CHL
Checked		Title	TURNBUCKLE
Issued		Ref. Dwg.	
		Dwg. No.	33248-620-000
		Sheet	1 of 1
Job Number	34344	Scale	3" = 1'-0"
Size	A	Unless Noted Otherwise

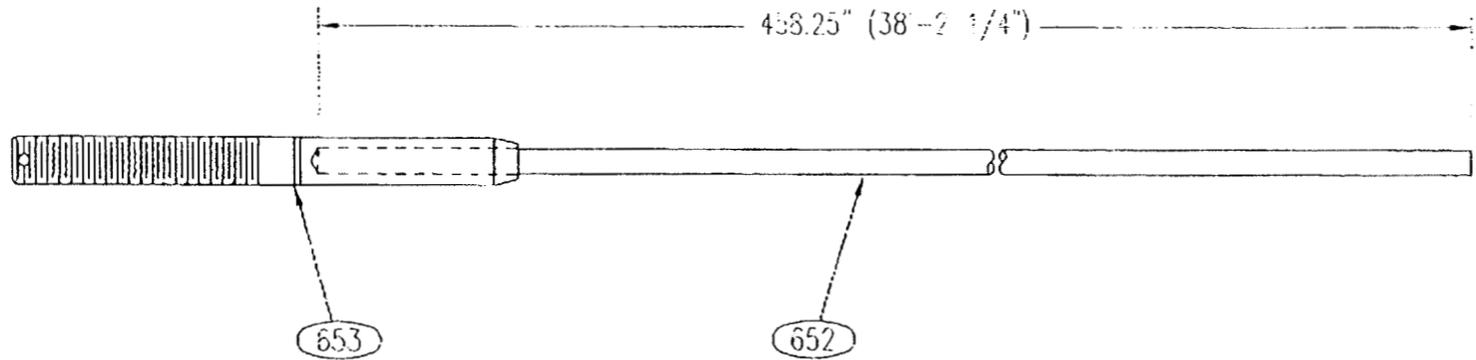
NOTES:
 1. EACH ASSEMBLY TO BE LOAD TESTED TO 9,120 LBS.

653	33248-623-651
ITEM	DETAIL DWG

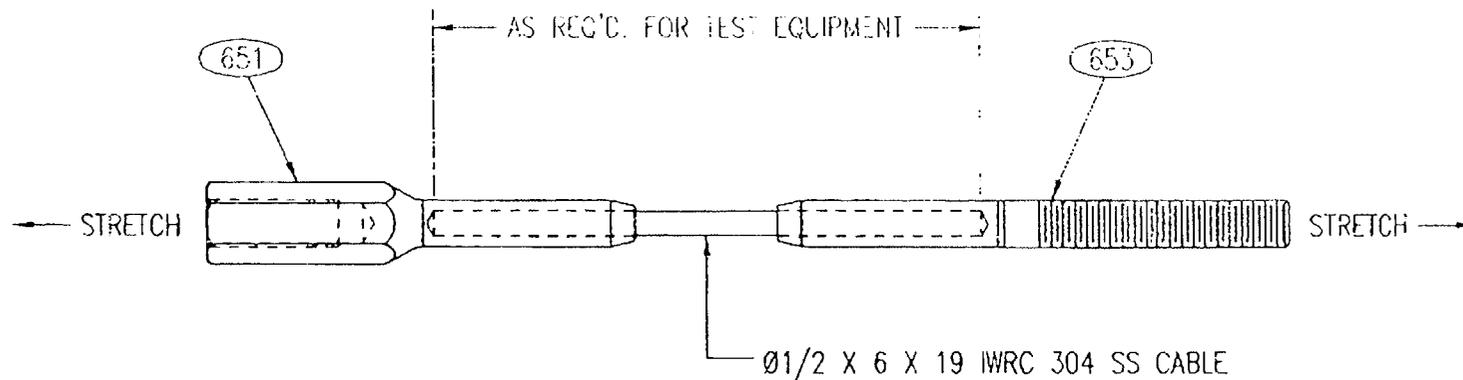
NOTES:

1. DESTRUCTIVE TEST BY STRETCHING TO FAILURE TO PROVE SWAGE SYSTEM.
- 1 2. RECORD BREAK STRENGTH. SYSTEM FAILURE POINT MUST EXCEED 22,800 LBS. FOR CHL ACCEPTANCE OF ANY CABLE ASSEMBLIES UTILIZING TYPICAL FITTINGS AND/OR SWAGE PROCEDURE.
- 1 3. CHL WILL RECEIVE DESTROYED ASSEMBLY.
